PERFORMANCE EVALUATION REPORT

MISSION 1114-1 and 1114-2

FTV 1660, CR-14

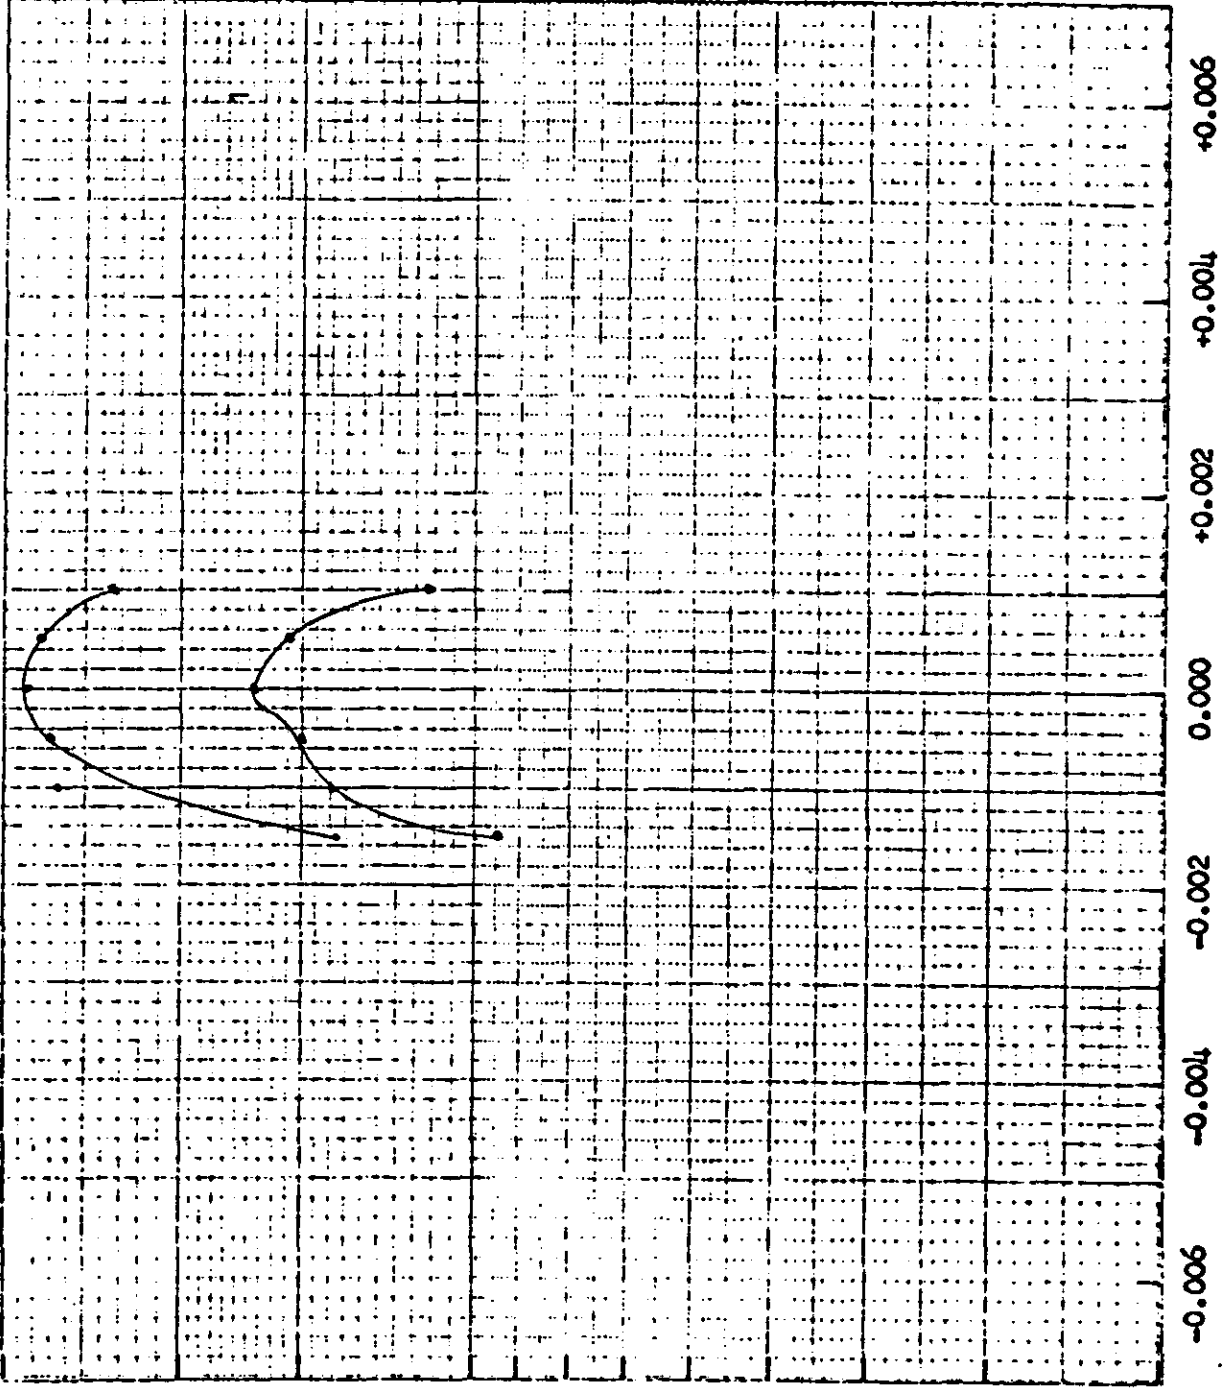
FIGURE 2-1

Figures 2-1 and 2-2 show the graphical thru focus results. The low contrast (2/1) dynamic resolution of the Forward-looking camera (#329) was 218 lines per millimeter; the high contrast resolution was 337 lines per millimeter. The final low contrast (2/1) dynamic resolution of the Aft-looking camera (#328) was 178 lines per millimeter; the high contrast resolution was 298 lines per millimeter.
