MISSION 1201

SYSTEM
PERFORMANCE EVALUATION TEAM
MISSION 1201

27 SEPTEMBER 1971

PERFORMANCE EVALUATION TEAM
REPORT NO. 1201/71

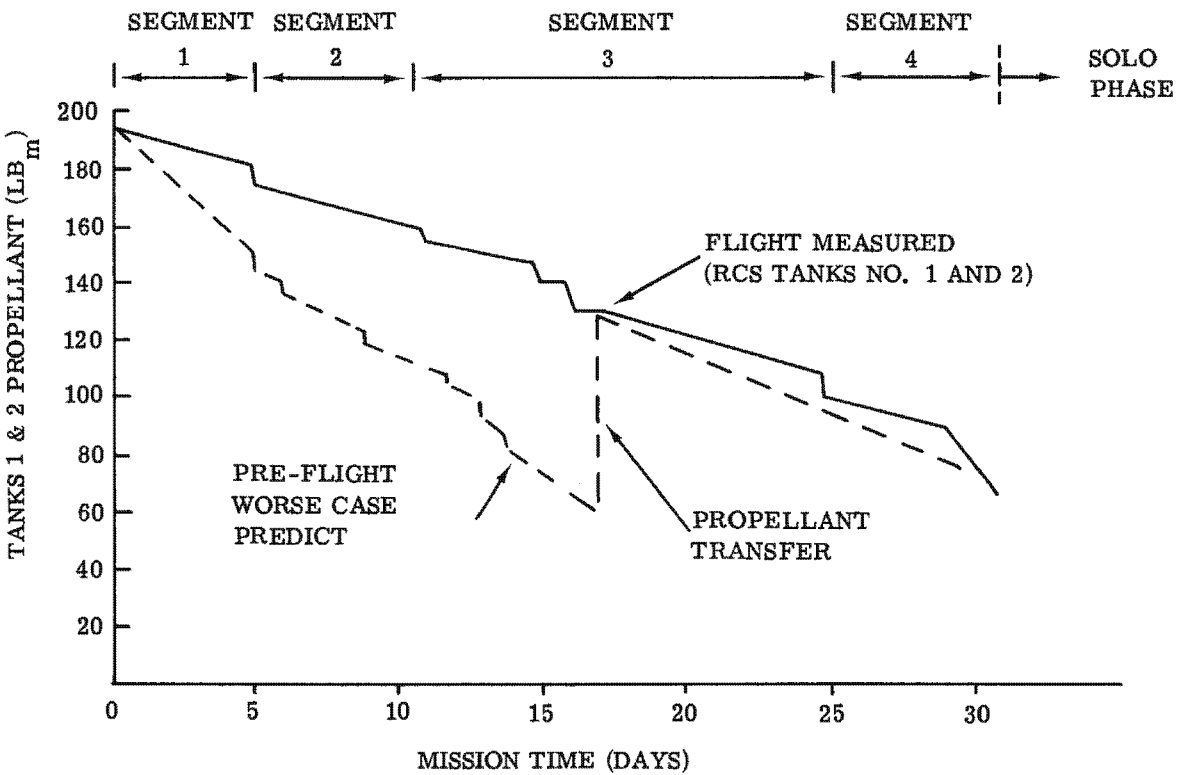
FIGURE 2-4

The RCS propellant consumed over the 31 days (502 Revs) was 134 ±10 lbs compared to an available 390 ±10 lbs with OA transfer as shown in Fig. 2-4. The flight measured consumption was computed from the RCS tank temperature and pressure telemetry data and has an uncertainty of ±10 lbs at beginning and end of mission. Also shown in the figure is the pre-flight worse case prediction which was based on P/L ops per Interface Control Document (ICD) and includes contingencies such as magnetic torques and leakage.

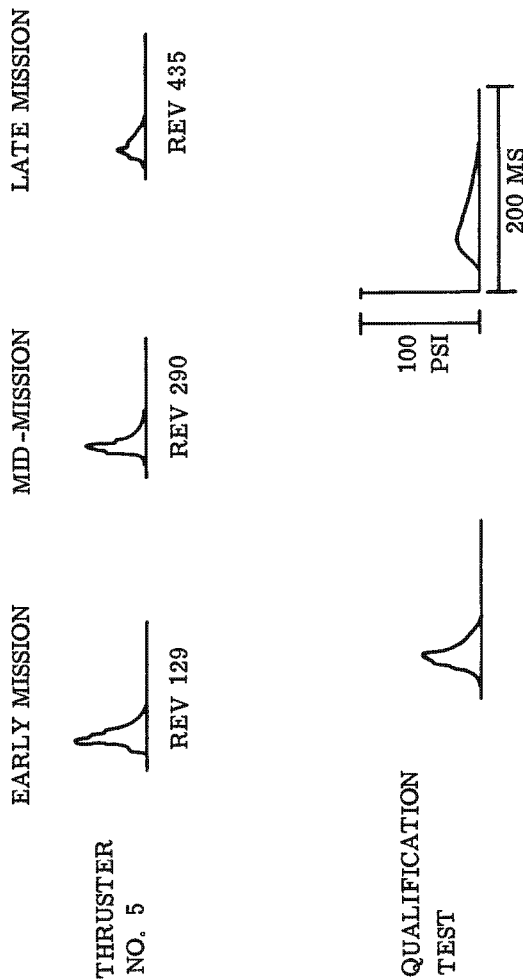
FIGURE 2-5
Handle via Byeman
Controls Only

Three RCS Thrusters showed some sluggishness in pulse shape tailoff at the end of the mission as shown in Fig. 2-5. The degree of tailoff change was minor and much less than observed during ground testing which is shown for comparison. The distortion of the pulse shape suggests some catalyst bed wear, particularly at low duty cycles. Vehicle control was not compromised and no change in propellant consumption could be detected. Pulses with tailoff sluggishness have the same total impulse as pulses with crisp shapes and thus no change in specific impulse is encountered. The small change in response and centroid is minor, not affecting vehicle control.

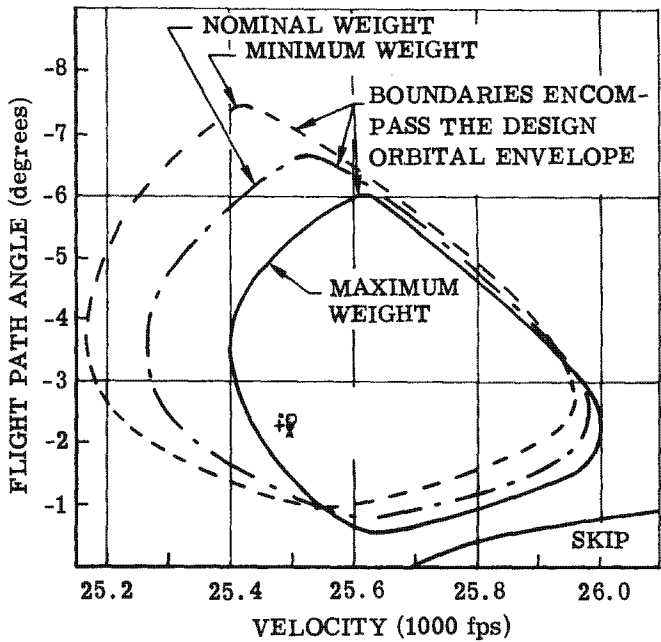
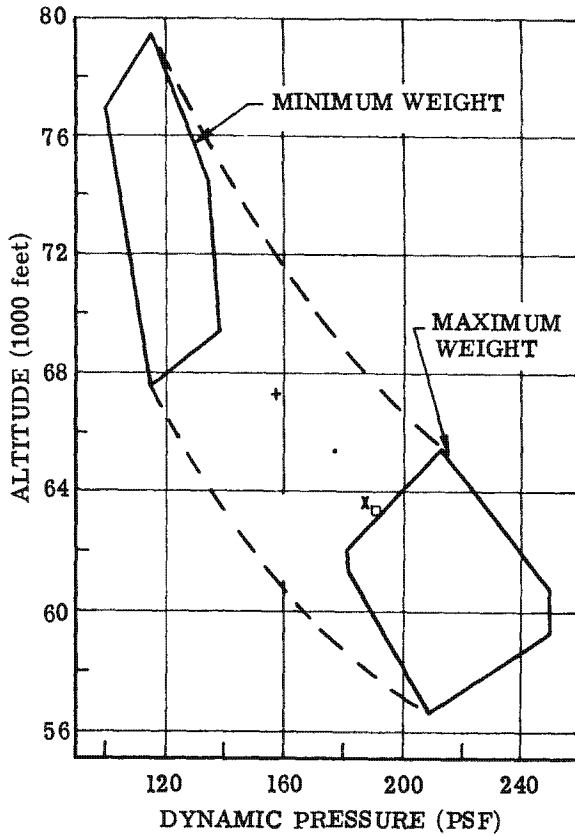
FIGURE 4-1
Handle via Byeman
Controls Only

The entry (400,000 ft altitude) velocity and flight path angle for each recovery are shown in Figure 4-1 compared to envelopes of possible entry conditions for which the reentry vehicle was designed to be compatible. During the early period of the entry phase, the residual roll rate, which had been nearly constant during the exoatmospheric coast phase, began to decrease. After approximately 110 sec, the roll direction reversed. This reversal was typical for all four recoveries and had no measurable effect on the capability of the RVs to enter successfully. Angle of attack was less than the predicted values throughout the significant heating portion of the entry due to roll reversal and associated phenomena. Velocity and altitude time histories apparently correlated well with predicted normal values as evidenced by the accuracy of the impact.

Figure 4-1 also shows the altitude and dynamic pressure for each recovery at the time of drogue parachute deployment with respect to the design envelope. Flight instrumentation data show that drogue performance as a decelerator was essentially as predicted. For example, the maximum dynamic pressure at drogue release and main parachute deployment was 58.7 psf observed on Recovery 2, and the predicted value was 60.2 psf.
