Performance Evaluation Team Report

MISSION 1204

SYSTEM
PERFORMANCE EVALUATION TEAM
MISSION 1204

PERFORMANCE EVALUATION TEAM
REPORT NO. 1204/73

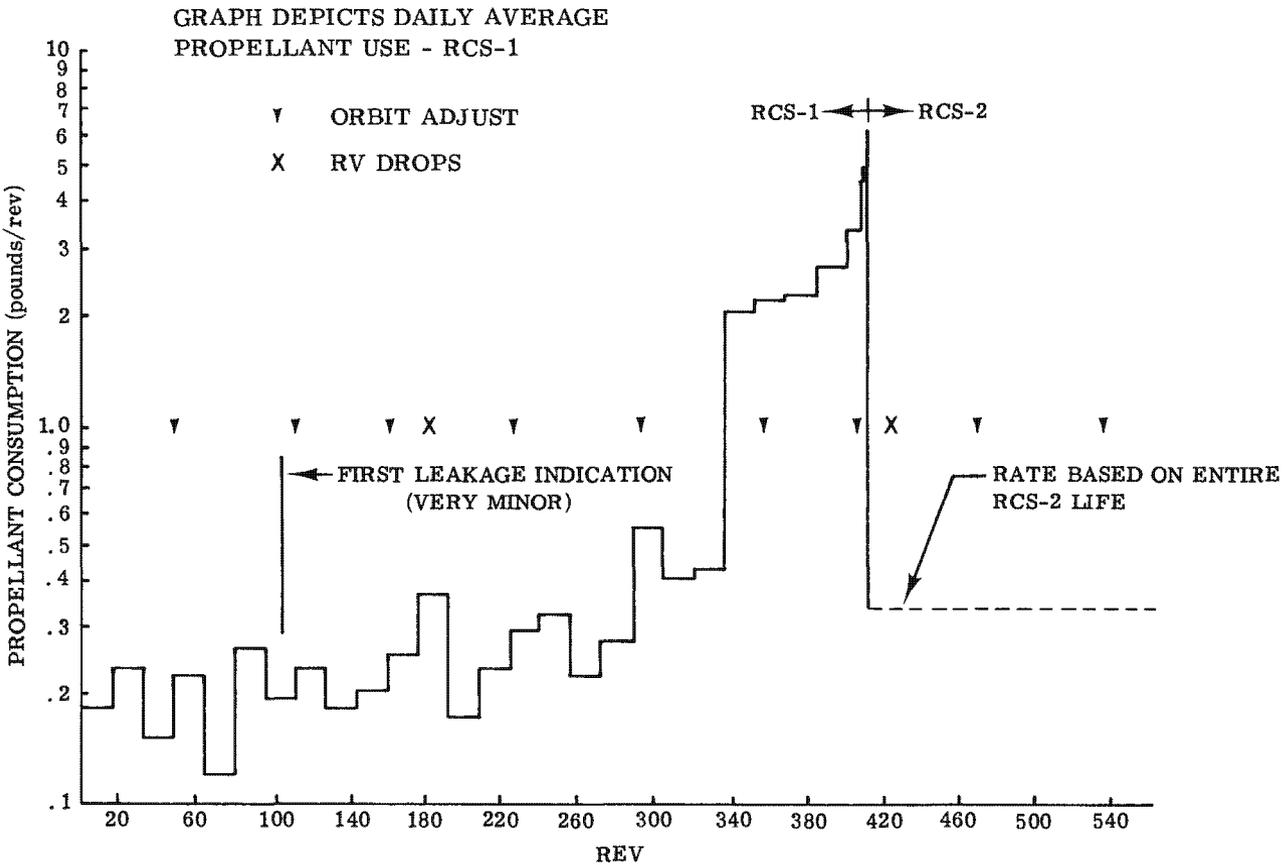
FIGURE 3-1

The history of RCS propellant consumption is shown in Figure 3-1. Satisfactory vehicle attitude and rate control was provided by the RCS at all times during the 91 day flight. Leaks developed in the primary system (RCS-1) as expected and control was switched to the standby system (RCS-2) on Day 26. No leaks were detected in RCS-2 for the remainder of the flight, and although some degradation of thrust

Management of propellant consumption in view of expected RCS valve leakage was very successful for SV-4. Total propellant consumption for the 91 day mission was computed to be 870 pounds. The primary (RCS-1) system was operated from RCS tanks 1 and 2 for the first 413 revs, at which time leakage exceeded tolerable limits and transfer was made to RCS-2. RCS-2 was fed directly from the main OAS tank. RCS tanks 3 and 4, which normally feed RCS-2, were cut out of the system prior to flight, thereby eliminating the source of the valve leakage, i. e., the non-volatile residue (NVR) from the tank expulsion diaphragms. As a result, no leakage occurred in the RCS-2 thruster valves for the remainder of the flight. A similar plan will be utilized on SV-5 except that tanks 1 and 2, which are associated with the primary (RCS-1) system, will be cut out instead of tanks 3 and 4. This was done to permit better insight into long term thruster performance in the presence of no leakage (RCS-1 has thrust chamber pressure and temperature instrumentation, while RCS-2 does not). In summary, the plan is to obtain the maximum life on the system wherein leaks are expected and then transfer to the remaining system at the point leakage exceeds tolerable limits.

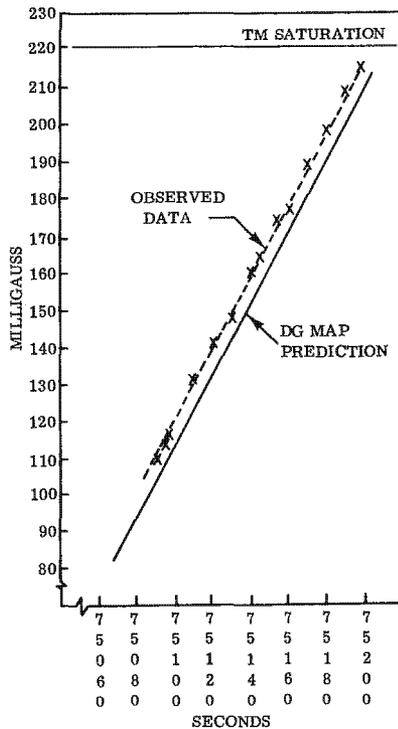
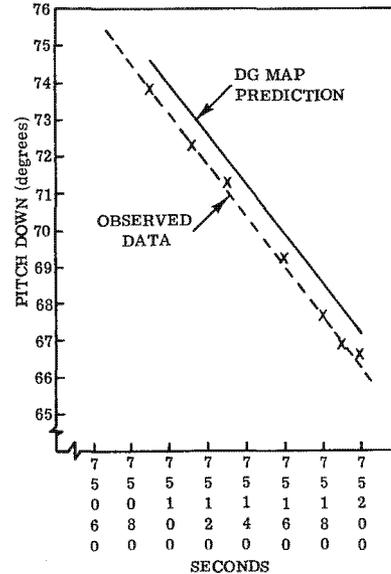
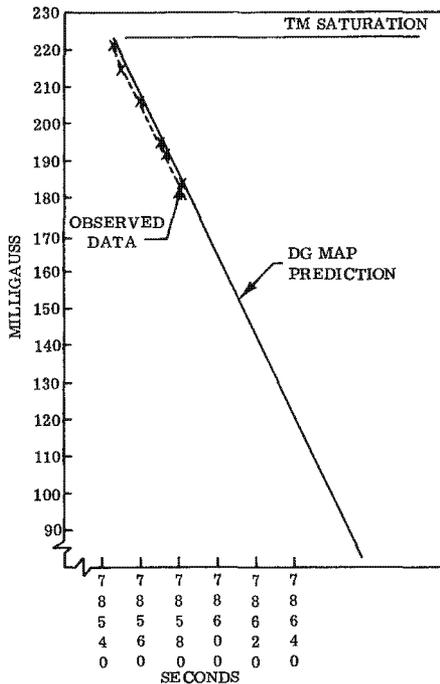
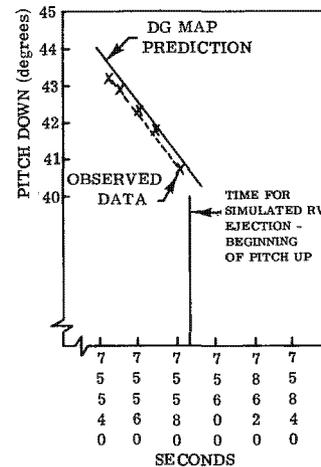
FIGURE 3-2

VEHICLE ATTITUDE AS DETERMINED BY LIFEBOAT II
 DURING INERTIAL RV RECOVERY EXPERIMENT
 (Rev 813)

R SENSOR IN N-S RV RECOVERY MODE OVER POGO (P SENSOR SATURATES TM)

P SENSOR IN S-N DEBOOST MODE OVER KODI (R SENSOR SATURATES TM)

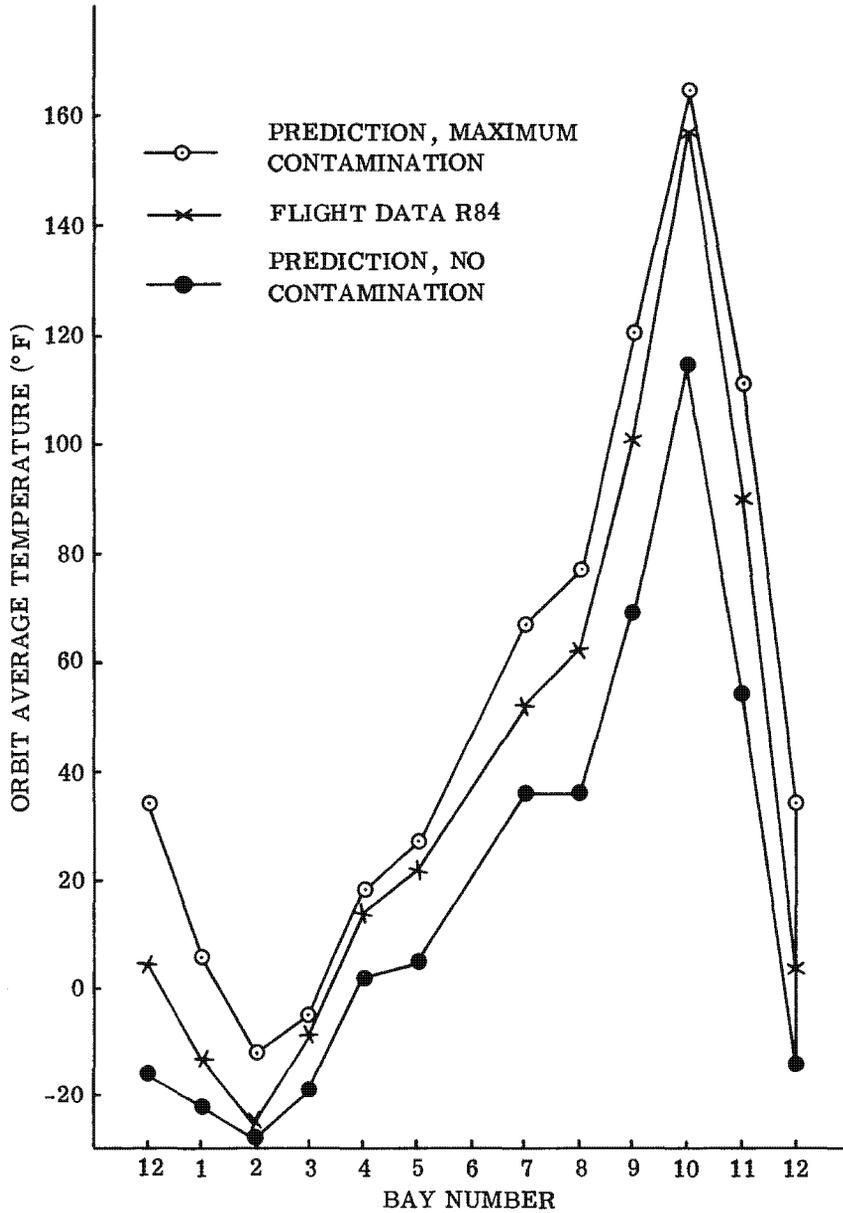
FIGURE 3-3

Equipment and structure temperatures indicated contamination degradation to external vehicle thermal control surfaces similar to that noted on all other flights. The amount of degradation appears to be less than occurred on SV-1, about the same as SV-2, and greater than occurred on SV-3. The amount of degradation was within the bounds of preflight analysis, as is indicated by Figure 3-3, which compares actual door temperatures with the preflight predictions.

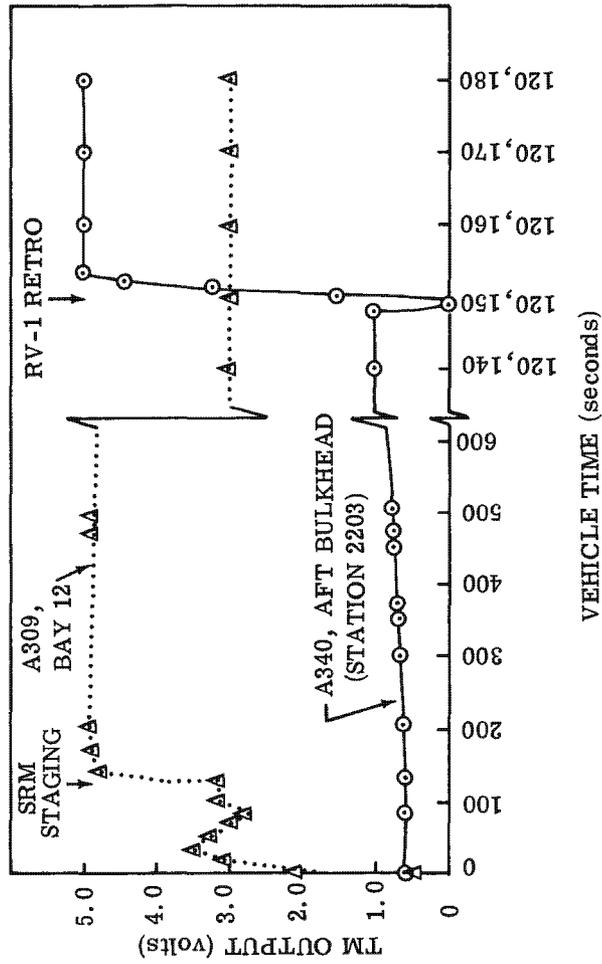
FIGURE 3-5

The ascent contamination caused negligible change in the mass deposition level measured by the Station 2203 QCM as shown in Figure 3-5. This was as expected, since the solid rocket motor (SRM) staging event causes only a momentary inflow of external gases into the Aft-section cavity via the vent ports. The first RV retro caused the mass deposit to rise from near lift-off levels to the telemetry limit of 5 TMV where it remained until the second RV retro. The extrapolated mass deposit due to the first RV was $3.8 \times 10^{-5} \text{ g/cm}^2$. The second RV retro caused the QCM to saturate and the crystal stopped oscillating as is expected when the mass deposit becomes excessive. The FOSR and white silicone calorimeter panels indicated an increase in α of .10 and .13 respectively from early flight to after the RV-3 retro event. After correction for ultraviolet degradation, a total change in α of .06 for both calorimeters is associated with the three contamination events.

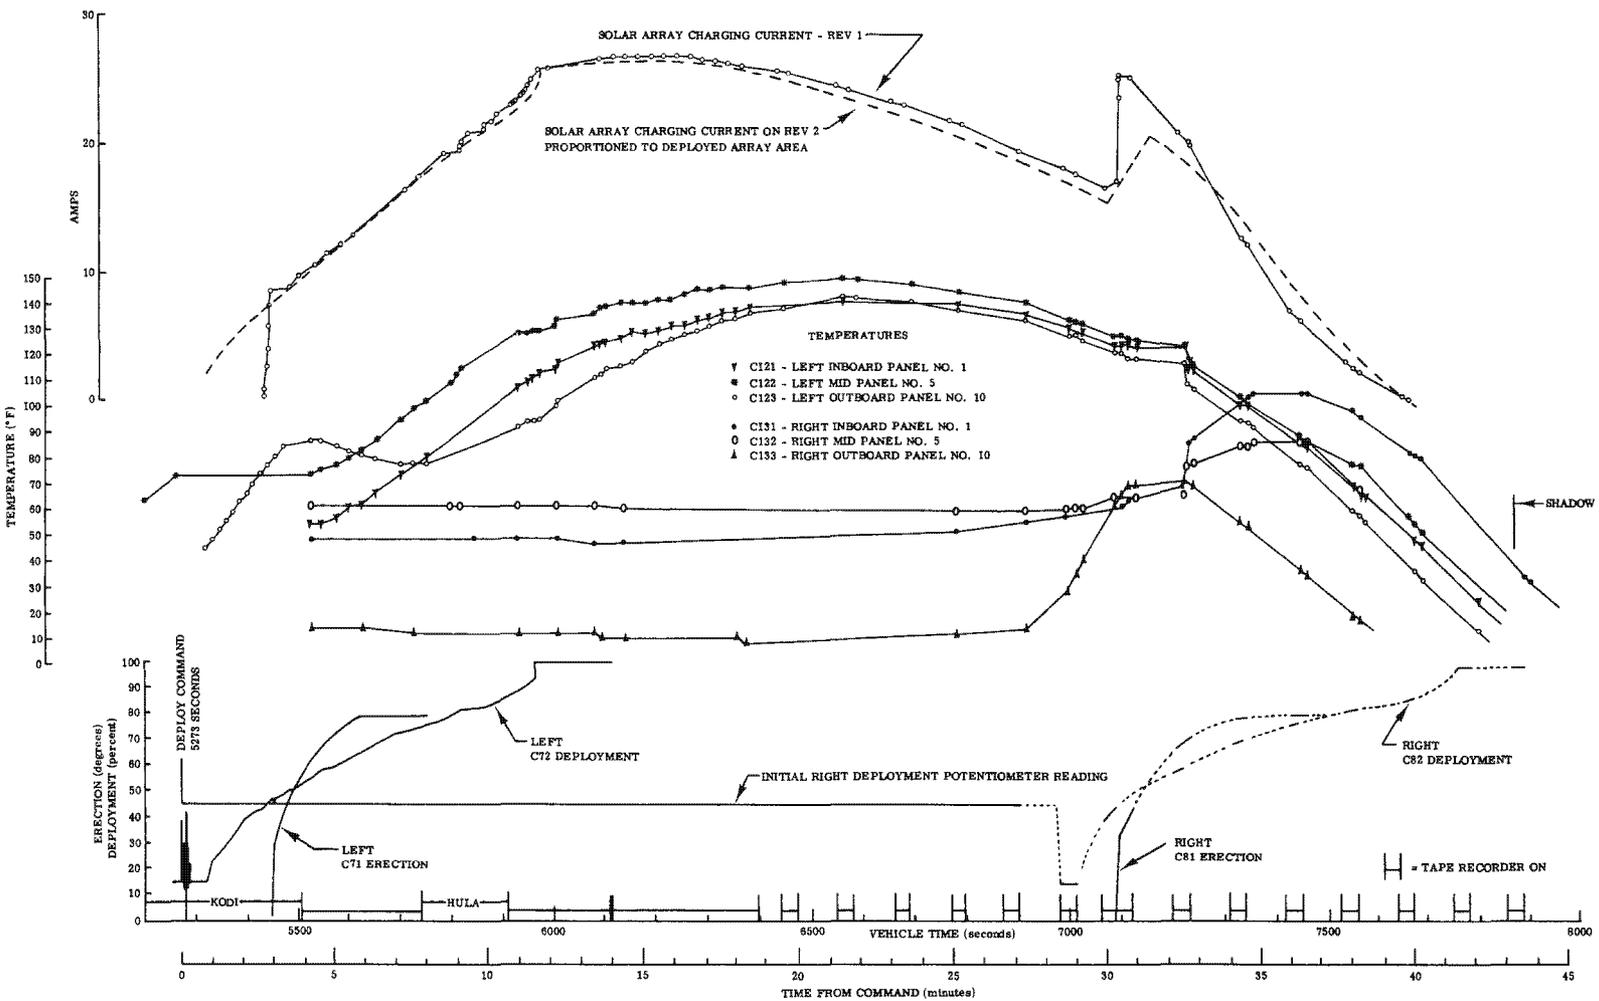
FIGURE 3-6

Solar arrays were extended on Rev 1. The left array started deployment on command and required 640 seconds to complete deployment and erection. The right array did not start to deploy until 1680 seconds after receiving the command and then required approximately 750 seconds to complete deployment and erection. Power output from each leg exceeded the specification value. Degradation from the initial output to end of the fourth segment was 2%. This is well below the 5% allocated.
