Performance Evaluation Team

MISSION 1201

SYSTEM
PERFORMANCE EVALUATION TEAM
MISSION 1201

PERFORMANCE EVALUATION TEAM
REPORT NO. 1201/71

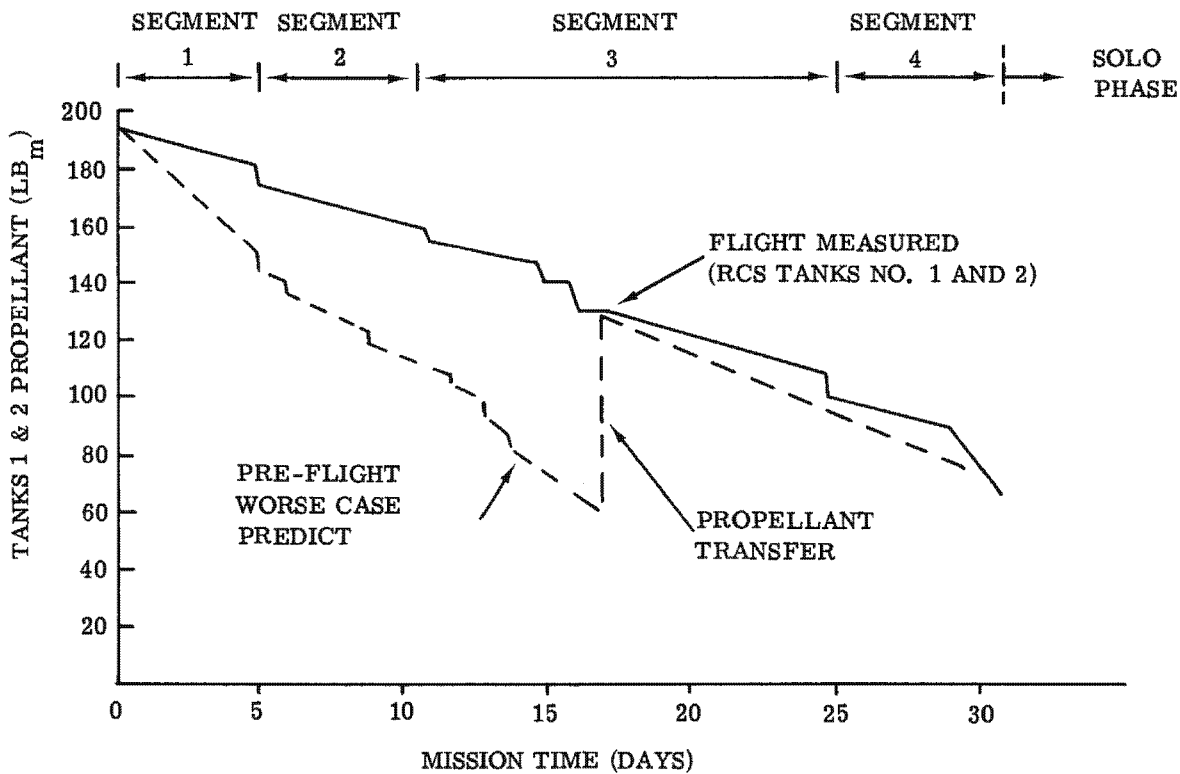
FIGURE 2-4

The RCS propellant consumed over the 31 days (502 Revs) was 134 ±10 lbs compared to an available 390 ±10 lbs with OA transfer as shown in Fig. 2-4. The flight measured consumption was computed from the RCS tank temperature and pressure telemetry data and has an uncertainty of ±10 lbs at beginning and end of mission. Also shown in the figure is the pre-flight worse case prediction which was based on P/L ops per Interface Control Document (ICD) and includes contingencies such as magnetic torques and leakage.

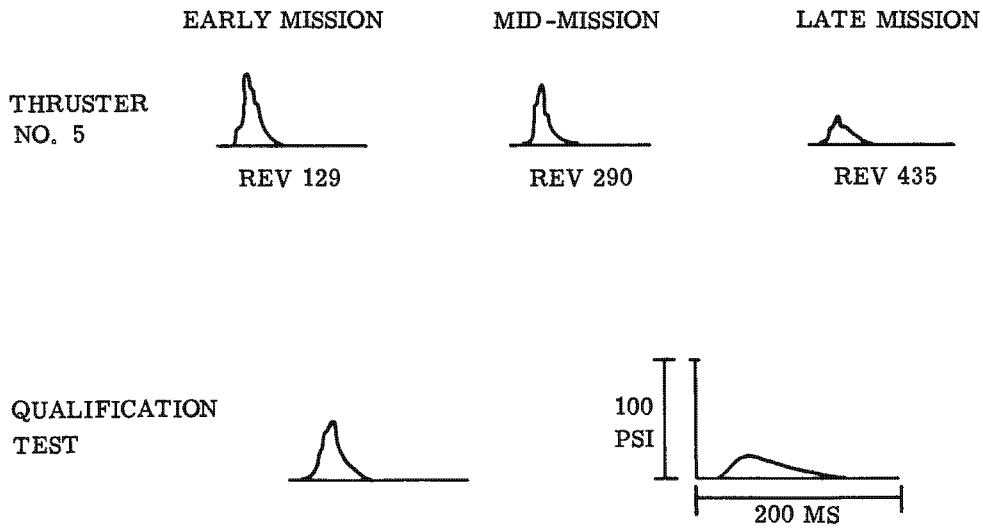
FIGURE 2-5

Three RCS Thrusters showed some sluggishness in pulse shape tailoff at the end of the mission as shown in Fig. 2-5. The degree of tailoff change was minor and much less than observed during ground testing which is shown for comparison. The distortion of the pulse shape suggests some catalyst bed wear, particularly at low duty cycles. Vehicle control was not compromised and no change in propellant consumption could be detected. Pulses with tailoff sluggishness have the same total impulse as pulses with crisp shapes and thus no change in specific impulse is encountered. The small change in response and centroid is minor, not affecting vehicle control.

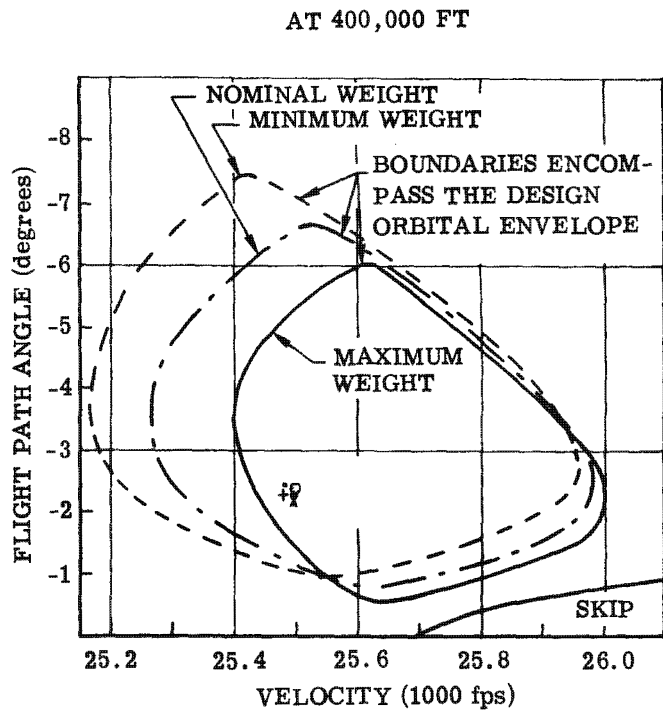
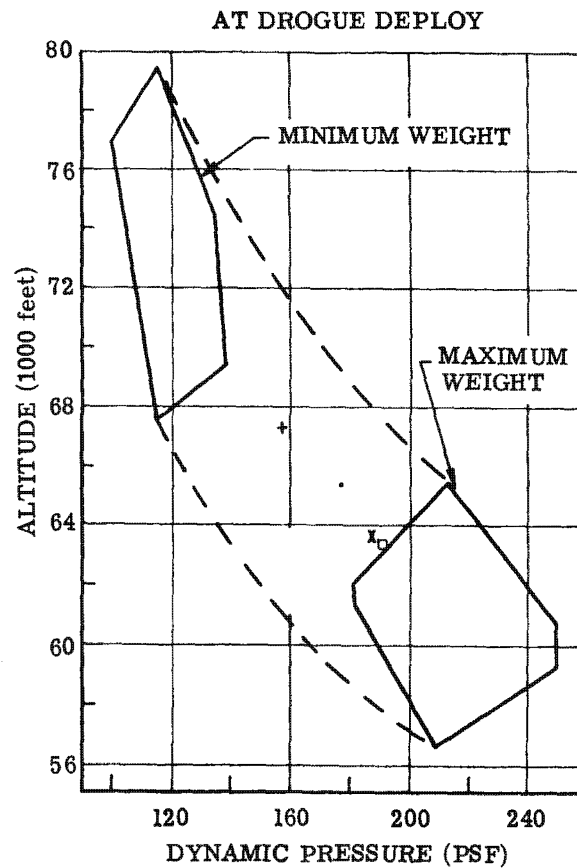
FIGURE 4-1
Handle via ~~Byeman~~
Controls Only

The entry (400,000 ft altitude) velocity and flight path angle for each recovery are shown in Figure 4-1 compared to envelopes of possible entry conditions for which the reentry vehicle was designed to be compatible. During the early period of the entry phase, the residual roll rate, which had been nearly constant during the exoatmospheric coast phase, began to decrease. After approximately 110 sec, the roll direction reversed. This reversal was typical for all four recoveries and had no measurable affect on the capability of the RVs to enter successfully. Angle of attack was less than the predicted values throughout the significant heating portion of the entry due to roll reversal and associated phenomena. Velocity and altitude time histories apparently correlated well with predicted normal values as evidenced by the accuracy of the impact.

Figure 4-1 also shows the altitude and dynamic pressure for each recovery at the time of drogue parachute deployment with respect to the design envelope. Flight instrumentation data show that drogue performance as a decelerator was essentially as predicted. For example, the maximum dynamic pressure at drogue release and main parachute deployment was 58.7 psf observed on Recovery 2, and the predicted value was 60.2 psf.
