BIF003W/2-067069-72  
HEXAGON Cy 5

13 April 1972  
Sheet Count: 79

FLIGHT TEST ENGINEERING ANALYSIS REPORT  
FOR  
THE HEXAGON PROGRAM SATELLITE VEHICLE NUMBER TWO ~~(S)~~

This report describes the performance of the second HEXAGON Program Satellite Vehicle (SV-2). The vehicle was launched on 20 January 1972 and completed its primary mission with the recovery of RV number four on 28 February 1972. This report encompasses these 40 days.

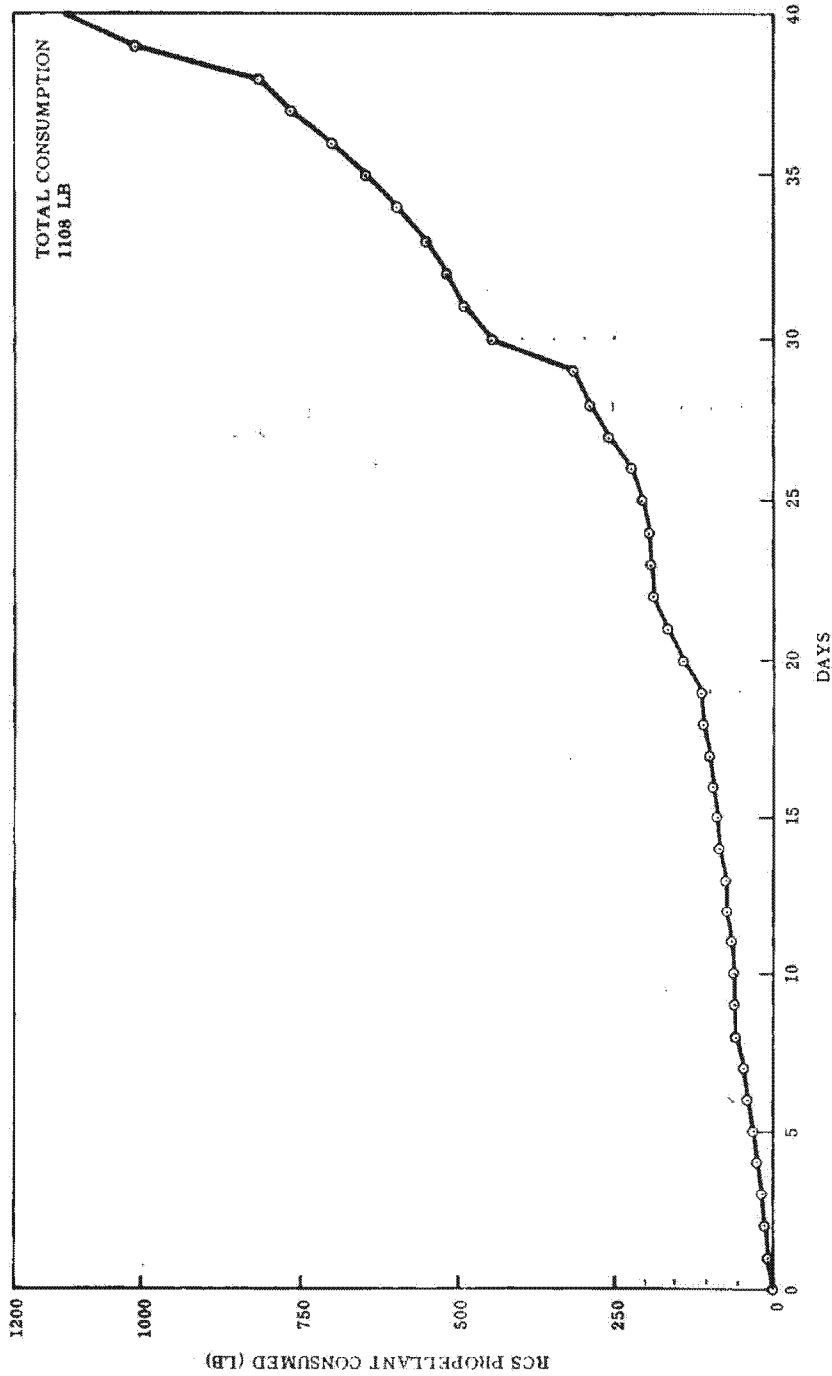
Fig. 2-2 RCS Propellant Consumption

The RCS propellant consumption for the mission was 1108 lb as indicated in Fig. 2-2. This consumption required transfer of 808 pounds from the OAS to the RCS. This large consumption rate of 2 to 17 lb per rev as compared to the normal rate of 0.3 to 0.4 lb per rev was attributed to REM valve leakage and opposing thruster activity. The normal rate did occur on both the Primary and Secondary RCS prior to the development of the leakage.

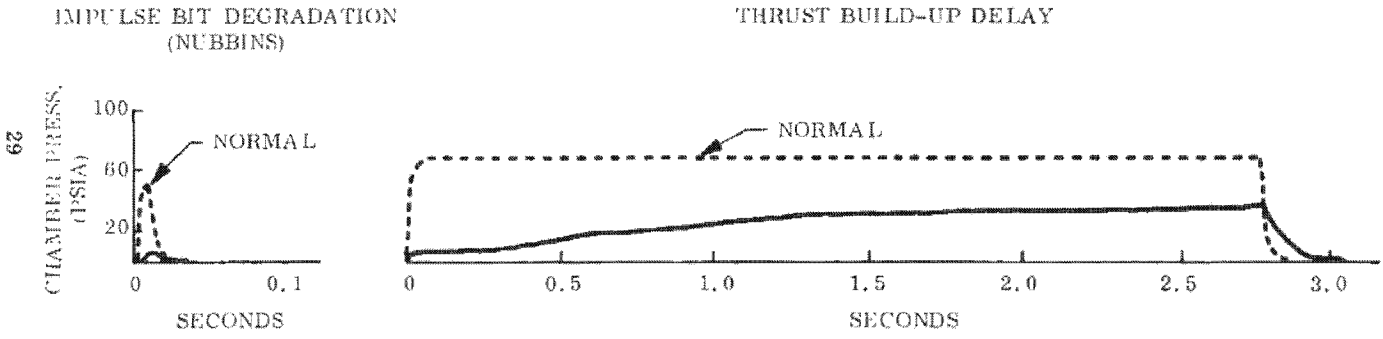
Fig. 2-4 Thrust Build-Up Delay/Impulse Bit Degradation (Nubbins)

Thrust build-up delay which was noted in steady-state firings, was preceded by impulse bit degradation which was observed during pulse mode duty cycles. These are illustrated in Fig. 2-4. The term "nubbins" has been introduced to indicate the "impulse bit degradation."

- Determine and eliminate the cause(s) of leaks.
- Make the valves less susceptible to leak producing agents.
- Recommend mission parameters to reduce leak effects until problem solved.
- Assure thruster degradation is a result of leaking.

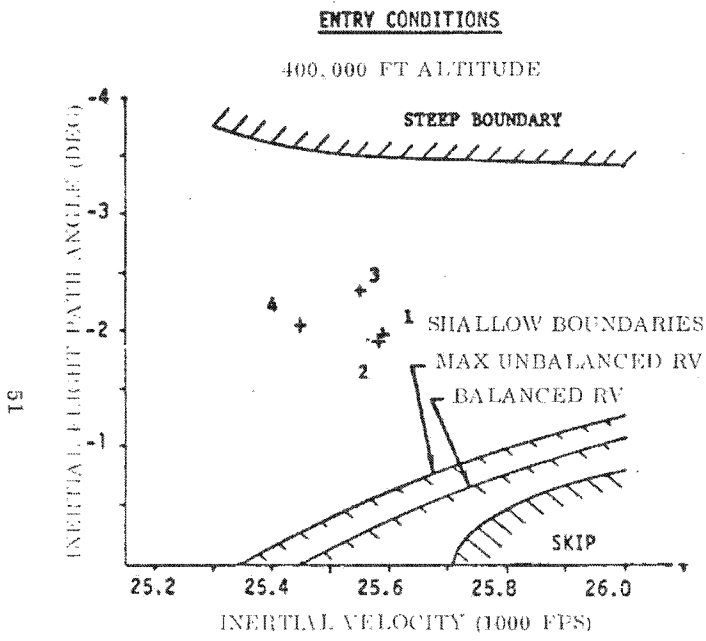
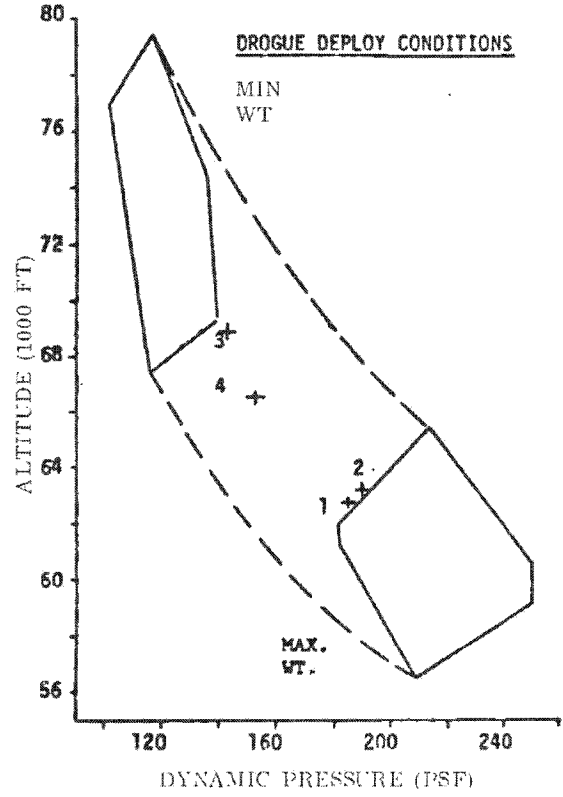
Fig. 8-1 SV-2 Re-entry Parameter Comparisons

Figure 8-1 shows the entry conditions to be well within previously established entry boundaries. The residual roll rate was nearly constant during the exoatmospheric coast phase, decreased during the early period of the entry phase and after 120 sec reversed. This reversal has been typical for all four RV's of this mission and for all four RV's of SV-1. The roll reversal had no significant effect on the capability of the RV's to enter successfully. Angle of attack was low throughout the significant heating portion of all four entries due to roll reversal and associated phenomena. The small range dispersions indicate the predicted entry trajectory was followed. Roll reversal and the unbalanced payloads resulted in the development of lunar mode\* flight characteristics approximately 175 sec after atmospheric entry of RV 3 and 4. Lunar mode prevailed at the time of maximum heating and maximum dynamic pressure for these flights.

Figure 8-1 also shows conditions at time of drogue chute deployment. Data indicates drogue performance was as predicted.

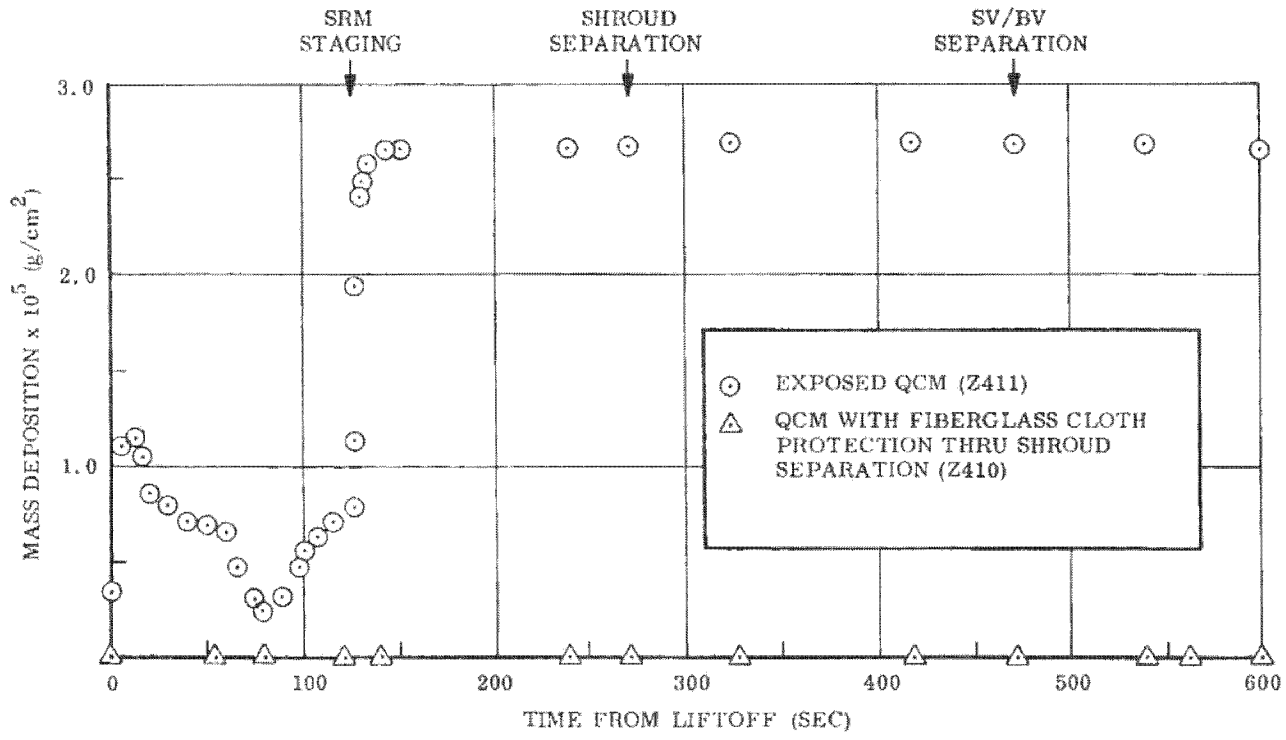
Fig. 12-3 SV-2 QCM Data

- The SRM staging event causes unacceptable contamination.
- The liftoff cloud causes minor contamination.
- SV/BV separation (and Stage II retro) causes no contamination.
- Fiberglass cloth appears to effectively prevent contamination.
- Z-93 and FOSR both showed somewhat less degradation than white silicone but still not acceptable.
- Smooth skin degradation is the same as the corrugations.

The sources of contamination during the SRM staging event are the aluminum oxide particles expelled by the SRM staging motors, and finely divided silver particles from the silver paint on the BV insulator pad that is burned off by the SRM staging motor exhausts.
