FLIGHT TEST ENGINEERING ANALYSIS REPORT
FOR
THE HEXAGON PROGRAM SATELLITE VEHICLE NUMBER THREE (S)

Prepared and Submitted by the
Satellite Vehicle Integrating Contractor

This report describes the performance of the third HEXAGON Program Satellite Vehicle (SV-3). The vehicle was launched on 7 July 1972 and after a 58 day primary mission and a 10 day SOLO mission was deboosted on 13 September 1972.

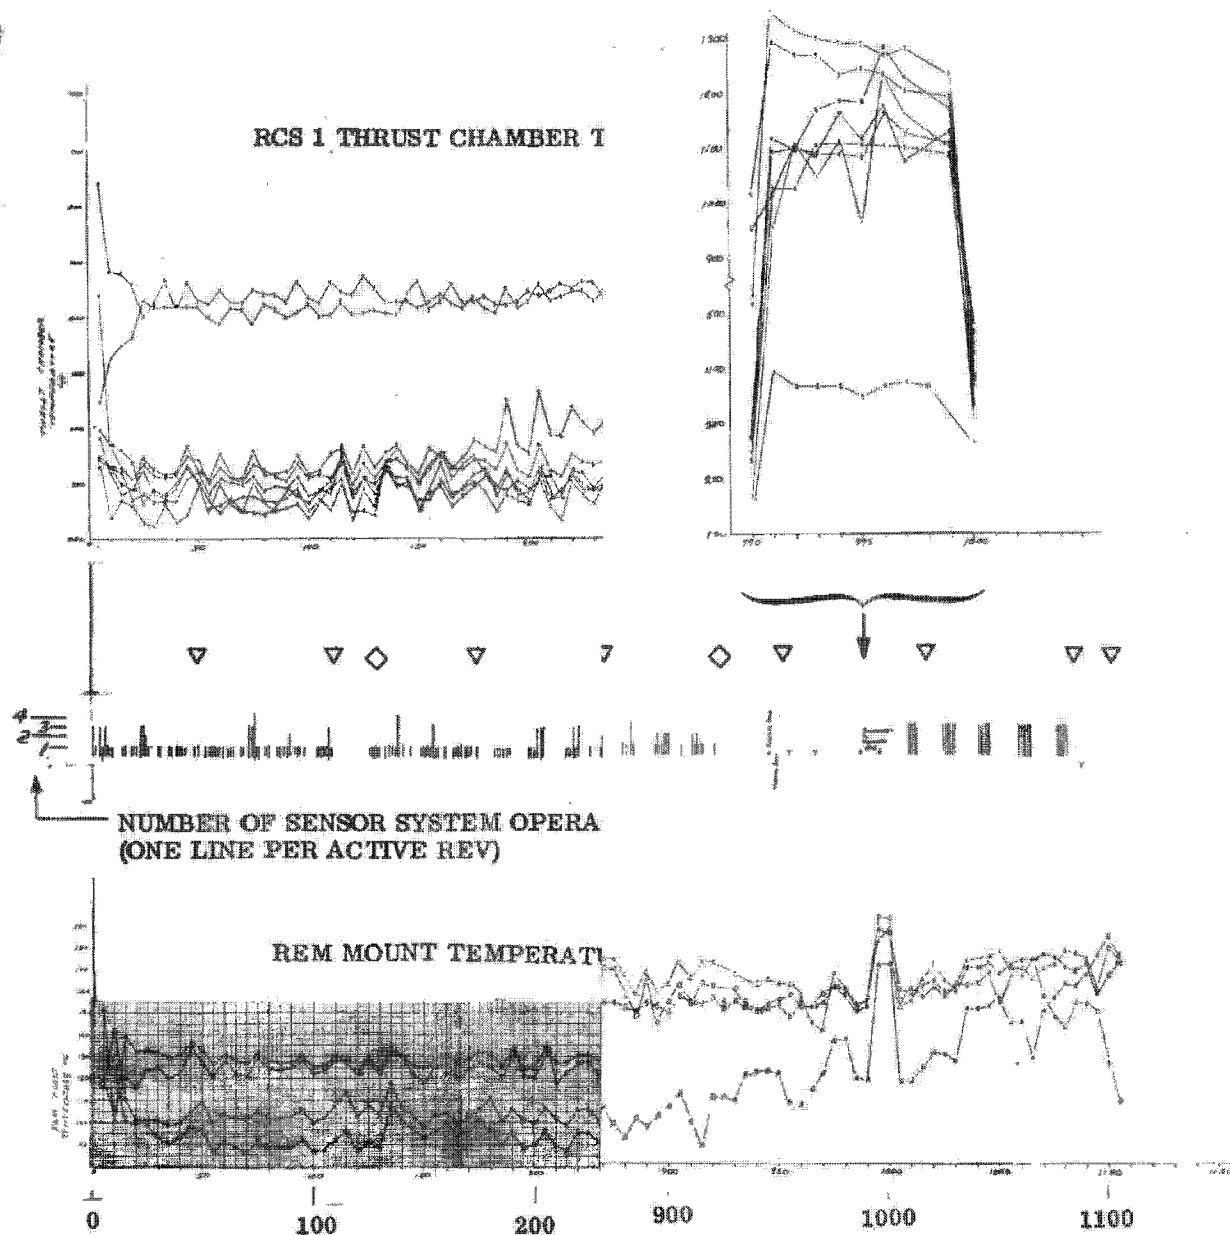
Fig. 2-3 History of RCS Performance

REA chamber and REM mount temperatures are shown in Fig. 2-3. Abrupt temperature increases can be noted when leakages developed and precede the onset of excessive propellant consumption. The mount temperatures lag the REA chamber temperatures; therefore, the detection of the leakage is not as sharp on the standby side when only the mount temperatures are available. These indicators were used during the flight to initiate more intensive data analysis to monitor the onset of leakage.

2.2.3.2 Standby RCS. The standby RCS was activated on Rev 436. Payload operations at this time consisted of Mono Ops with both OBs and a distinctive REM mount temperature pattern can be seen in Fig. 2-3 during this period. A second pattern developed when stereo operations were resumed with unbalanced supply units on Rev 574. A third pattern can be observed after Rev 801 when Mono Ops with one OB was the payload mode of operation. REA8' started leaking on Rev 825, REA3' on Rev 870 and REA6' on Rev 905. RV-4 was separated on Rev 927 and the SOLO mission was begun. During SOLO a series of experiments including yaw arounds, pitch downs, payload operations, etc., were conducted to test the capability of RCS-2. RCS-2 maintained control until the tumble on Rev 1089 when the FDU sensed REA6' firing in a steady state mode for 27 seconds. Capture of the tumbling SV was successfully accomplished without difficulty using RCS-2 and vehicle stability was maintained through the start of the deboost sequence.

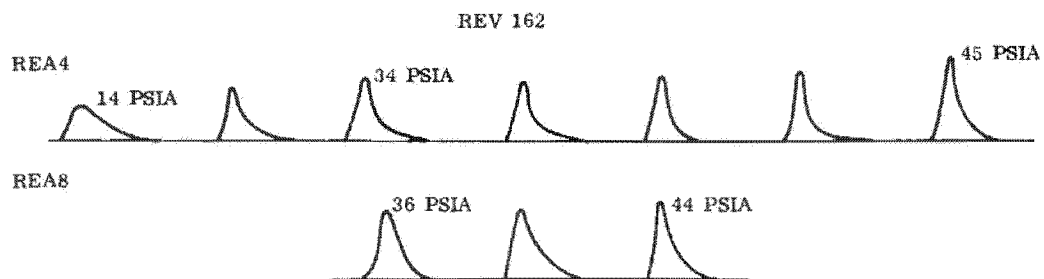
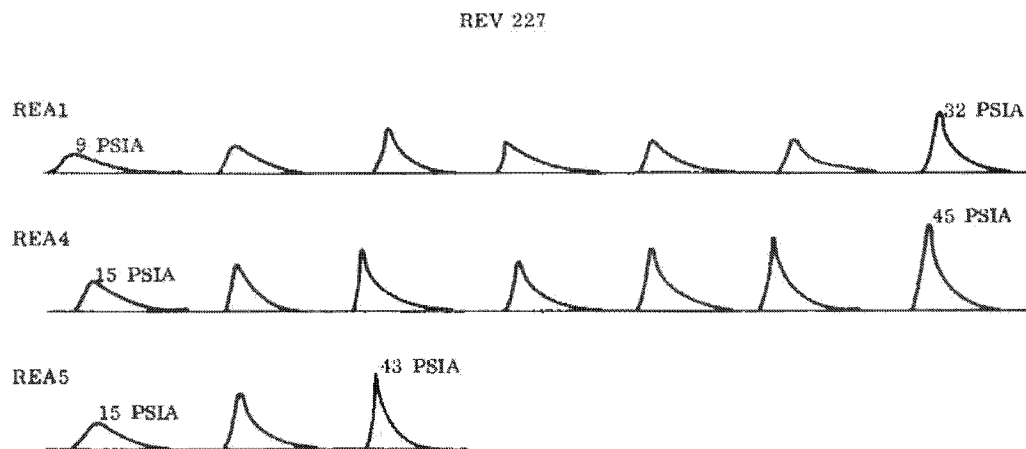
Fig. 2-4 Primary RCS Pulse Shape Characteristics

2.2.3.1 Primary RCS. The first indication of thruster degradation was a sluggish pulse to pulse peak chamber pressure buildup observed on Rev 162. Fig. 2-4 shows how REA4 required seven pulses to reach 45 psi whereas REA8 starting with the same chamber temperature required only three. On Rev 227, REA1 and 4 appear sluggish as compared to REA5. However, no significant loss in performance of RCS-1 was detected before the transfer to RCS-2 on Rev 436.

When the transfer was made back to RCS-1 on Rev 990, the pulse shape tailoff on REA3 was noted and is shown for Rev 991 in Fig. 2-4. REAs 3, 4, 5, 6 and 8 were observed leaking. Vehicle control was maintained during this period when the RCS-1 was used; however, propellant consumption was 34 pounds per rev on Rev 990 and gradually reduced to 12 pounds per rev by Rev 999.

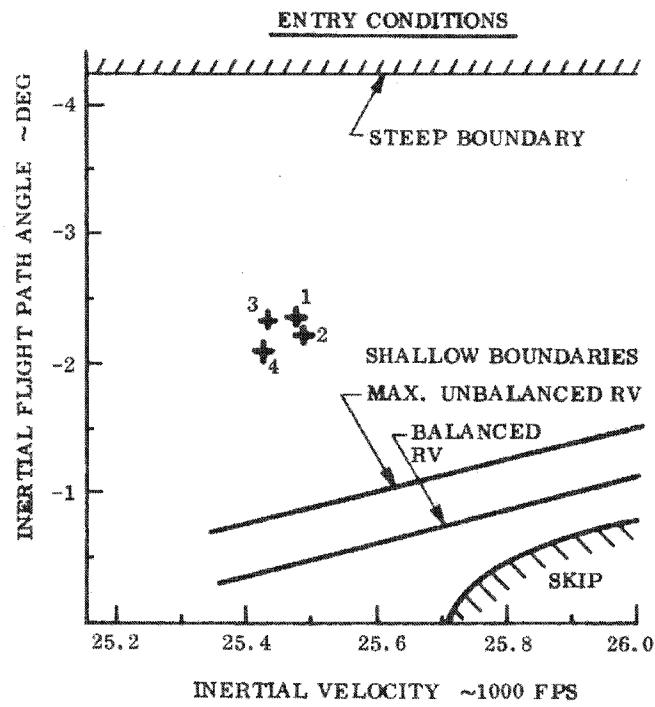
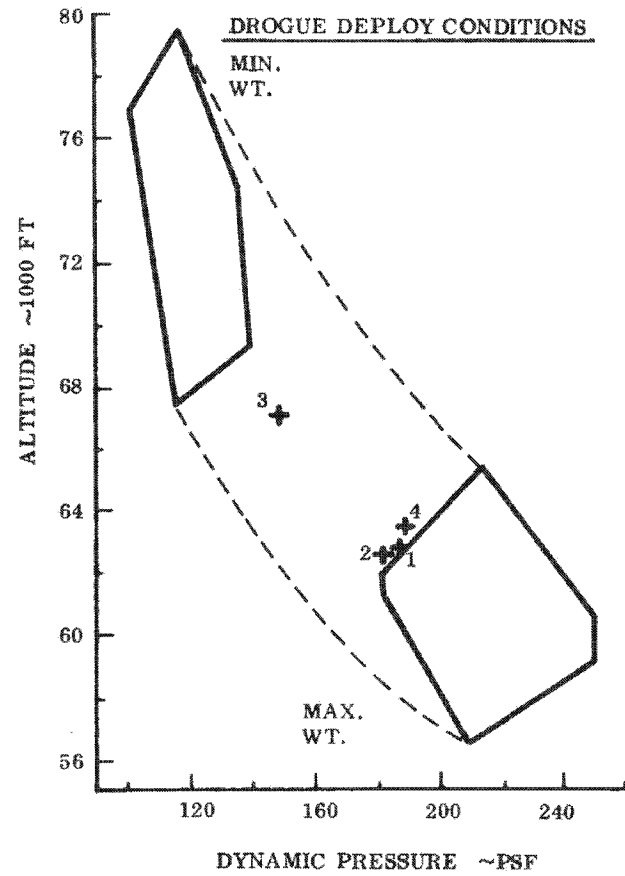
Fig. 8-1 SV-2 Re-entry Parameter Comparisons

Figure 8-1 shows the entry conditions to be well within previously established entry boundaries. The residual roll rate was nearly constant during the exoatmospheric coast phase, decreased during the early period of the entry phase and after 120 sec reversed. This reversal has been typical for all four RVs of this mission and for all RVs of previous missions. The roll reversal has not significant effect on the capability of the RVs to enter successfully. Angle of attack was low throughout the significant heating portion of all four entries due to roll reversal and associated phenomena. The small range dispersions indicate the predicted entry trajectory was followed.

Figure 8-1 also shows conditions at time of drogue chute deployment. Data indicates drogue performance was essentially as predicted.

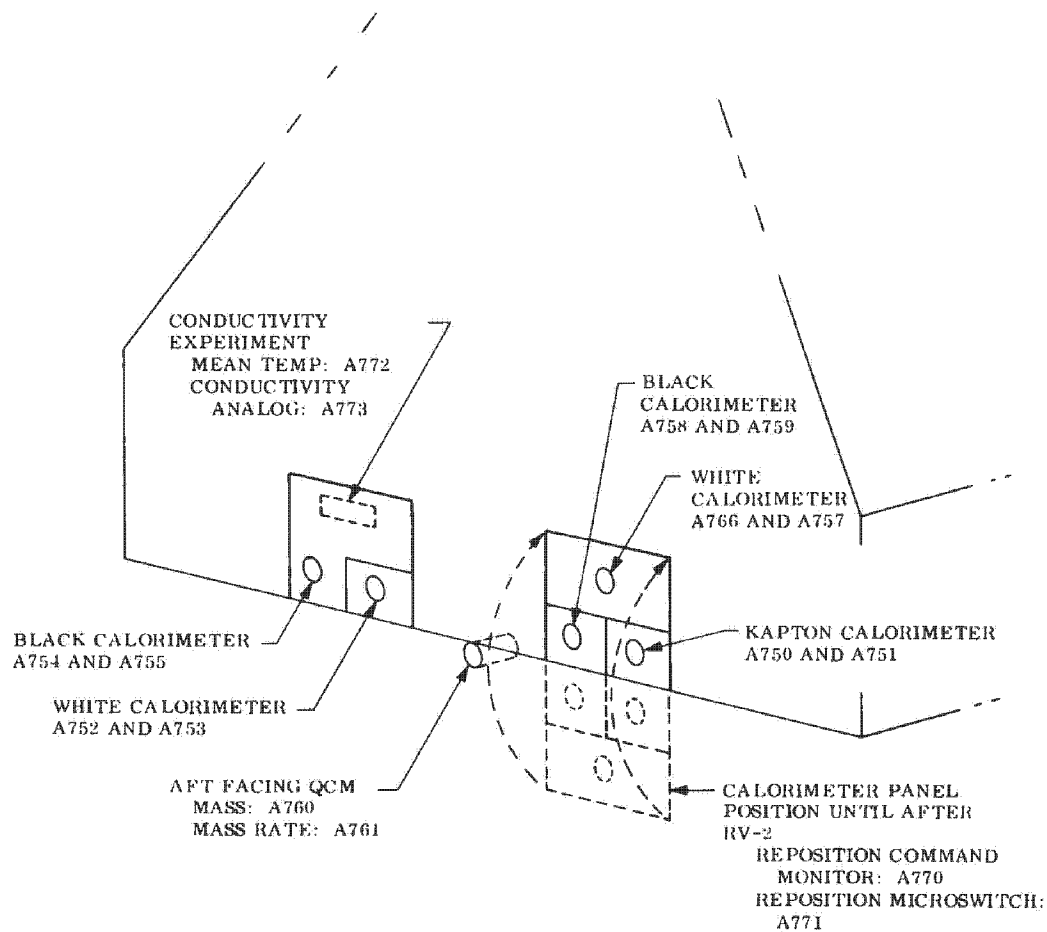
Fig. 12-2 Station 1642 Contamination Experiments

12.4.2.2 Station 1642. The spin-up event for the first RV caused negligible change in the mass deposition level measured by the Station 1642 QCM. Therefore, it was decided to wait until after the second RV was released to flip the exposed calorimeter panel up to its read-out position adjacent to the fixed reference calorimeter panel. The second RV spin-up produced a very slight increase in measured mass deposit (about 0.1×10^{-5} g/cm²) and the calorimeter panel was flipped. The third and fourth RV spin-up events were still monitored by the QCM and these events both caused small decreases in the level of mass deposit (about 0.5×10^{-5} and 0.25×10^{-5} g/cm², respectively). After the exposed calorimeter panel was flipped up, the temperature cycling of the white and black calorimeters were compared directly with their counterparts on the fixed reference panel:

The above uncertainties notwithstanding, the conclusion to be reached from the Station 1642 experiment is clear -- the MCM thermal control surfaces will not be appreciably degraded by the RV spin-up events and the present thermal design is adequate.

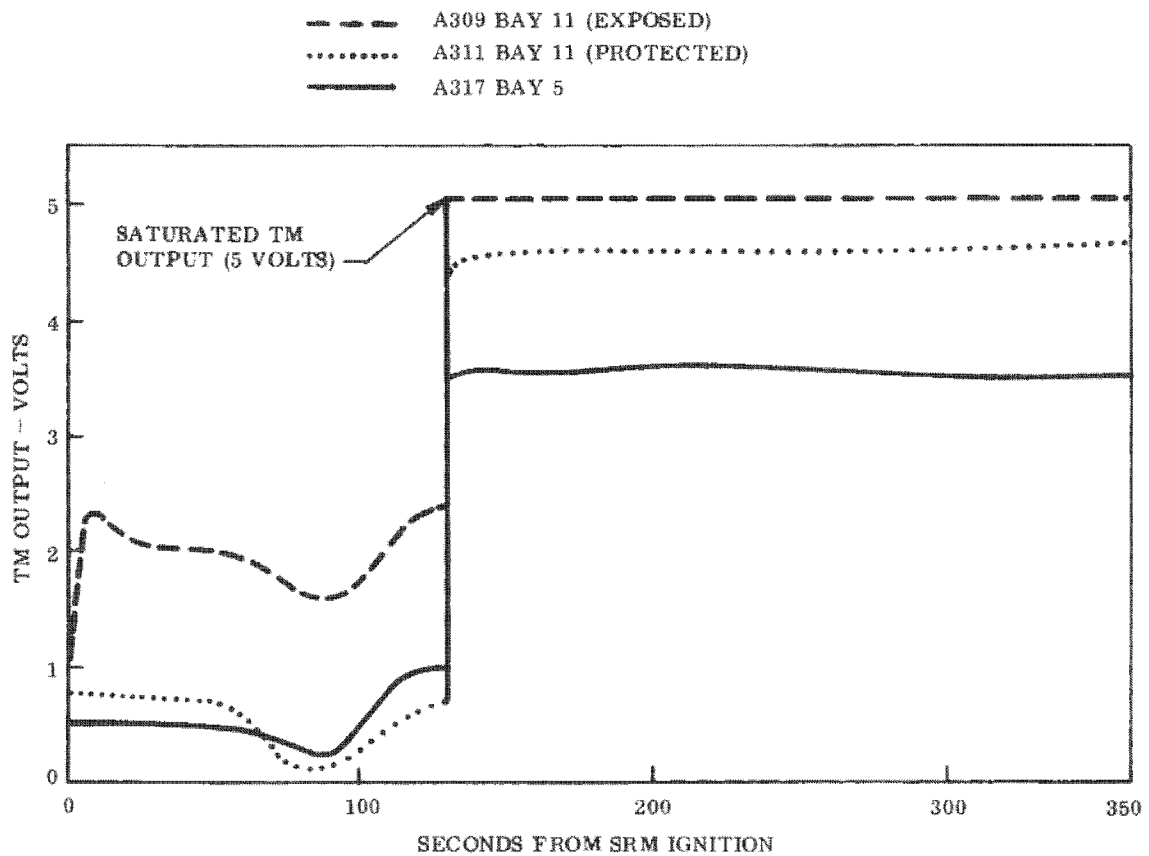
Fig. 12-3 SV-3 QCM Mass Deposit During Launch

12.4.3.1 Aft Section. The first point to note on the QCM data of Fig. 12-3 is that the Bay 11 exposed QCM was saturated at 5.0 TM volts at SRM staging. By plotting the other two QCM outputs in fine detail during SRM staging, it can be estimated that another 10 percent of mass deposit should be added to the level indicated at TM saturation. Another point to be made is that the dip in indicated mass deposit between 60 and 100 seconds after liftoff is felt to be caused by temperature gradients induced in the QCM during ascent aeroheating and does not indicate an actual mass loss. The QCM protected from the liftoff cloud showed less deposit than the Bay 11 exposed QCM but the Bay 5 exposed QCM showed even less deposition both at liftoff and at SRM staging. It may be concluded that the liftoff deposition does not appear to be uniform around the circumference of the aft section.

Similarly, the deposition at SRM staging is not circumferentially uniform either but is more nearly so than the liftoff deposition. Although the non-uniformity of the measured deposition is academically interesting, the basic information provided by the aft section QCMs confirms the conclusion reached on SV-2 -- the SRM staging event causes significant contamination of aft section surfaces. The calorimeter data agrees with the QCM data in that the white silicone sample protected from the liftoff cloud showed slightly less degradation than the white silicone sample exposed throughout ascent. As on SV-2, the FOSR sample suffered less degradation than white silicone and this characteristic plus FOSR's inherent resistance to ultraviolet degradation is sufficient justification to proceed as rapidly as possible to substitute FOSR for white silicone paint on future vehicles.

As noted above, the MCM thermal design will not be jeopardized by the RV spin motor contamination; hence, no changes to the MCM paint pattern is indicated and no further experiments are planned. With respect to the ascent contamination environment, the approach to a solution has changed considerably due to two factors. The first is the failure of the fiberglass cloth shield in the wind tunnel tests. This failure indicated that a redesign of the shield and perhaps a shift to a different shielding concept is required in order to accomplish the complete protection of aft section surfaces during ascent. The second factor was that the relatively narrow Beta range imposed on SV-2 and SV-3 would be adequate for the next few flights provided that the Beta range could be shifted to bracket zero (noon launch). Feasibility studies show that the latter objective can be met in the presence of ascent contamination by relocating equipment away from the hot Bays 11, 12 and 1. In particular, relocating the type 29 batteries to Bay 10 and 3 will allow a launch window around noon. In addition, the incorporation of FOSR in lieu of white silicone paint should allow an even wider launch window. In view of these possibilities, contamination shield redesign efforts have been relegated to a non-priority position and detailed thermal analysis of the Bays 10 and 3 battery installation as well as FOSR implementation efforts now have full priority.
