FLIGHT TEST ENGINEERING ANALYSIS REPORT
FOR
THE HEXAGON PROGRAM SATELLITE VEHICLE NUMBER FOUR ~~(S)~~

Prepared and Submitted by the
Satellite Vehicle Integrating Contractor

This report describes the performance of the fourth HEXAGON Program Satellite Vehicle (SV-4). The vehicle was launched on 10 October 1972 and after a 69 day primary mission and a 22 day SOLO mission was deboosted on Rev 1463 on 8 January 1973.

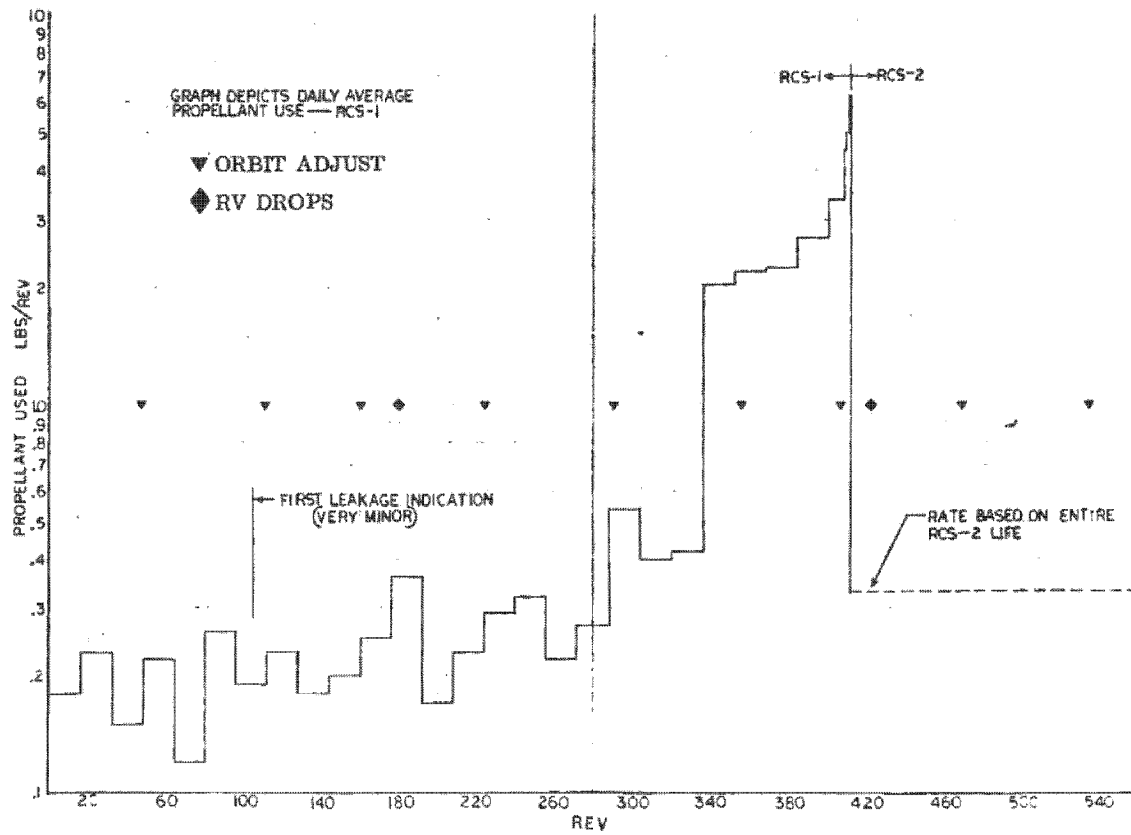
Fig. 2-1 RCS Propellant Consumption

RCS propellant consumption for the 91 day mission was computed to be 870 pounds. Propellant was consumed from RCS-1 tanks 1 and 2 until day 26 when control was switched to RCS-2 which was fed directly from the main OAS tank as RCS tanks 3 and 4 were cut out of the system prior to flight. Abrupt temperature increases on both the REA and mount can be noted when the leaks began on RCS-1 and precede the onset of excessive propellant consumption. On RCS-2 no leak-significant increases in the mount temperatures (this is the only instrumentation available on RCS-2) and no significant increase in fuel consumption occurred.

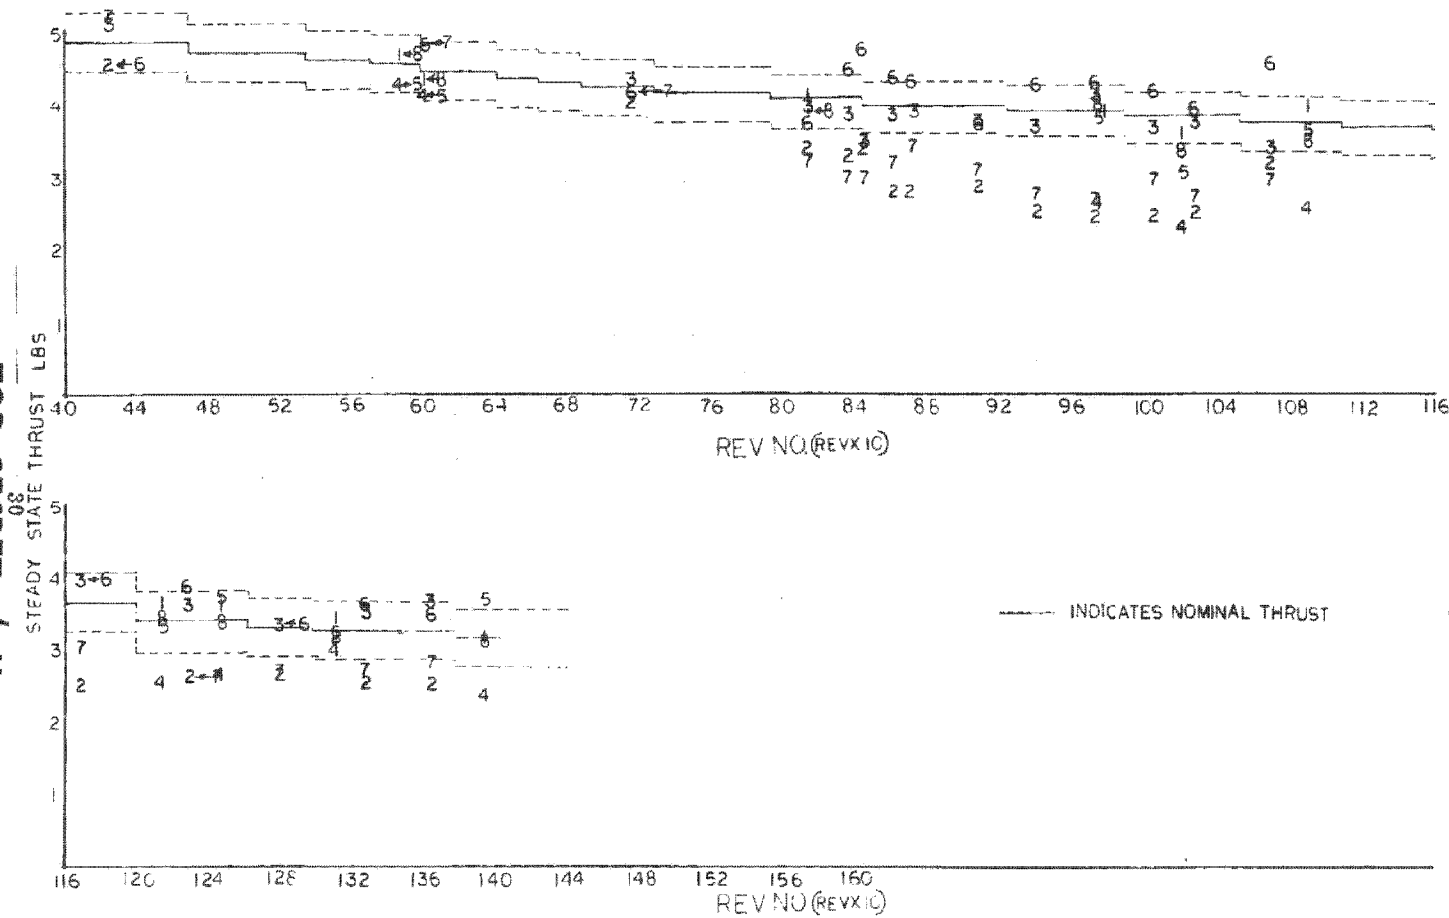
Fig. 2.3 Steady State Thrust Trends

- Elimination of the present RCS tankage using EPT10 rubber diaphragms stops the gross valve leakage problem experienced on previous flights
- Thrust degradation was not accelerated by operation at duty cycles (and temperatures) lower than the Rocket Research ground test. The degradation observed in operation on the ground was not confirmed in orbit operation.

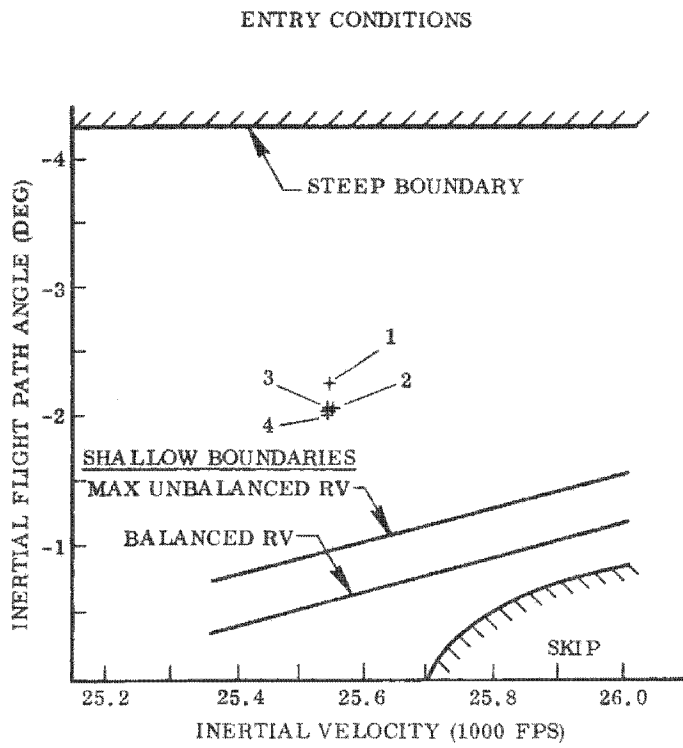
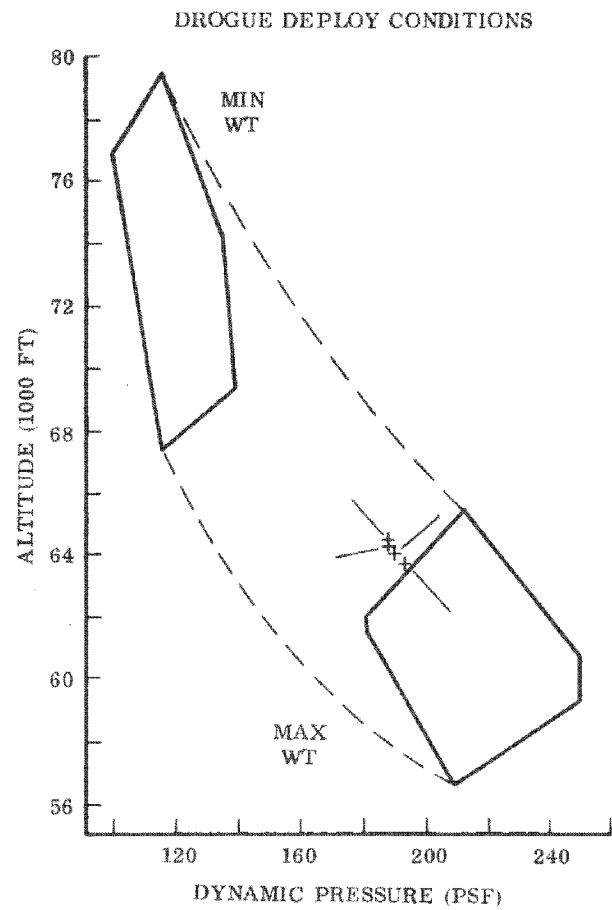
Fig. 8-1 SV-4 Reentry Parameter Comparisons

The RVs were adequately spin stabilized during the exoatmospheric coast and retrograde phase of the reentry trajectory. Figure 8-1 shows the entry conditions to be well within previously established entry boundaries. Also shown are the conditions at time of drogue chute deployment which are within the design envelope.

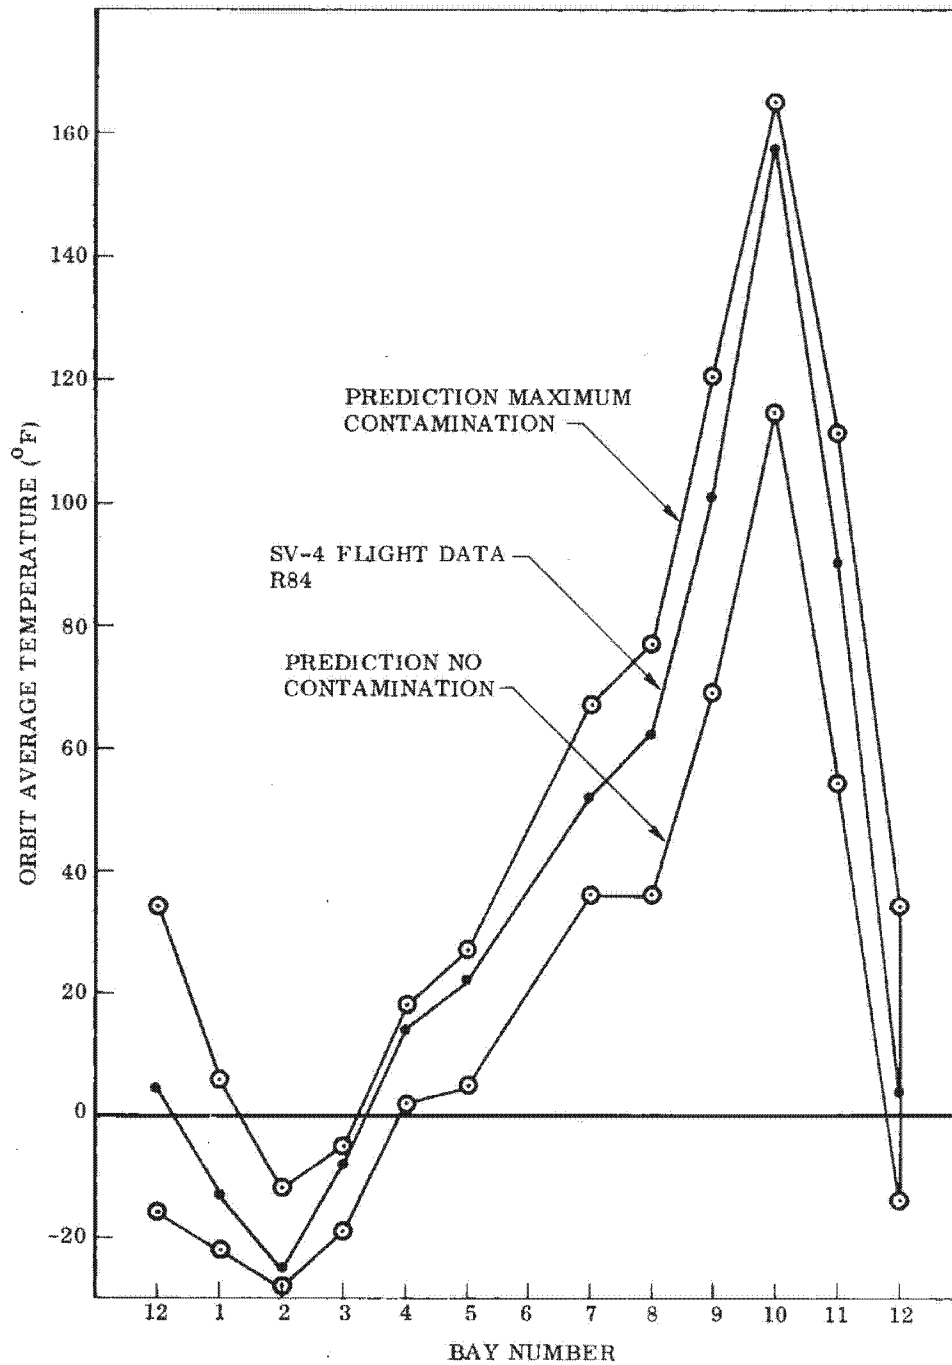
Fig. 12-1 SV-4 Equipment Door Temperatures

Equipment and structure temperatures indicated contamination degradation to external vehicle thermal control surfaces similar to that noted on all other flights. The amount of degradation appears to be less than occurred on SV-1, about the same as SV-2, and greater than occurred on SV-3. The amount of degradation was within the bounds of preflight analysis, as is indicated by Figure 12-1, which compares actual door temperatures with the pre-flight predictions.

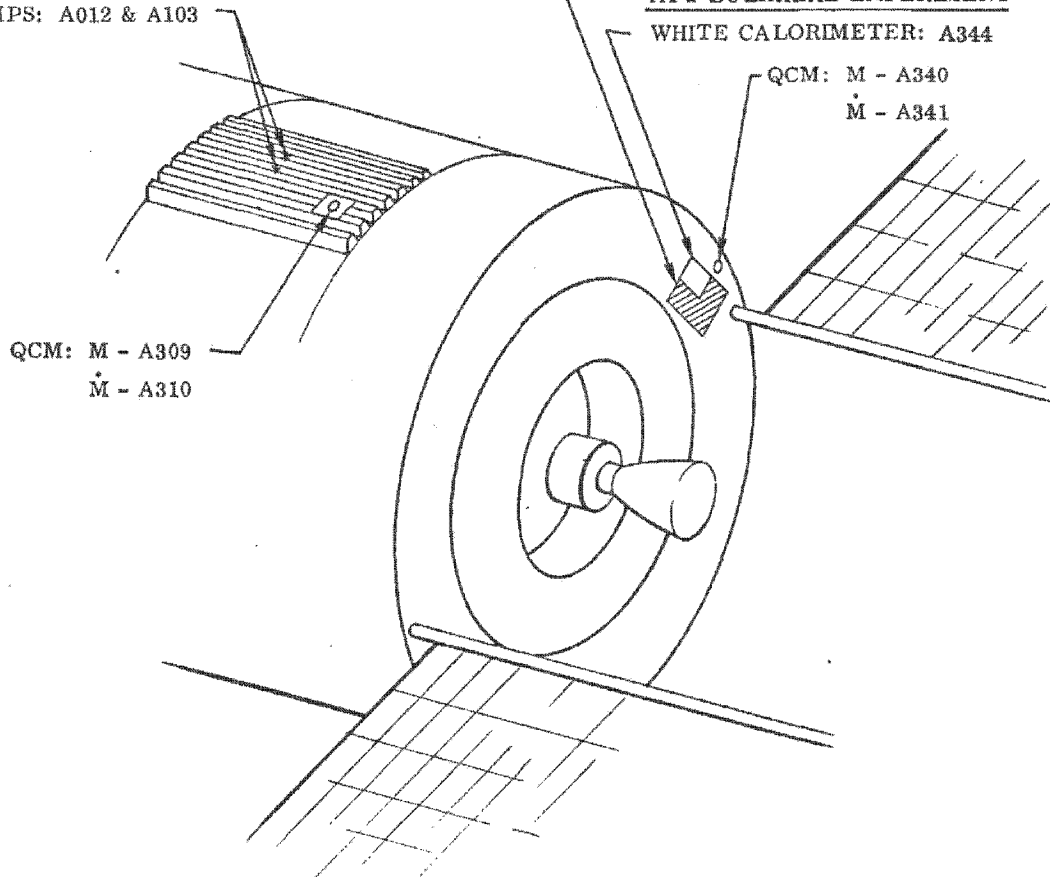
Fig. 12-2 8004 Contamination Experiments

12.4.2.2 Aft Bulkhead. The ascent contamination caused negligible change in the mass deposition level measured by the Station 2203 QCM as shown in Fig. 12-2. This was as expected, as the SRM staging event causes only a momentary inflow of external gases into the aft section cavity via the vent ports. The first RV retro caused the mass deposit to rise from near lift-off levels to the telemetry limit of 5 TMV where it remained until the second RV retro. The extrapolated mass deposit due to the first RV was $3.8 \times 10^{-5} \text{ g/cm}^2$. The second RV retro caused the QCM to saturate and the crystal stopped oscillating as is expected when the mass deposit becomes excessive. The FOSR and white silicone calorimeter panels indicated an increase in α of 0.10 and 0.13 respectively from early flight to after the RV-3 retro event. After correction for ultraviolet degradation, a total change in α of 0.06 for both calorimeters is associated with the three contamination events.

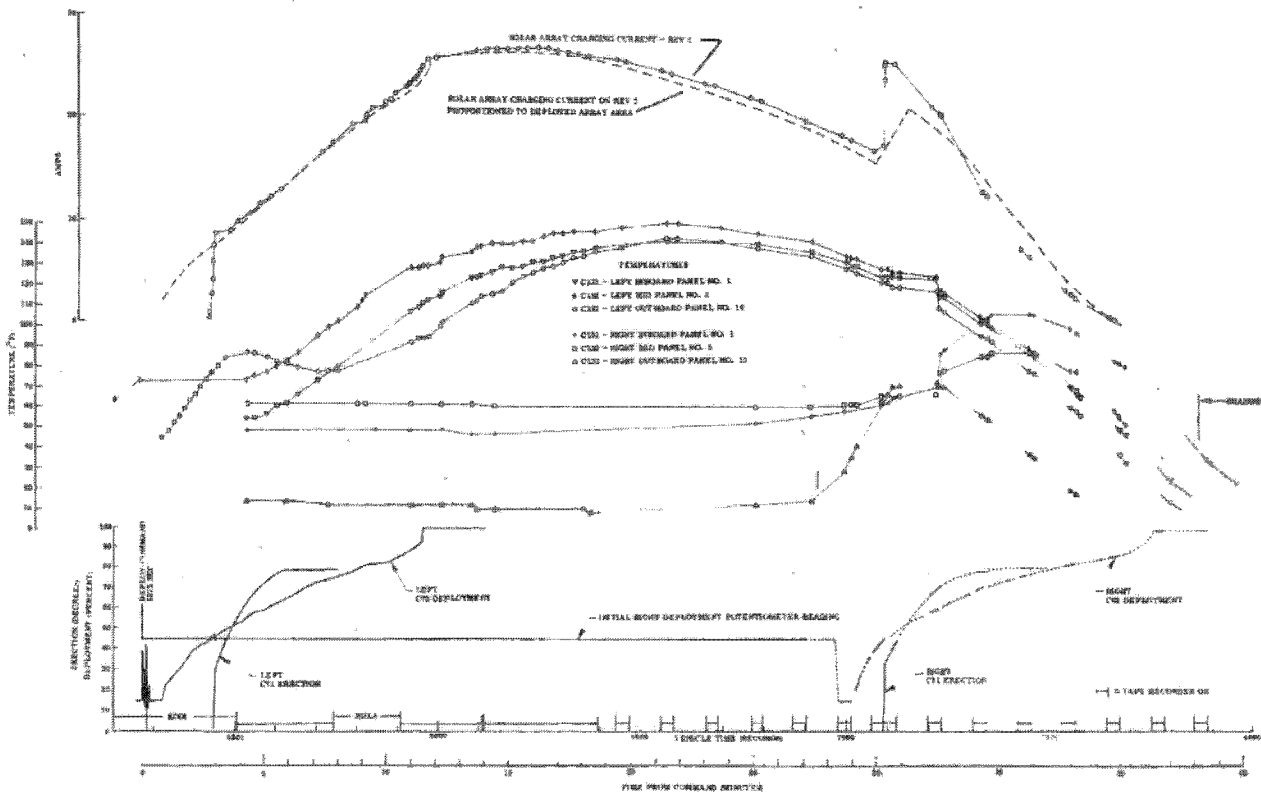
Fig. 14-2 Time History of Solar Array Parameters During Deployment

Solar Arrays were extended on Rev 1. The left array started deployment on command and required 640 seconds to complete deployment and erection. The right array did not start to deploy until 1680 seconds after receiving the command and then required approximately 750 seconds to complete deployment and erection. Power output from each leg exceeded the specification value. Degradation from the initial output to end of the fourth segment was 2 percent. 2 percent is well below the 5 percent allocated.
