BIF003W/2-069747-73

27 June 1973

FLIGHT TEST ENGINEERING ANALYSIS REPORT
FOR
THE HEXAGON PROGRAM SATELLITE VEHICLE NUMBER FIVE ~~(S)~~

Prepared and Submitted by the
Satellite Vehicle Integrating Contractor

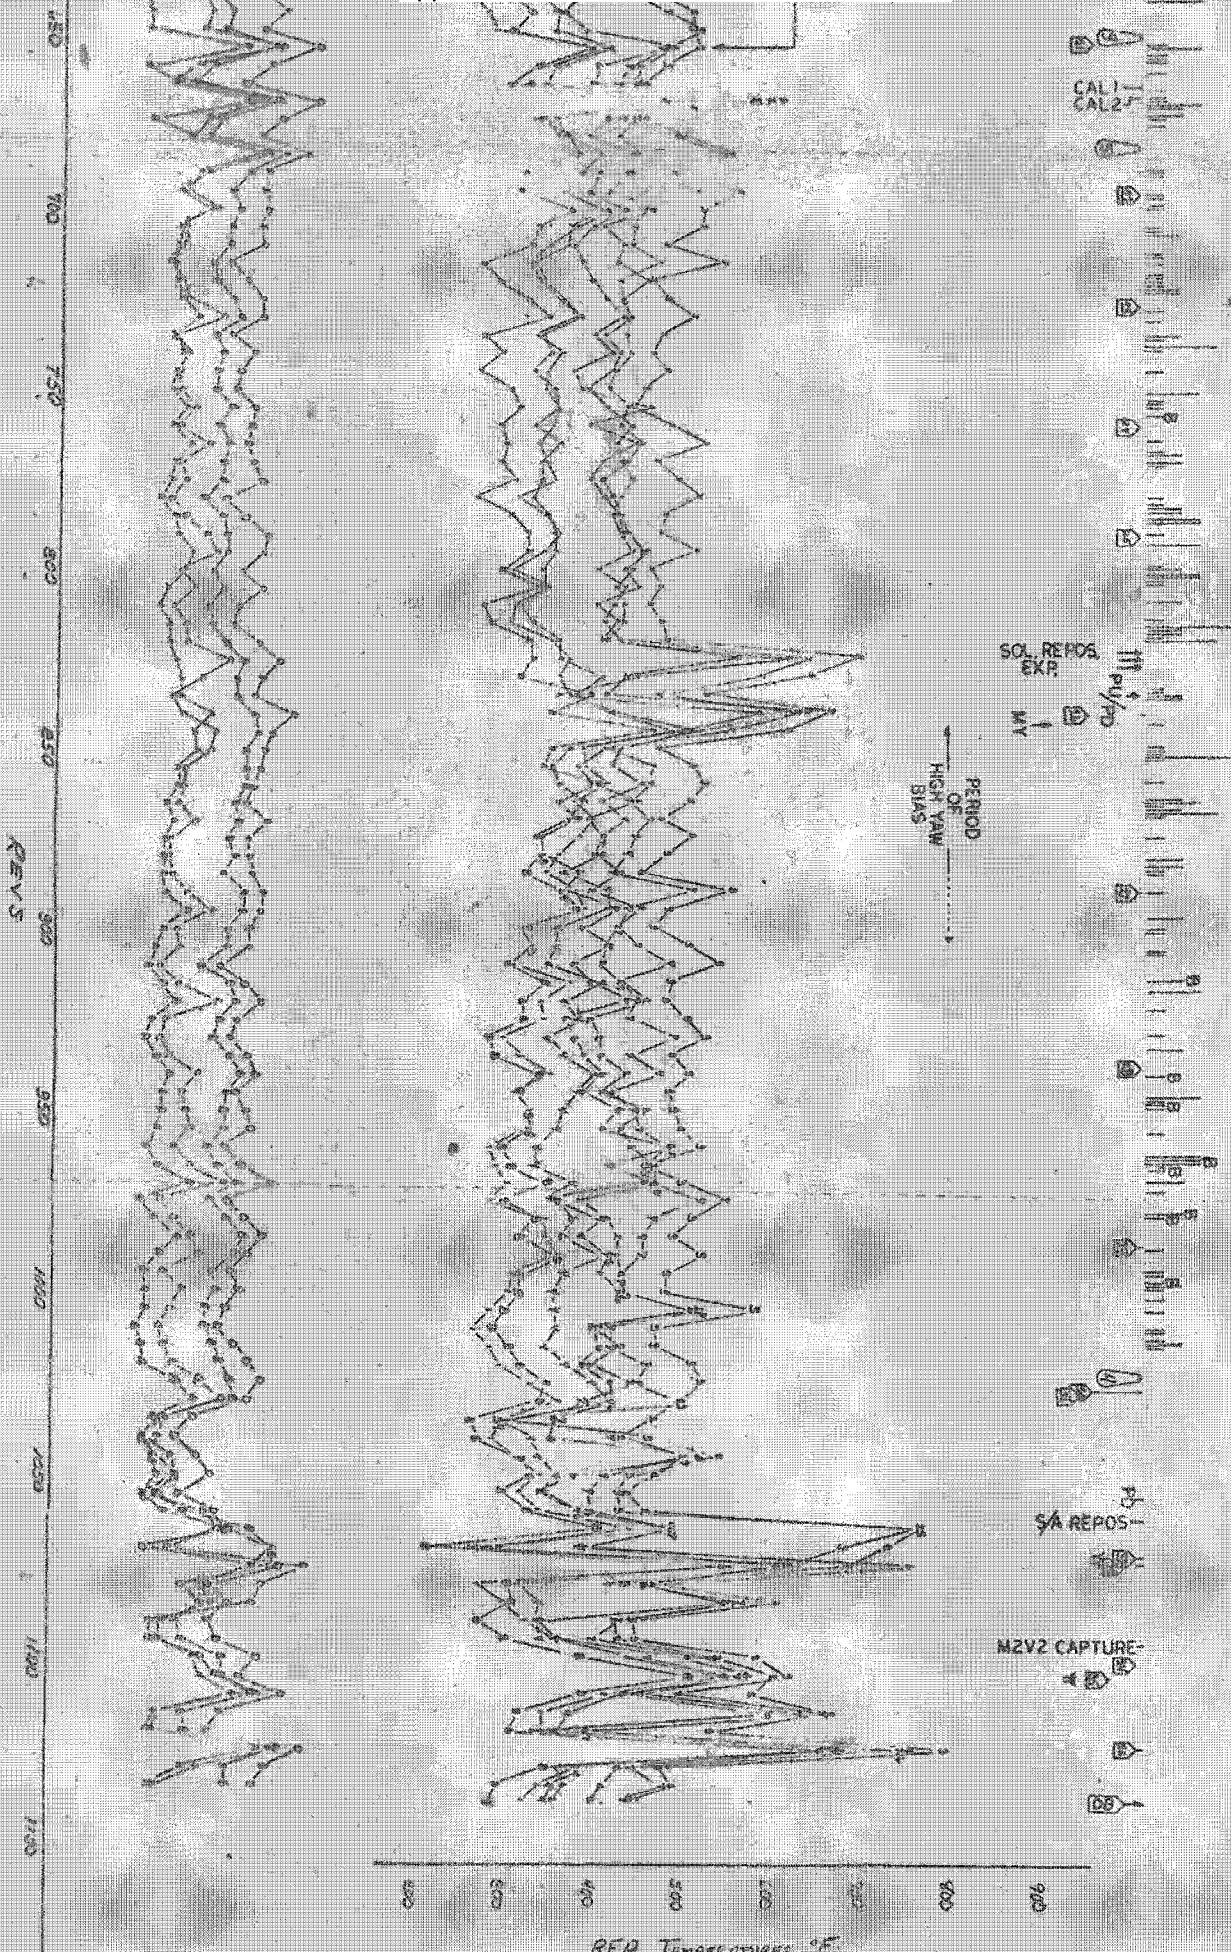
Figure 2-1 History of RCS Propellant Consumption

Satisfactory vehicle and rate control were provided by the RCS System during the 71 Day flight. Leakage developed in the standby system (RCS 2) as expected and control was switched to the primary system (RCS 1) on Day 32. No further leakage was detected throughout the remainder of the flight since non NVR propellant was supplied from the OAS Tank.

RCS propellant consumption for the 71 day mission was computed to be 333 pounds. Propellant was consumed from RCS Tanks 3 and 4 until Day 32 when control was switched to RCS 1 which was fed directly from the OAS Tank. The standard leakage signatures (an abrupt mount temperature increase and excessive propellant consumption) were observed starting on Day 29. After switching to RCS 1, no abrupt temperature increases were noted in either the individual REA or the mount temperature monitors. The daily RCS propellant consumption does not provide an early leak detector as the ullage is too large on the OAS Tank to accurately measure the pressure change caused by a nominal 5.0 pound per day usage rate.

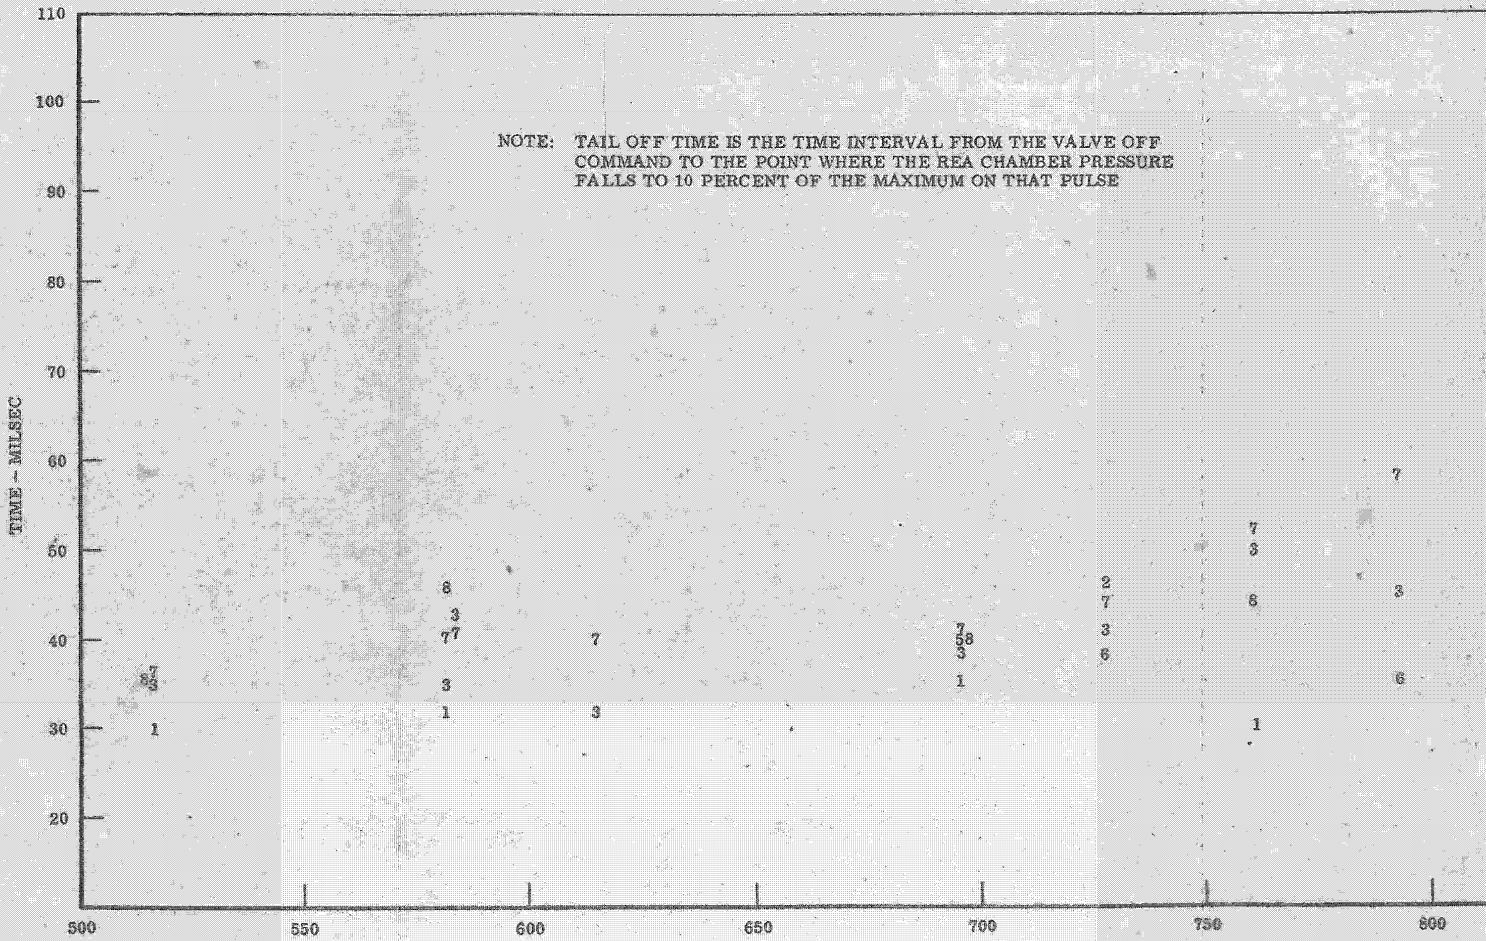
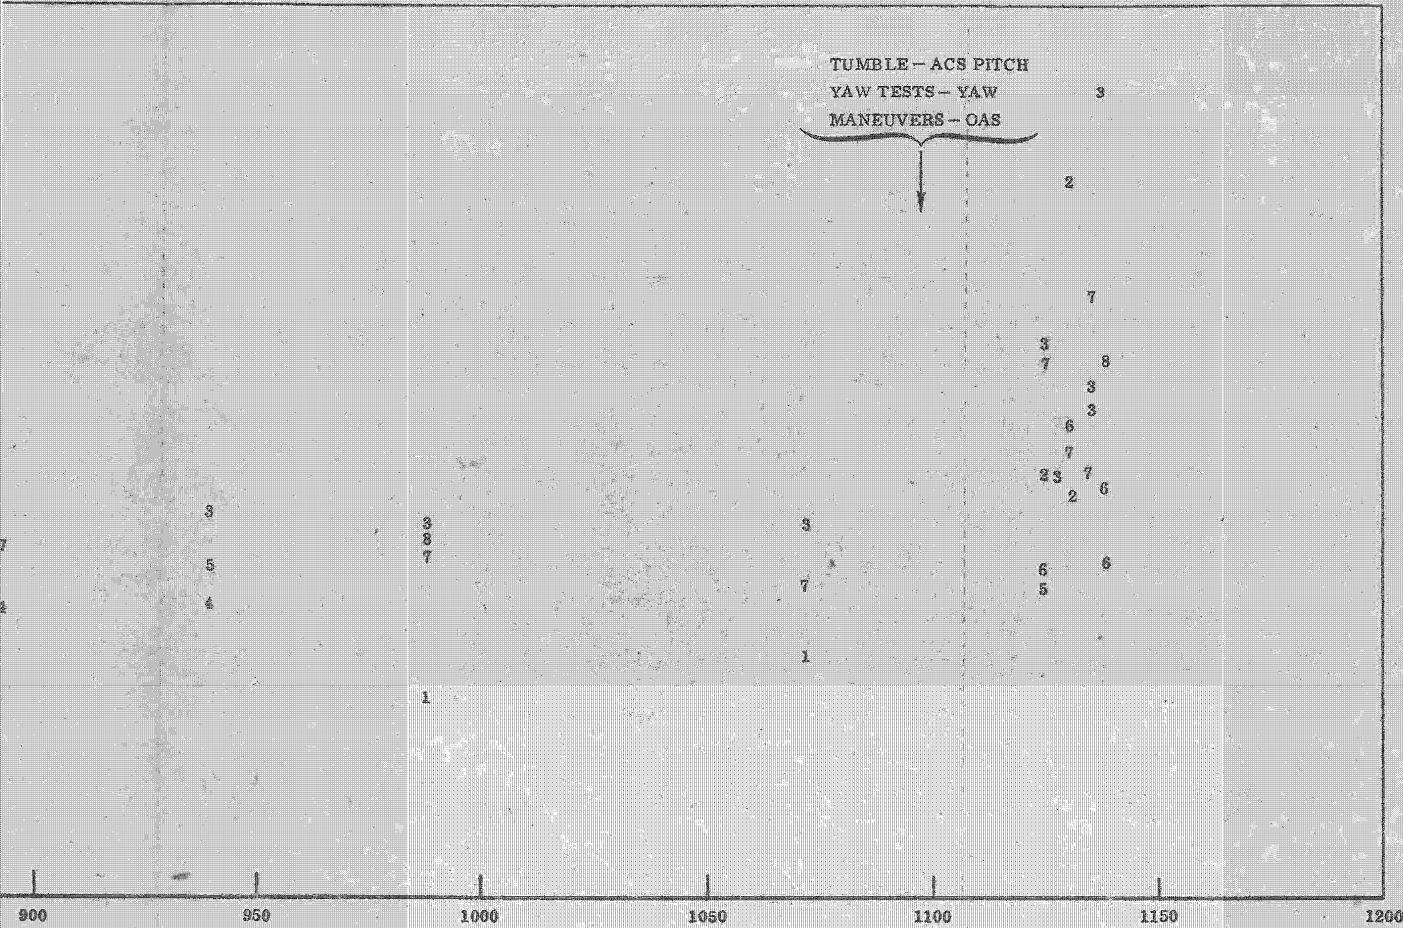
FIG. 2-2 TAIL OFF TIMES FOR RCS 1

After Day 32, the thruster performance of RCS 1 was determined from the thruster chamber pressures and from gyro data when available. Neither RCS 1 nor RCS 2 exhibited the thrust decay observed at Rocket Research during the Extended Life Thruster Evaluation Test (ELTET). Figure 2-2 is a plot of the chamber pressure tailoff times. The doubling of tailoff time was used as the onset of pulse shape distortion which in turn preceded the drop in thrust during the ELTET. As shown, tailoff times for the period after Rev 1100 doubled even though for these values the REA temperatures were high (in excess of 1000^oF) which has the effect of shortening the tailoff times, but no change in calculated I_{Bit} or I_{sp} was observed.

- Elimination of the use of the NVR fuel from the RCS tankage stopped the RCS valve leakage.
- Thrust degradation was not experienced on this flight as observed in ground tests; however, pulse shape changes were noted toward the end of mission.

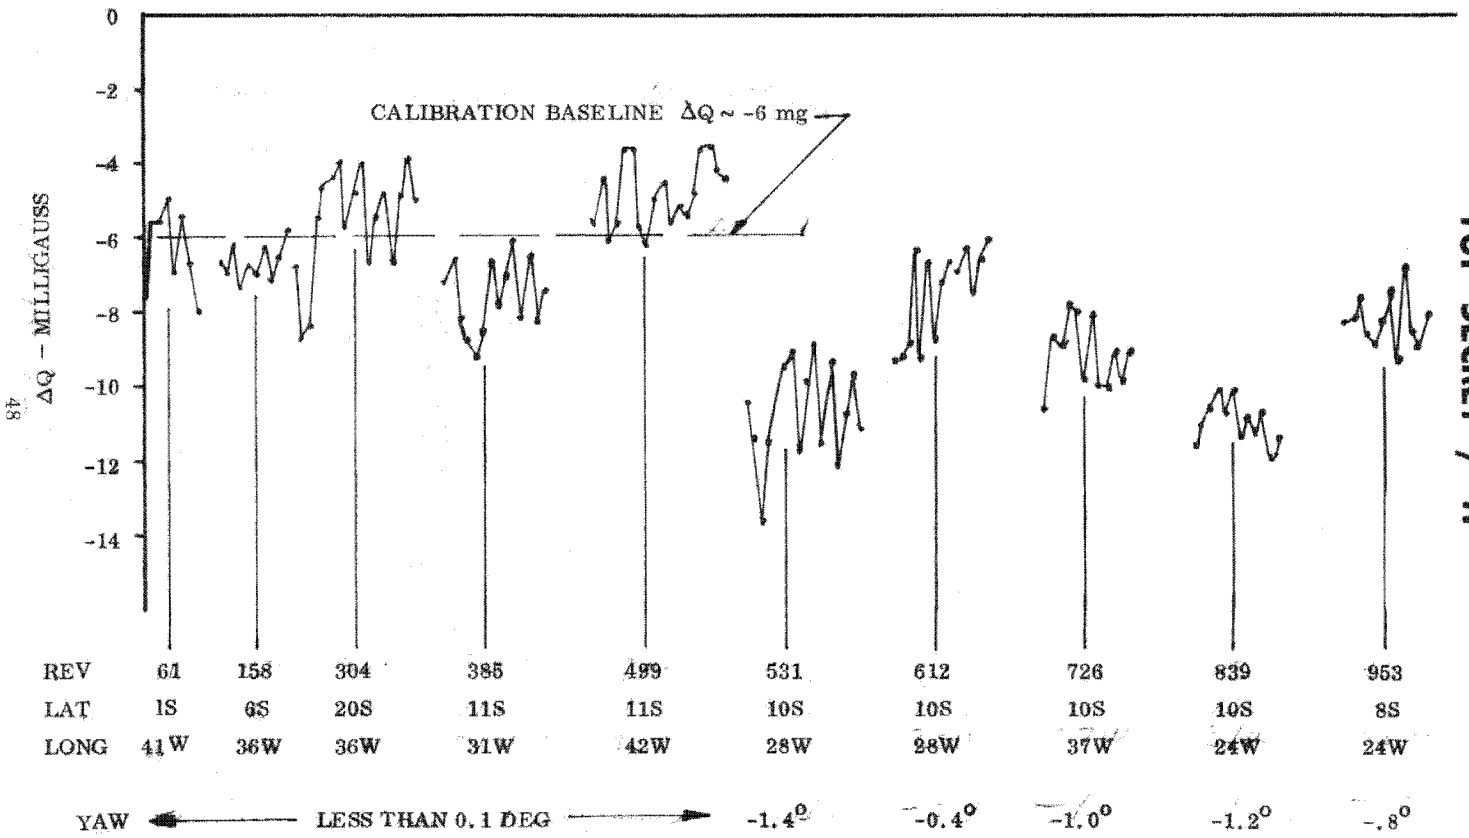
Figure 6-1 Yaw Effect on Q Magnetometer

Flight tests demonstrated the Q magnetometer capability to determine yaw attitude errors (in case of an ACS gyro malfunction) of 1 degree or more provided the magnetic field inclination angle is not large and a satisfactory calibration has been accomplished prior to the ACS failure. The restriction to the method is that the calibration must be for the same latitude and within $\pm 5^{\circ}$ of longitude for the point at which the yaw is to be

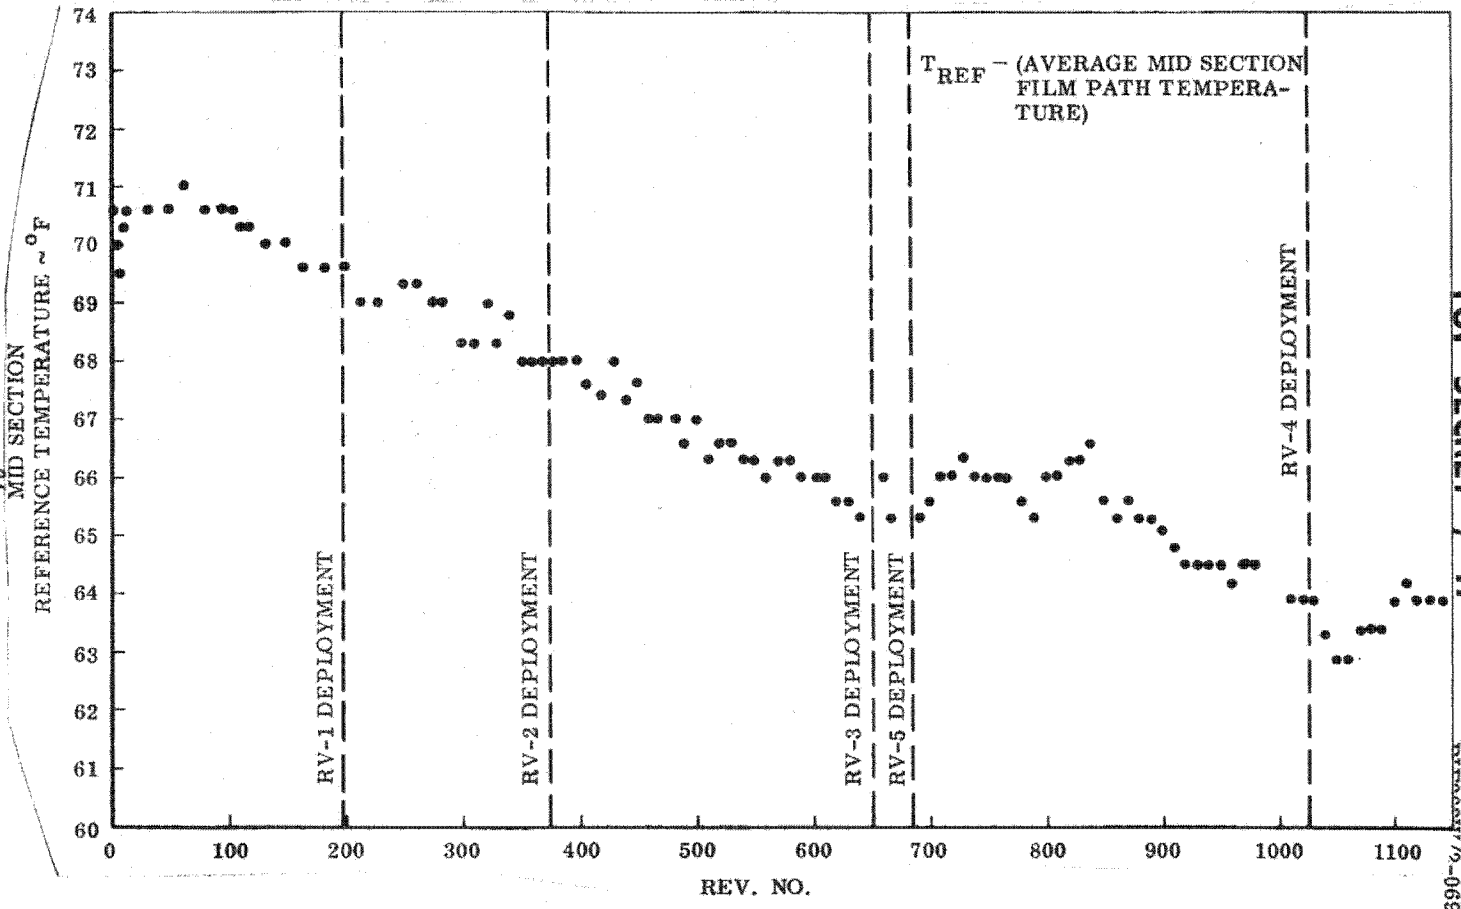
Fig. 12-1 SV-5 Mid Section Temperature History

T_{Ref} , which represents the average Mid Section film path temperature, decreased from 71 to 63°F during the flight as shown in Fig. 12-1. This followed a gradual cooling of the Mid Section from 69 to 63°F. These temperatures are well within the allowable range of 47 to 93°F but are noted since this cooling had not been seen on previous vehicles. Changes in the solar constant during the flight could account for approximately 2°F or 30 percent of the temperature reduction. At present, no reason for the rest of the decrease has been found. No further action is contemplated. The temperatures will be studied again on future flights.
