25 August 1971  
Sheet Count: 73

FLIGHT TEST ENGINEERING ANALYSIS REPORT  
FOR  
THE HEXAGON PROGRAM SATELLITE VEHICLE NUMBER ONE (S)

This report describes the performance of the first HEXAGON Program Satellite Vehicle (SV-1). The vehicle was launched on 15 June 1971 and completed its primary mission with the recovery of RV number four on 16 July 1971. This report encompasses only these 31 days.

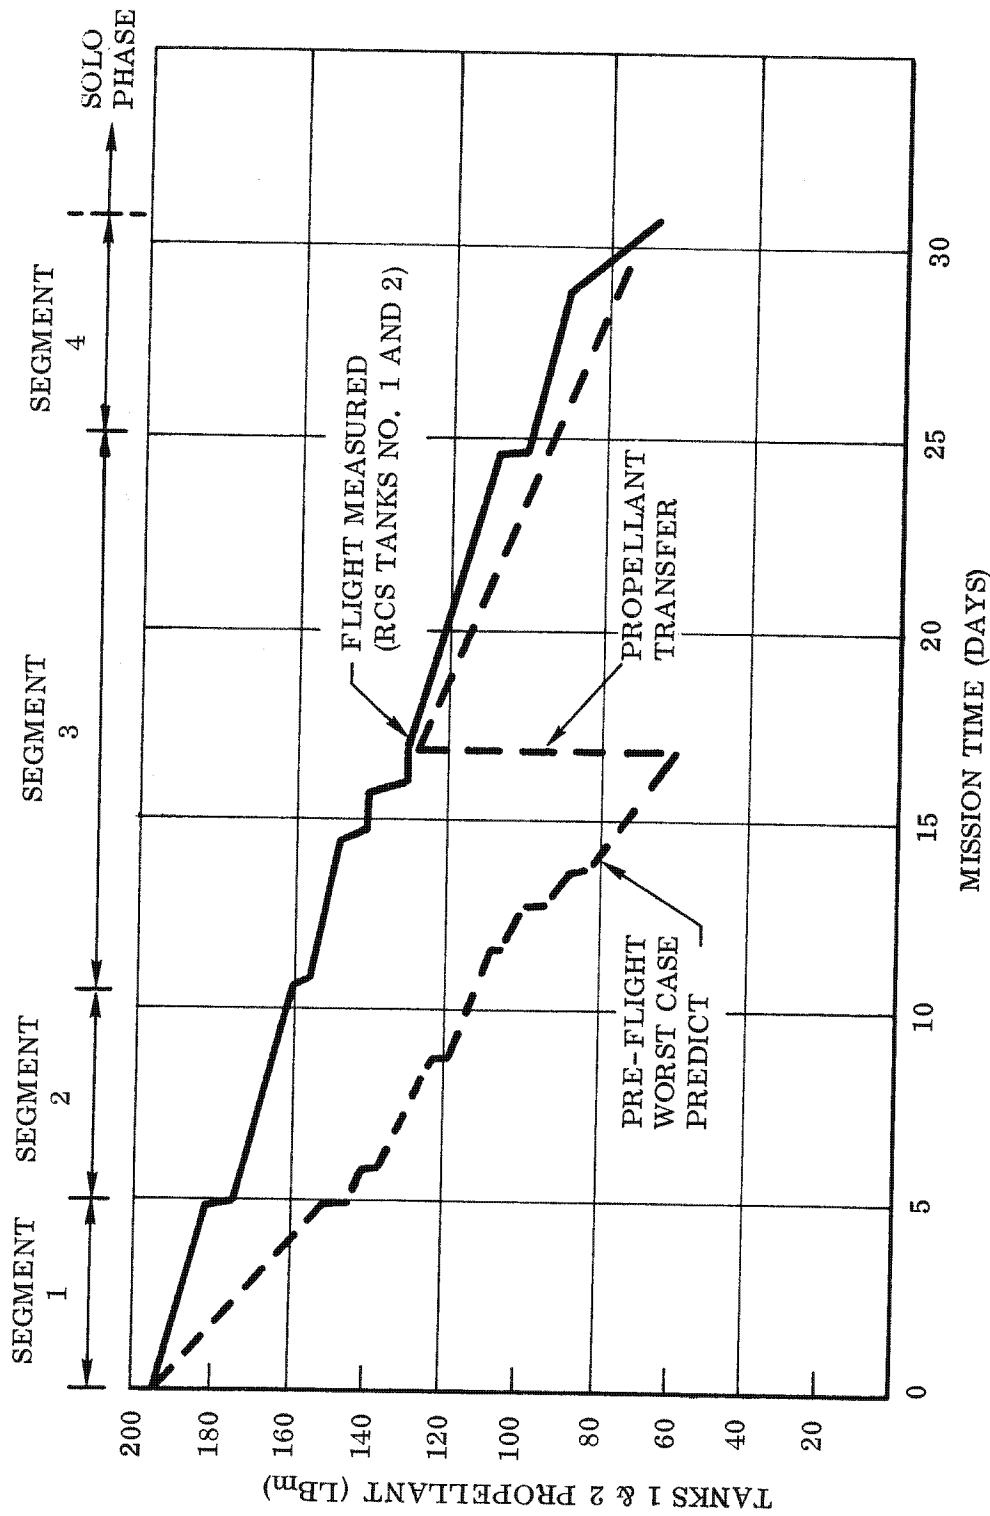
Fig. 2-1 RCS Propellant Consumption

The RCS propellant consumed over the 31 days (502 Revs) was 134 ±10 lb as shown in Fig. 2-1. The flight measured consumption was computed from the RCS tank temperature and pressure telemetry data and has an uncertainty of ±10 lb at beginning and end of mission. Also shown in the figure is the pre-flight worst case prediction which was based on P/L ops per ICD and includes contingencies such as magnetic torques and leakage.

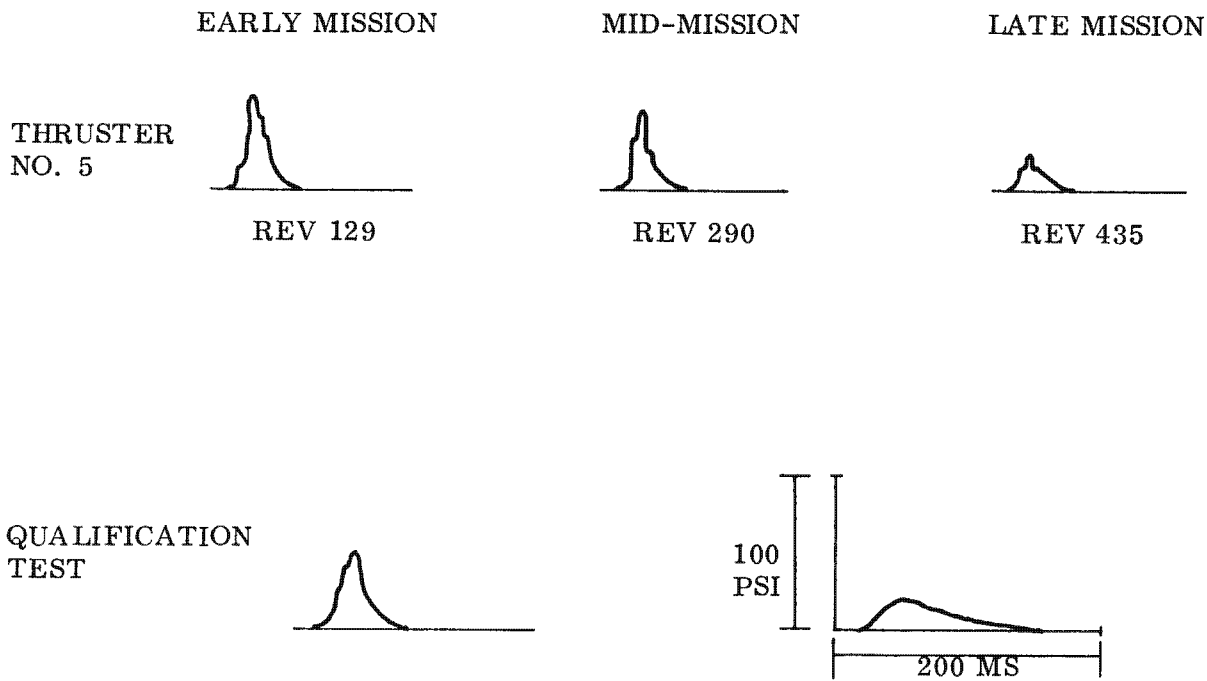
Fig. 2-2 RCS Thruster Performance

Three RCS Thrusters showed some sluggishness in pulse shape tailoff at the end of the mission as shown in Fig. 2-2. The degree of tailoff change was minor and much less than observed during ground testing which is shown for comparison. The distortion of the pulse shape suggests some catalyst bed wear, particularly at low duty cycles. Vehicle control was not compromised and no change in propellant consumption could be detected. Pulses with tailoff sluggishness have the same total impulse as pulses with crisp shapes and thus no change in specific impulse is encountered. The small change in response and centroid is minor, not affecting vehicle control.

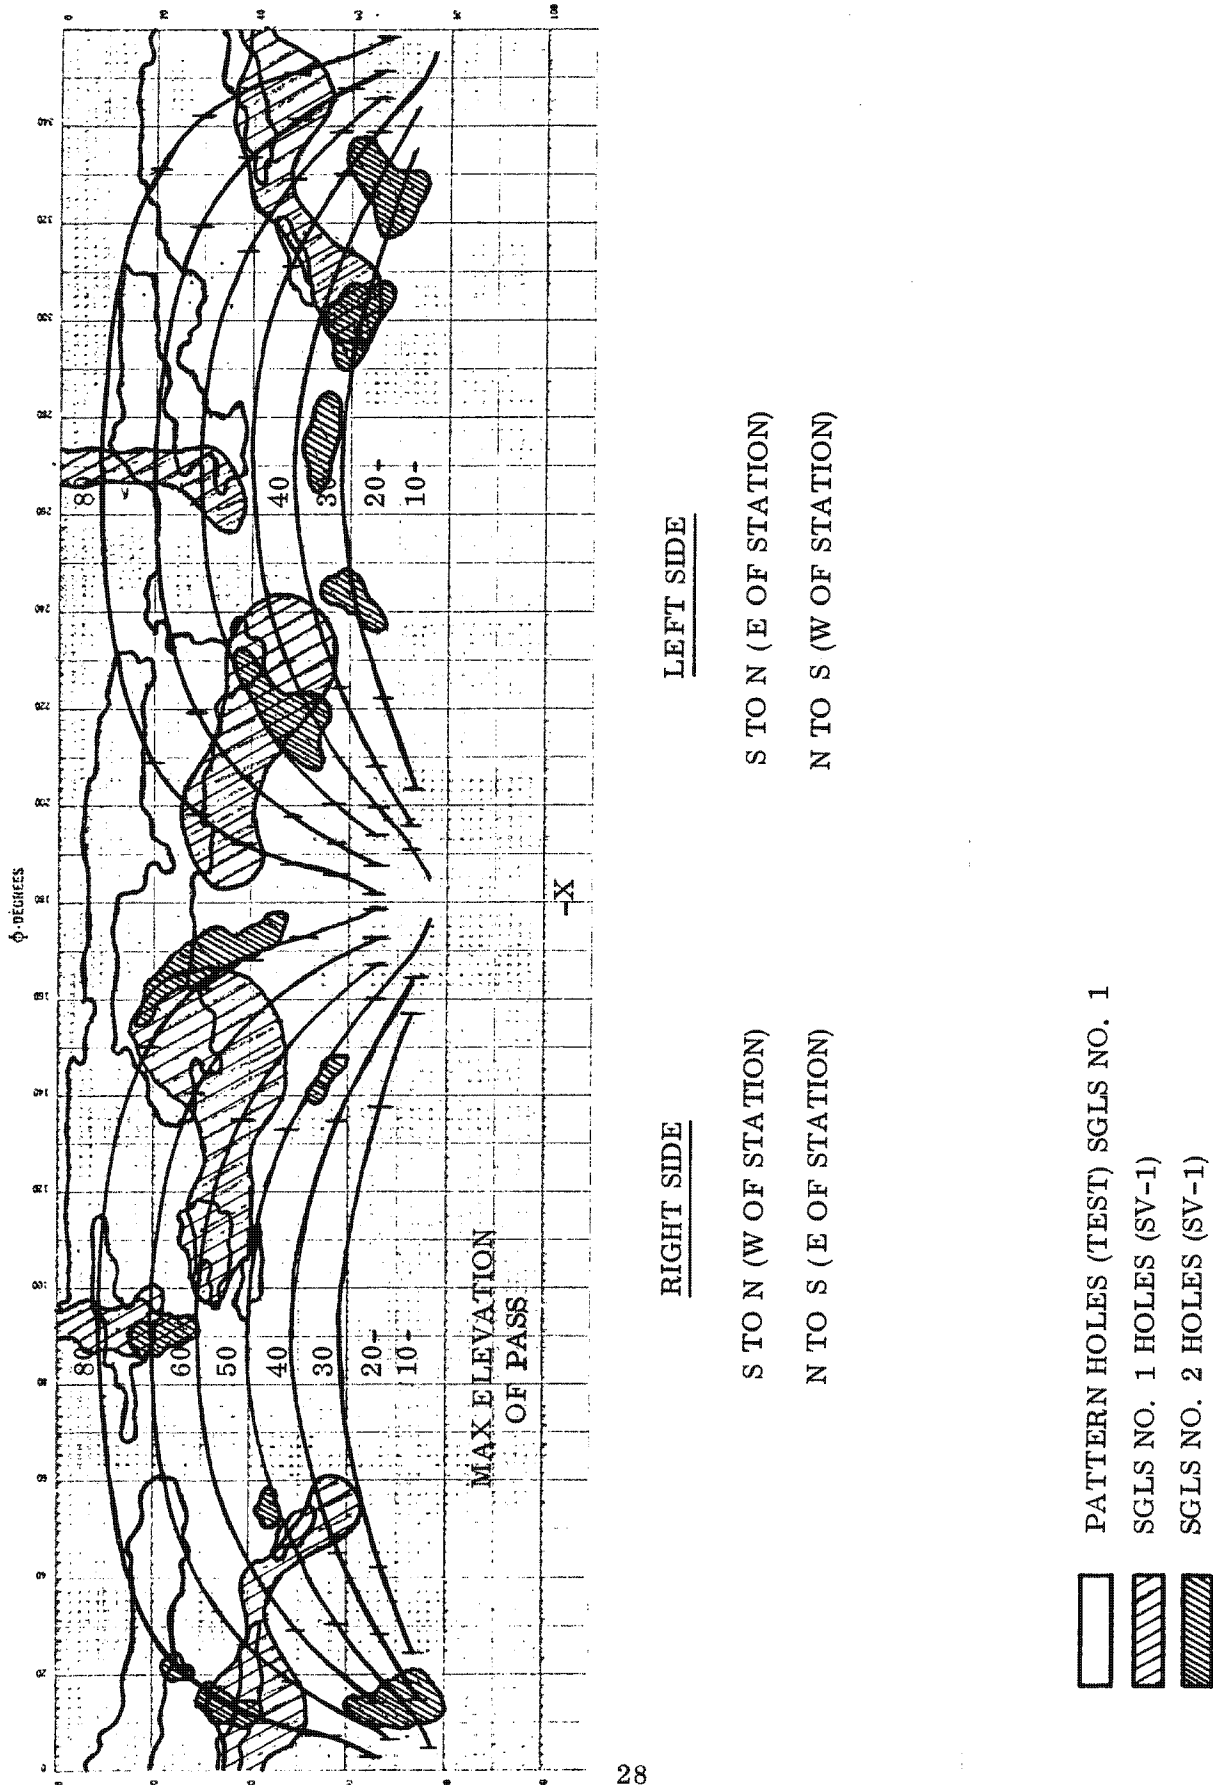
Fig. 4-1 Antenna Patterns

The report states that the requirements cannot be met in all directions at the down-link frequencies, but considering where these deficiencies occur, they were not considered significant.

All Remote Tracking Stations experienced fluctuations during the mission. These fluctuations ranged from minor changes (5 dB) to complete drop-outs. The majority of fluctuations were identified and plotted. The observed SGLS 1 fluctuations are symmetrical (right/left side of SV) as shown in Fig. 4-1. Solar array positioning (during SOLO) to other locations resulted in no significant pattern changes. As a result of the SGLS 1 data obtained, a secure block loading constraint was recommended to Test Control. Also, predictions were made by the SBAC Flight Support Team (FST) and provided to Test Control for both block loading and tape recorder playback. These methods of avoiding the drop-outs were easily followed by Test Control with minimal impact and essentially no data loss. SGLS 2 was also used during the mission to obtain signal strength data. The data obtained indicates that the fluctuations are not symmetrical (i. e., left side different than right side). This data is also provided in Fig. 4-1.

In summary, the original analysis published in 1970 defined holes in the pattern where drop-outs could be expected. After the fluctuations were identified and understood in flight, the system (Test Control, Test Advisor, FST, etc.) continued their functions knowing what the constraints were, and there was little or no impact to those tasks. For SV-2 and up, SBAC recommends that these same constraints be utilized and the FST continue to provide predictions as a normal function. No hardware changes are recommended.

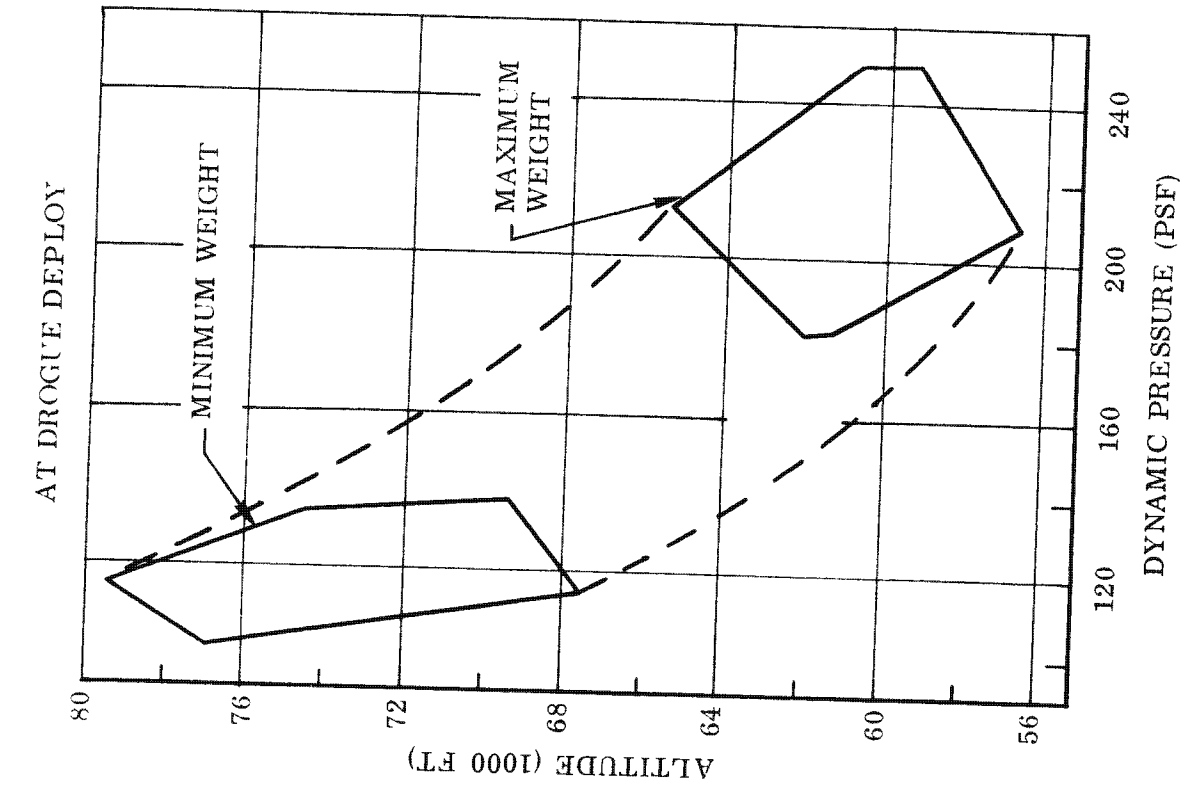
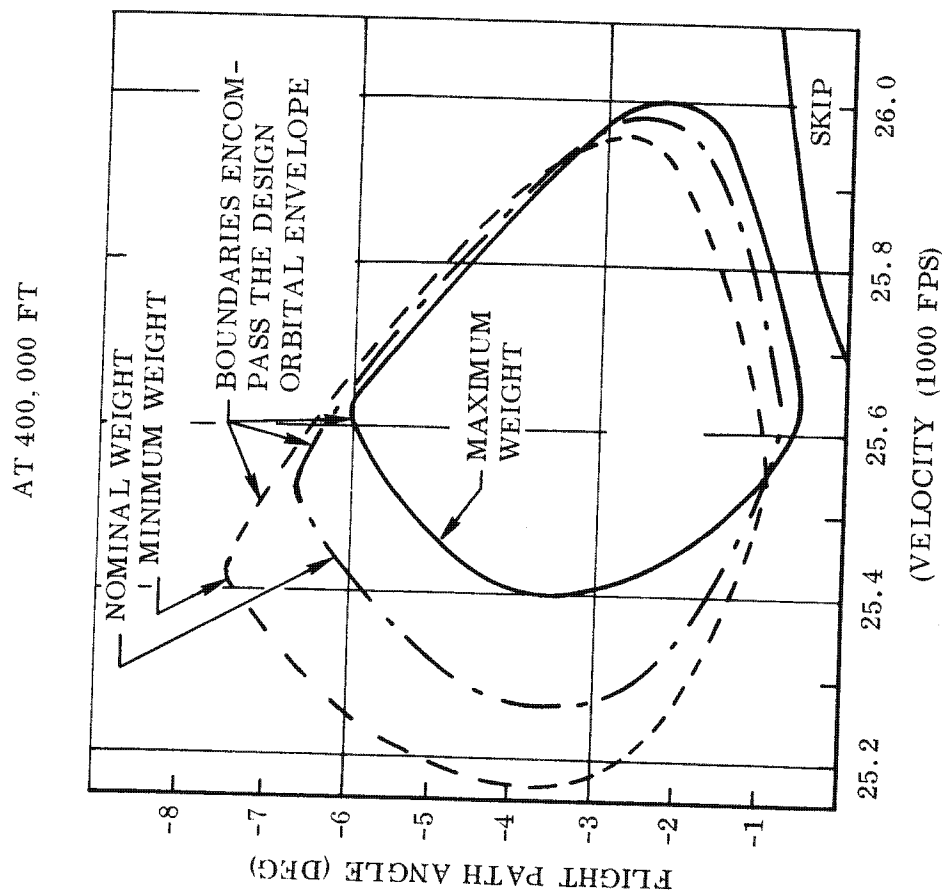
Fig. 8-1 Reentry Parameter Comparison

The entry (400,000 ft altitude) velocity and flight path angle for each flight are shown in Fig. 8-1 compared to envelopes of possible entry conditions for which the reentry vehicles was designed to be compatible. During the early period of the entry phase, the residual roll rate, which had been nearly constant during the exoatmospheric coast phase, began to decrease. After approximately 110 sec the roll direction reversed. This reversal was typical for all four flights and had no measurable effect on the capability of the RVs to enter successfully. Angle of attack was less than the predicted values throughout the significant heating portion of the entry, due to roll reversal and associated phenomena. Velocity and altitude time histories apparently correlated well with predicted normal values as evidenced by the accuracy of the impact.

Figure 8-1 also shows the altitude and dynamic pressure for each flight at the time of drogue parachute deployment with respect to the design envelope. Flight instrumentation data show that drogue performance as a decelerator was essentially as predicted. For example, the maximum dynamic pressure at drogue release and main parachute deployment was 58.7 psf observed on Flight 2, and the predicted value for this flight was 60.2 psf.

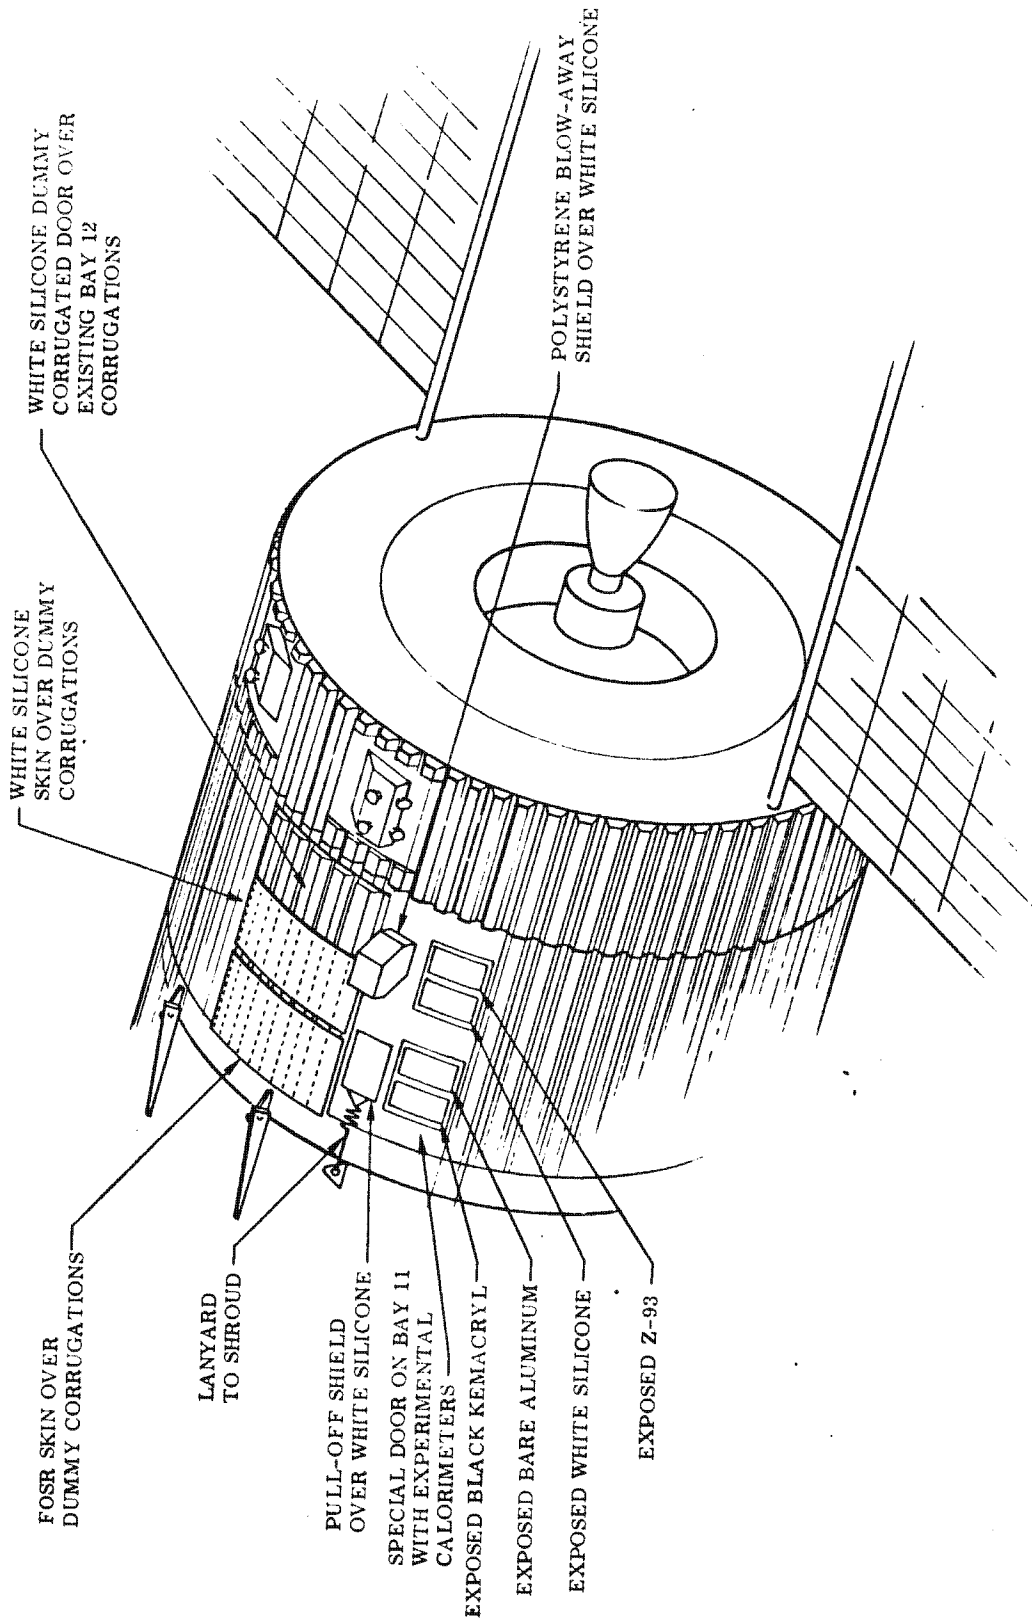
Fig. 12-1 SV-2 Contamination Experiments

Contamination of Aft Section surfaces during ascent is the apparent cause of the anomalous Aft Section temperature levels. Ascent events that could contribute to contamination include the liftoff ground cloud, SRM staging, Stage I/II separation, RV separation, Stage II retro, and Shroud separation. Although it is impossible to distinguish between these possible sources, review of available ascent temperature data, review of movies of SV-1 and other vehicles during lift-off and ascent, discussions with other program offices, and review of prior analyses of these contamination sources has resulted in the conclusion that most of the contamination occurred during liftoff and/or SRM staging. Accordingly, a plan of action as described below was formulated for SV-2, leading to a positive fix on SV-3.

The existing Bay 11 Door will be replaced with a modified Bay 6 door. The Bay 6 door will not have a Horizon Sensor Fairing and the four Horizon Sensor Head holes will be used for calorimeters having white silicone, black Kemacryl, bare aluminum and Z-93 surfaces. One of the four calorimeter panels will be protected through the lift-off cloud event, a second panel will be protected through the SRM staging event, and the remaining two panels will be exposed throughout ascent. The layout of this experimental Bay 11 door is shown in Fig. 12-1. Orbital temperature data from these calorimeter panels are expected to satisfy objectives 1, 2, 3 and 6 as stated above.

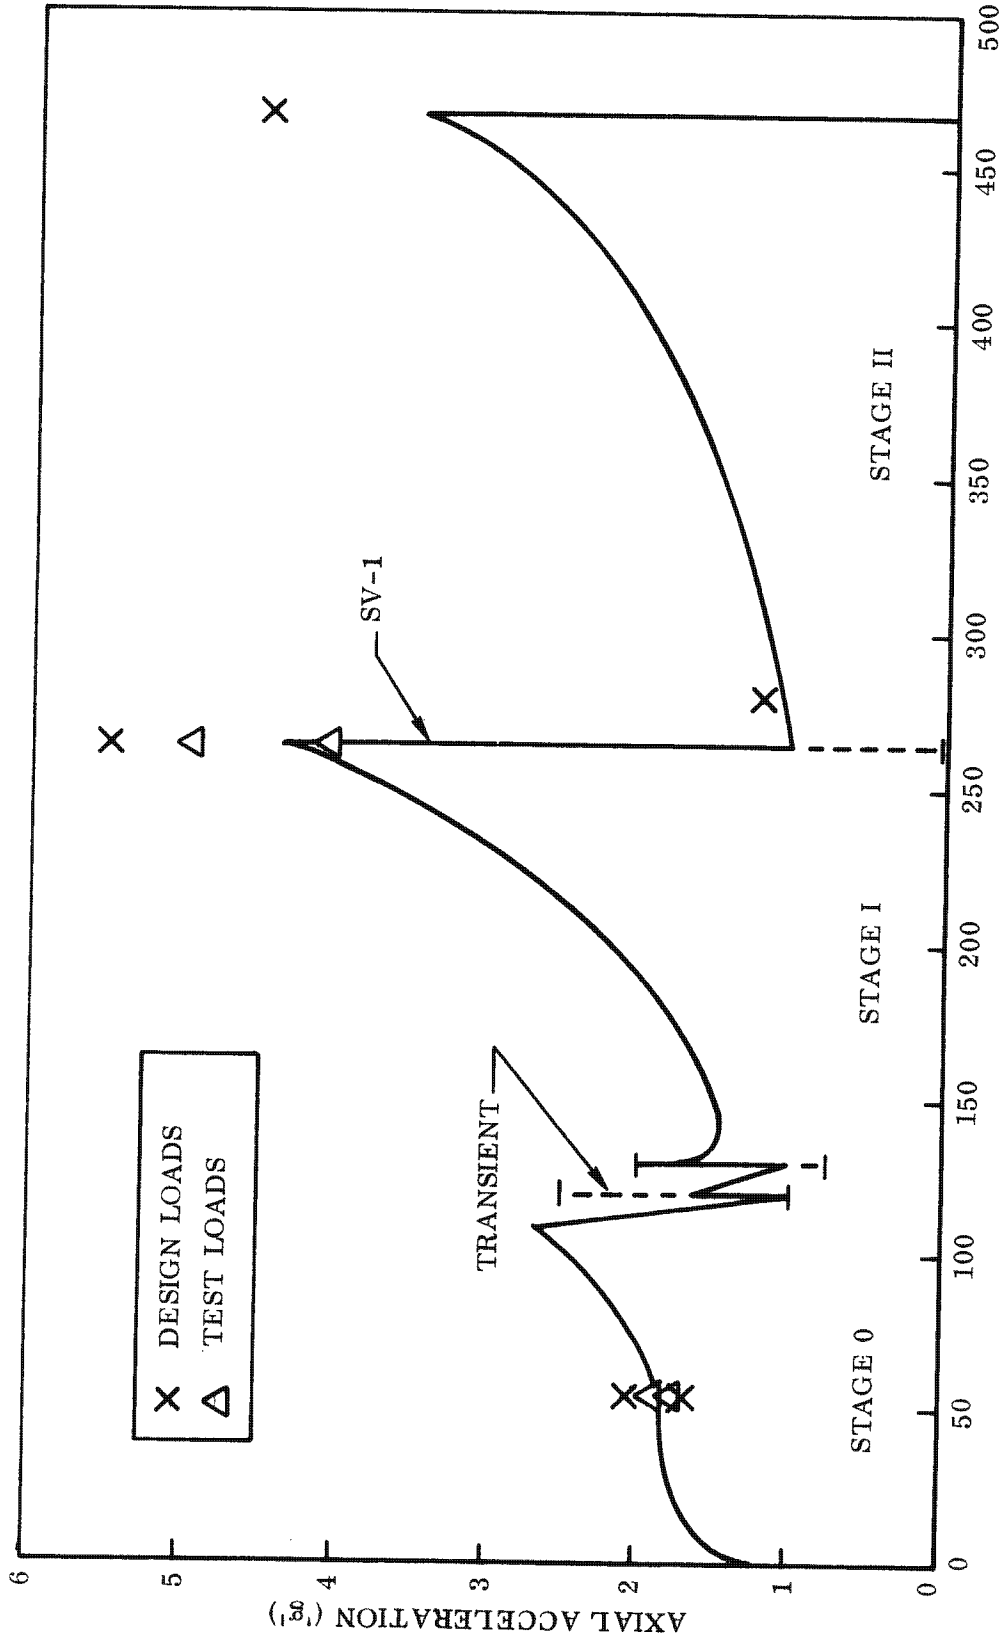
Fig. 14-1 Axial Acceleration History

The fundamental longitudinal mode response, which can occur anytime during Stage I flight, reached its highest level shortly before Stage I burnout. The maximum level measured was 0.4 g's (zero to peak) at station 1642 which was well below the design level of 1.0 g's at the same location.
