SYSTEM

PERFORMANCE EVALUATION TEAM

MISSION 1208

PERFORMANCE EVALUATION TEAM REPORT NO. 1208/74

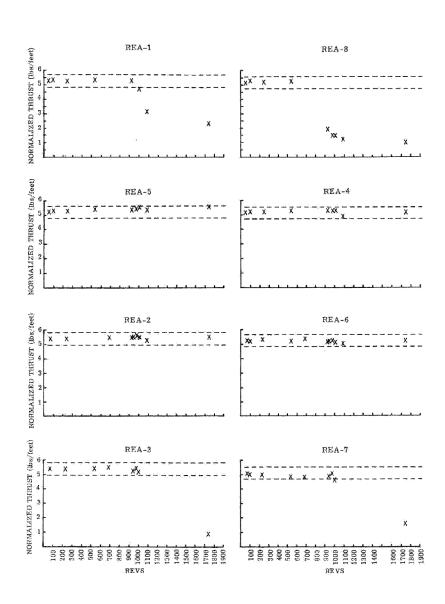
FIGURE 3-1

RCS-1 thrust levels were determined using individual REA chamber pressures. Figure 3-1 is a history of the normalized thrust. The dashed lines are the ±8% run-to-run tolerance allowed. As can be seen, REAs -1 and 8 were seriously degraded while REA-7 was just starting to degrade when the control function was switched on Rev 1083. RCS-1 was re-activated on Rev 1761 for a two rev thruster performance evaluation during Solo operations. REAs -1 and 8 of RCS-1 produced less thrust during this test than they did just prior to the switch to RCS-2. Similarly, REAs -3 and 7 of RCS-1 exhibited a marked decrease in thrust output during the Solo re-activation. No explanation currently exists for thruster degradation after dormant periods.
