Performance Evaluation Team Report

MISSION 1207

SYSTEM
PERFORMANCE EVALUATION TEAM
MISSION 1207

AUGUST 1974

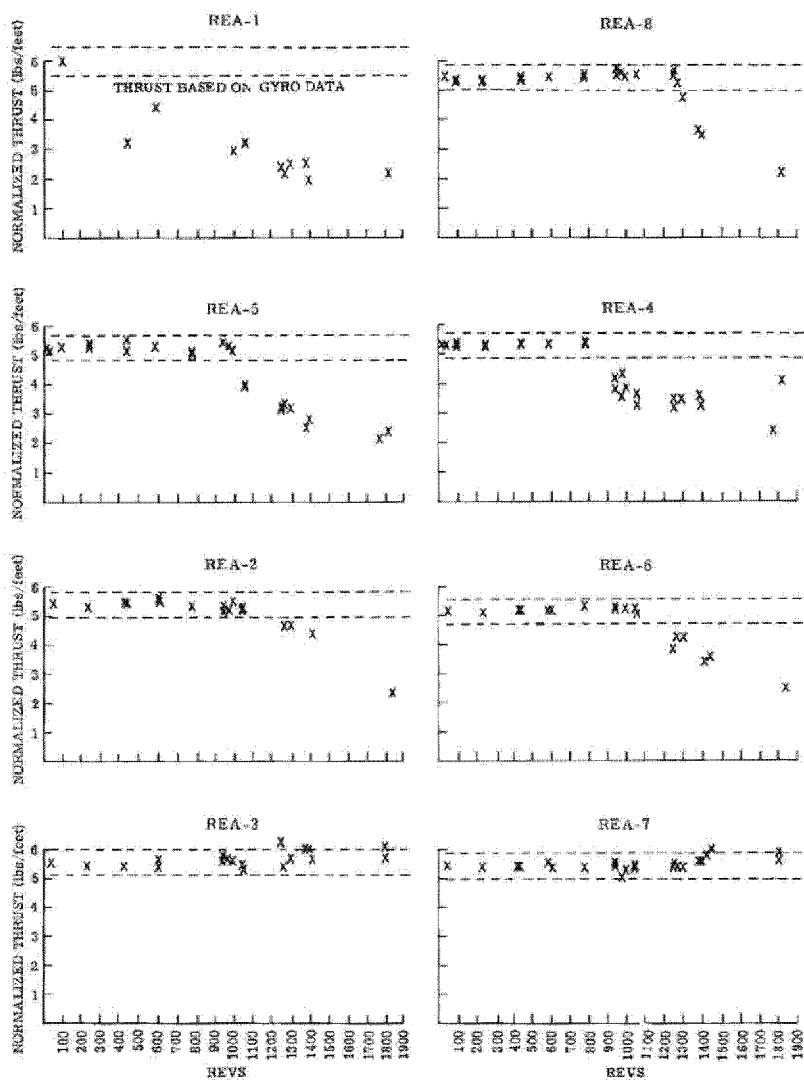
FIGURE 3-1

Thrust levels for RCS-1 were determined using the individual REA chamber pressures with the exception of REA-1 where thrust was determined from gyro data. Figure 3-1 is a plot of the normalized thrust over the mission life. The dashed lines are the $\pm 8\%$ run-to-run specification limits. As can be seen, all of the yaw thrusters and the two low activity pitch roll thrusters degraded while the active thrusters (3 and 7) remained healthy throughout flight. All REA duty cycles were slightly lower than previously experienced.

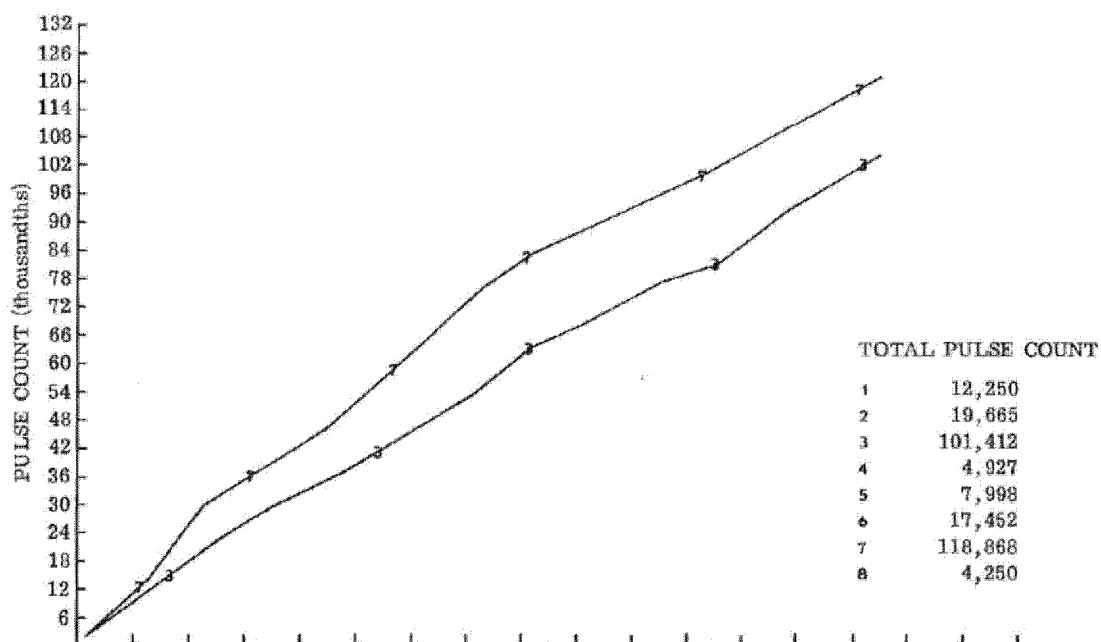
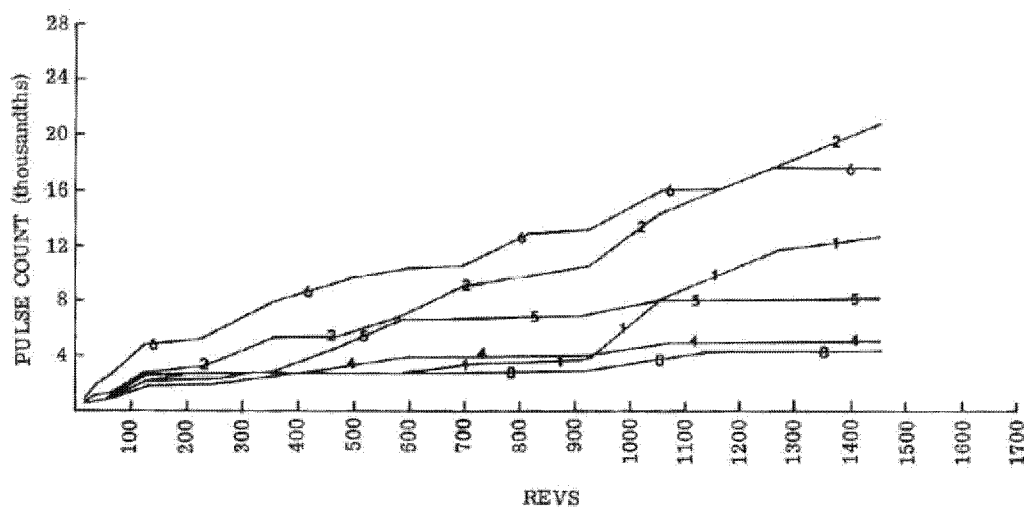
FIGURE 3-2

Total pulse count for RCS-1 thru Rev 1449 is shown in Figure 3-2. The method used to determine pulse count was checked during Solo by comparing continuous record sequences with the sampling system used for Figure 3-2. For the high duty REAs (3 and 7), the accuracy is $\pm 30\%$; for the other thrusters, the technique does not give an accurate count and can only be used to verify the thruster has a low duty cycle. RCS-1 was again activated on Rev 1740. Health tests were conducted to determine if the degraded thrusters of RCS-1 could perform critical vehicle maneuvers while operating at low feed pressures. All attempted maneuvers were successfully accomplished. During this period of Solo operation, RCS-2 was brought on line each evening to minimize the possibility of operational problems. RCS-2 was operated for control during the deboost event.
