SYSTEM

PERFORMANCE EVALUATION TEAM

MISSION 1207

~~TOP SECRET-HEXAGON~~PERFORMANCE EVALUATION TEAM  
REPORT NO. 1207/74

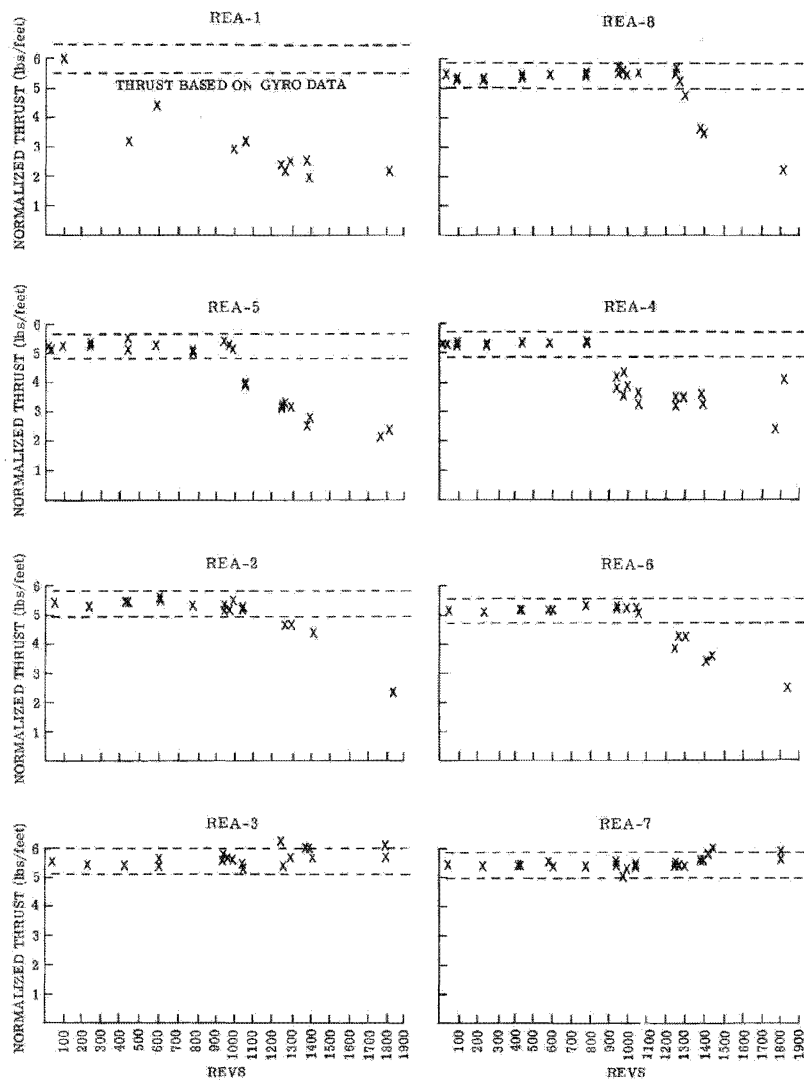
FIGURE 3-1

Thrust levels for RCS-1 were determined using the individual REA chamber pressures with the exception of REA-1 where thrust was determined from gyro data. Figure 3-1 is a plot of the normalized thrust over the mission life. The dashed lines are the  $\pm 8\%$  run-to-run specification limits. As can be seen, all of the yaw thrusters and the two low activity pitch roll thrusters degraded while the active thrusters (3 and 7) remained healthy throughout flight. All REA duty cycles were slightly lower than previously experienced.

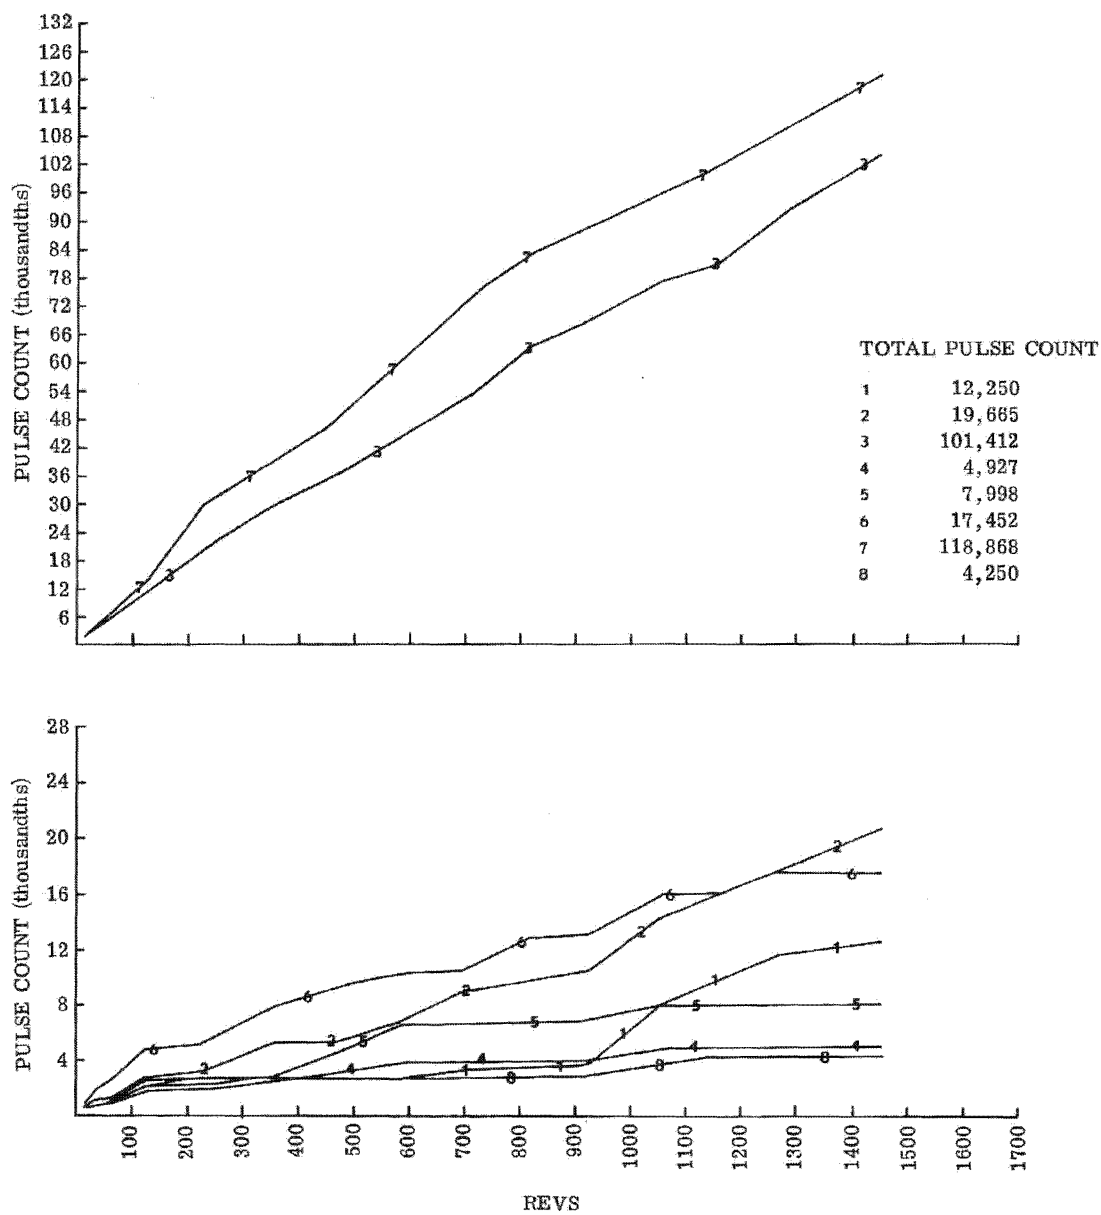
FIGURE 3-2

Total pulse count for RCS-1 thru Rev 1449 is shown in Figure 3-2. The method used to determine pulse count was checked during Solo by comparing continuous record sequences with the sampling system used for Figure 3-2. For the high duty REAs (3 and 7), the accuracy is  $\pm 30\%$ ; for the other thrusters, the technique does not give an accurate count and can only be used to verify the thruster has a low duty cycle. RCS-1 was again activated on Rev 1740. Health tests were conducted to determine if the degraded thrusters of RCS-1 could perform critical vehicle maneuvers while operating at low feed pressures. All attempted maneuvers were successfully accomplished. During this period of Solo operation, RCS-2 was brought on line each evening to minimize the possibility of operational problems. RCS-2 was operated for control during the deboost event.
