SYSTEM
PERFORMANCE EVALUATION TEAM
MISSION 1207

AUGUST 1974

~~TOP SECRET-HEXAGON~~PERFORMANCE EVALUATION TEAM
REPORT NO. 1207/74

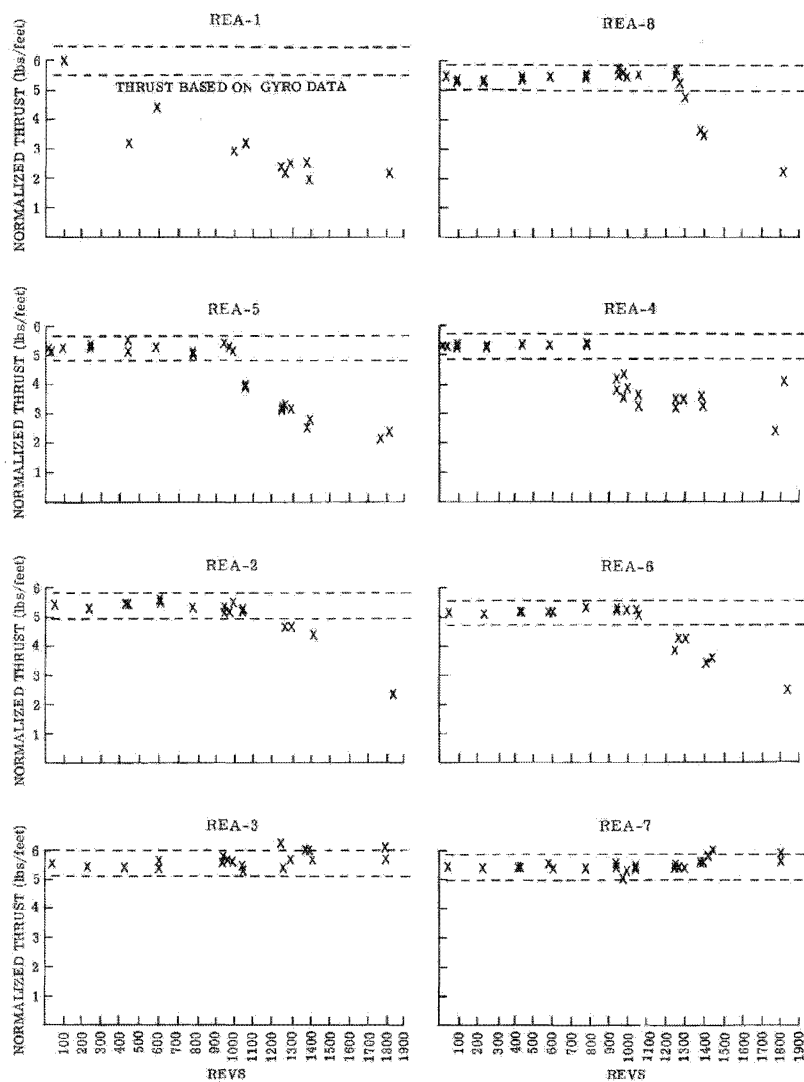
FIGURE 3-1

Thrust levels for RCS-1 were determined using the individual REA chamber pressures with the exception of REA-1 where thrust was determined from gyro data. Figure 3-1 is a plot of the normalized thrust over the mission life. The dashed lines are the $\pm 8\%$ run-to-run specification limits. As can be seen, all of the yaw thrusters and the two low activity pitch roll thrusters degraded while the active thrusters (3 and 7) remained healthy throughout flight. All REA duty cycles were slightly lower than previously experienced.

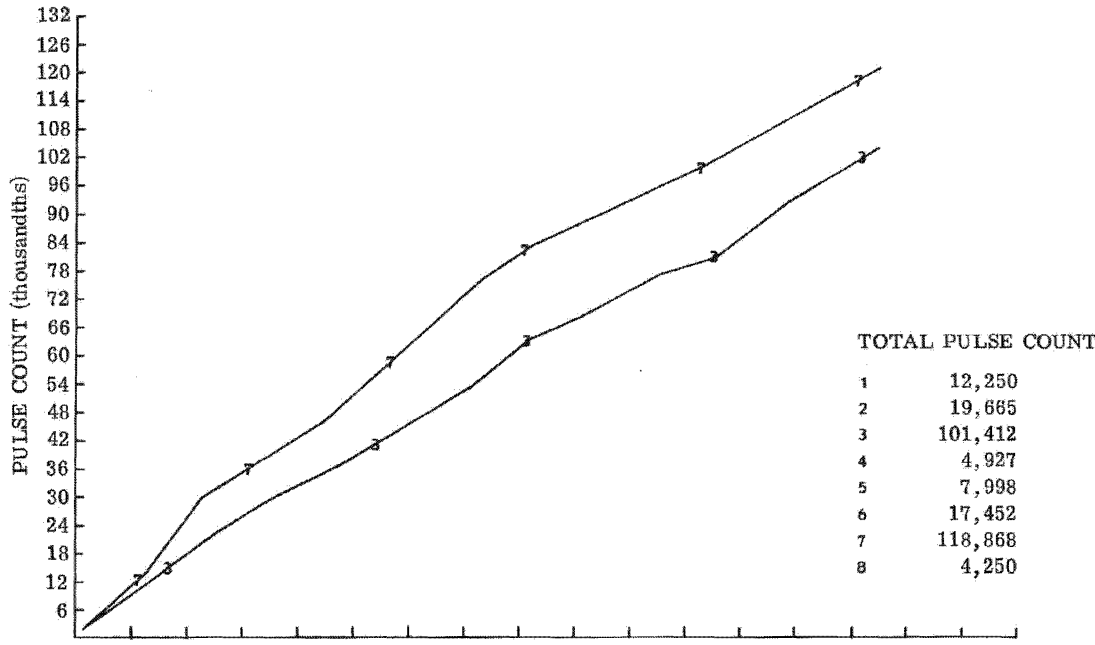
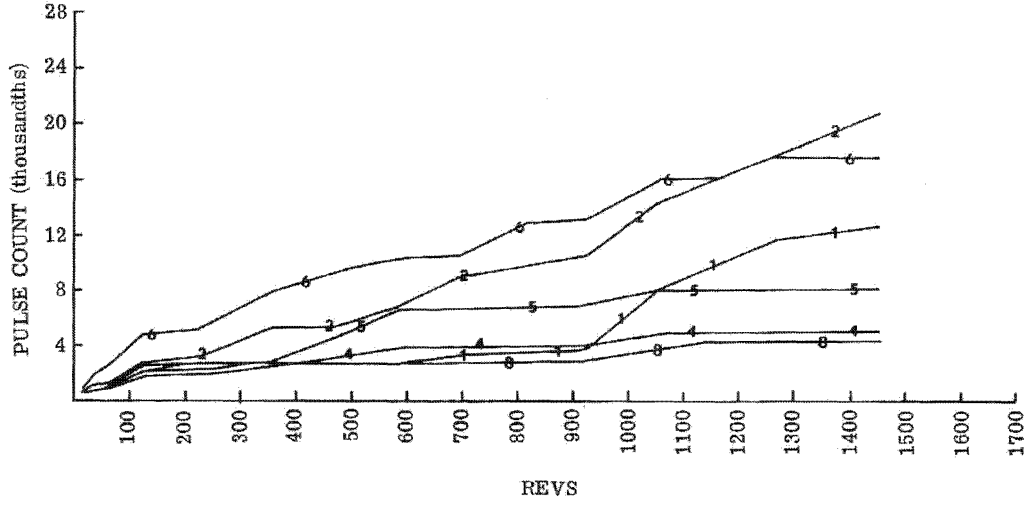
FIGURE 3-2

Total pulse count for RCS-1 thru Rev 1449 is shown in Figure 3-2. The method used to determine pulse count was checked during Solo by comparing continuous record sequences with the sampling system used for Figure 3-2. For the high duty REAs (3 and 7), the accuracy is $\pm 30\%$; for the other thrusters, the technique does not give an accurate count and can only be used to verify the thruster has a low duty cycle. RCS-1 was again activated on Rev 1740. Health tests were conducted to determine if the degraded thrusters of RCS-1 could perform critical vehicle maneuvers while operating at low feed pressures. All attempted maneuvers were successfully accomplished. During this period of Solo operation, RCS-2 was brought on line each evening to minimize the possibility of operational problems. RCS-2 was operated for control during the deboost event.
