PROGRAM REPORT

QUALIFICATION TEST REPORT

EASTMAN KODAK COMPANY
Apparatus and Optical Division
Rochester 4, New York

Date: 17 April 1964

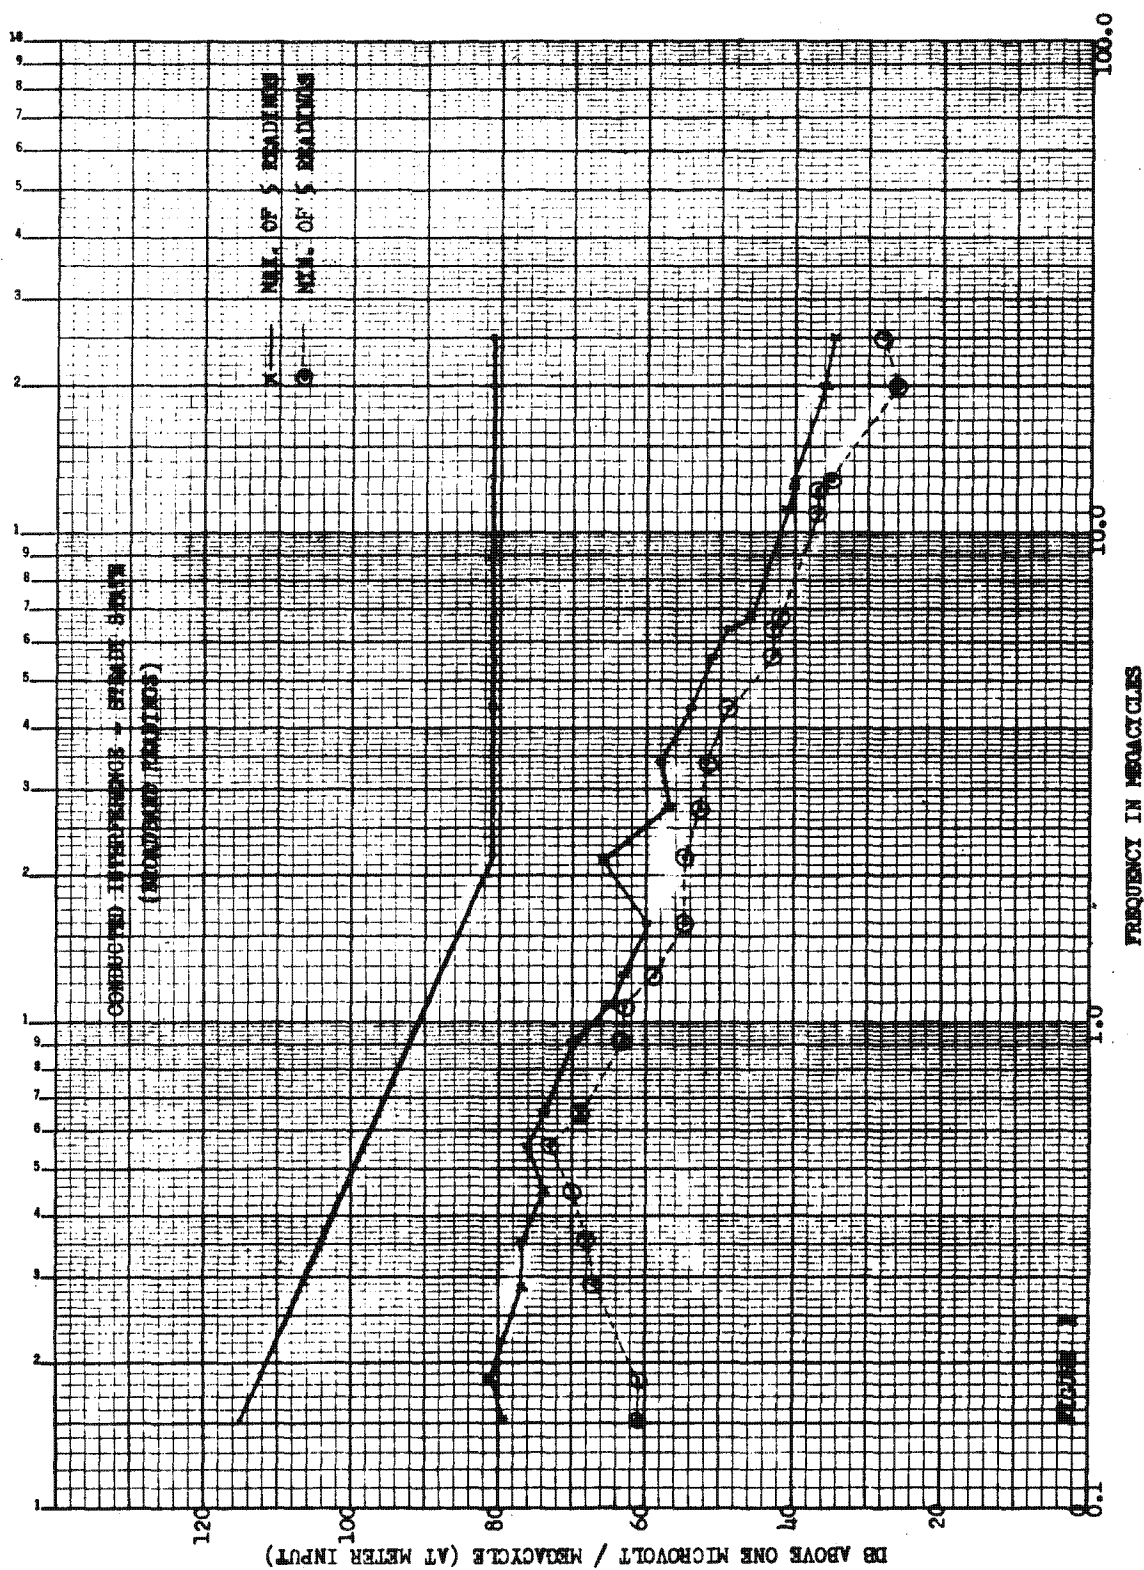
Figure 1. Conducted Interference-Steady State (Broadband)

The Regulated Power Supply as now designed does not meet all requirements of MIL-I-26600 for class 1b equipment. As a result of the above tests, an investigation is in progress to modify the Regulated Power Supply so that it will meet the specified portions of MIL-I-26600.

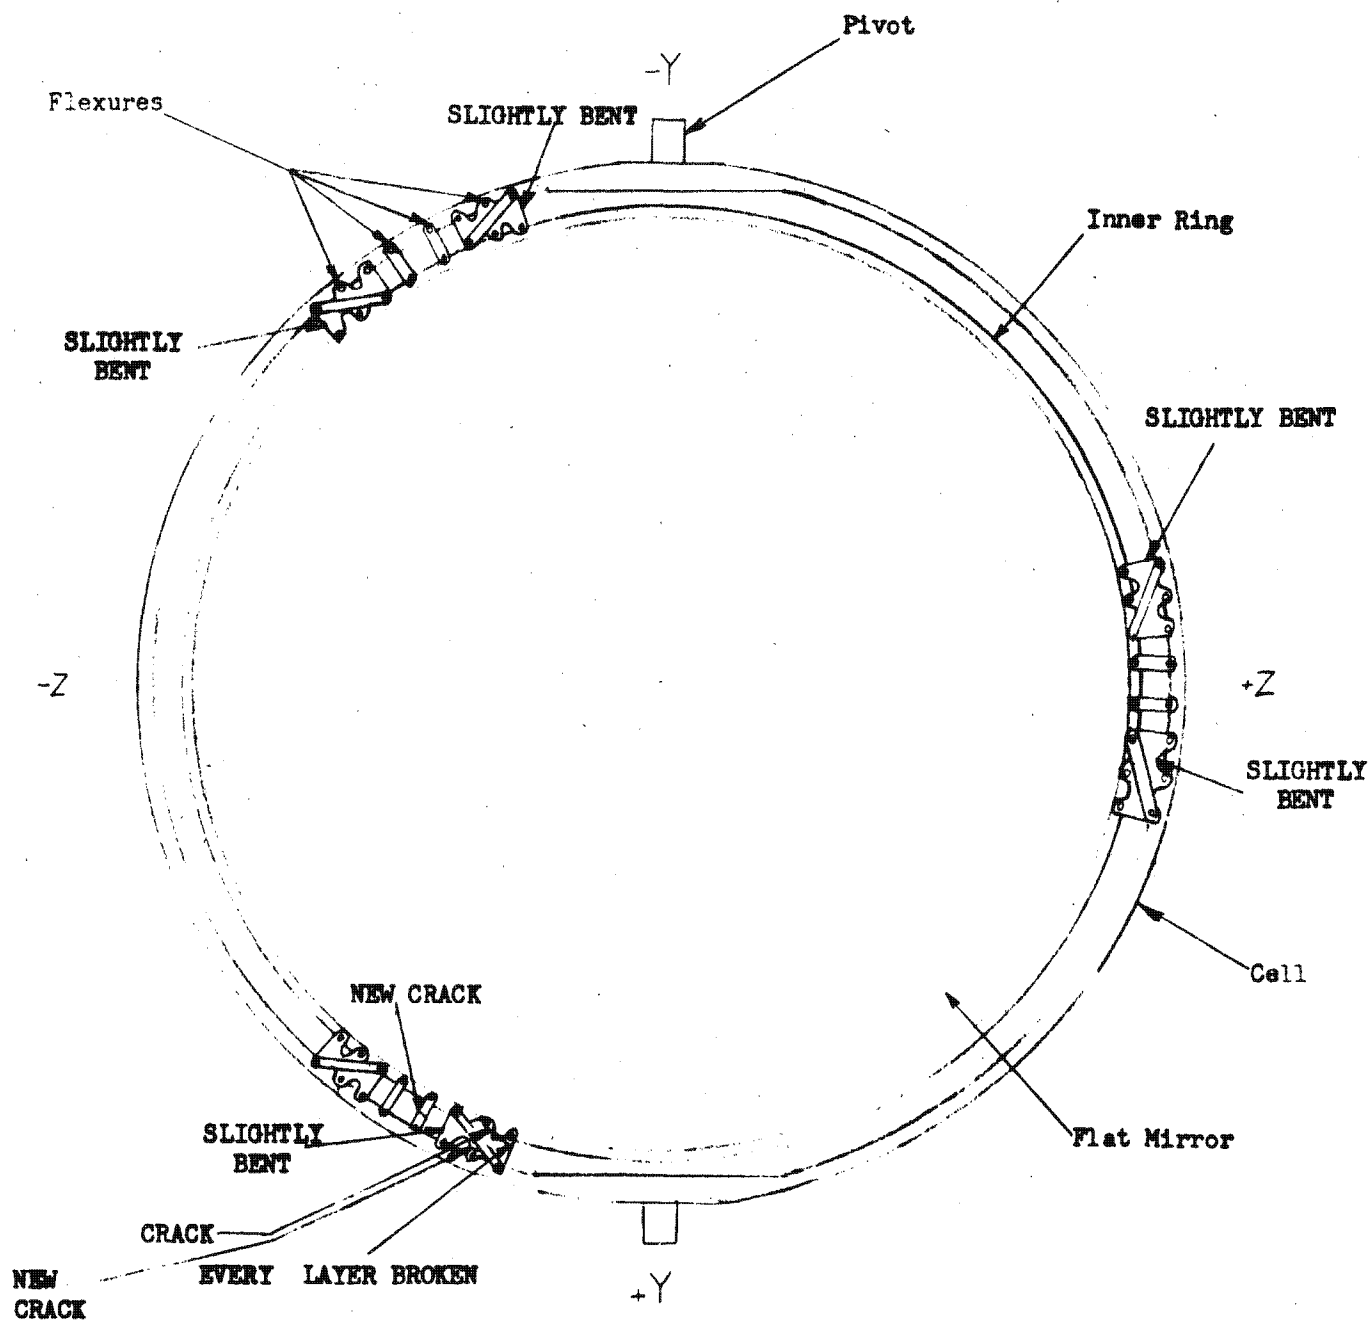
Figure 2. Location of Failures after X-Axis Vibration

As indicated above, there was considerably less damage to the stereo mirror flexures as a result of this vibration test compared to the former test. The explanation for this is not clear since there were a number of differences between the tests. However, it is believed that the extra vibration the former stereo mirror received in the 15 to 24 cps region in the Z axis is the most probable cause for the additional damage.

As a result of the flexure failures that occurred in this test and the previous test, a design change will be made beginning with the F-205 Payload. This change will incorporate an additional 12 flexures and six snubbers will be added to limit the lateral motion of the mirror.

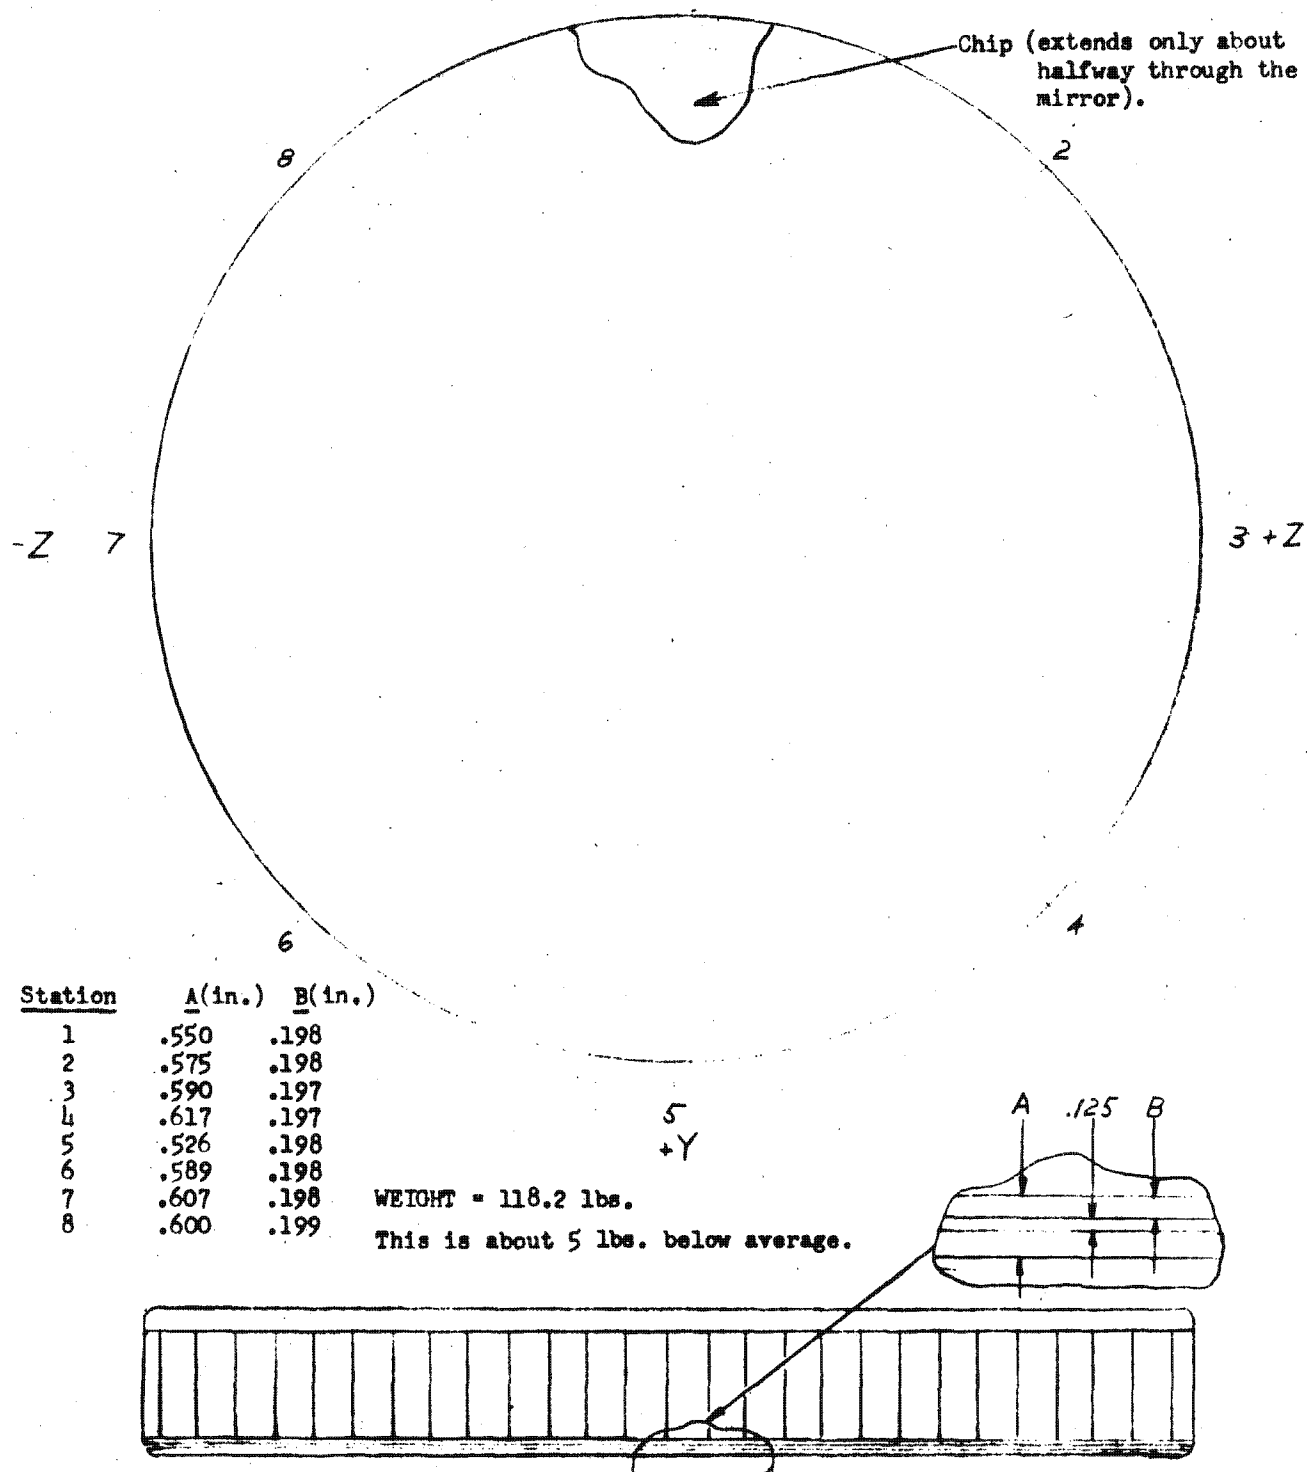
Figure 3. Weight and Dimensions of the Flat Mirror

A piece was missing from the thick plate and egg-crate structure of the stereo mirror glass blank used in this test. This piece was chipped out some time prior to the test. However, it is believed that this defect had little effect on the test results. Its dimensions and weight are given in Figure 3.

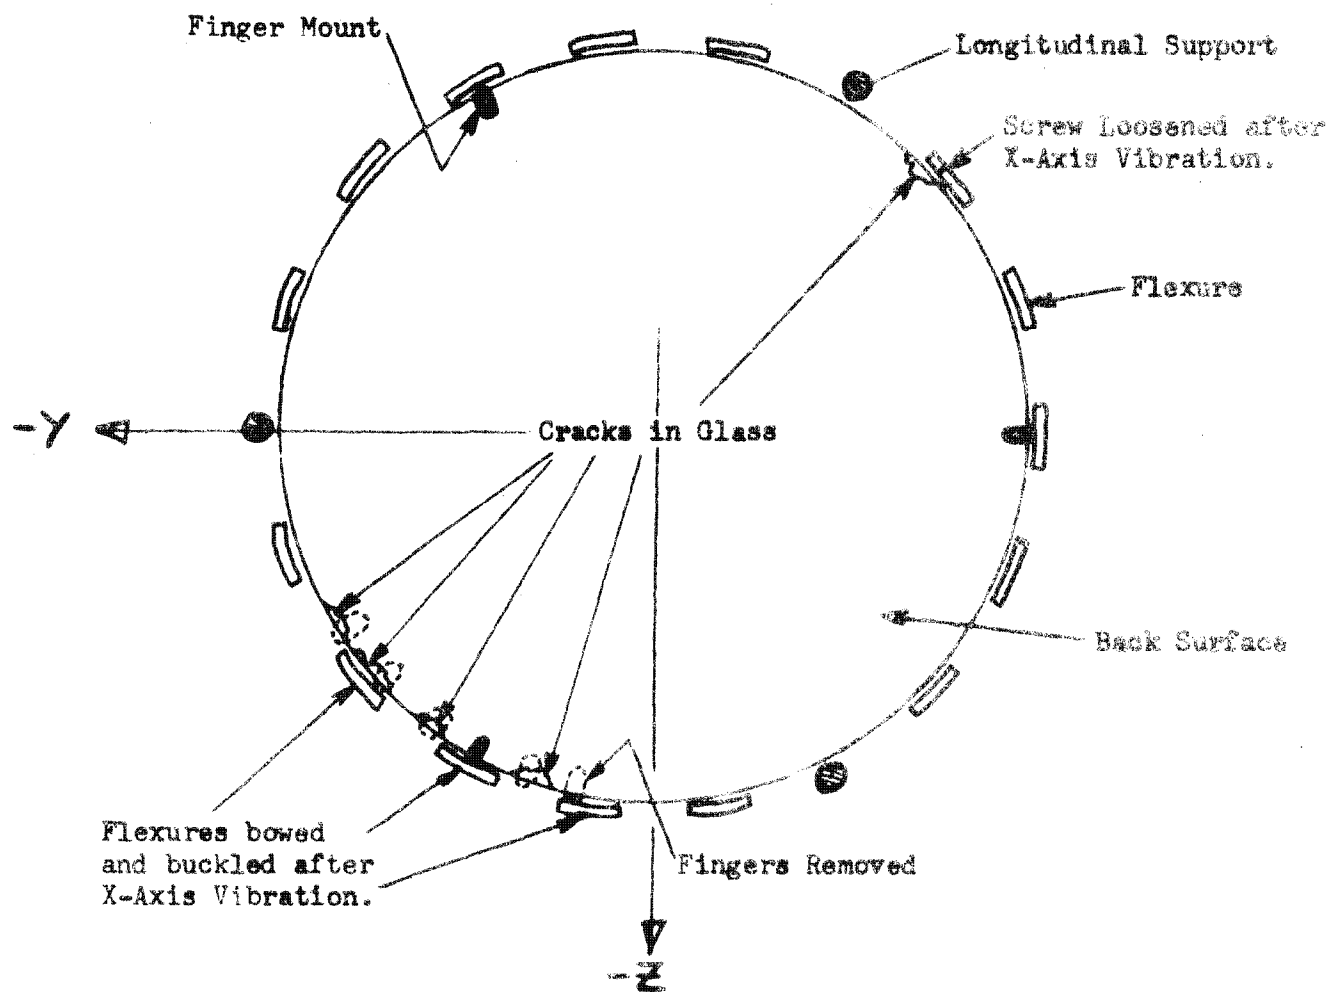
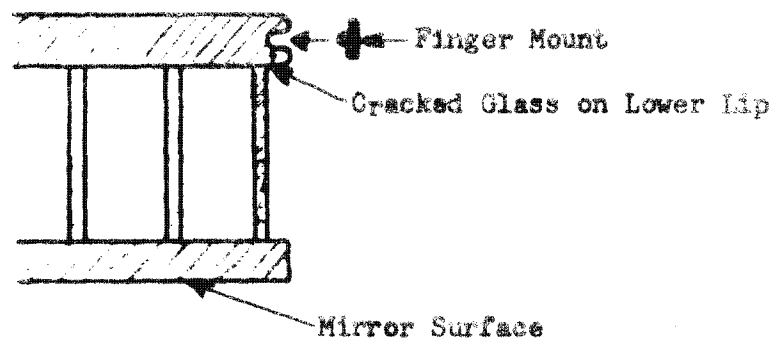
Figure 2. Primary Mirror Failures (Sketch)

Further investigation showed that the thickness of the lower lip (see Figure 2) at the cracked areas ranged from 0.075" to 0.131" with an average thickness of 0.097". Measurements at the uncracked areas ranged from 0.108" to 0.265" with an average thickness of 0.172". It is evident that the lower lip was structurally weaker at the cracked areas.

Inspection records (Waiver #AO-7061) on the S/N 252 Primary Mirror showed the back plate thickness to be 0.638" to 0.672". The thickness of the lower lip was then calculated to be 0.168" to 0.202". Therefore, it is concluded that S/N 252 Primary Mirror has a high probability of no significant structural damage during a qualification level vibration test.

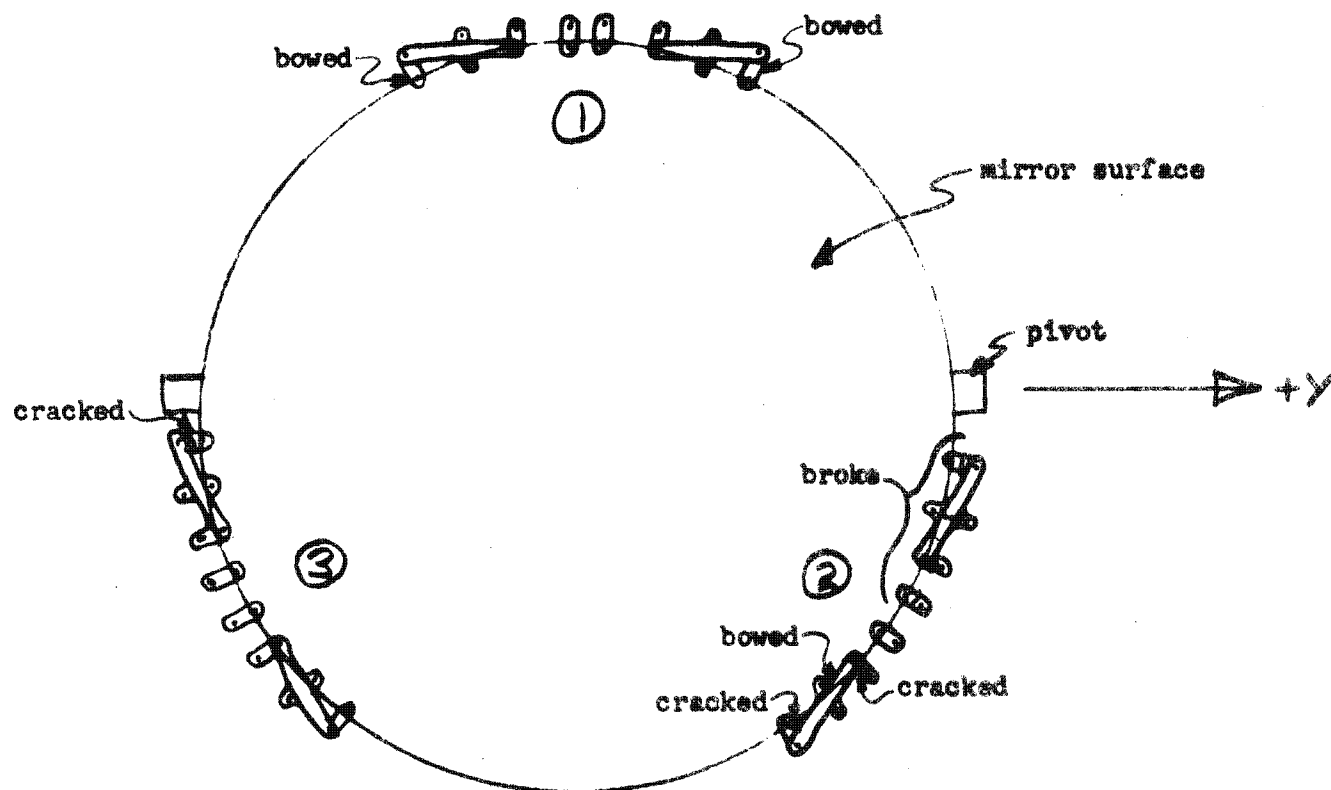
Figure 1. Sketch Showing Stereo Mirror Flexure Failures

Disassembling of the Stereo Mirror showed no structural damage to the mirror, or any noticeable relaxation of the mirror with respect to the inner cells. The mirror is held in place by the potting compound at the base of the tube and 52 to 54. Failures did occur in the flexures and Figure 1 gives a detailed description. During the disassembly stage all screws and nuts were tightly secured.
