DISCOVERER LAUNCH REPORT

Agna 1110 / Thor 322

Agna 1110/Thor 322

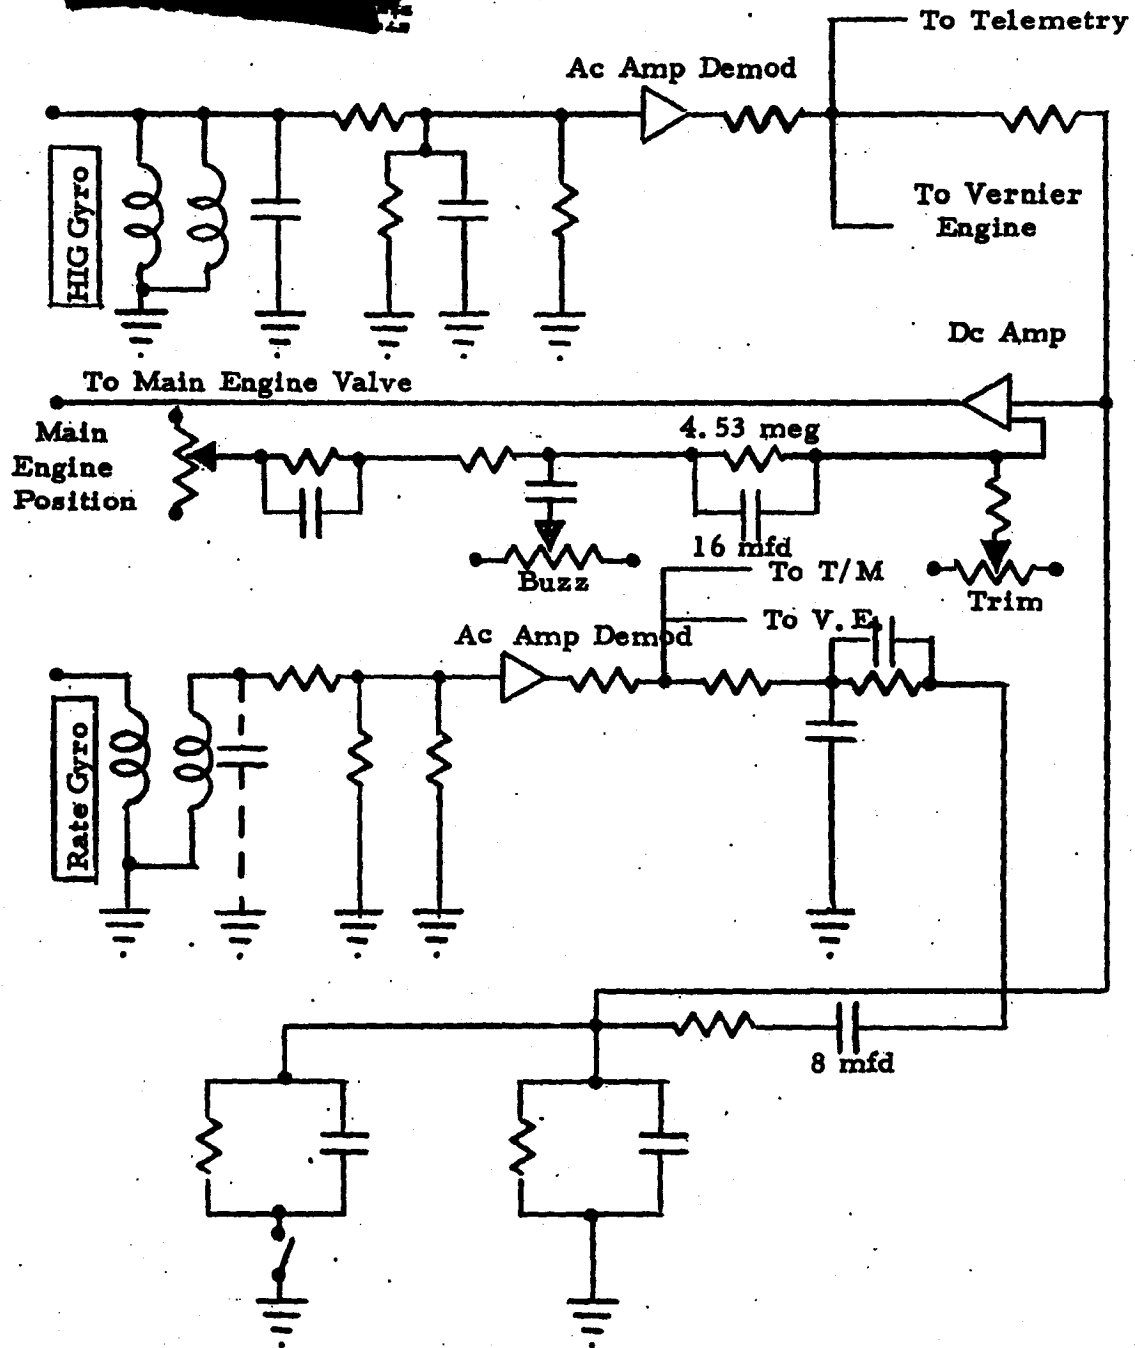
Fig. 2. Simplified Schematic
Diagram of Thor Pitch Attitude and Rate Loops

Calculations indicate an open circuit in the pitch rate loop. The gain and phase of the pitch rate signal out of the demodulator were proper; however, the signal was not present at the main engine pitch d-c amplifier. The loss of the damping signal caused the booster control system to become unstable at its rigid-body frequency.

All auxiliary shapng network assemblies at the Vandenberg Field Station (DAC) have been inspected for possible open or short circuits. The leads on several of the 8-mfd capacitors were of questionable reliability; one lead was cracked half-way through at the solder bend next to the capacitor.

For future flights, the series-connected 8-mfd capacitor in the rate shaping network and the 16-mfd capacitor/4.5-megohm resistor parallel combination in the engine feedback shaping network (Figure 2) will be removed. Their removal will simplify the circuitry and facilitate a more reliable checkout of the system. In addition, the shaping network boards will be modified and encapsulated to preclude malfunctions produced by vibration. A new procedure has been generated for verification of total loop response of the HIG and rate gyros.
