DISCOVERER XXVII
(Thor 322/Ageng 1110)
SYSTEM TEST EVALUATION
AND
PERFORMANCE ANALYSIS REPORT
(35-Day Report)
Title Unclassified
Contract AF 04(647)-558

This document is the final system test evaluation and performance report for the flight of Discoverer XXVII from Vandenberg Air Force Base on 21 July 1961. The report has been prepared in compliance with a requirement of Contract AF 04(647)-558 and in accordance with Paragraph 1.4.1 of LMSD-445158-B, Discoverer Program.

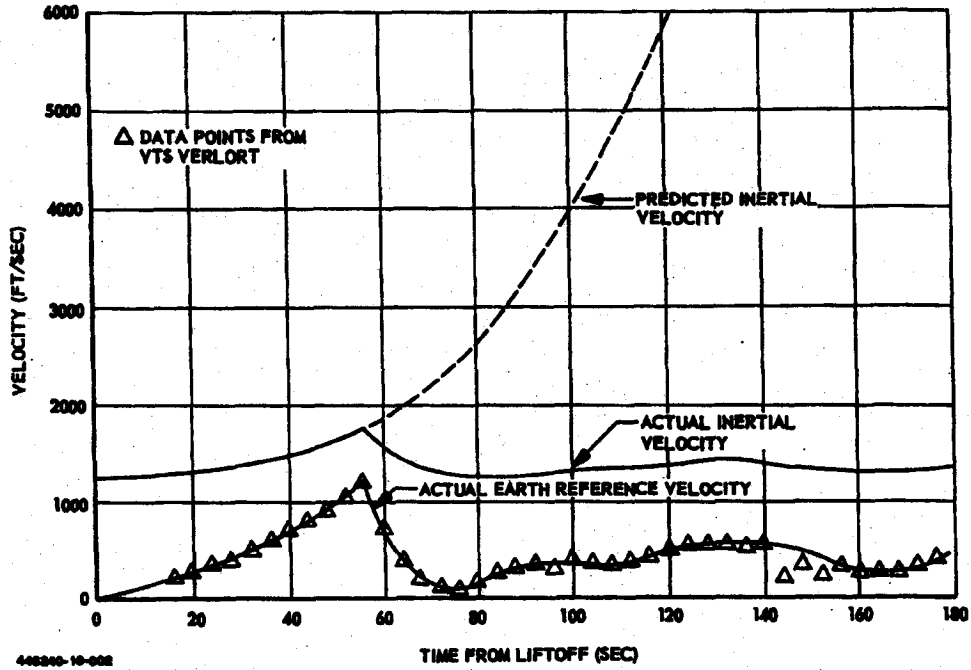
Figure 2-1 Velocity During Thor Boost

Tracking data obtained from the Mod II VERLORT at VTS and substantiated by FPS-16 skin-track radar at PMR show that the ascent trajectory of the Discoverer was nominal until approximately 56 seconds. Thereafter, it deviated (Figs. 2-1 and 2-2). When the Agena's S-band beacon was lost at approximately 184 seconds, the Agena was at 13,000 feet downrange. Data indicate that the Agena reached a maximum altitude of 34,500 feet, whereas the Thor continued upward and farther downrange. Loss of FPS-16 track at approximately 60 seconds prevented the plotting of the Thor's full trajectory.

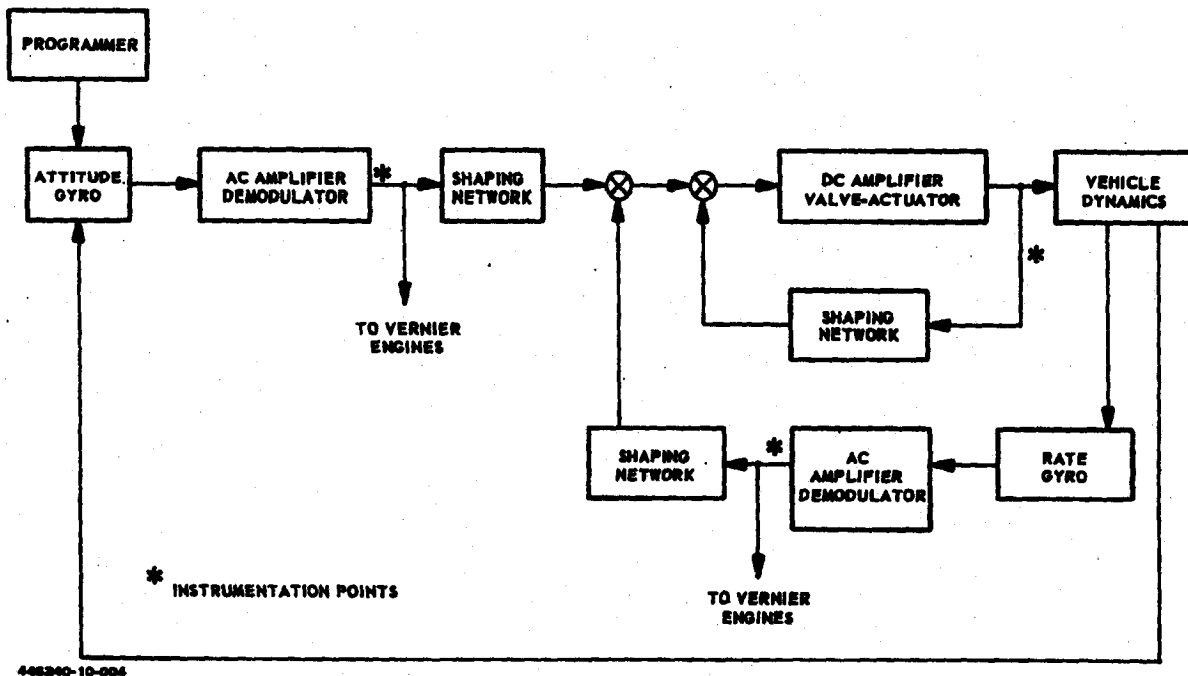
Figure 2-3 Flight-Control System (Pitch Plane)

By comparing the phase and amplitude of main-engine pitch position with that of the rate and attitude demodulator output data, the main engine was found to be lagging the attitude signal by approximately 200 degrees. This value was theoretically shown to be the correct engine response if the rate demodulator signal were not received at the d-c amplifier input. The main engine was responding to the attitude error signal only. A schematic of the flight-control system (pitch plane) is presented in Figure 2-3.

proper operation of the pitch rate gyro and its associated a-c amplifier-demodulator. The vernier engines were responding properly to both the attitude and rate demodulator outputs, further confirming that the pitch rate gyro and its associated a-c amplifier-demodulator were operating properly. On the basis of these facts, the malfunction must have been within the main engine's pitch-rate shaping network.

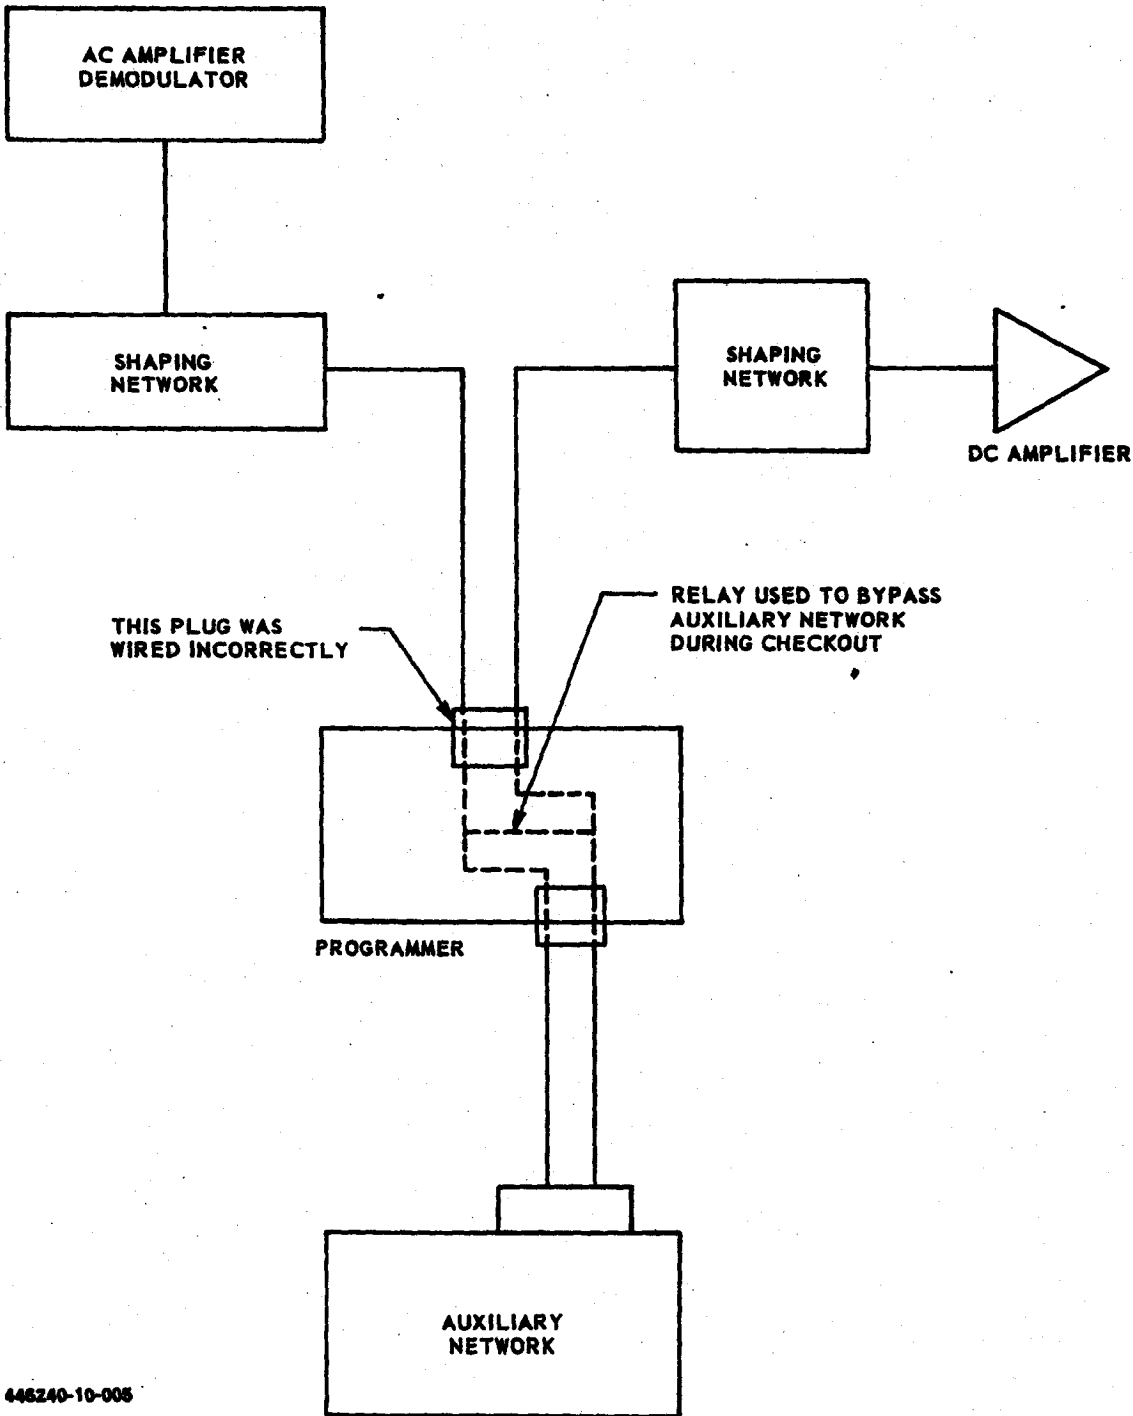
Figure 2-4 Shaping Network Schematic

A postflight review of engineering documentation affecting changes to the control electronics assembly was made by DAC personnel. It was revealed that during VAFB laboratory checks, a pin on the connector between the main-engine shaping network and the programmer was broken. The wire to this broken pin was moved to a spare pin on the same connector, and the plug on the programmer side was rewired for continuity. Later, it was necessary to replace the programmer. However, records indicate that the programmer connector was never re-modified to match the standard programmer. Therefore, the programmer side of the plug was not compatible with the modified plug from the main-engine shaping network. The result was an open circuit which prevented the pitch-rate gyro signal from reaching the main engine controls. This open-circuit condition is also the only condition that satisfies all the characteristics encountered during the flight.

The polarity check performed at the launch emplacement did not include a test of the main-engine shaping network, because this test results in severe gimbaling of the engine. To prevent possible structural damage, the main engine is temporarily disconnected from the circuitry during this test. Therefore, when the rate gyros were physically displaced, only the vernier-engines responded (Fig. 2-4). Thus, discontinuity in the main-engine shaping network circuitry was not detected during this test.

Corrective action to be taken on all future Discoverer boosters will be as follows: (1) The auxiliary shaping network will be removed. This network was originally installed to raise the d-c loop gains, thereby reducing velocity direction errors at main-engine cutoff. However, when the BTL guidance system was added, the need for this network was eliminated. This elimination

will also obviate the need for the rate gyro signal to be routed through the programmer. (2) The main shaping network boards within the control electronics assembly will be encapsulated to reduce the possibility of terminals being broken or shorted subsequent to checkout. (3) The launch emplacement polarity check will be revised so that complete end-to-end system continuity and polarity will be confirmed. This will be accomplished by physically moving the rate gyros and monitoring movement of all engines. (4) Also, the polarity check will be run three times with a separate meter read during each run. Previously, all three meters were read simultaneously.
