LAUNCH REPORT

LV-2A/395 SS-01A/1604

PMR OPERATION NO. 2921 - "WICE BIRD"

15 May 1964

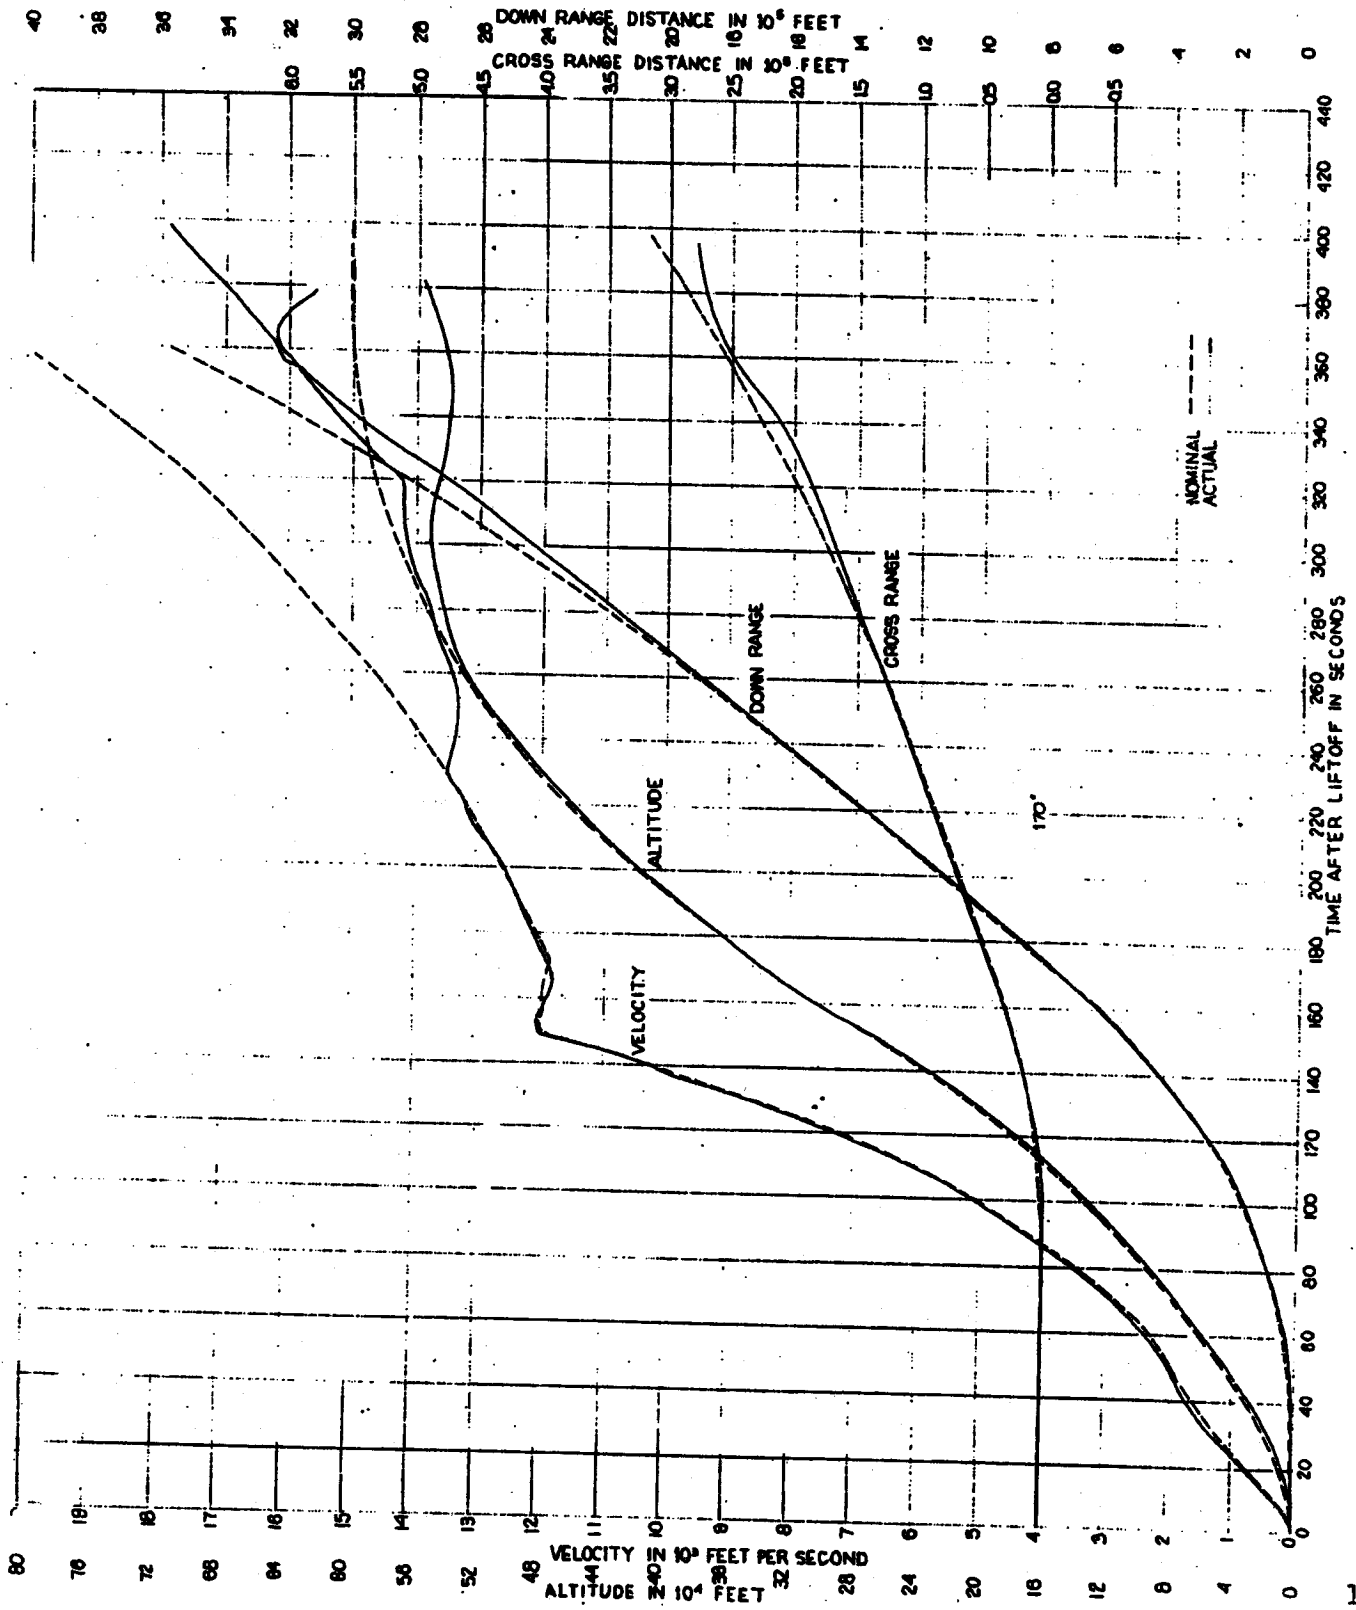
FIGURE 1
VEHICLE TRAJECTORIES

b. Trajectory evaluation based on a composite of BTL data, FPS-16 metric radar tabular data and PRELORT radar tabular data indicate near nominal trajectory until T+230 seconds (See Figure 1). Subsequently the velocity showed a decrease even with the SS-01A engine burning. By T+260 seconds a deviation of altitude and downrange plots was evident. The flight trajectory then rapidly diverged downward from the nominal altitude and corresponding changes occurred in the downrange and crossrange tracks. The computed SS-01A impact area was reported to be at 21° north latitude and 111.7° west longitude. The apparent loss of velocity from T+230 seconds to T+260 seconds correlates well with axial accelerometer and magnetometer outputs of the second stage during this time period which indicated a tumbling motion of the vehicle. The terminal flight phase began about T+360 seconds resulting in separation of the payload due to structural loading at T+372.2 seconds and engine shutdown at T+376 seconds.
