**PHOTOGRAPHIC EVALUATION REPORT**  
**MISSION 4001**  
**13 JULY 1963**

This document contains information referring to  
**Project Gambit**

NPIC TP-4/64

February 1964

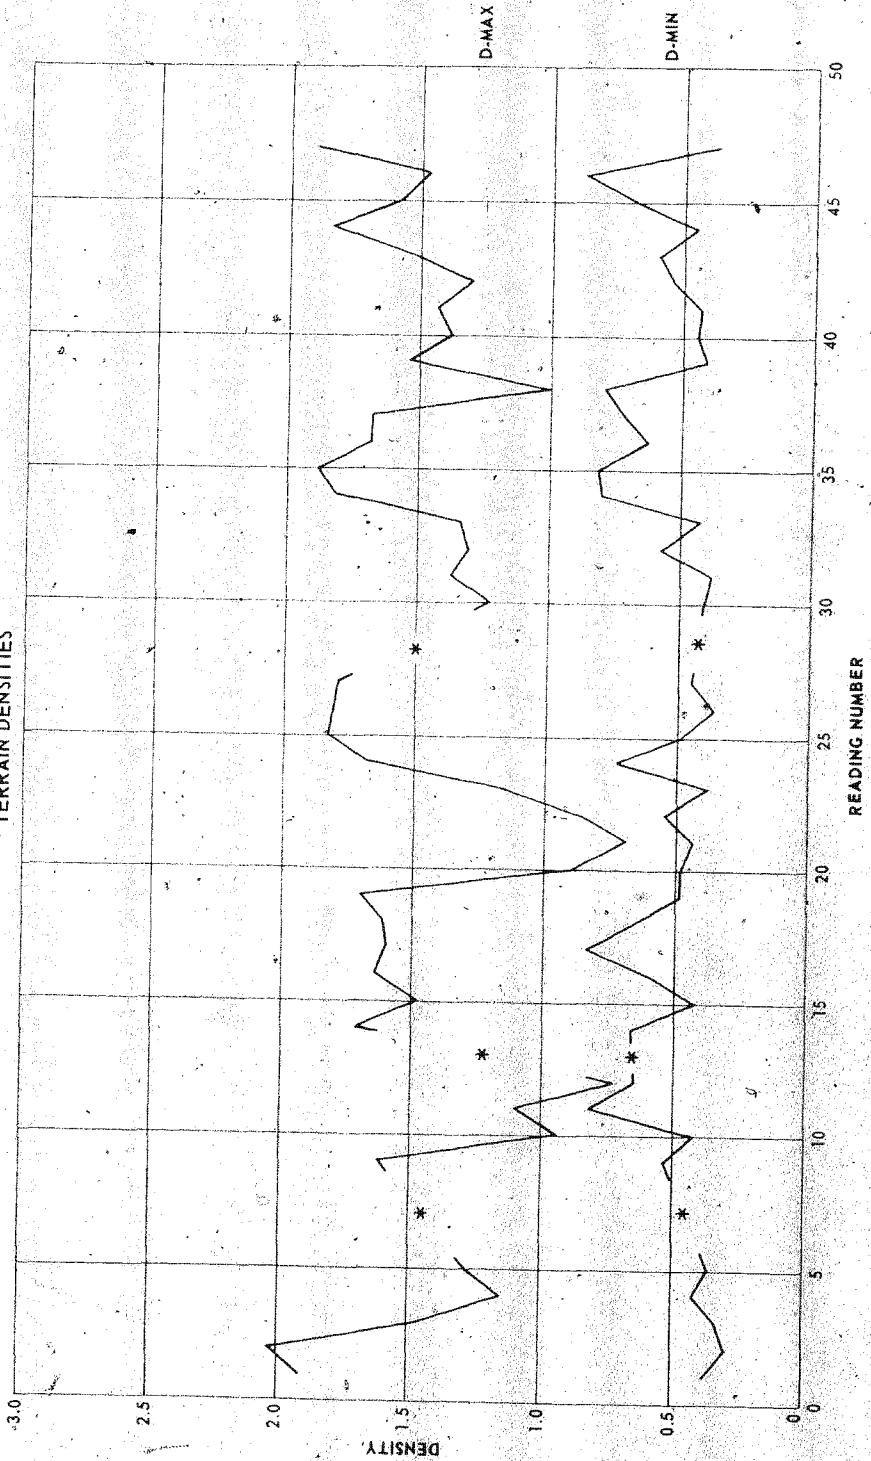
MISSION 4001  
TERRAIN DENSITIES

3. Exposure: Exposure is adequate on the majority of the frames. However, exposure differences are apparent within stereo pairs and great changes in the brightness range occur on the long monoscopic frames (see density charts).
