MURAL SYSTEM PERFORMANCE EVALUATION

28 JANUARY 1964

Prepared by
Techniques Office
Missile Support Division

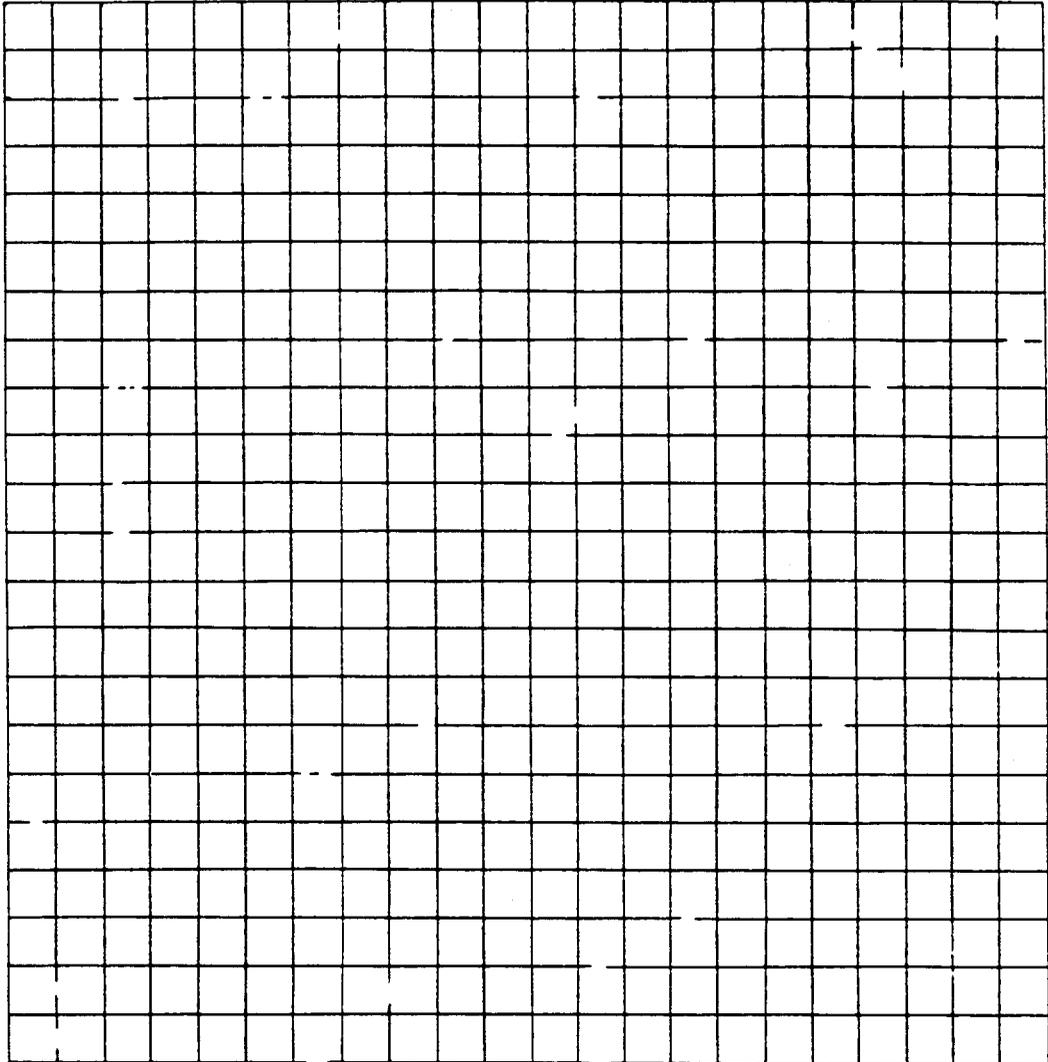
is reasonably complete in that it is nearly continuous throughout. Occasional breaks in lines occur as shown in Figure (1) for exposure No. 5 of Mission 1002-1 but these have no influence on exploitation. In Mission 1002-1 the reseau was not placed to cover the entire film area shown in Figure 2.

Figure 1. Frame Camera reseau used in Mission 1002-1

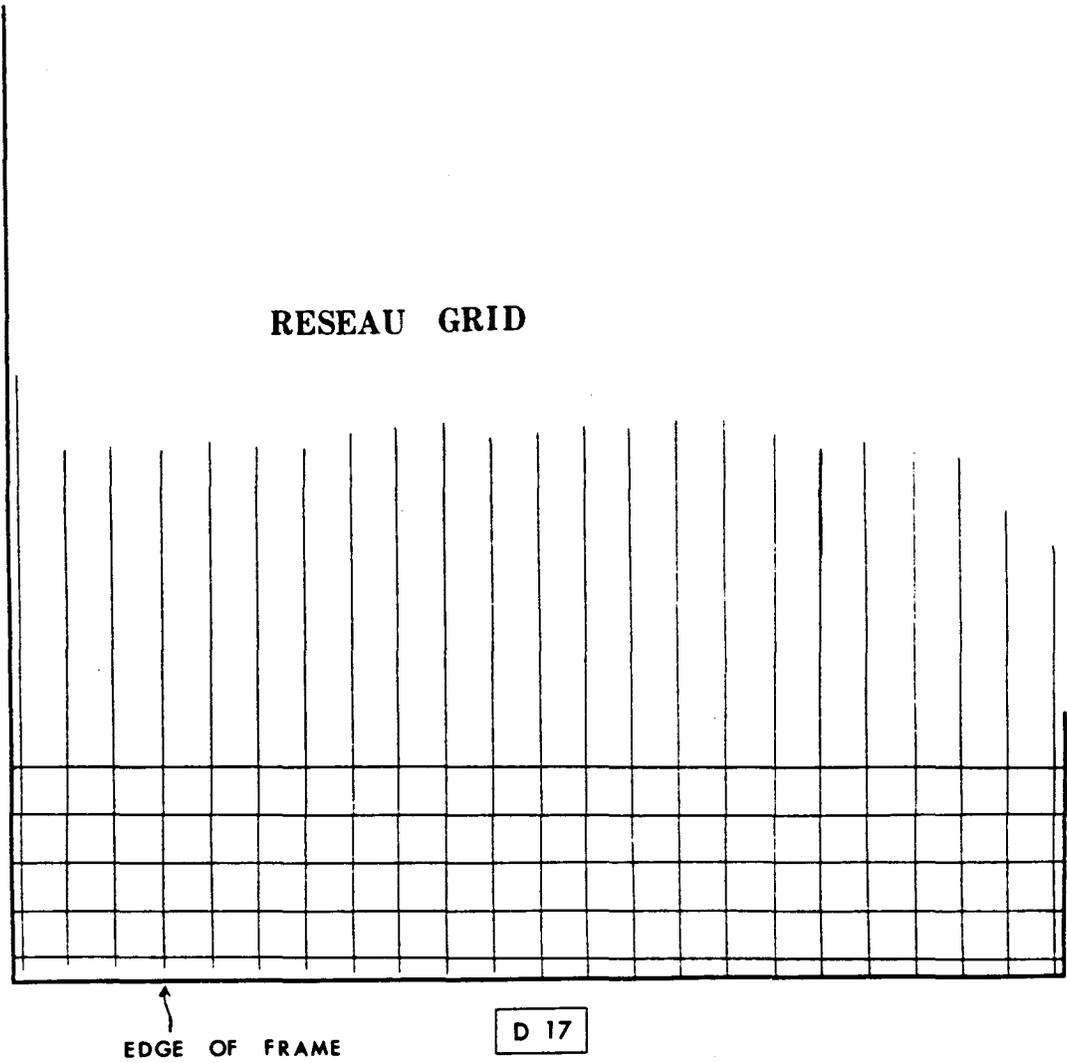
Figure 2. Placement of reseau with respect to frame camera format of Mission 1002-1
