PHOTOGRAPHIC EVALUATION REPORT

Mission 9043  
18, 19 September 1962 Z

FE No. 36-62

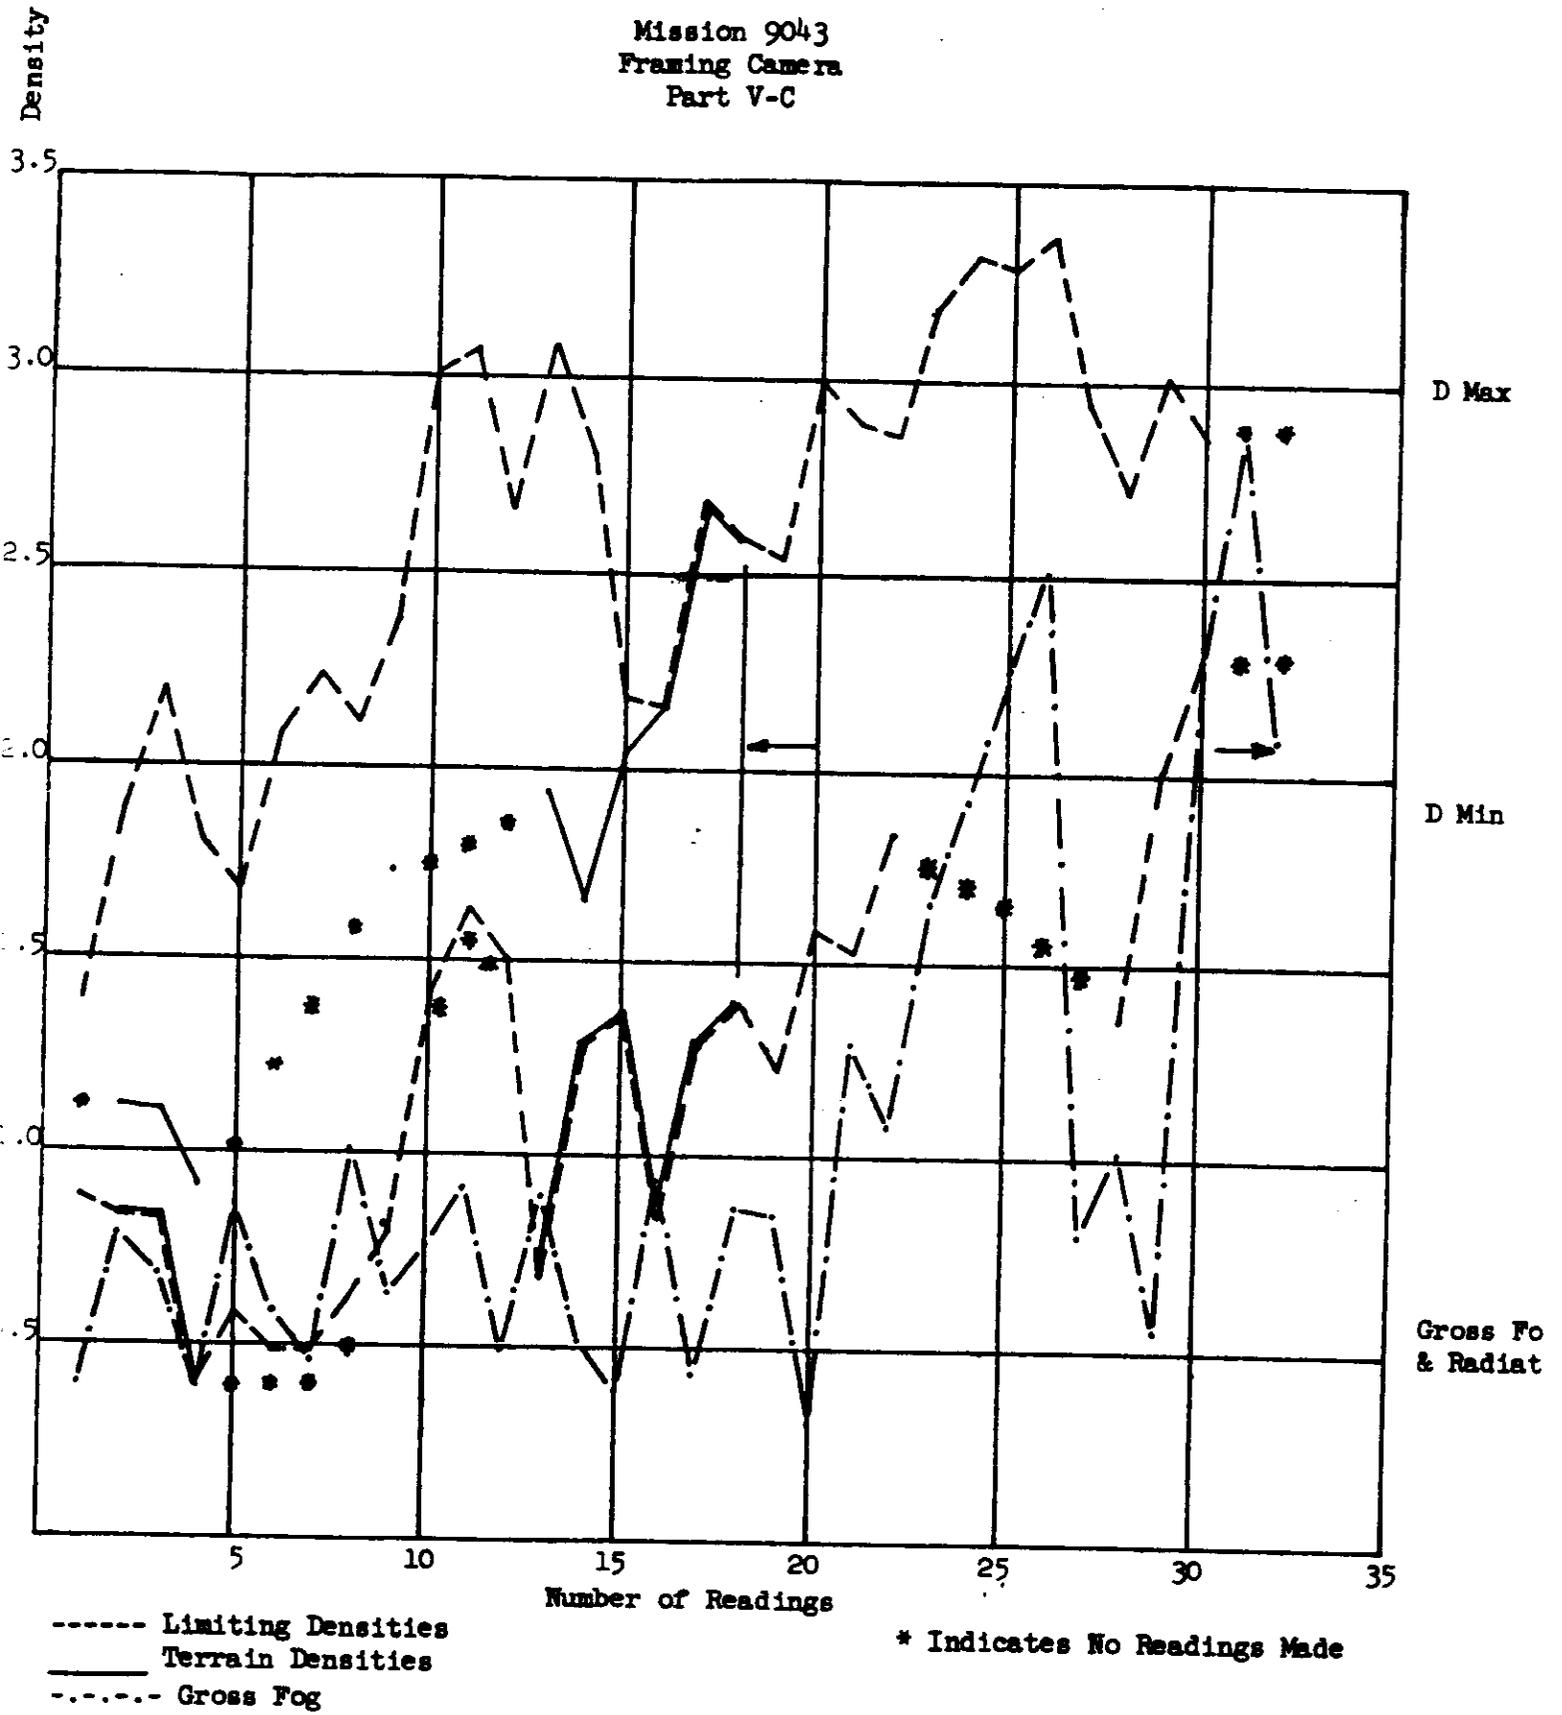
Mission 9043  
Framing Camera  
Part V-C

Note: Gross fog readings are excessive due to radiation exposure.
