PRELIMINARY
PERFORMANCE EVALUATION
MISSIONS 1021-1 and 1021-2

30 June 1965

III MASTER PANORAMIC CAMERA #166.

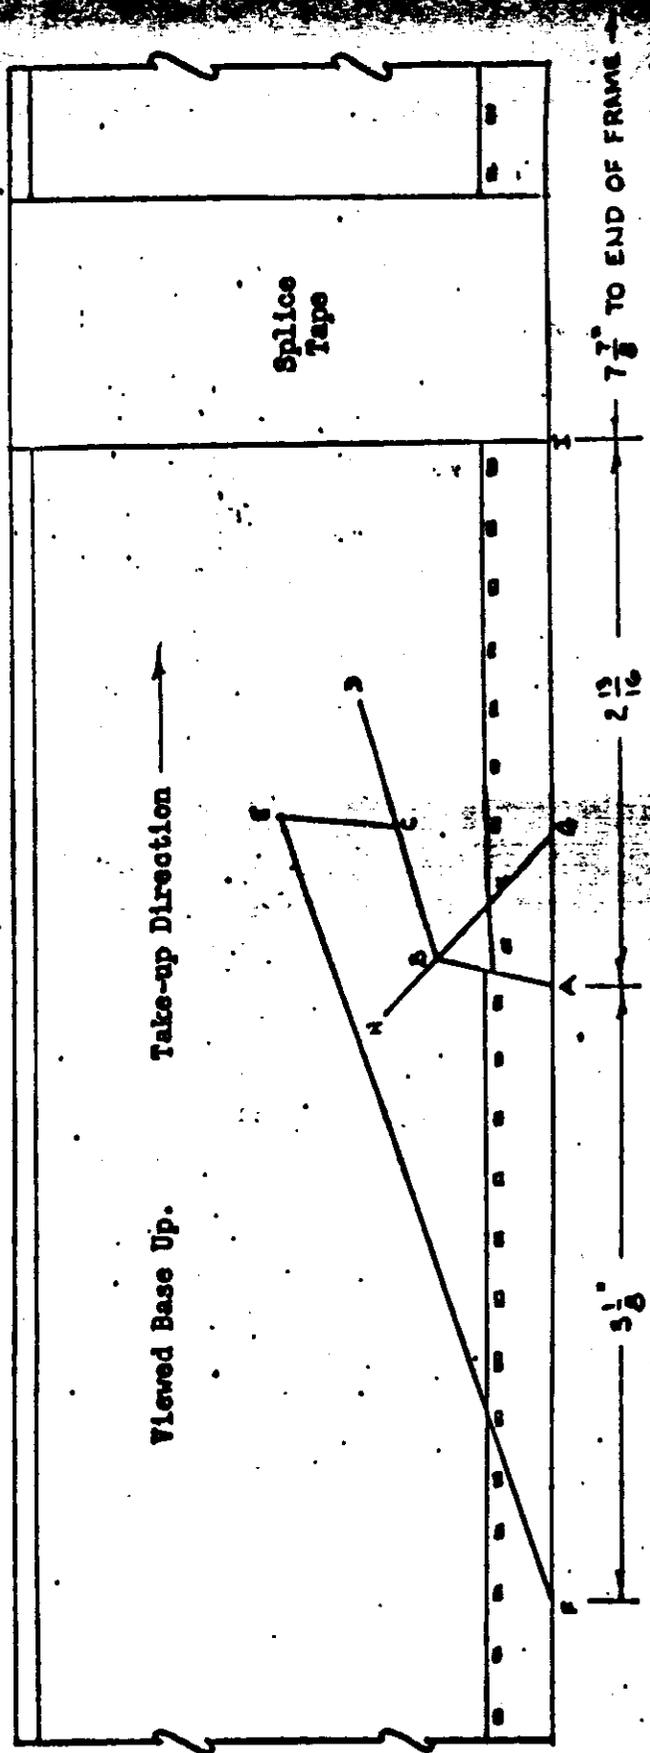
MISSION 1021-2
 MASTER CAMERA; PASS D85, FRAME 11.

The quality of the Master camera photography from Mission 1021-2 was very poor as the film pulled out of the camera rails in frame 11 of the first programmed operation of the mission, pass D85. The subsequent frames contained approximately 25% to 30% of detectable ground scenes of poor quality while the remaining frame area was badly smeared and unusable.

The film came out of the rails as a result of a manufacturing defect in the film supply. Figure 1 shows this defect and the resulting film damage. During the initial inspection of the coated and slit film defective areas are noted by manually folding the film and cutting the edge with scissors. The film was folded along line G-H, as shown in Figure 1, and cut from B to A and C simultaneously. The scissors scratched the emulsion from point C to point D. This film cut is used as the indicator to the individual splicing the film that a splice is required at that point. Unfortunately the splice was made on the wrong side of the indicator cut.

Examination of frame 11 showed that the entire frame was properly metered into the camera platen as the rail scratch could be followed from frame 10 through frame 11 but was absent in frame 12. The character of the take-up end of frame 11 showed that the film was in the platen at the start of scan as the end was sharp and straight and the first two time track bits were normal. The third and all subsequent time track bits were abnormal in both position and size.

<u>SEGMENT</u>	<u>CONDITION</u>	<u>LENGTH</u>	<u>ANGLE</u>	<u>DEGREES</u>
A-B	Film Cut; Smooth edges.	0.620"	GAB	78
B-C	Film Cut; Smooth edges.	0.720"	ABC	118
C-D	Heavy emulsion scratch.	0.675"	ABG	58
C-E	Film Tear; Rough edges.	0.570"	CBG	59
E-F	Heavy film crease; Base to base.	1.312"	DCE	85
G-H	Light film crease; Emulsion to emulsion.	1.275"	AFE	19
			IGB	137

It was not possible to ascertain when the film was torn along line C-E however it is obvious that the film was not creased along line E-F until after the exposure of that area. It is most probable that the E-F crease occurred when the film passed through the film metering roller.

1. The splicing techniques and procedures used by the film manufacturer should be reviewed to preclude the re-occurrence of the encountered failure mode.
2. A film chute should be added to the Corona system between the Slave camera main-plate and the intermediate roller assembly. It does not appear possible to eliminate the camera drum light leak hence a protective chute merits consideration.
3. The slur pulse now presented on the Master camera film to denote Stellar-Index camera operation should also be displayed on the Slave camera film. It is recognized that the pulse would not always be present due to the lack of camera synchronization however this modification would permit partial time correlation of the S/I camera when the Master camera time track is inoperative.
