PHOTOGRAPHIC
EVALUATION REPORT
MISSION 1043

SPECIAL STUDY ON SCAN
SPEED DEVIATION ANALYSIS
OF THE FORWARD CAMERA

DECEMBER 1967

NATIONAL PHOTOGRAPHIC INTERPRETATION CENTER

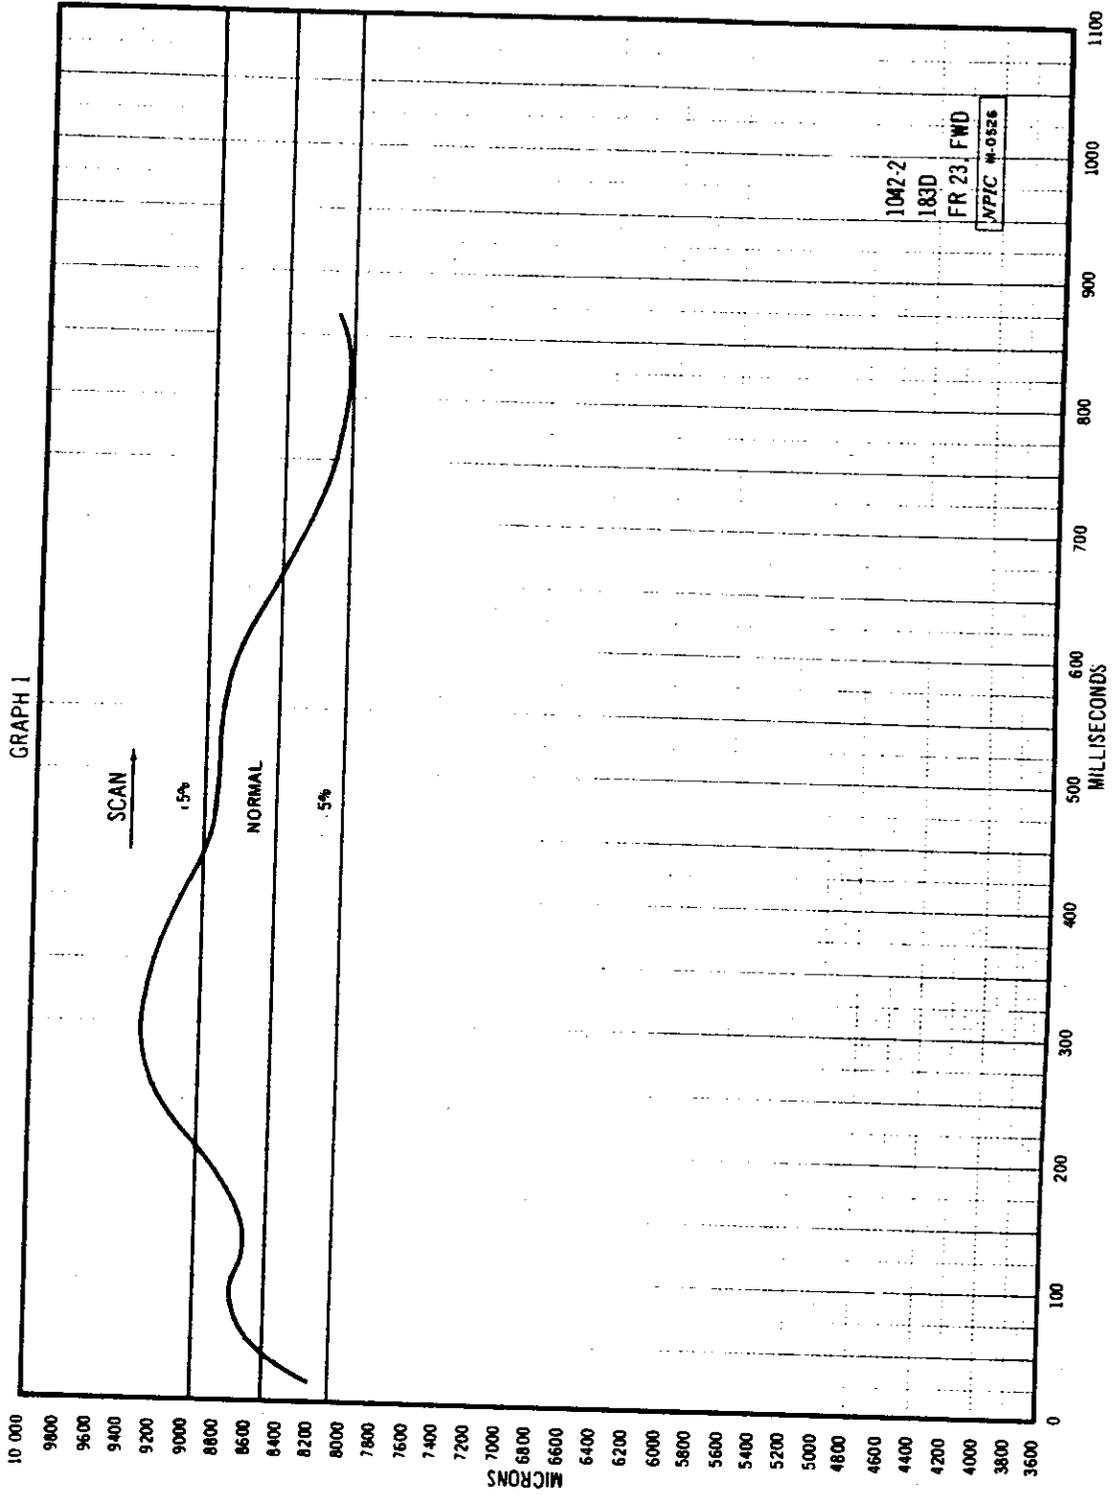
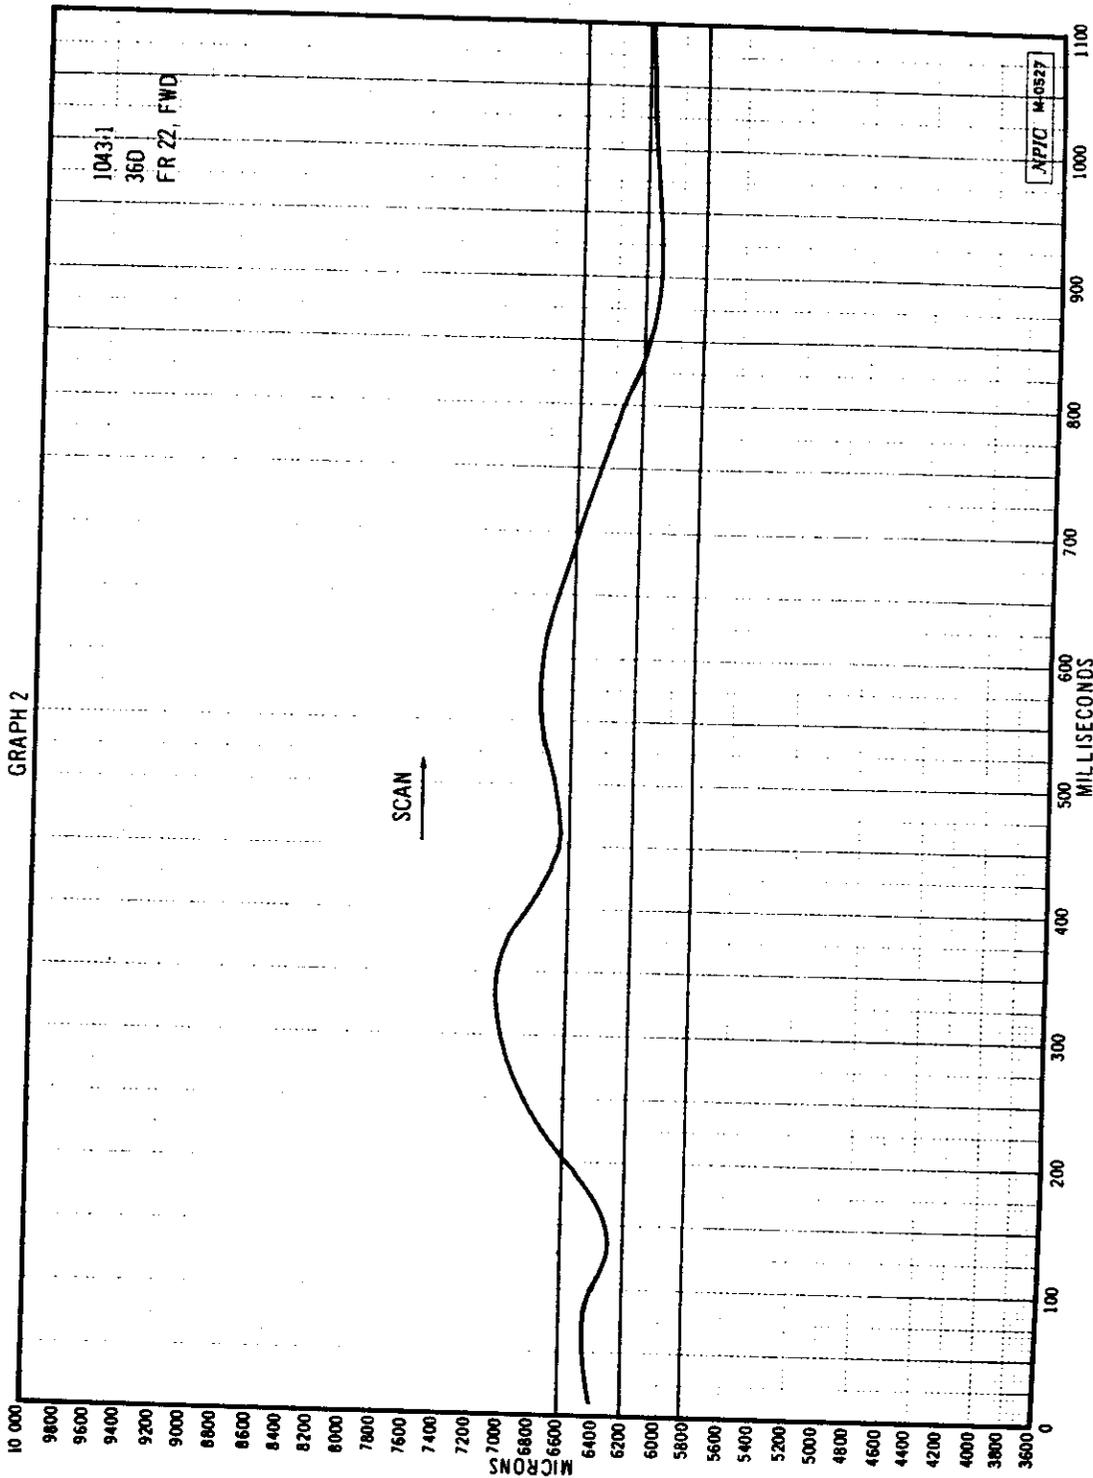
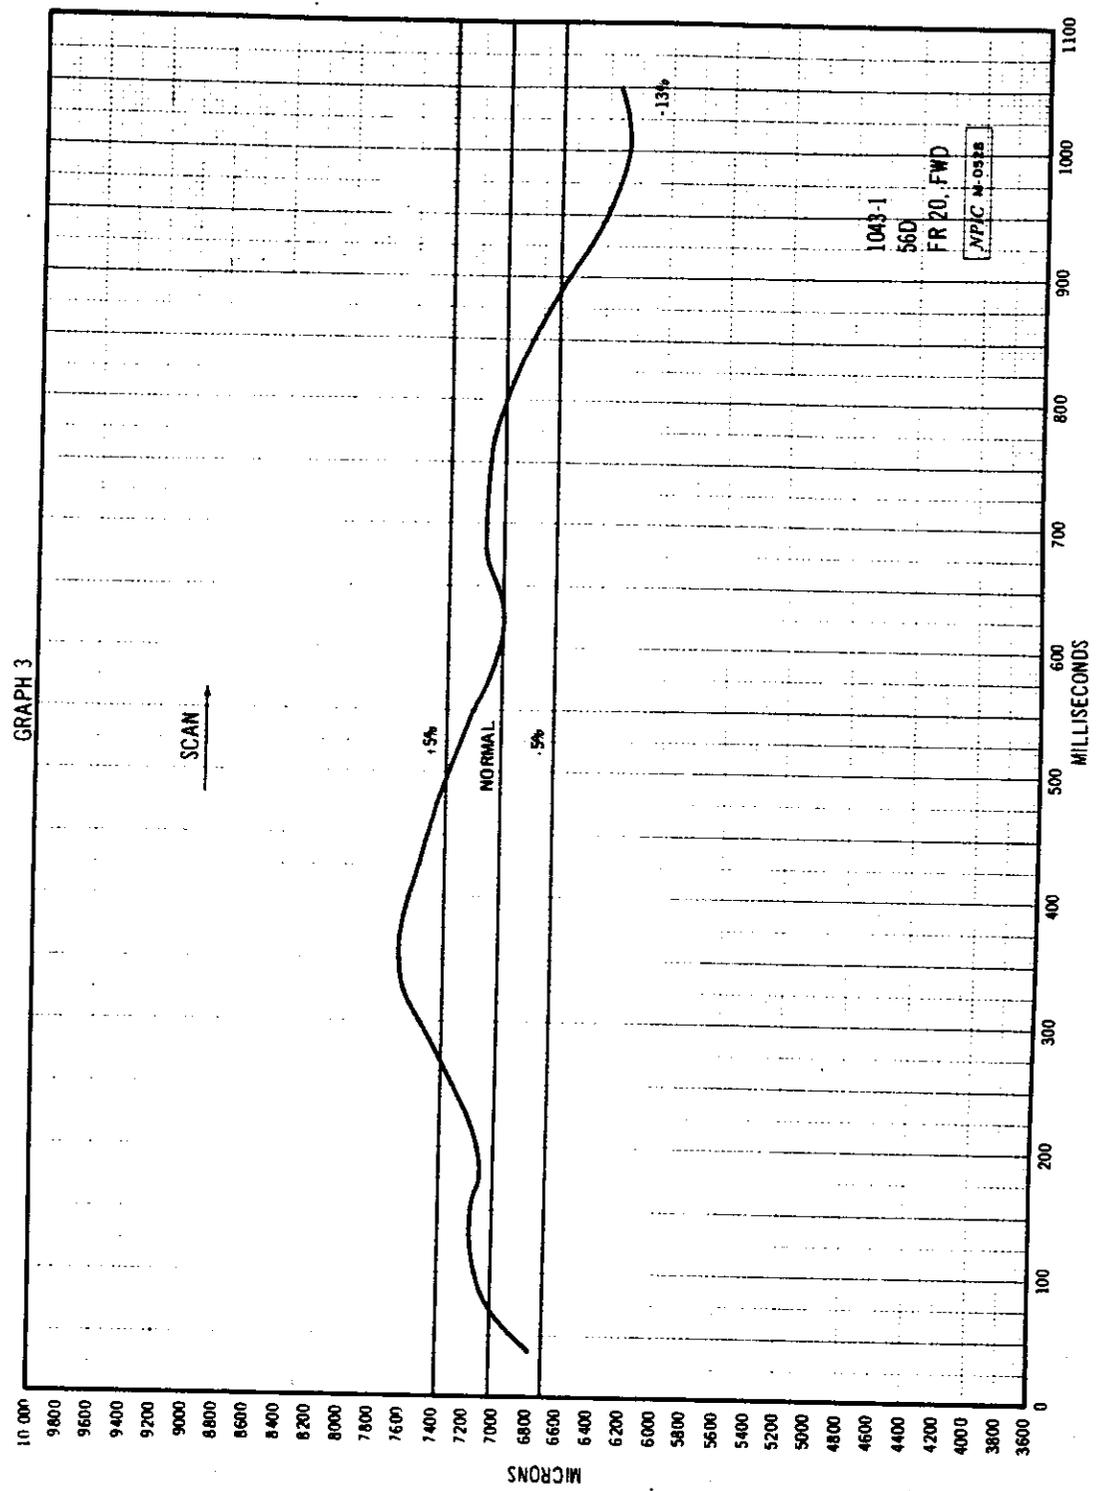
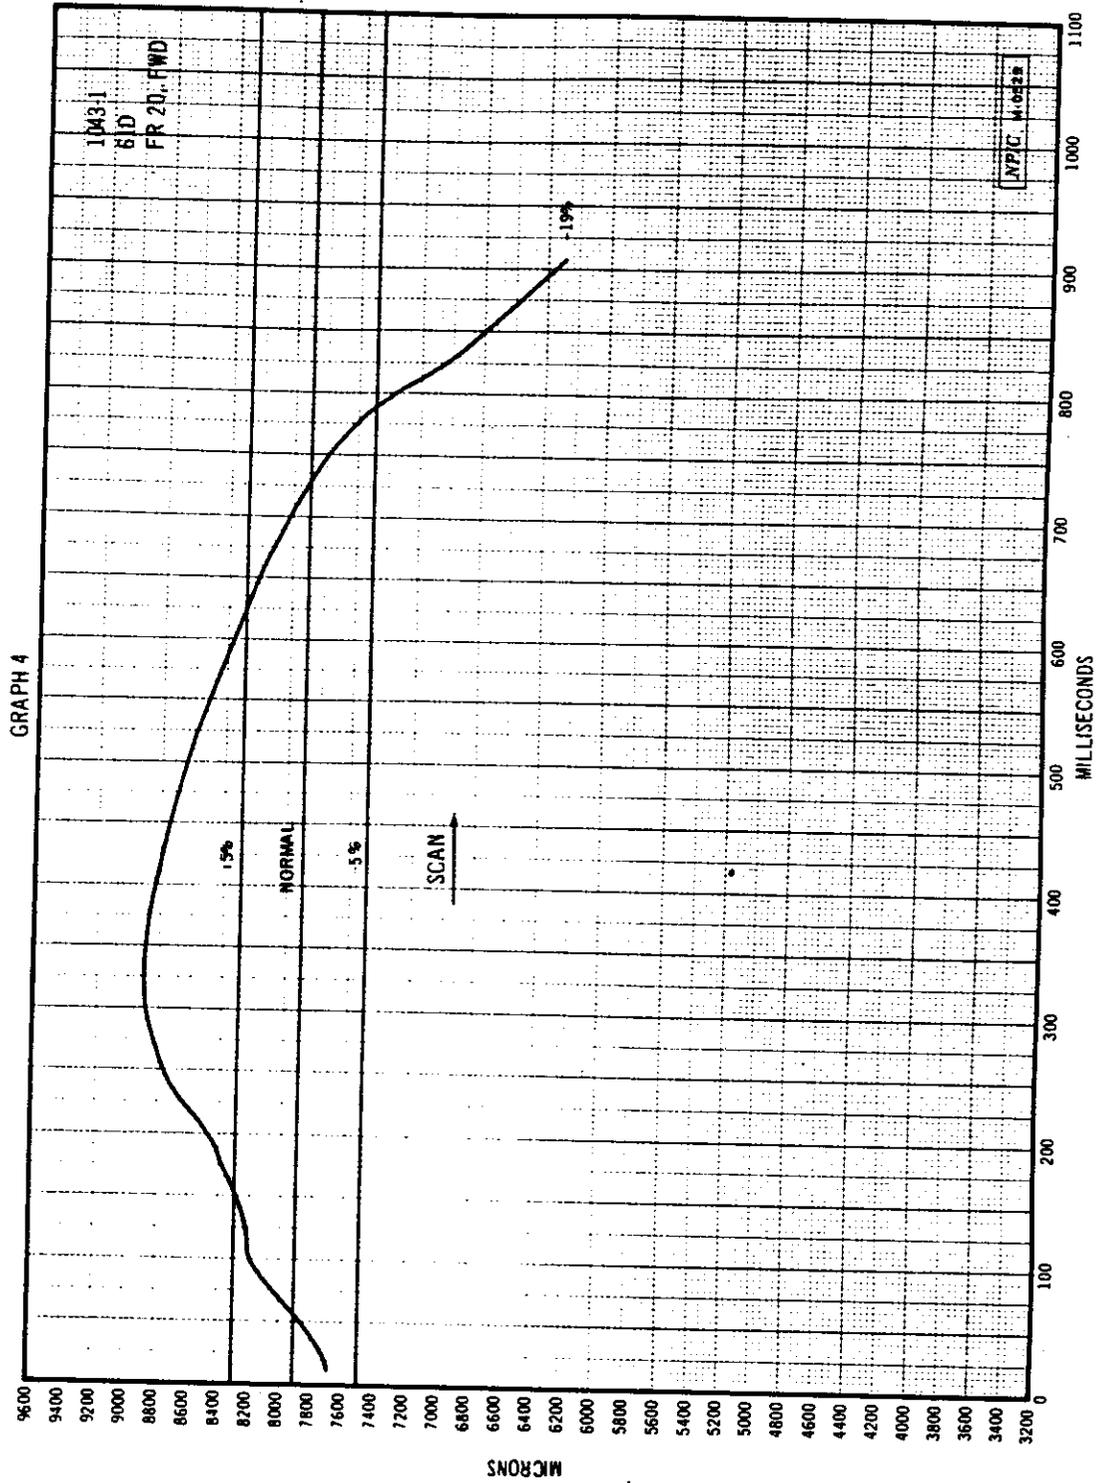
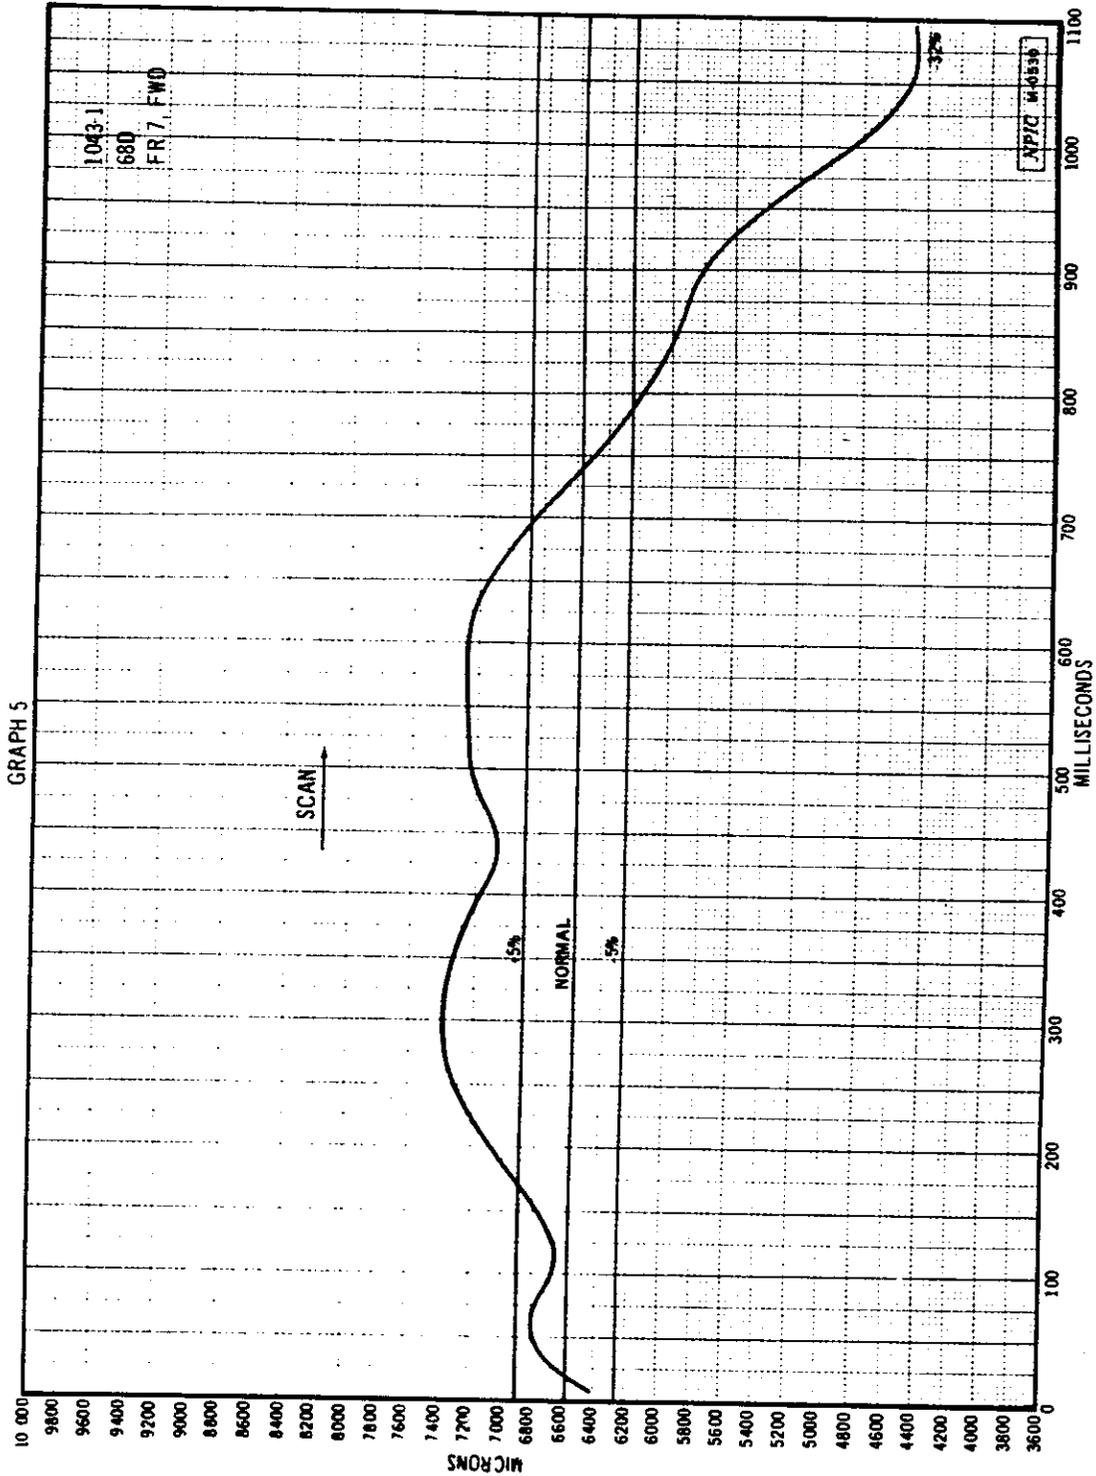
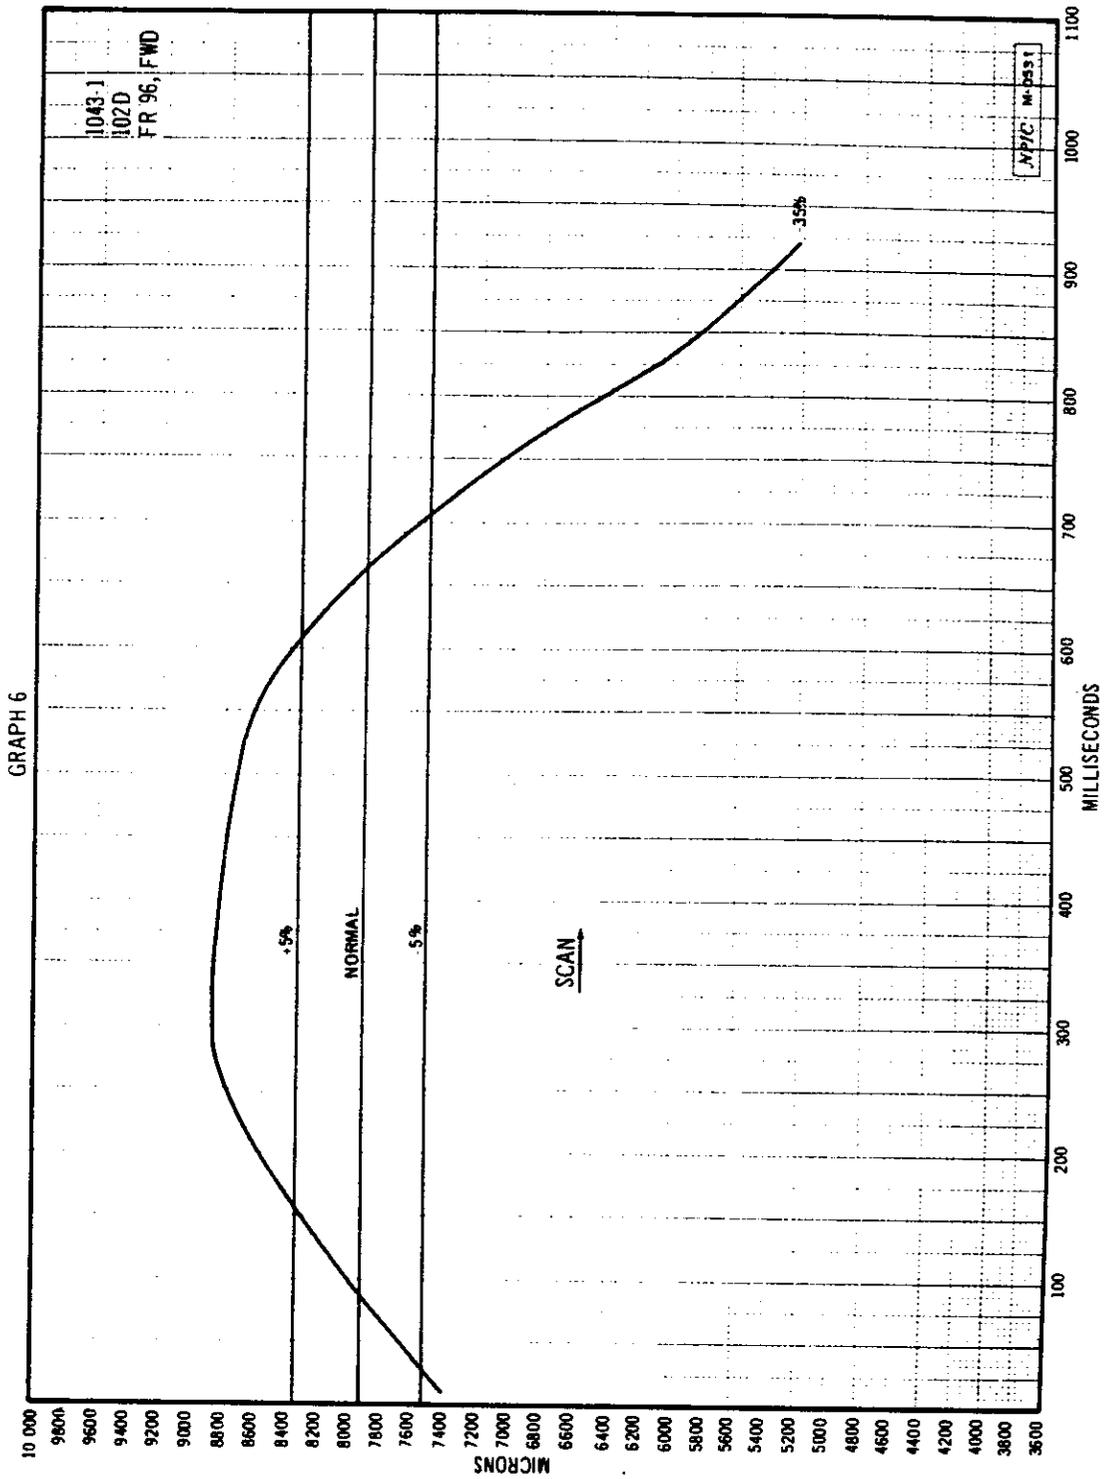
D. Scan Rate Plots:

A. The following Special Study graphically describes the nature and magnitude of the scan speed deviations on the fwd camera photography of Mission 1043. The film of the fwd (master) camera came out of the guide rails on pass 228, causing the remainder of the fwd camera film to be of little or no intelligence value. It is believed that there is a connection between the scan rate anomaly and the pulling of the film from the rails. A scan rate perturbation was first noted on pass 68D during a routine, subjective analysis of the time track. It was observed that the scan rate was slower toward the end of the scan than at the beginning or center of the scan.

Graph 5: Mission 1043-1, pass 68D, frame 7 fwd -- continuation of the anomaly. This is the point at which the anomaly was first noted subjectively.

3. Traces of frames between pass 56D and 61D, showing a gradual increase in the magnitude of the scan rate retardation.
4. Traces generated from frames between passes 61D and 68D. These also show a gradual increase in magnitude of the anomaly.
5. Traces of frames between pass 68D and pass 102D, indicating that the degree of scan rate retardation remained unchanged during that period of the mission.
6. Traces on frames of passes between 104D and 228D, indicating an unchanged continuation of the anomaly.

1. The scan speed was apparently normal through the first 55 orbital revolutions.
2. The first scan rate retardation of a measurable magnitude is on pass 56D. The maximum error observed on that pass is 10 percent.
3. The magnitude of the scan rate retardation became progressively more pronounced from pass 56D through approximately pass 68D.
4. The variation in scan speed can first be detected subjectively on pass 68D. The magnitude of the error at that point is 32 percent.
5. The magnitude of the scan rate perturbation is about 35 to 45 percent less than the normal scan rate and remains fairly consistent throughout the mission after pass 68D.
6. The degree of scan rate retardation is not changed in association with the cut and wrap between mission segments.
