PHOTOGRAPHIC
EVALUATION REPORT
MISSION 1046

SPECIAL STUDY: COMPARISON OF
SO-230 & 3404 FILM TYPES FROM
MISSION 1102-2

MISSION 1046

NATIONAL PHOTOGRAPHIC INTERPRETATION CENTER

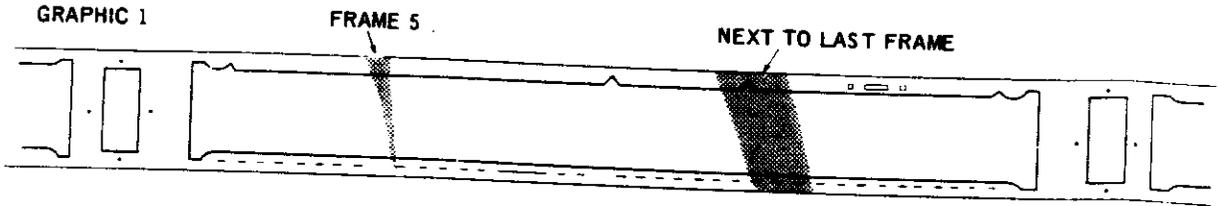
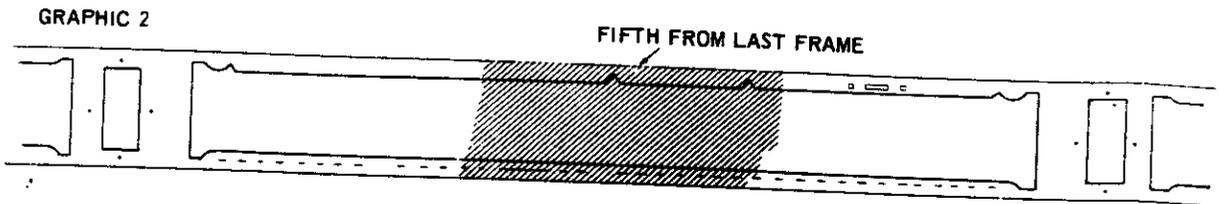
a. Light Leaks: Light leak induced fog patterns appear more often and are of greater severity than on the more recent missions of this system. The fogging that occurred near the intermediate roller assembly is especially severe when there is a long sit period between camera operations. The fog patterns correlated directly with the duration of camera sit periods. The major fog patterns occurred on the last, first and fifth from last frame, and fifth frame of most passes. The more severe fog patterns cause some degradation to the imagery. The fog patterns are illustrated on Graphics 1 and 2, page 10.
