PHOTOGRAPHIC  
EVALUATION REPORT

MISSION 1048

FEBRUARY 1969

NATIONAL PHOTOGRAPHIC INTERPRETATION CENTER

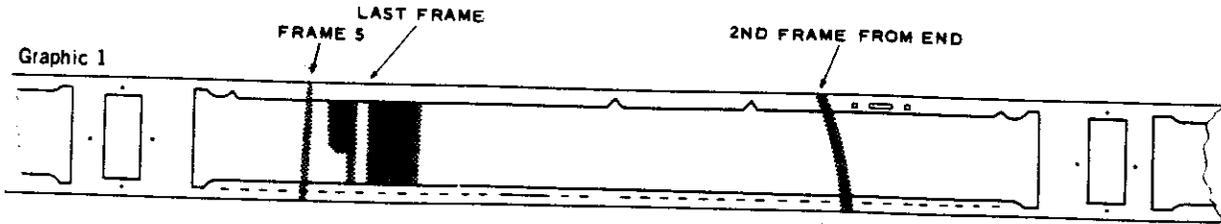
b. Static: A few instances of dendritic static traces are present along the edge of the film from Mission 1048-1 (Examples: Frames 75-35, pass 84D). Traces of corona static are detectable at random throughout the record from Mission 1048-2. The traces are easy to detect within areas of low density and contrast, and their frequency and intensity increase slightly as the mission progresses (Examples: Pass 164D, see Graphic No 1, page 12).

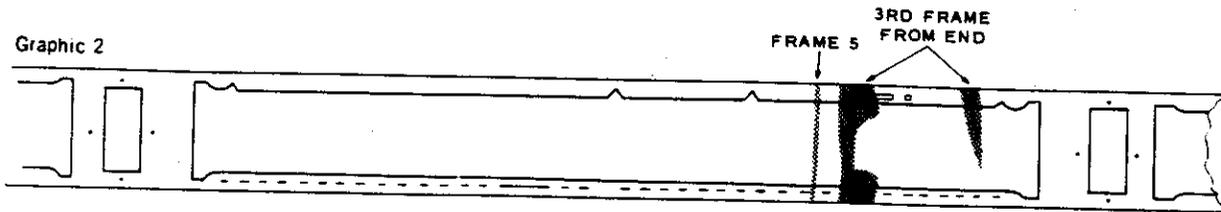
a. Light Leaks: A thin band of fog is present on the fifth frame from the beginning of most passes, (Example: Passes 16D and 180D) and on the third frame from the end of a few passes (Examples: Frame 8, pass 16D and frame 22, pass 135D). Faint equipment images are also present on the third frame from the end of a few passes (Example: Frame 8, pass 16D, see Graphic No 2, page 12).

contrast areas, and their frequency and intensity increase slightly as the mission progresses (Examples: Pass 164D, see Graphic No 2, page 12).

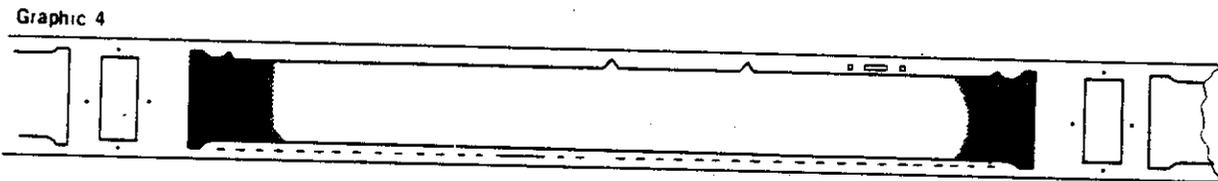
3. Acuity: The image quality of the aft-looking camera material is superior to that of the fwd. An MIP rating of 85 was assigned to both mission segments. The best ground resolution obtained from a 25:1 contrast fixed B-2 target is 7.1 feet across track -- resolution along track is not resolved. The overall quality of the imagery is good but it should be noted that there are out-of-focus areas near the bonus area. The size of the out-of-focus area is inconsistent and varies throughout the mission (See Graphic No 4, page 12).
