27 June 1973

FLIGHT TEST ENGINEERING ANALYSIS REPORT
FOR
THE HEXAGON PROGRAM SATELLITE VEHICLE NUMBER FIVE (S)

Prepared and Submitted by the
Satellite Vehicle Integrating Contractor

This report describes the performance of the fifth HEXAGON Program Satellite Vehicle (SV-5). The vehicle was launched on 9 March 1973 and after a 64-day primary mission and a 7-day SOLO mission was deboosted on Rev 1139 on 18 May 1973.

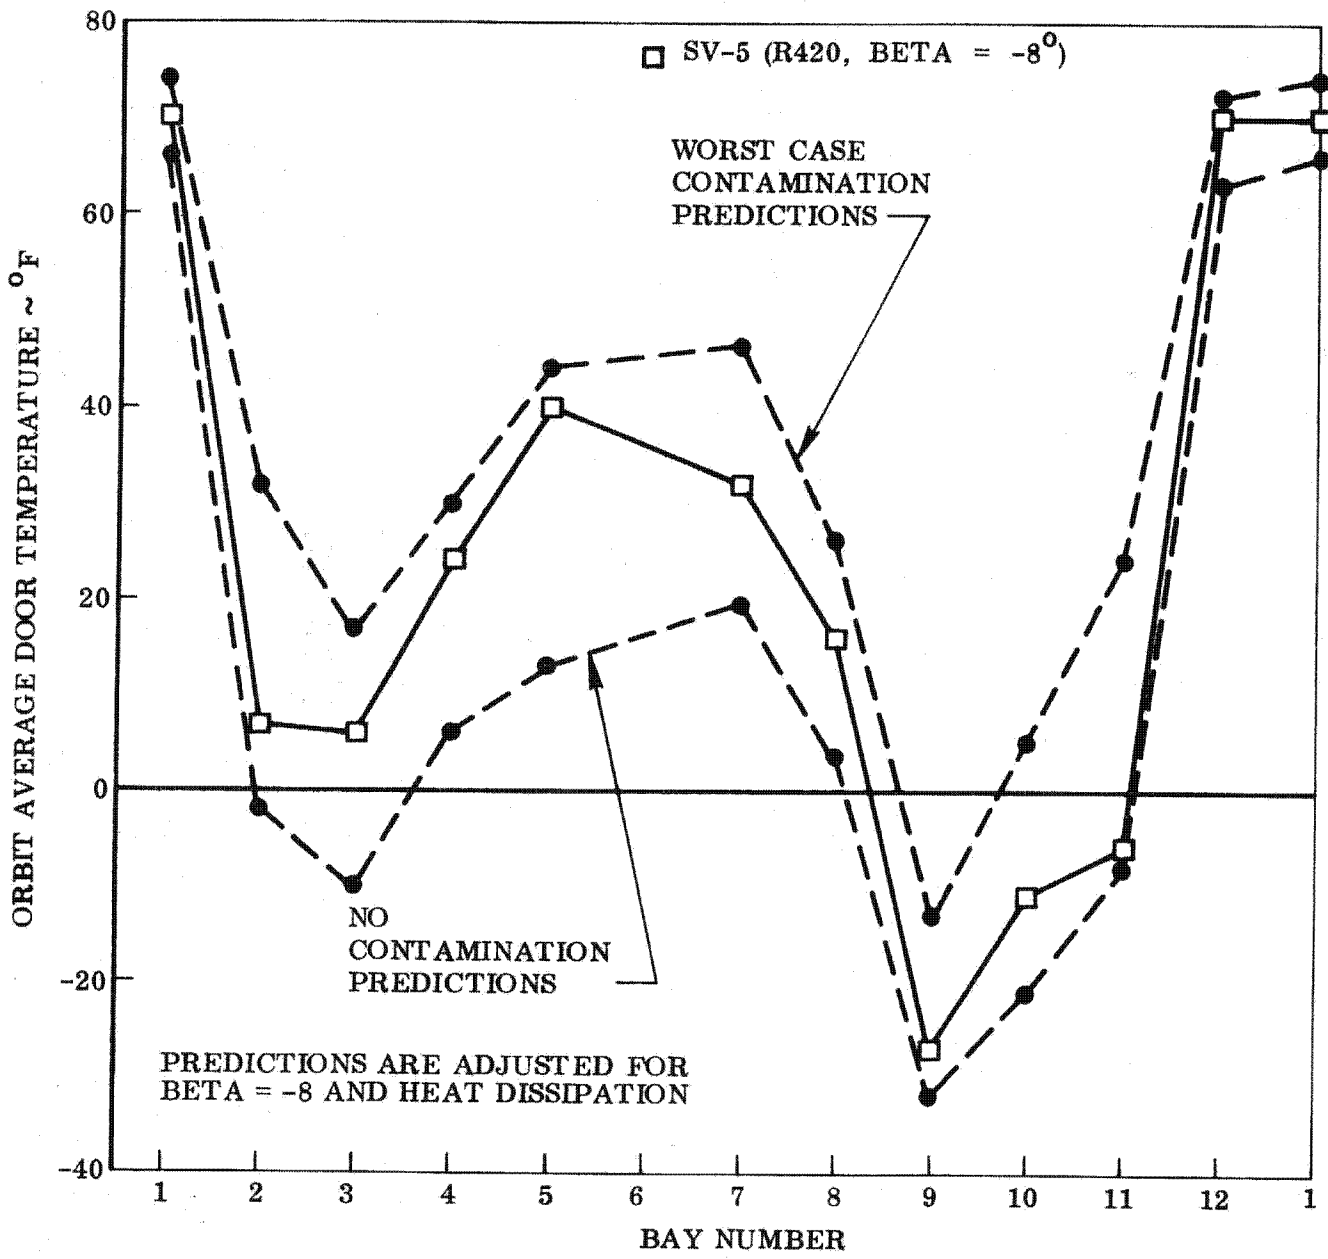
Fig. 12-2 SV-5 Equipment Door Temperatures

Equipment and structural temperatures indicated contamination degradation to external vehicle thermal control surfaces similar to that of all other flights. The amount of degradation was within the bounds of preflight analysis as indicated by Fig. 12-2, which compares actual Equipment Section door temperatures with predictions of a Beta angle of -8 degrees. Solar absorptance (α_s) for the degraded FOSR was estimated to be 0.30 to 0.36, less than the $\alpha_s = 0.50$ assumed for the worst case.
