BIF003W/2-068875-73
HEXAGON Cy /
5 February 1973
Sheet Count: 73

FLIGHT TEST ENGINEERING ANALYSIS REPORT
FOR
THE HEXAGON PROGRAM SATELLITE VEHICLE NUMBER FOUR (S)

This report describes the performance of the fourth HEXAGON Program Satellite Vehicle (SV-4). The vehicle was launched on 10 October 1972 and after a 69 day primary mission and a 22 day SOLO mission was deboosted on Rev 1463 on 8 January 1973.

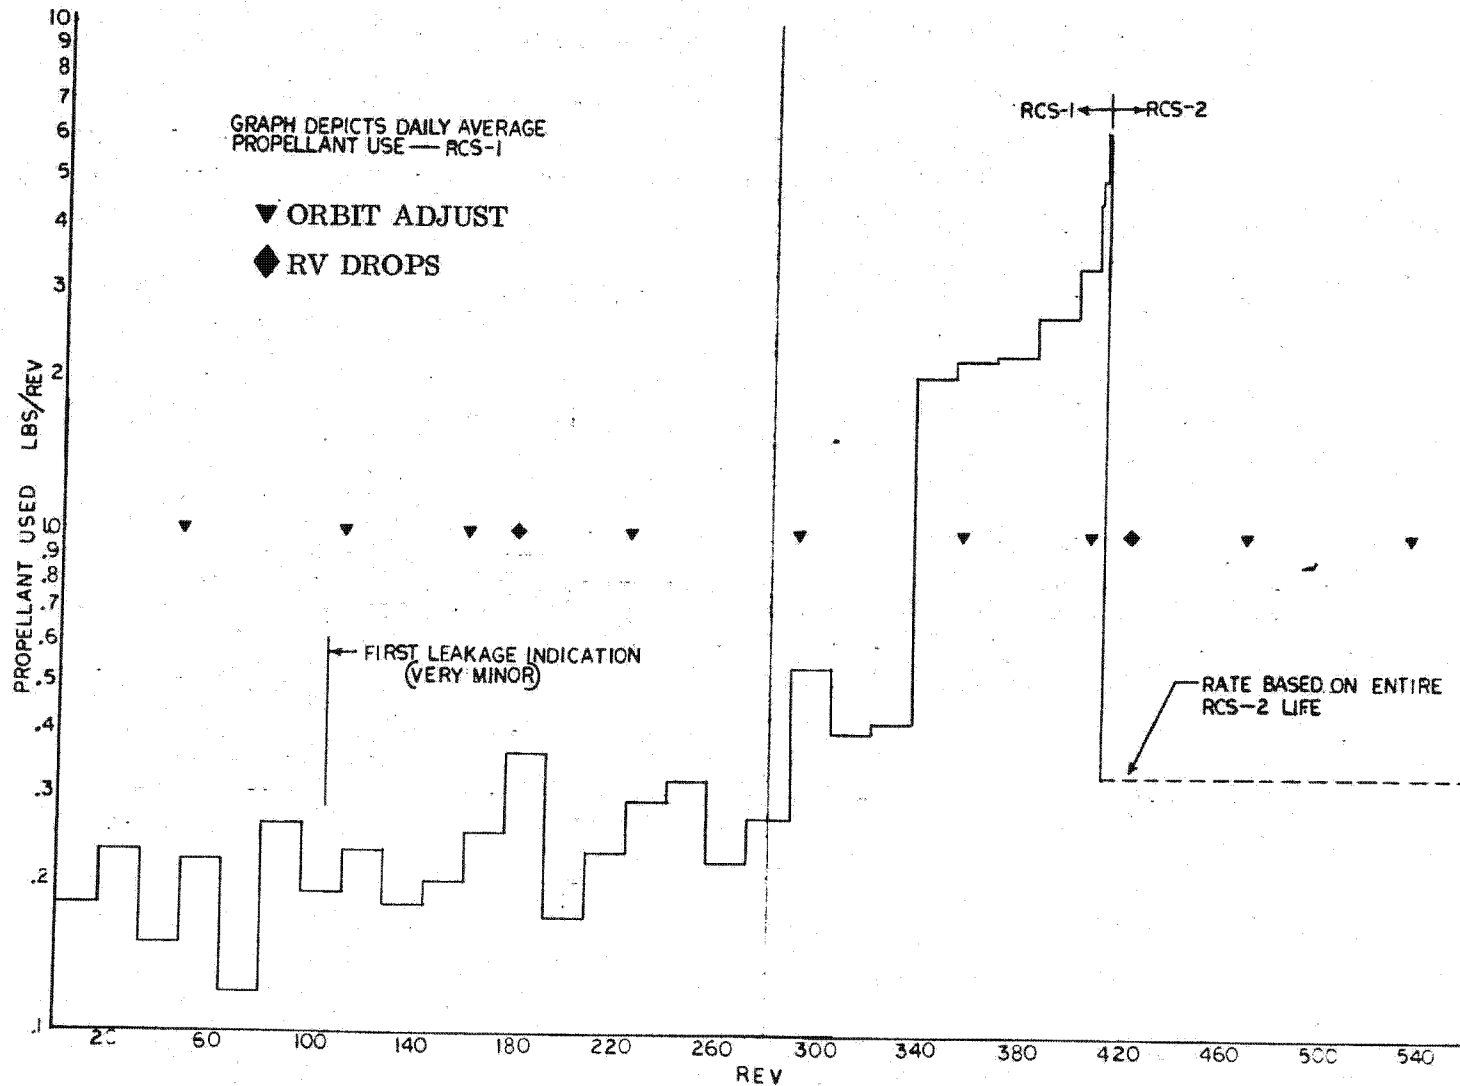
Fig. 2-1 RCS Propellant Consumption

Satisfactory vehicle attitude and rate control were provided by the RCS at all times during the 91 day flight. Leaks developed in the primary system (RCS-1) as expected and control was switched to the standby system (RCS-2) on day 26. No leaks were detected in RCS-2 for the remainder of the flight and although some degradation of thrust was observed, the large degradation expected from ground tests did not occur.

RCS propellant consumption for the 91 day mission was computed to be 870 pounds. Propellant was consumed from RCS-1 tanks 1 and 2 until day 26 when control was switched to RCS-2 which was fed directly from the main OAS tank as RCS tanks 3 and 4 were cut out of the system prior to flight. Abrupt temperature increases on both the REA and mount can be noted when the leaks began on RCS-1 and precede the onset of excessive propellant consumption. On RCS-2 no leak-significant increases in the mount temperatures (this is the only instrumentation available on RCS-2) and no significant increase in fuel consumption occurred.

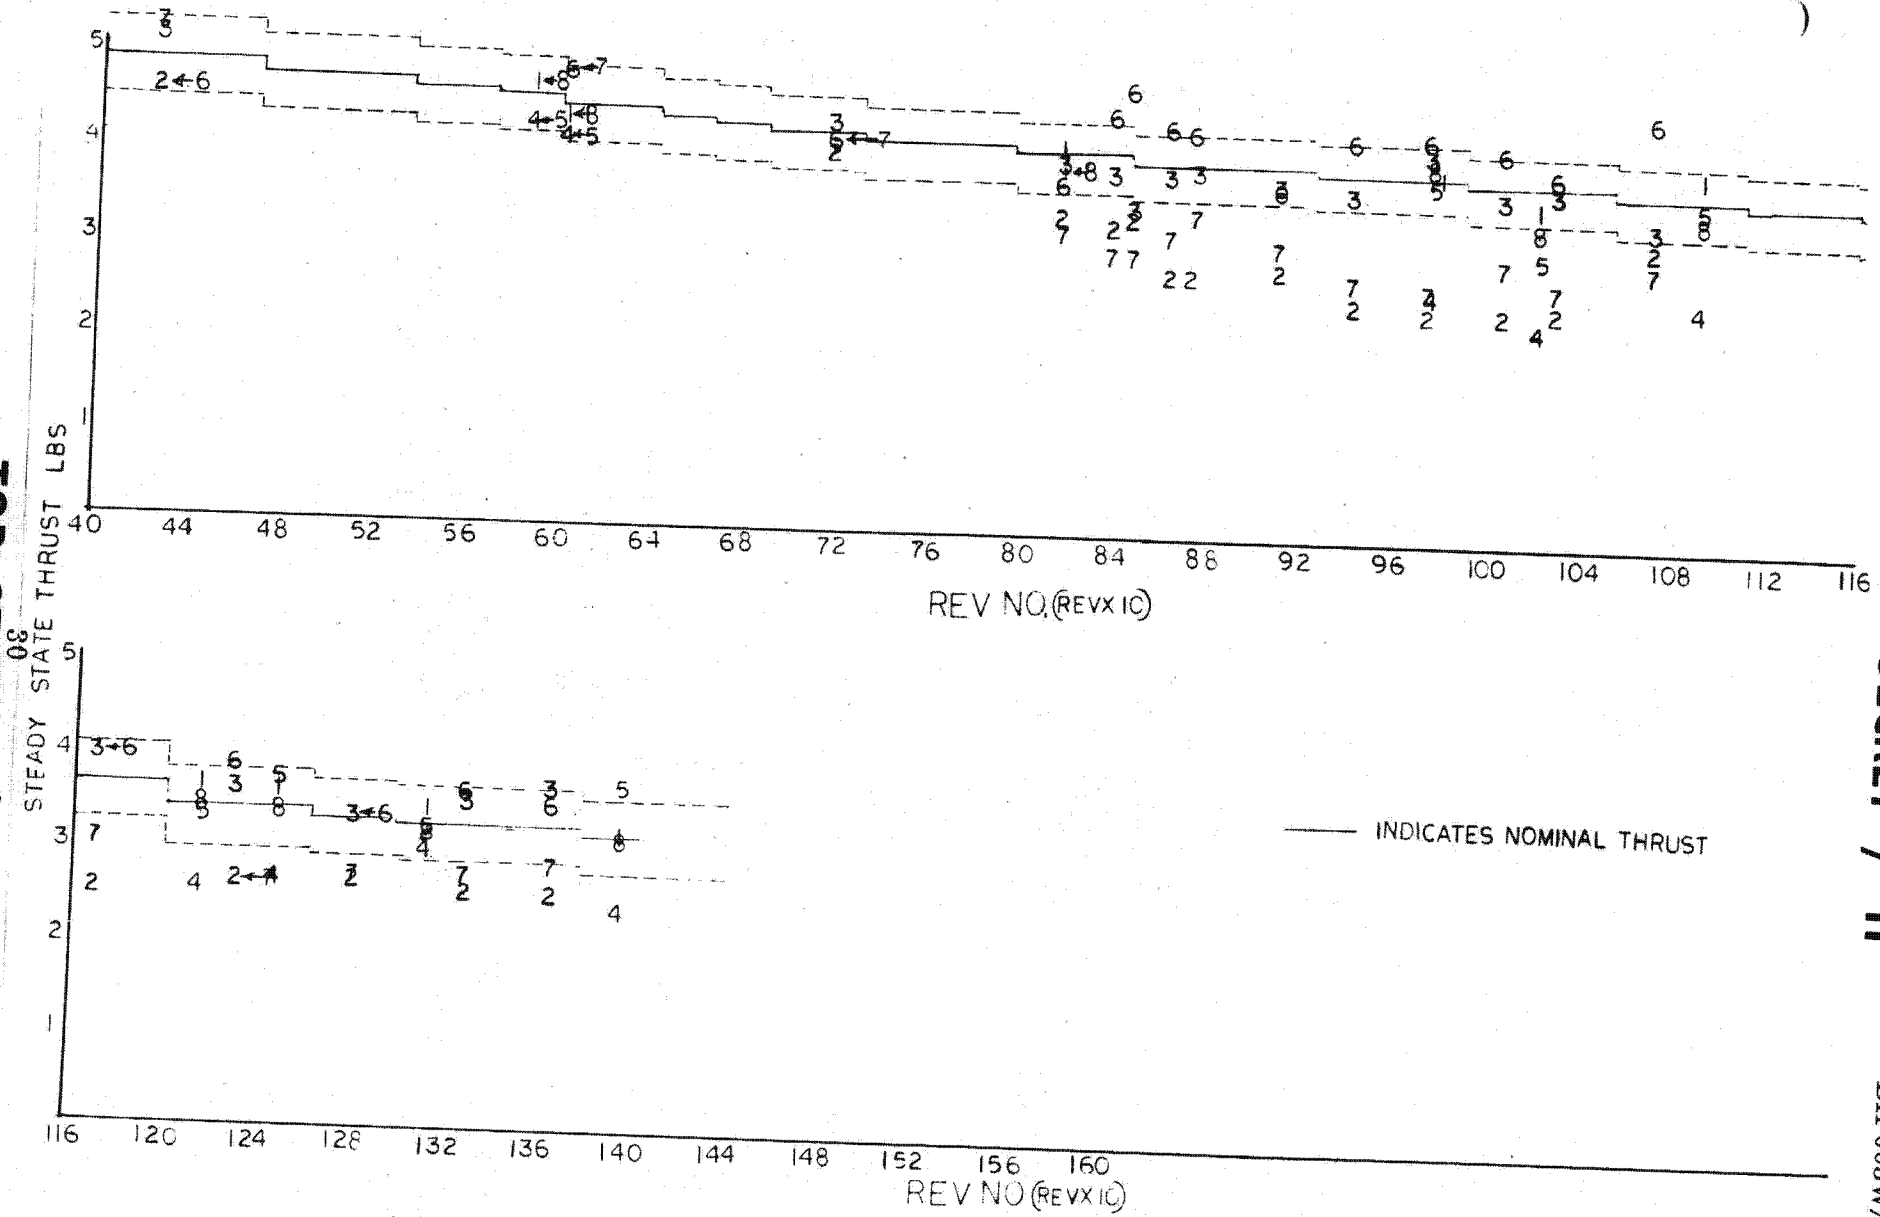
Fig. 2.3 Steady State Thrust Trends

The REA thrust levels of RCS-2 were determined from the events listed in Table 2-2. Since ground test data indicated that a drop in steady state thrust would be the first indication of a failing thruster, a series of mini-pitch and mini-yaw maneuvers

producing steady state thrust were commanded and are noted on Fig. 2-2. Mini-pitch consisted of pitching the vehicle down 14° and then flying for 3.5 minutes prior to reconnecting the Horizon Sensors which allowed the vehicle to reattain the proper flight attitude without additional commanding. The mini-yaw was a 14° yaw and then a commanded return to the zero yaw position. Results obtained are shown in Fig. 2-3, and Fig. 2-4. Figure 2-3 is a non-normalized plot and shows the method of determining the thrust is accurate enough to follow the normal blow down curve. Figure 2-4 presents the REA thrusts normalized to a 220 psi feed pressure plotted against pulse count. Included on Fig. 2-4 are the results of the combined system ground test at Rocket Research. The thrust degradation at 60-70,000 pulses seen in the ground test did not materialize in flight. It can be seen that only one thruster significantly exceeded the ground test pulse life; however, the more important parameter, mission days, was more than doubled.

- Elimination of the present RCS tankage using EPT10 rubber diaphragms stops the gross valve leakage problem experienced on previous flights
- Thrust degradation was not accelerated by operation at duty cycles (and temperatures) lower than the Rocket Research ground test. The degradation observed in operation on the ground was not confirmed in orbit operation.

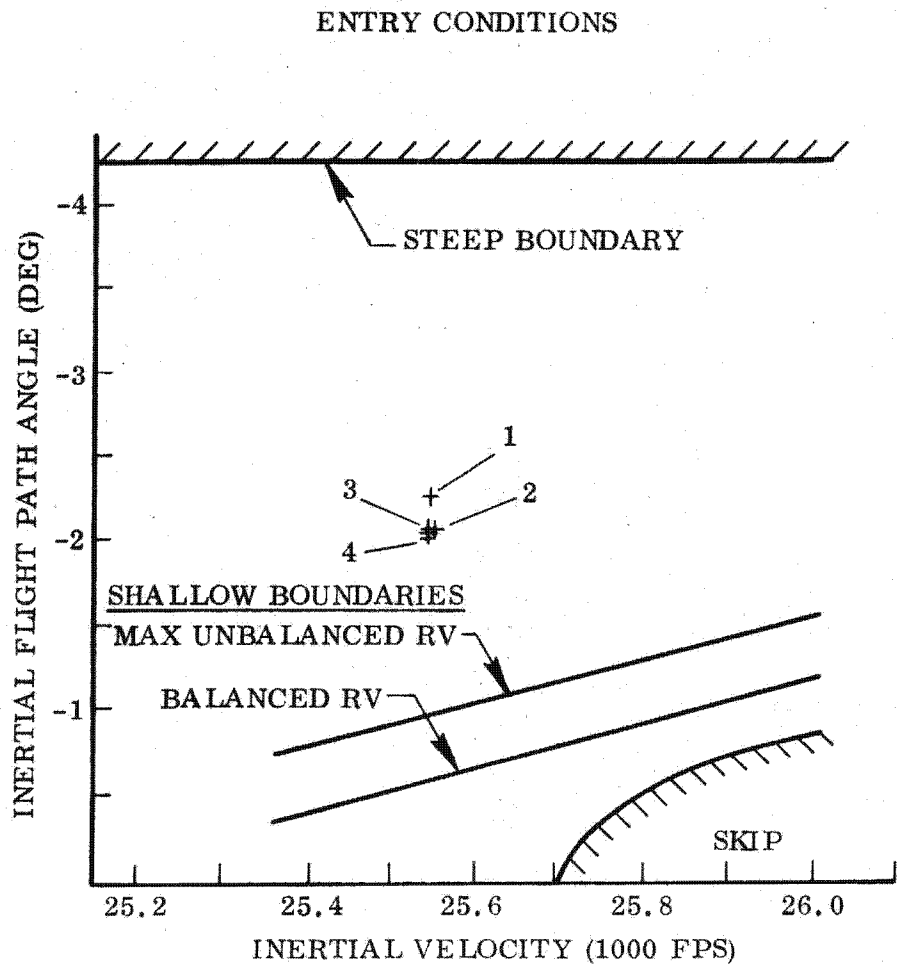
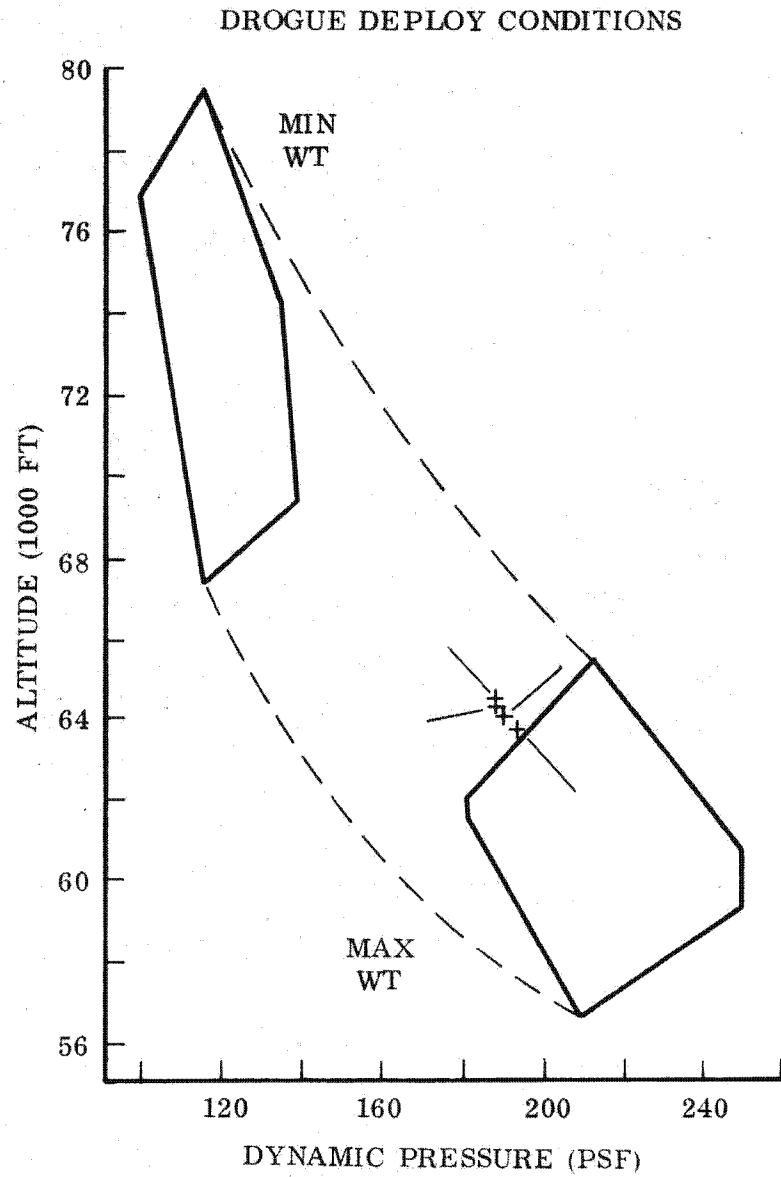
The RVs were adequately spin stabilized during the exoatmospheric coast and retrograde phase of the reentry trajectory. Figure 8-1 shows the entry conditions to be well within previously established entry boundaries. Also shown are the conditions at time of drogue chute deployment which are within the design envelope.

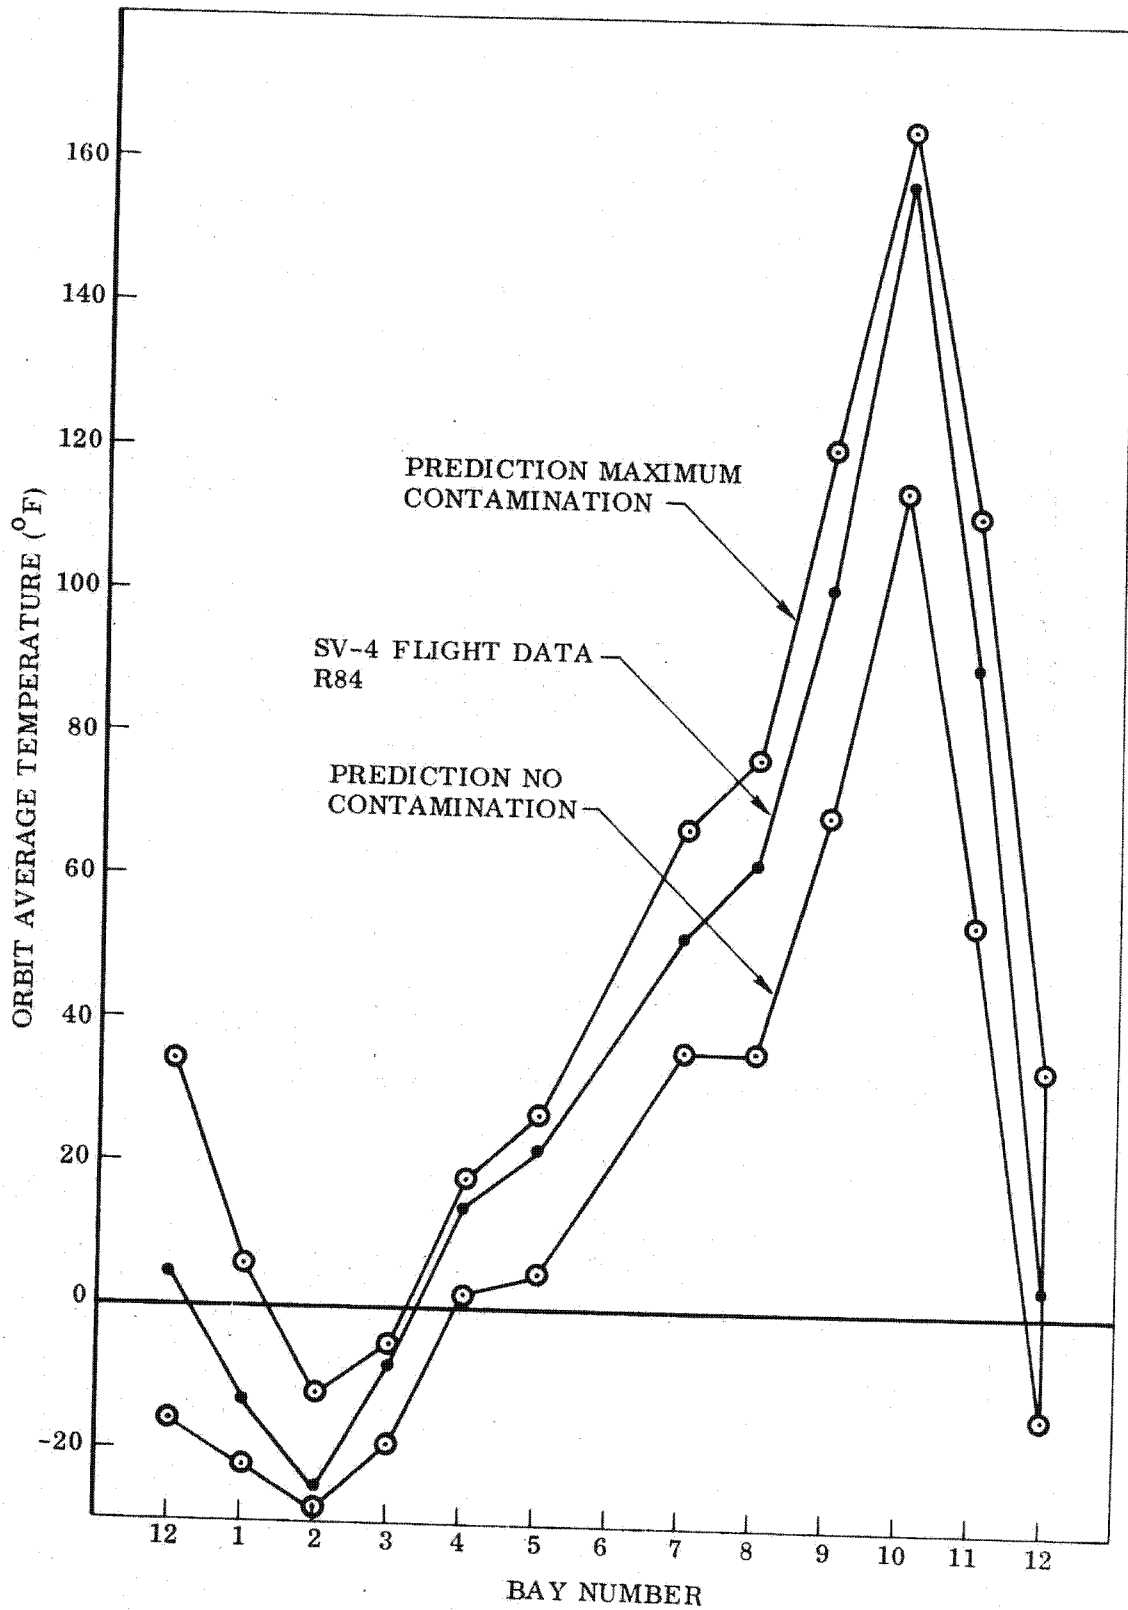
Fig. 12-1 SV-4 Equipment Door Temperatures

Equipment and structure temperatures indicated contamination degradation to external vehicle thermal control surfaces similar to that noted on all other flights. The amount of degradation appears to be less than occurred on SV-1, about the same as SV-2, and greater than occurred on SV-3. The amount of degradation was within the bounds of preflight analysis, as is indicated by Figure 12-1, which compares actual door temperatures with the pre-flight predictions.

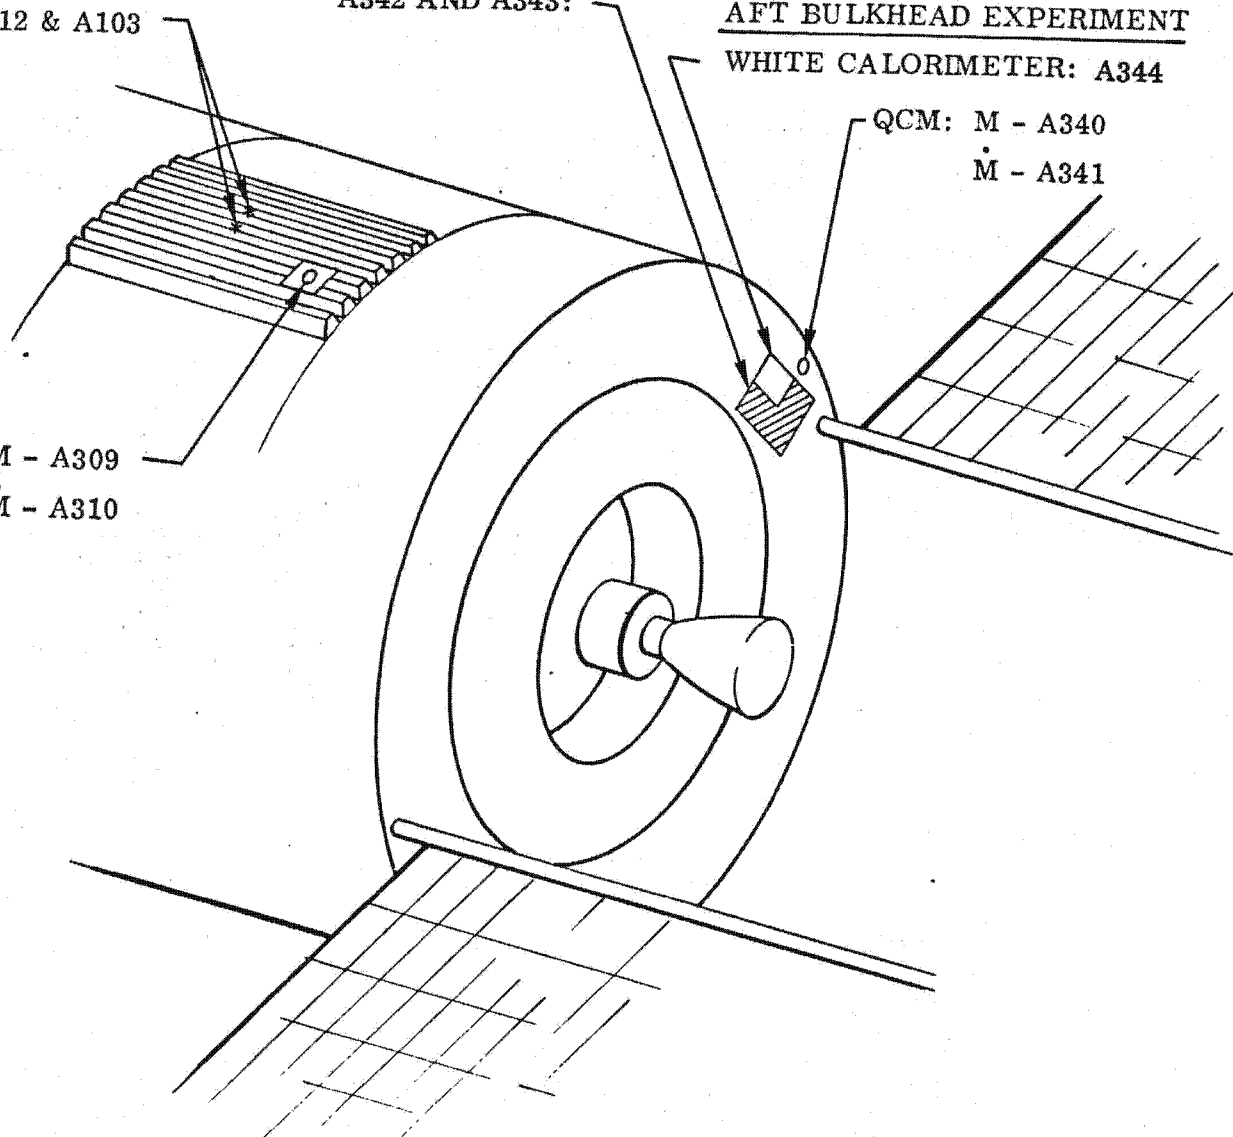
Fig. 12-2 8004 Contamination Experiments

12.4.2.2 Aft Bulkhead. The ascent contamination caused negligible change in the mass deposition level measured by the Station 2203 QCM as shown in Fig. 12-2. This was as expected, as the SRM staging event causes only a momentary inflow of external gases into the aft section cavity via the vent ports. The first RV retro caused the mass deposit to rise from near lift-off levels to the telemetry limit of 5 TMV where it remained until the second RV retro. The extrapolated mass deposit due to the first RV was $3.8 \times 10^{-5} \text{ g/cm}^2$. The second RV retro caused the QCM to saturate and the crystal stopped oscillating as is expected when the mass deposit becomes excessive. The FOSR and white silicone calorimeter panels indicated an increase in α of 0.10 and 0.13 respectively from early flight to after the RV-3 retro event. After correction for ultraviolet degradation, a total change in α of 0.06 for both calorimeters is associated with the three contamination events.

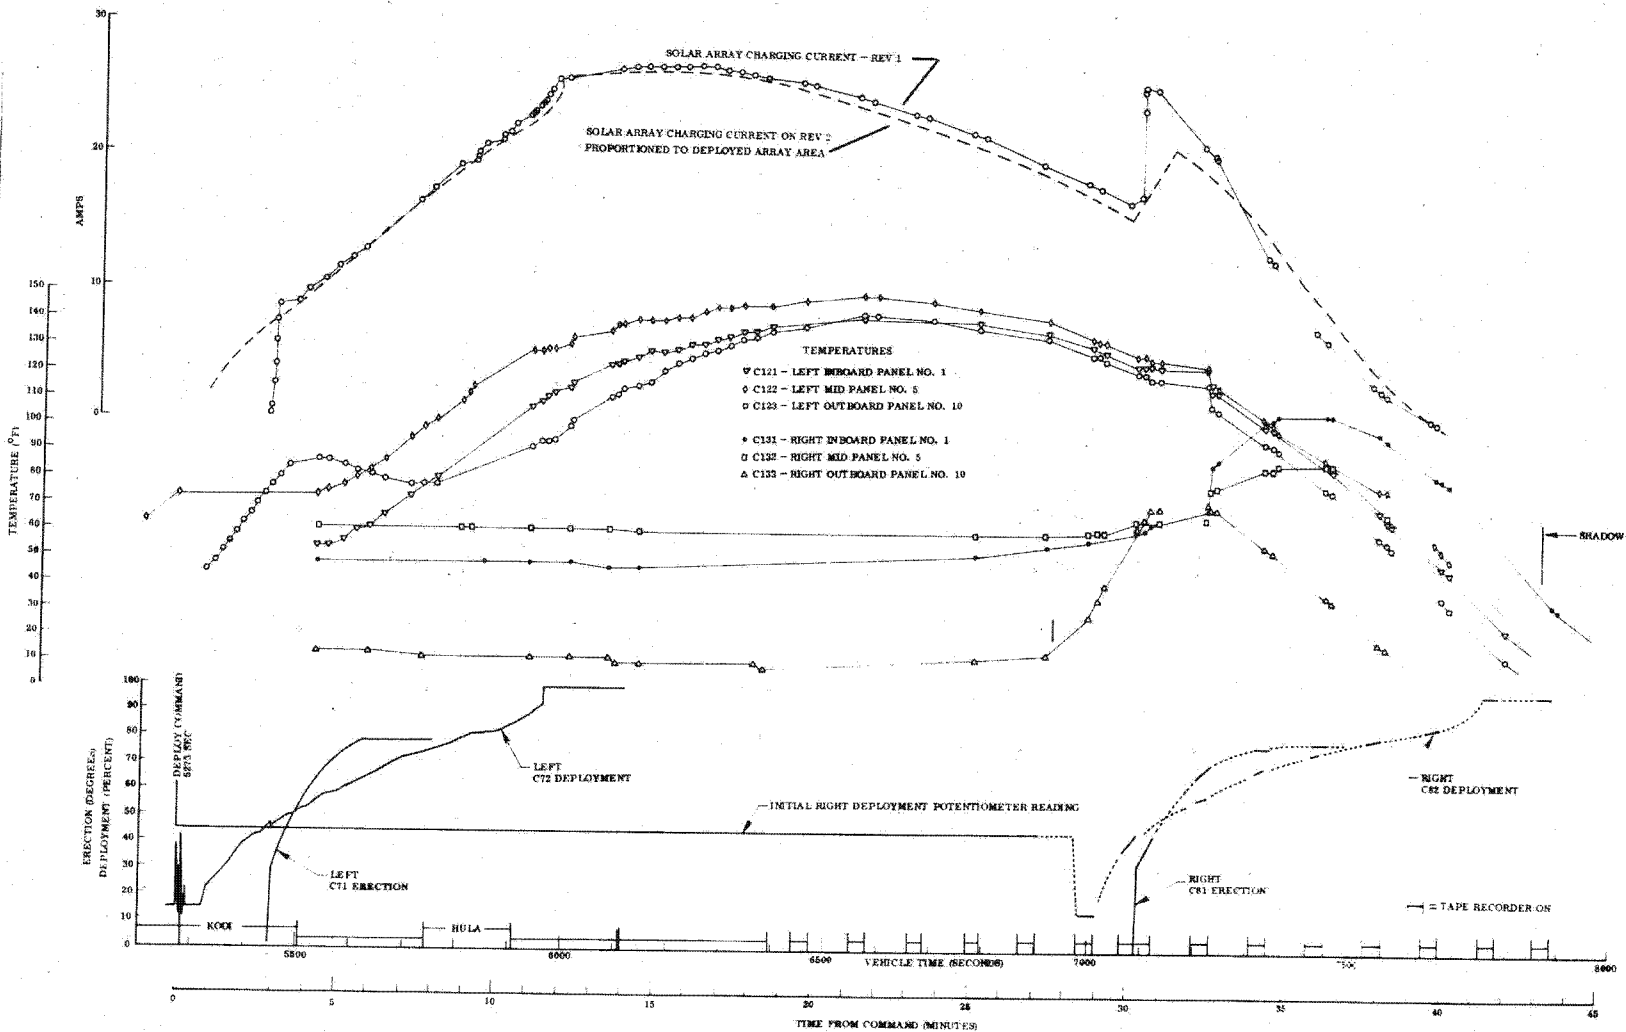
Fig. 14-2 Time History of Solar Array Parameters During Deployment

Solar Arrays were extended on Rev 1. The left array started deployment on command and required 640 seconds to complete deployment and erection. The right array did not start to deploy until 1680 seconds after receiving the command and then required approximately 750 seconds to complete deployment and erection. Power output from each leg exceeded the specification value. Degradation from the initial output to end of the fourth segment was 2 percent. 2 percent is well below the 5 percent allocated.
