25 August 1971

FLIGHT TEST ENGINEERING ANALYSIS REPORT  
FOR  
THE HEXAGON PROGRAM SATELLITE VEHICLE NUMBER ONE (S)

Prepared and Submitted by the  
Satellite Vehicle Integrating Contractor

This report describes the performance of the first HEXAGON Program Satellite Vehicle (SV-1). The vehicle was launched on 15 June 1971 and completed its primary mission with the recovery of RV number four on 16 July 1971. This report encompasses only these 31 days.

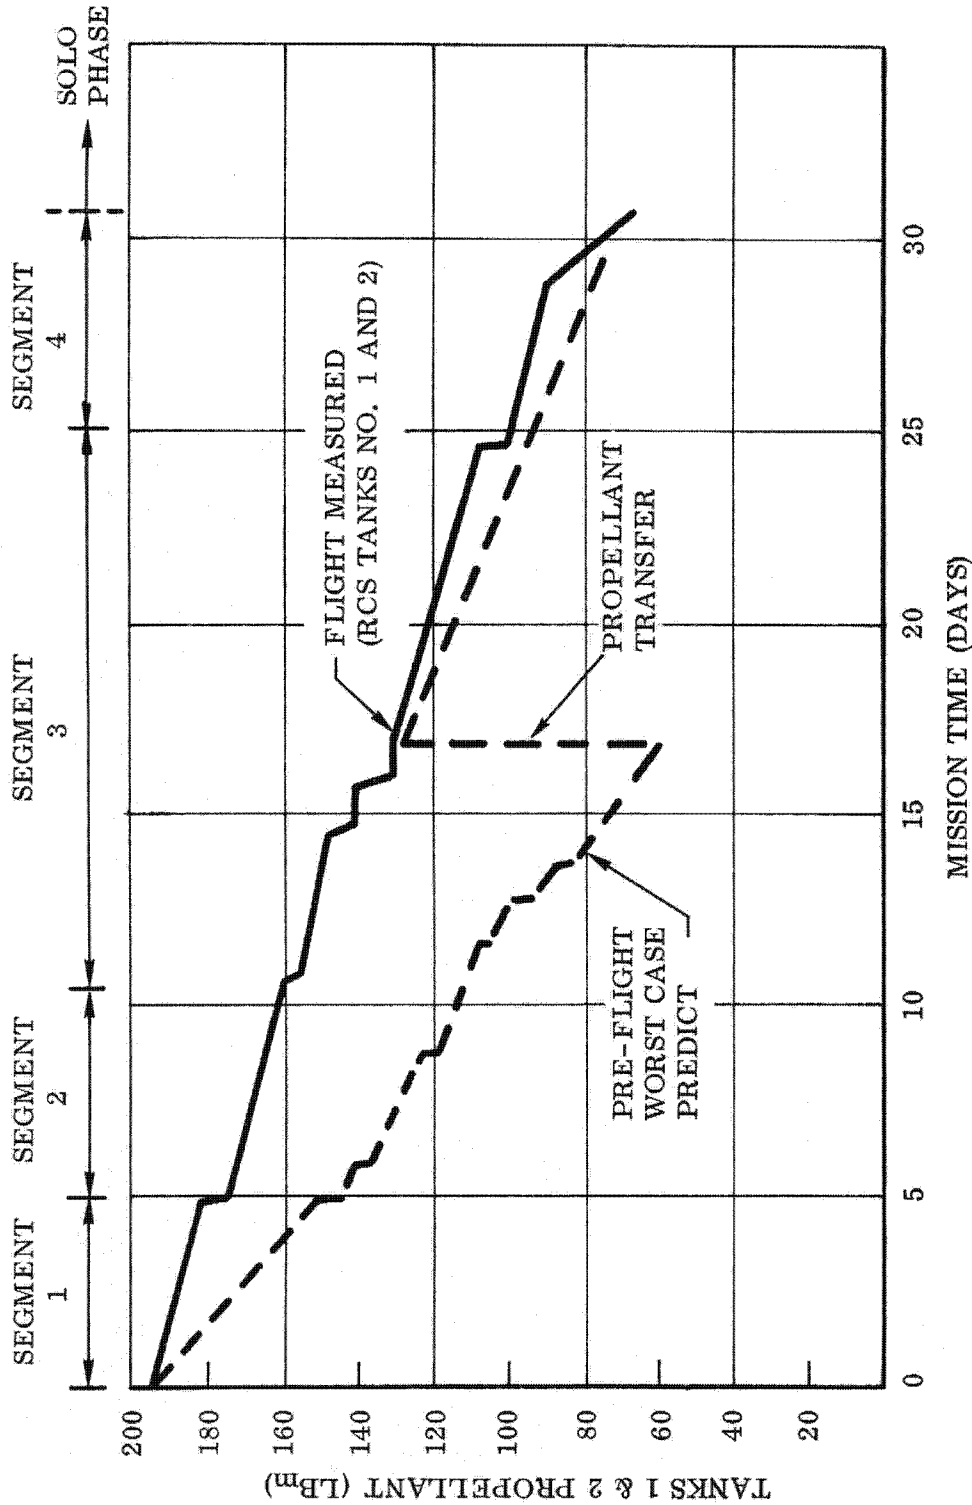
Fig. 2-1 RCS Propellant Consumption

The RCS propellant consumed over the 31 days (502 Revs) was 134  $\pm$ 10 lb as shown in Fig. 2-1. The flight measured consumption was computed from the RCS tank temperature and pressure telemetry data and has an uncertainty of  $\pm$ 10 lb at beginning and end of mission. Also shown in the figure is the pre-flight worst case prediction which was based on P/L ops per ICD and includes contingencies such as magnetic torques and leakage.

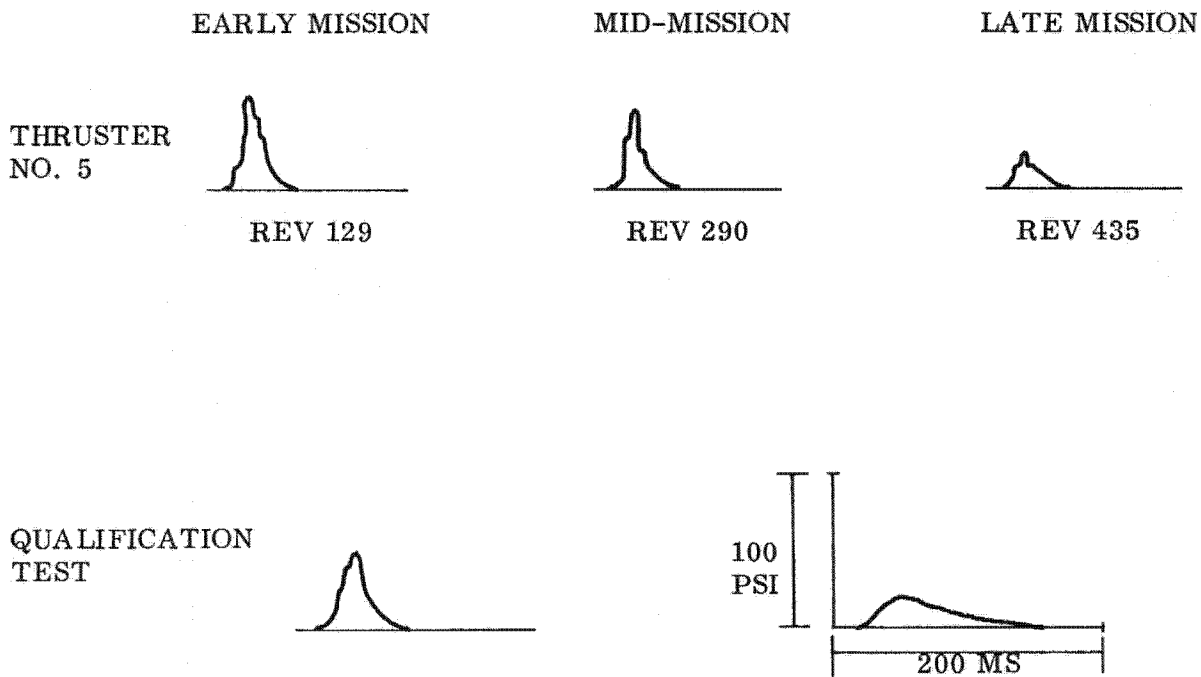
Fig. 2-2 RCS Thruster Performance

Three RCS Thrusters showed some sluggishness in pulse shape tailoff at the end of the mission as shown in Fig. 2-2. The degree of tailoff change was minor and much less than observed during ground testing which is shown for comparison. The distortion of the pulse shape suggests some catalyst bed wear, particularly at low duty cycles. Vehicle control was not compromised and no change in propellant consumption could be detected. Pulses with tailoff sluggishness have the same total impulse as pulses with crisp shapes and thus no change in specific impulse is encountered. The small change in response and centroid is minor, not affecting vehicle control.

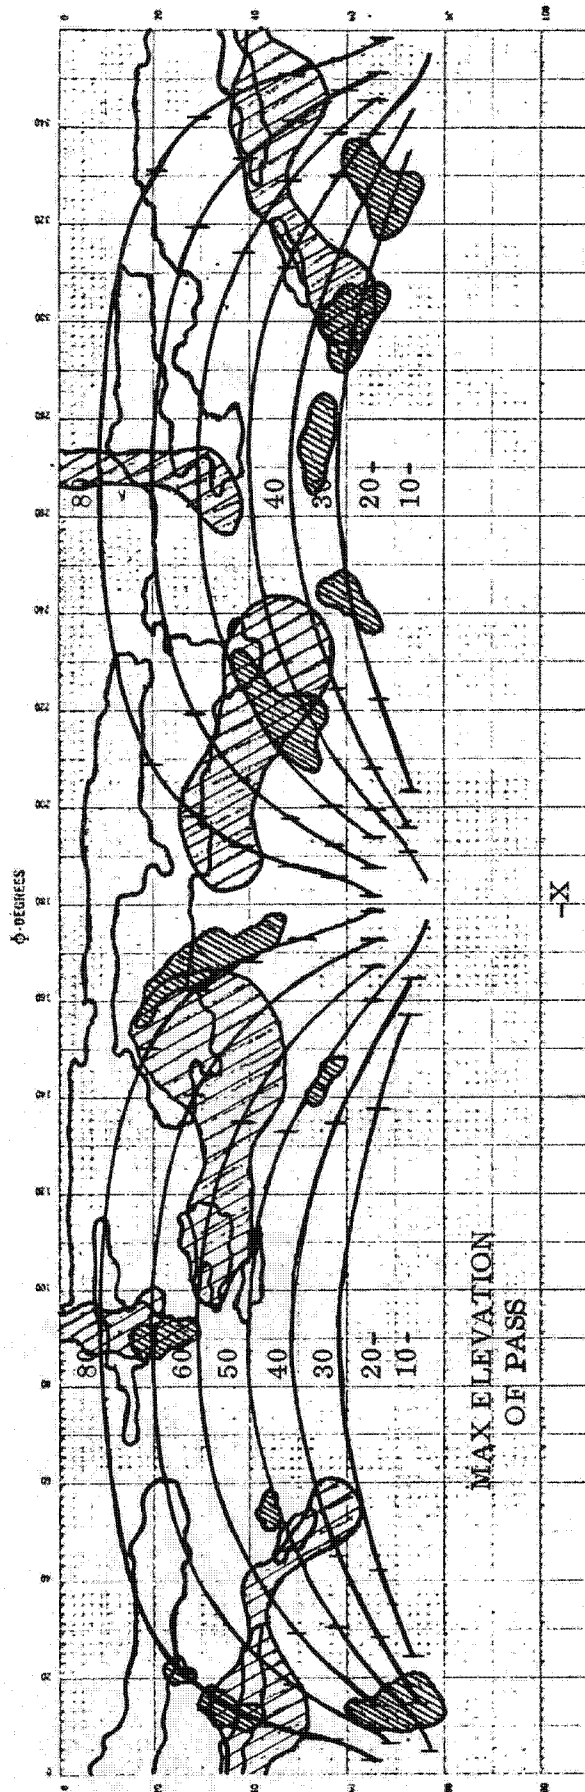
All Remote Tracking Stations experienced fluctuations during the mission. These fluctuations ranged from minor changes (5 dB) to complete drop-outs. The majority of fluctuations were identified and plotted. The observed SGLS 1 fluctuations are symmetrical (right/left side of SV) as shown in Fig. 4-1. Solar array positioning (during SOLO) to other locations resulted in no significant pattern changes. As a result of the SGLS 1 data obtained, a secure block loading constraint was recommended to Test Control. Also, predictions were made by the SBAC Flight Support Team (FST) and provided to Test Control for both block loading and tape recorder playback. These methods of avoiding the drop-outs were easily followed by Test Control with minimal impact and essentially no data loss. SGLS 2 was also used during the mission to obtain signal strength data. The data obtained indicates that the fluctuations are not symmetrical (i. e., left side different than right side). This data is also provided in Fig. 4-1.

In summary, the original analysis published in 1970 defined holes in the pattern where drop-outs could be expected. After the fluctuations were identified and understood in flight, the system (Test Control, Test Advisor, FST, etc.) continued their functions knowing what the constraints were, and there was little or no impact to those tasks. For SV-2 and up, SBAC recommends that these same constraints be utilized and the FST continue to provide predictions as a normal function. No hardware changes are recommended.

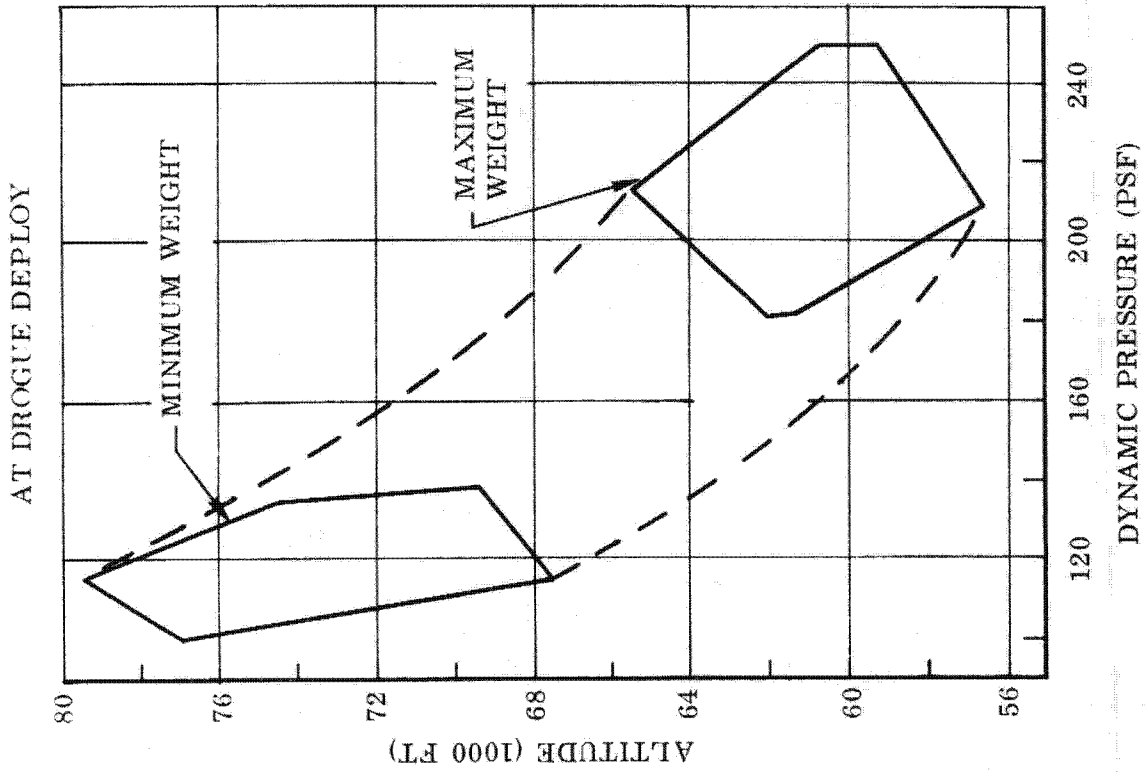
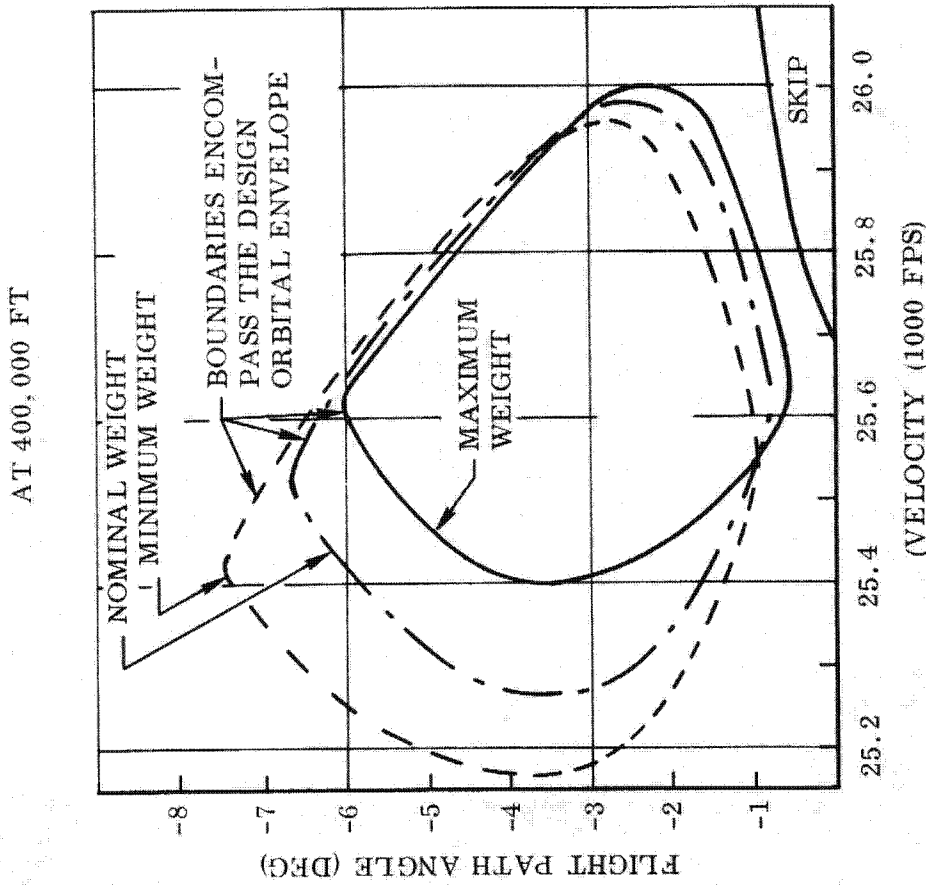
Fig. 8-1 Reentry Parameter Comparison

The entry (400,000 ft altitude) velocity and flight path angle for each flight are shown in Fig. 8-1 compared to envelopes of possible entry conditions for which the reentry vehicles was designed to be compatible. During the early period of the entry phase, the residual roll rate, which had been nearly constant during the exoatmospheric coast phase, began to decrease. After approximately 110 sec the roll direction reversed. This reversal was typical for all four flights and had no measurable effect on the capability of the RVs to enter successfully. Angle of attack was less than the predicted values throughout the significant heating portion of the entry, due to roll reversal and associated phenomena. Velocity and altitude time histories apparently correlated well with predicted normal values as evidenced by the accuracy of the impact.

Figure 8-1 also shows the altitude and dynamic pressure for each flight at the time of drogue parachute deployment with respect to the design envelope. Flight instrumentation data show that drogue performance as a decelerator was essentially as predicted. For example, the maximum dynamic pressure at drogue release and main parachute deployment was 58.7 psf observed on Flight 2, and the predicted value for this flight was 60.2 psf.

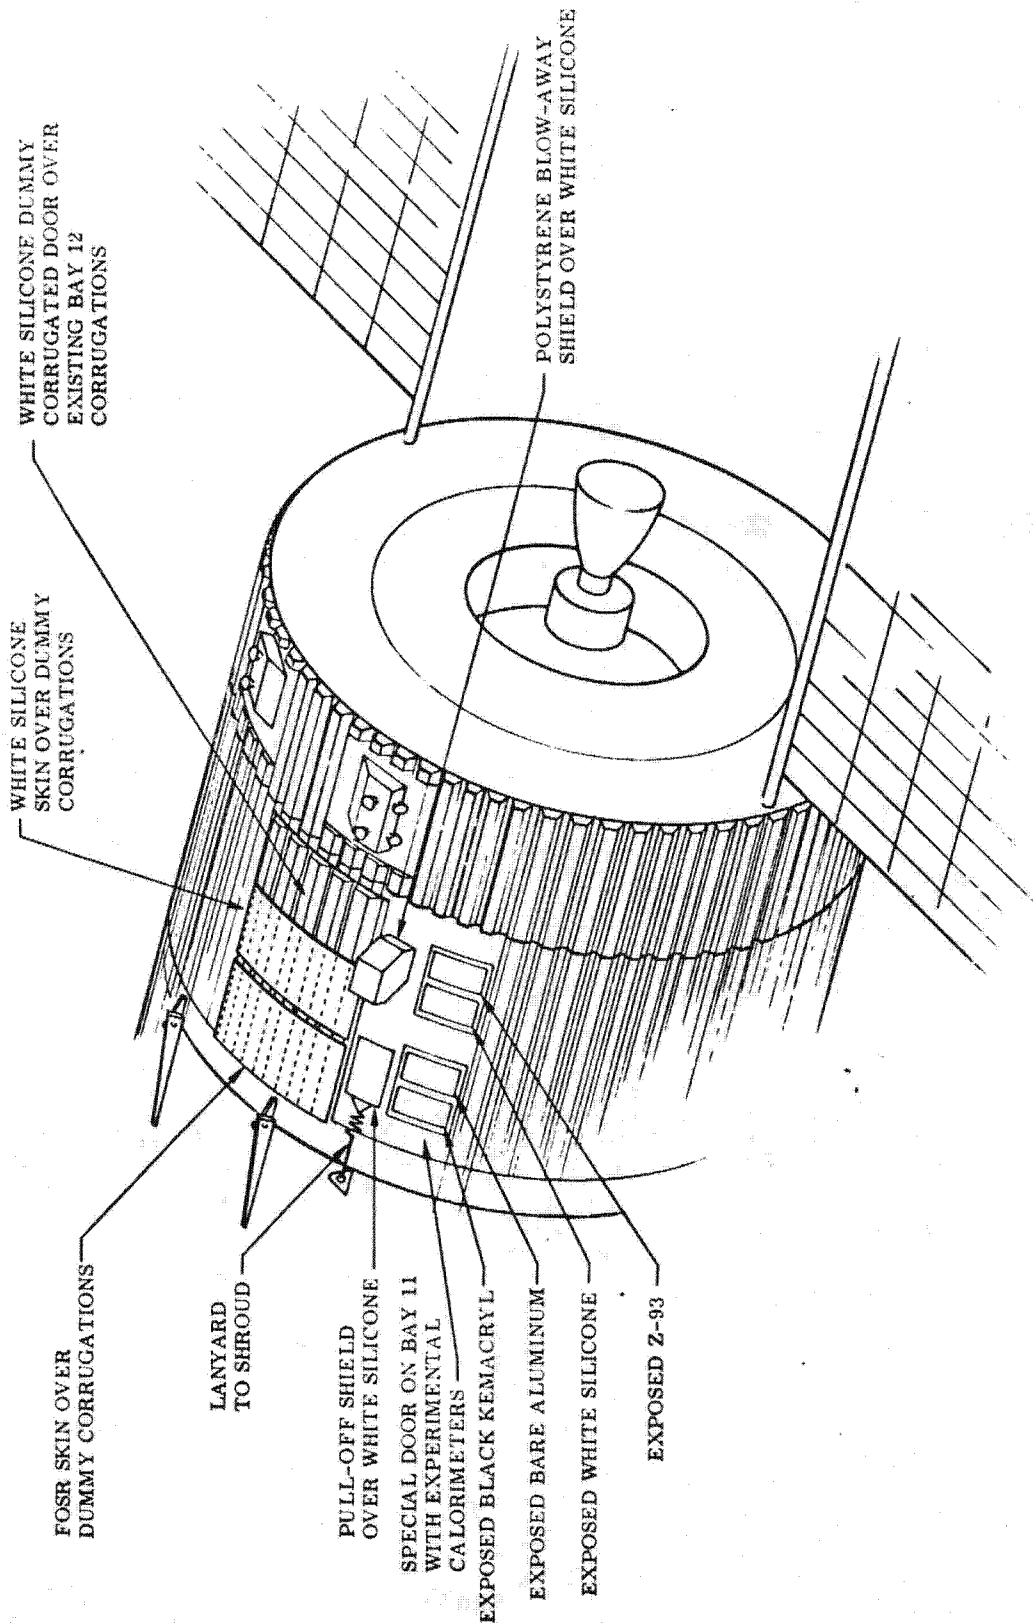
Fig. 12-1 SV-2 Contamination Experiments

Contamination of Aft Section surfaces during ascent is the apparent cause of the anomalous Aft Section temperature levels. Ascent events that could contribute to contamination include the liftoff ground cloud, SRM staging, Stage I/II separation, RV separation, Stage II retro, and Shroud separation. Although it is impossible to distinguish between these possible sources, review of available ascent temperature data, review of movies of SV-1 and other vehicles during lift-off and ascent, discussions with other program offices, and review of prior analyses of these contamination sources has resulted in the conclusion that most of the contamination occurred during liftoff and/or SRM staging. Accordingly, a plan of action as described below was formulated for SV-2, leading to a positive fix on SV-3.

The existing Bay 11 Door will be replaced with a modified Bay 6 door. The Bay 6 door will not have a Horizon Sensor Fairing and the four Horizon Sensor Head holes will be used for calorimeters having white silicone, black Kemacryl, bare aluminum and Z-93 surfaces. One of the four calorimeter panels will be protected through the lift-off cloud event, a second panel will be protected through the SRM staging event, and the remaining two panels will be exposed throughout ascent. The layout of this experimental Bay 11 door is shown in Fig. 12-1. Orbital temperature data from these calorimeter panels are expected to satisfy objectives 1, 2, 3 and 6 as stated above.
