BIF003W/2-090260-73 HEXAGON Copy No. Sheet Count: 64 9 November 1973

FLIGHT TEST ENGINEERING ANALYSIS REPORT

THE HEXAGON PROGRAM SATELLITE VEHICLE NUMBER SIX (S)

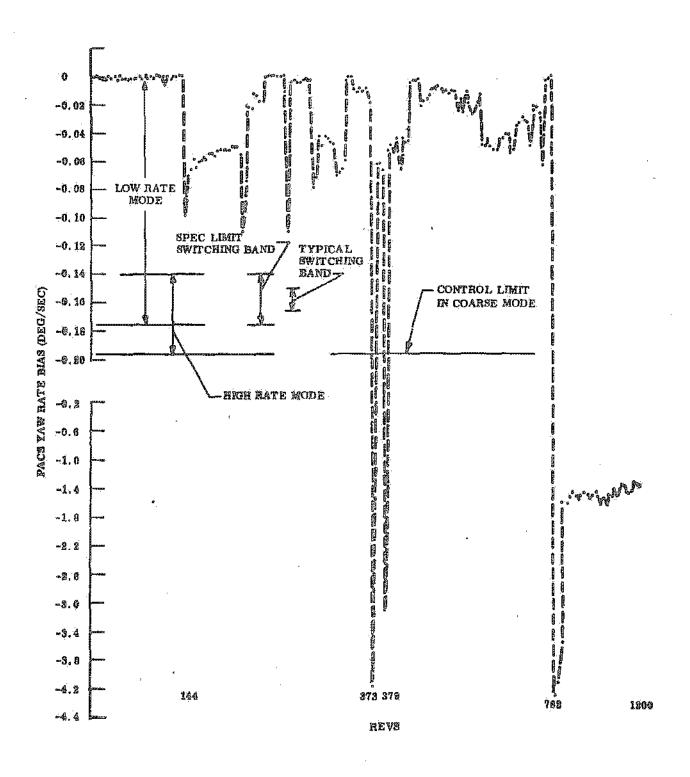
Fig. 2-1 PACS Yaw Rate Bias History

Figure 2-1 is a graph of the PACS yaw rate bias observed from launch through Rev 1202. The bias was first observed on Rev 45 and on Rev 66 control was transferred to RACS cross-strapped to the primary reaction control system. After transfer the bias was monitored and remained in the range of 0 to -0.012 deg/sec until Rev 373 when the bias increased and the IRA began switching between high rate mode and low rate mode. Similar switching was again observed on Rev 379 after which the bias decreased to 0 to -0.005 deg/sec. On Rev 782 the gyro rate output switched to the high rate mode and remained at rates of -1.3 to -1.6 deg/sec which is beyond the limit of control for the rest of the mission.

The yaw rate bias appears to be due to a high impedance short from the gyro torquer circuits to ground. This type of anomaly was previously seen in both IRAs on SV-5.

The cause and mechanism of the torquer shorts are still being studied with the aim of eliminating them; in the meantime, all IRAs to be flown subsequent to SV-6 will incorporate the torquer isolation.

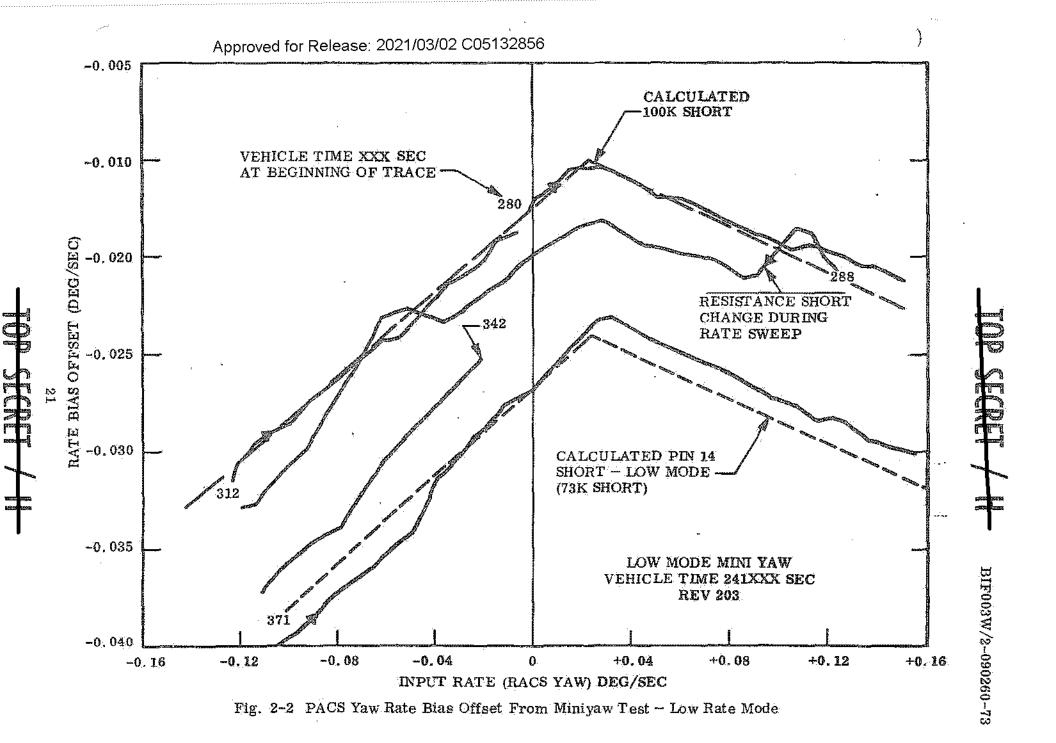
A miniyaw maneuver was performed on Rev 203 with the results shown in Figs. 2-2 and 2-3. The positive and negative rates achieved are sufficiently large that a variation in the yaw bias as a function of the yaw rate may be determined and, based on analysis previously performed, the expected rate bias variation with yaw input rate

for location and resistance of the short can be calculated. Figure 2-2 shows that the data when the rates are in the gyro low rate mode range correspond to a calculated short of 70 to 100k ohms between gyro pin 14 and the case. The exact location of the short in the circuit is not known.

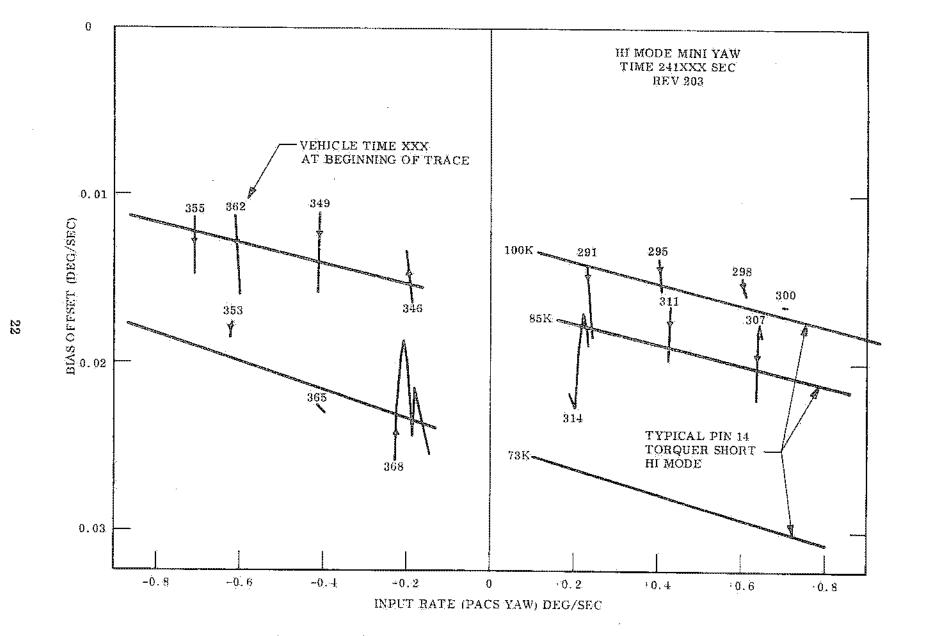
Fig. 2-3 PACS Yaw Rate Bias Offset From Miniyaw Test - High Rate Mode

Figure 2-3 presents the data when the vehicle rates were high enough to switch the gyro to the high rate mode. The data while not as definitive as the low rate mode data roughly indicates a torquer short of the same magnitude as the low rate mode data.

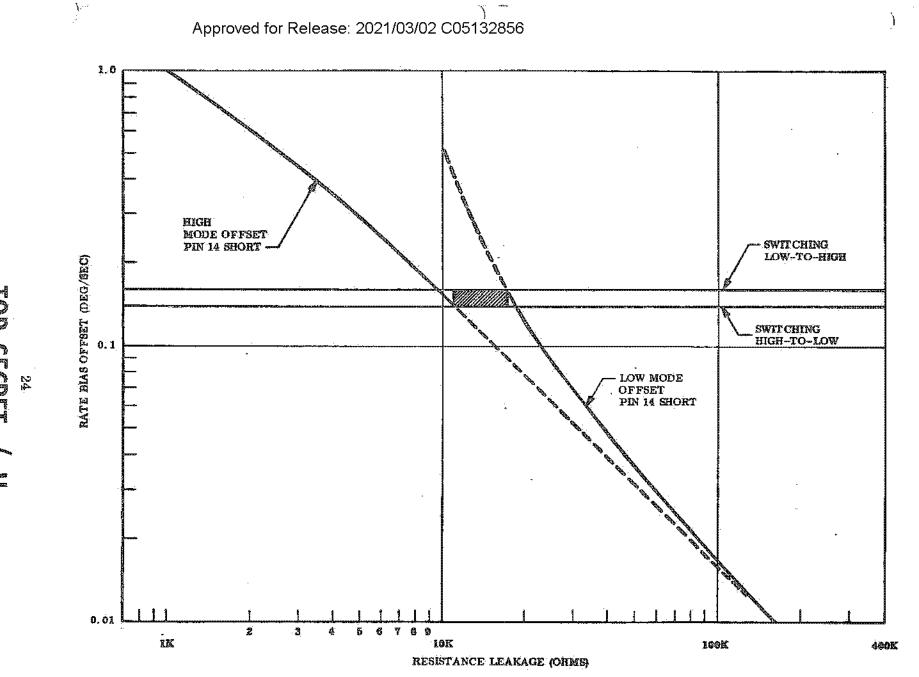
Fig. 2-4 Pin 14 Torquer Short Bias Offset

The mode switching on Revs 373 and 379 are indicative of a gyro torquer short with the resistance of the short decreased to 10 to 20k obms. With such a short, the rate bias falls in the high rate-low rate mode switching region of the IRA and instability results. Figure 2-4 is a graph of rate bias versus resistance of a short showing the switching region.

The large increase in rate bias observed from Rev 782 on, is an indication that the resistance of the short further decreased to a value of approximately 600 ohms.

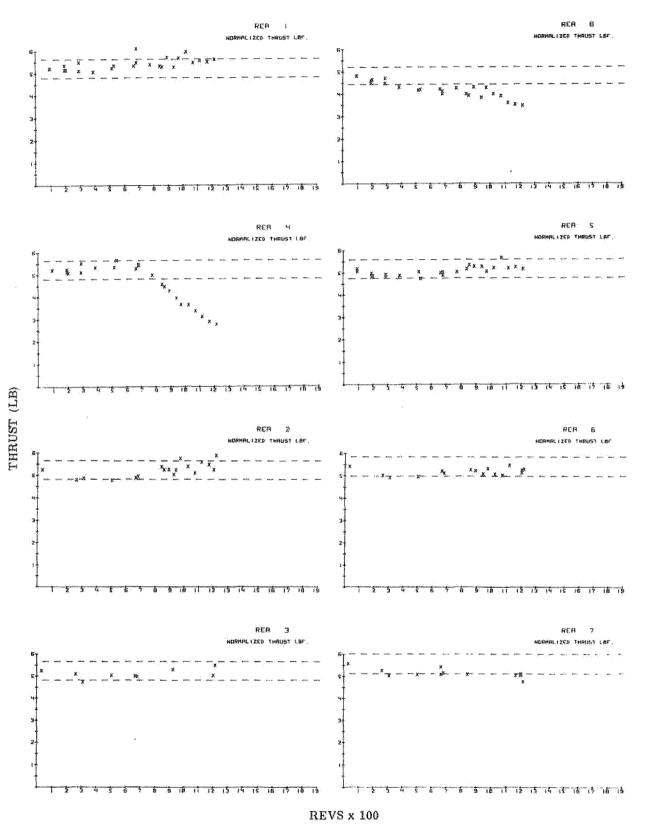
Fig. 2-6 Normalized Thrust History

Thrust levels were determined using the individual REA chamber pressures. Figure 2-6 is a plot of the normalized thrust over the mission life. The dashed limits are the ± 8 percent run to run tolerance allowed per specification. As can be seen REA 8 dropped out of limits at Rev 350, REA 4 around Rev 800 and REA 7 at approximately Rev 1200. REA 8 degraded to an actual thrust level of 1.93 lbf, REA 4 to 1.44 lbf and REA 7 to 2.42 lbf by the end of the active mission, Rev 1202. Due to the position on the vehicle occupied by REAs 4 and 8, this degradation could be tolerated and permitted tracking these thrusters throughout the active mission. Figure 2-7 shows the change in chamber pressure tail-off with life. Some lengthening is expected with life; however, times in excess of 100 ms are indicative of the starting of thrust degradation.

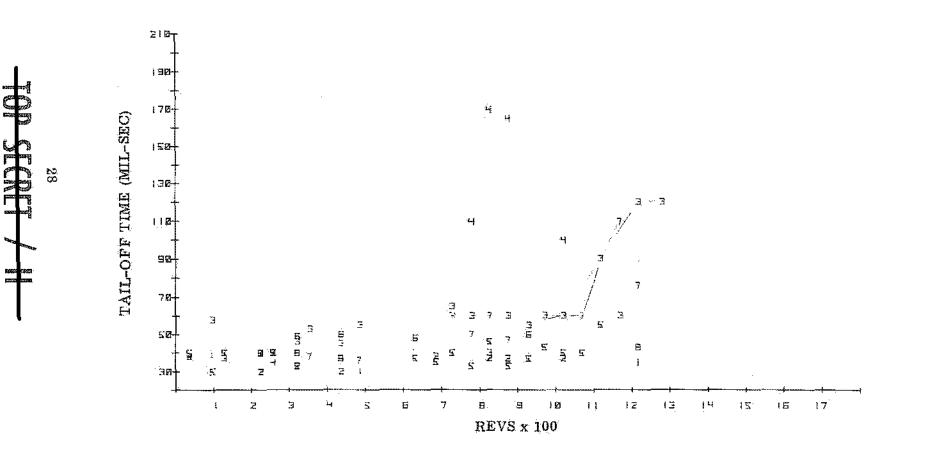
Fig. 2-7 Tail-Off Times for RCS 1 (U)

NOTE: TAIL-OFF TIME IS THE TIME INFERVAL FROM THE VALVE OFF COMMAND TO THE POINT WHERE THE REA CHAMBER PRESSURE FALLS TO 10 PERCENT OF THE MAXIMUM ON THAT PULSE
