Recommendations on Equipment Specification by CTO  
Paul L. LINKER, USN

Subj: Recommendations on Specifications for the New Buffered-Tape Data Storage System

PROJECT: EARPOP Magnetic Core Memory

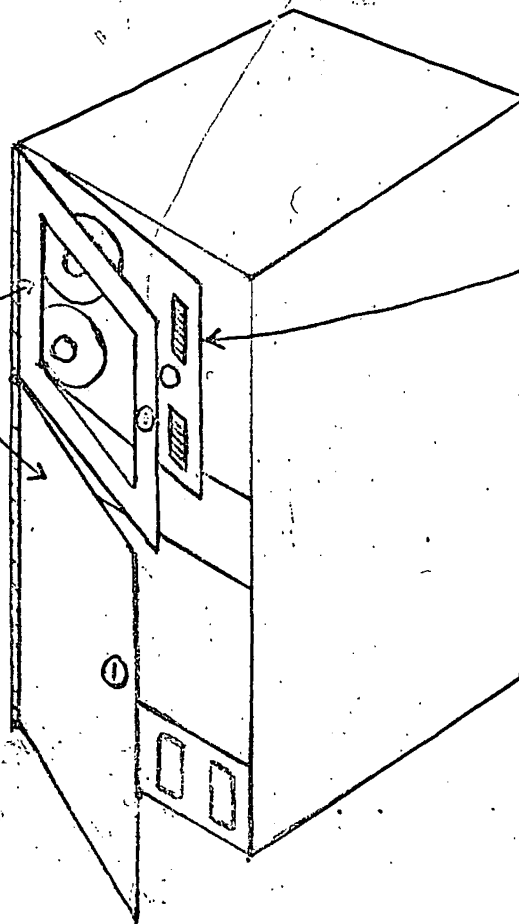
ENCLOSURE (1)

a. To replace an SCR or other component in the Reel Servo Electronics, it is necessary to remove the whole top of the RFI Cabinet.

b. To scope points of the Capstan Servo Amplifier, it is necessary to remove all cabling from the Capstan Servo Amp./Power Supply Unit, remove the unit from the cabinet to take off it's rear shield, reinstall the unit and cabling, and, finally, crawl through the front of the cabinet to insert the scope probe.

~~SECRET~~Split  
Double Hinged  
RFI Door

Hinged  
Recorder~~SECRET~~HANDLE VIA  
BYEMAN  
CONTROL SYSTEM ONLY

In view of the inaccessability of the Reel Servo Electronics, I recommend that the TM-9 transport be placed on a hinge as shown in encl. (1). This not only provides accessability to the reel servo electronics, but it will make tape guide replacement and capstan motor removal a one man job instead of a two man job. Also greater accessability would be provided to the transport control circuits; reel motors, and vacuum pump. In view of the time and work involved in placing a scope probe on inaccessible circuits, I recommend that all cable lengths be increased on the unhinged units within the cabinet. The increase in length should be sufficient to allow the units to be removed from their rack and worked on without disconnecting their cables. This recommendation applies specifically to the following units:

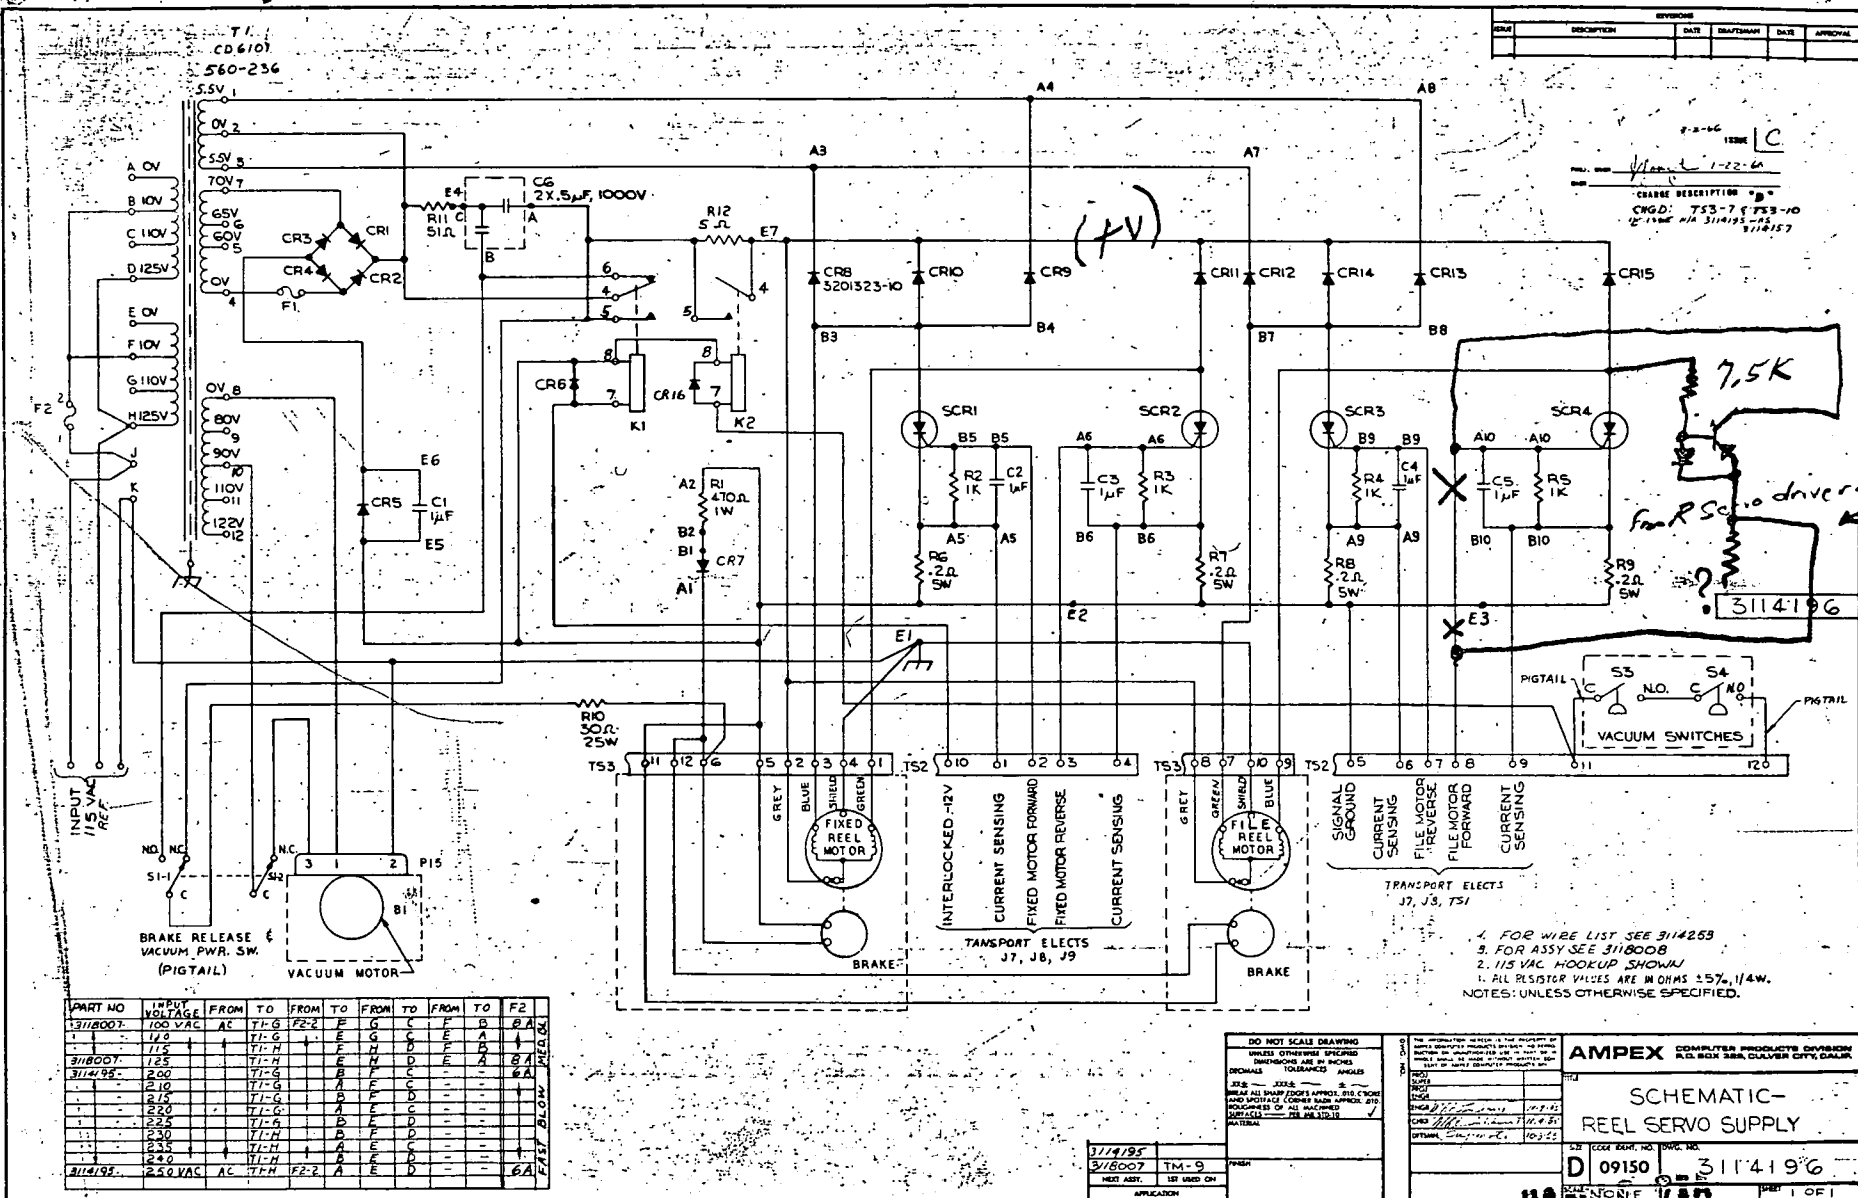
Bye-57856-68 ENCLOSURE (2)

a. In the Reel Servo Electronics, there are additional transistor circuits to control the voltage that their respective SCR's fire. With this additional circuitry, the SCR can fire only at the null of the power supply voltage. Compare drawing No. 3114196 in ref (b) with enclosure (2). On the enclosure's right side, I have drawn as much of the transistor circuitry that I could trace out for one SCR. There are four of these circuits in our machine.

c. I need new schematics for Assemblies indicated above and additional adjustment procedures involving the pot mentioned above.

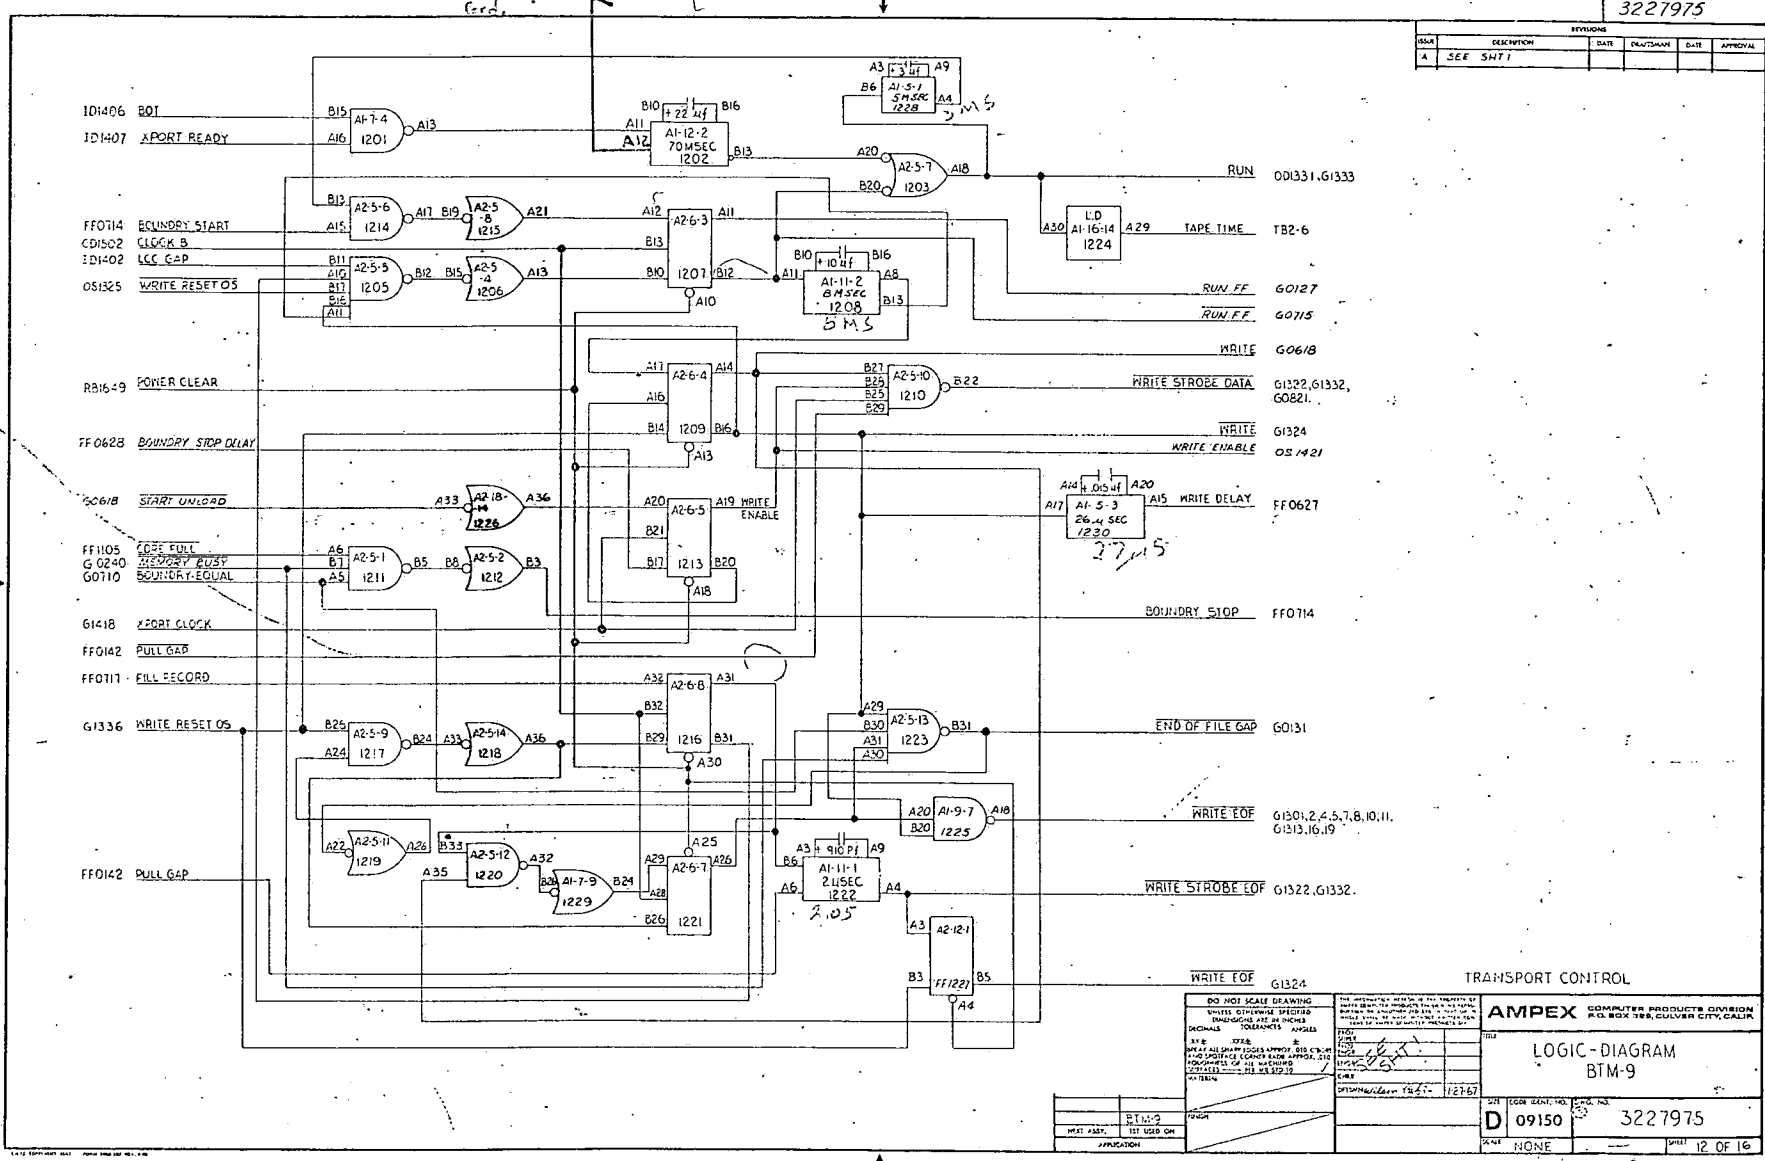
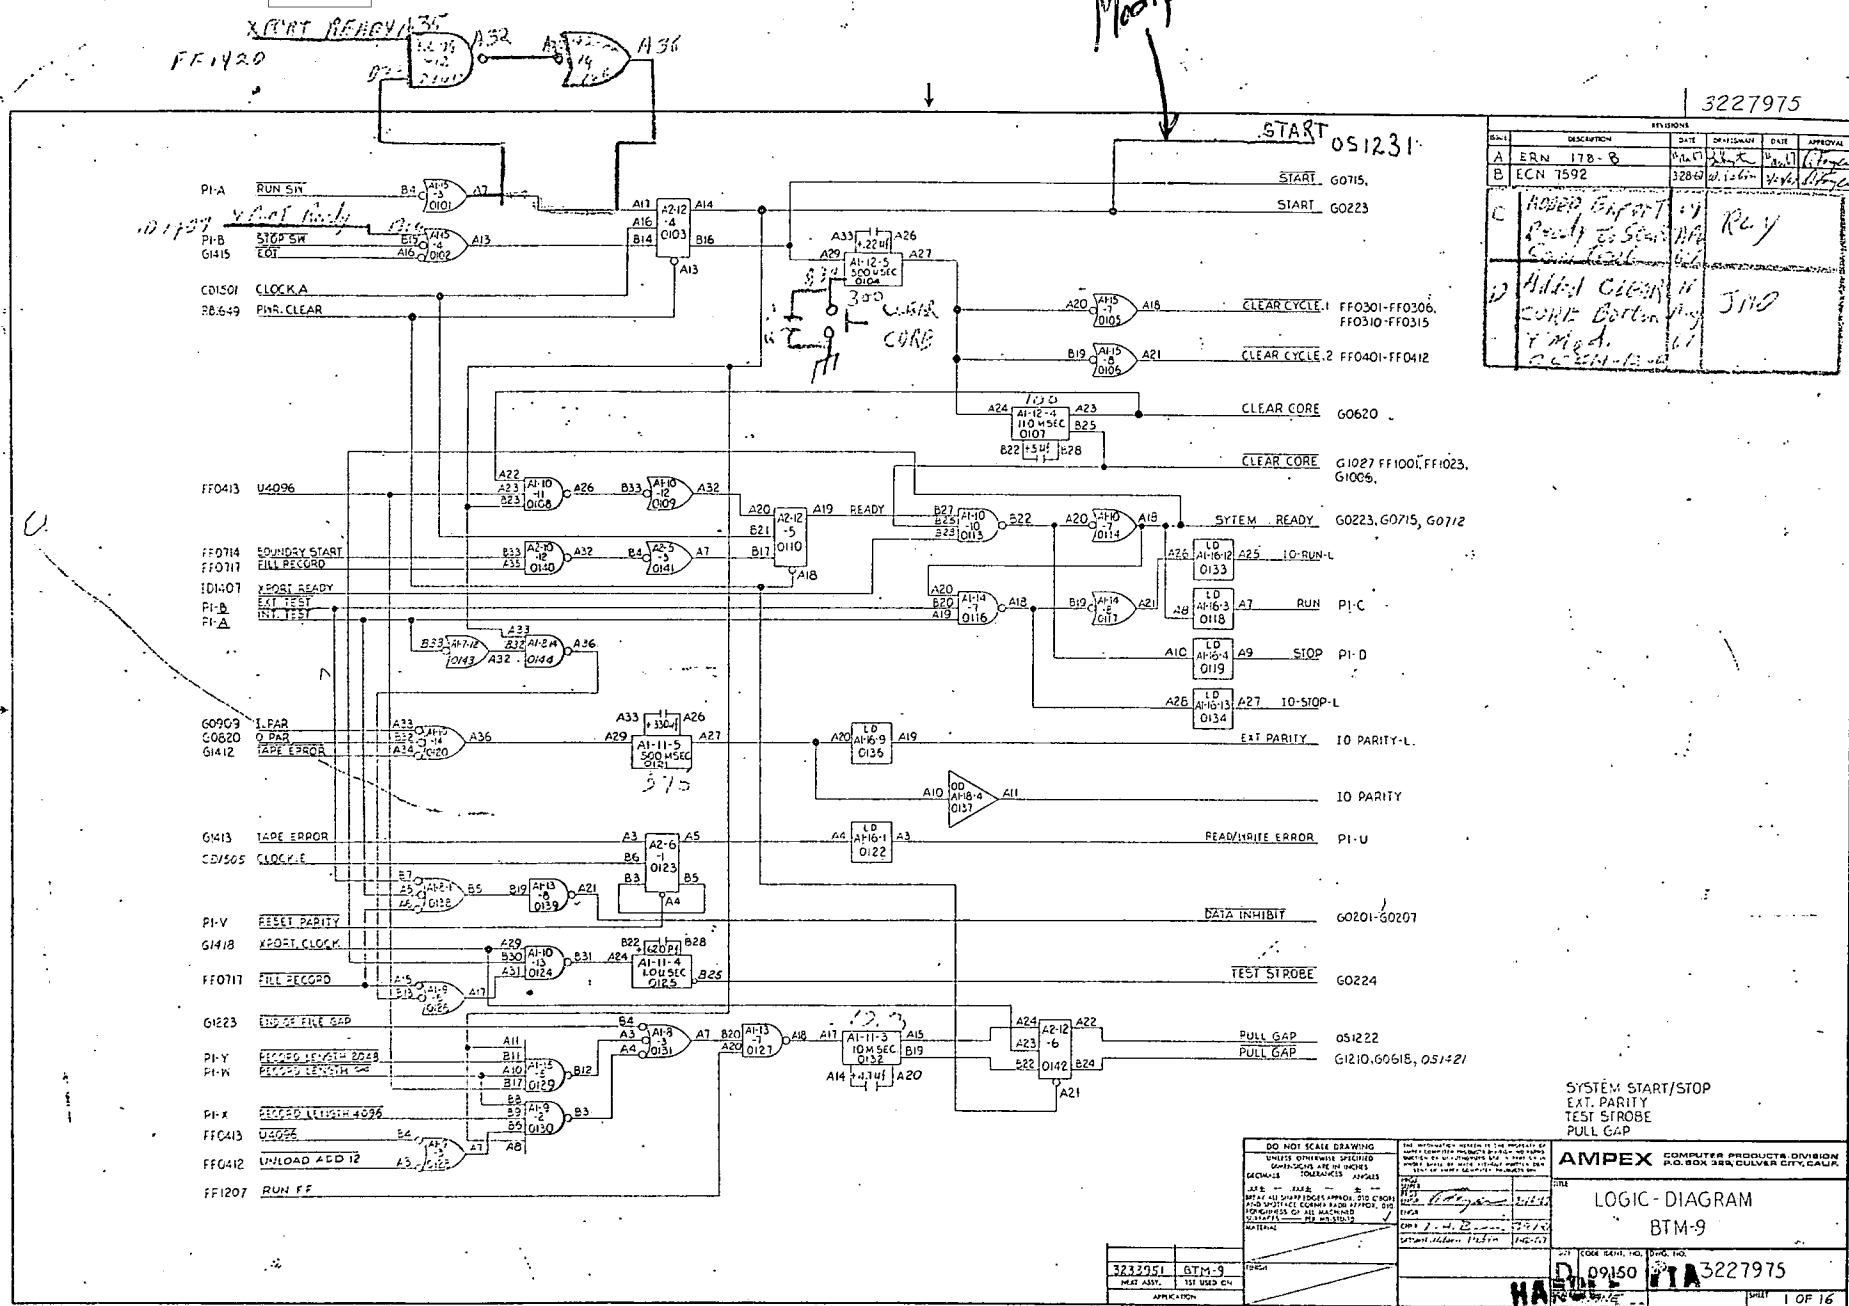
HANDLE VIA  
BYEMAN  
ENCLOSURE (3)

a. A gap of erased tape 3 to 5 inches long must be obtained between the header/trailer and the EOF, or generate this gap after the EOF. This is because the normal IRG on the BTM-9 tape is  $3/4$  inch; and if a header/trailer was replaced, the EOF would be erased because the erase head on the TM-11 is  $3/4$  inch ahead of the write. Since the SEL TCU is hard-wired to put this gap before an EOF, the best place for the gap on the BTM-9 tape would be between the header/trailer and the EOF. The main advantage to this placement would be that the same basic program could be used to edit a BTM-9 tape or an SEL tape. However, without spare gates to put the gap before the EOF, I was able to obtain an erased gap after the EOF. This gap is generated by firing the 70ms.SS (A1-12-2) 300 ms. after clearing the start FF. The circuit modifications that I have made to acquire this gap are shown in enclosure (3) (a spare SS A1-5-5 is now used). A 300 ms. delay in firing the 70 ms. SS will permit the following to occur before erasing 4 inches of tape:

Modification

8. Since it is impossible to edit a BTM-9 tape without the gap described in paragraph 4.a. above, I recommend that the modification shown in enclosure (3) be approved for inclusion in the existing BTM-9's. This would serve as an interim solution to editing BTM-9 tapes until Ampex could furnish a modification to place the gap ahead of the EOF.
