# Performance Evaluation Team Report

**MISSION 1205**

# PERFORMANCE EVALUATION TEAM REPORT NO. 1205/73

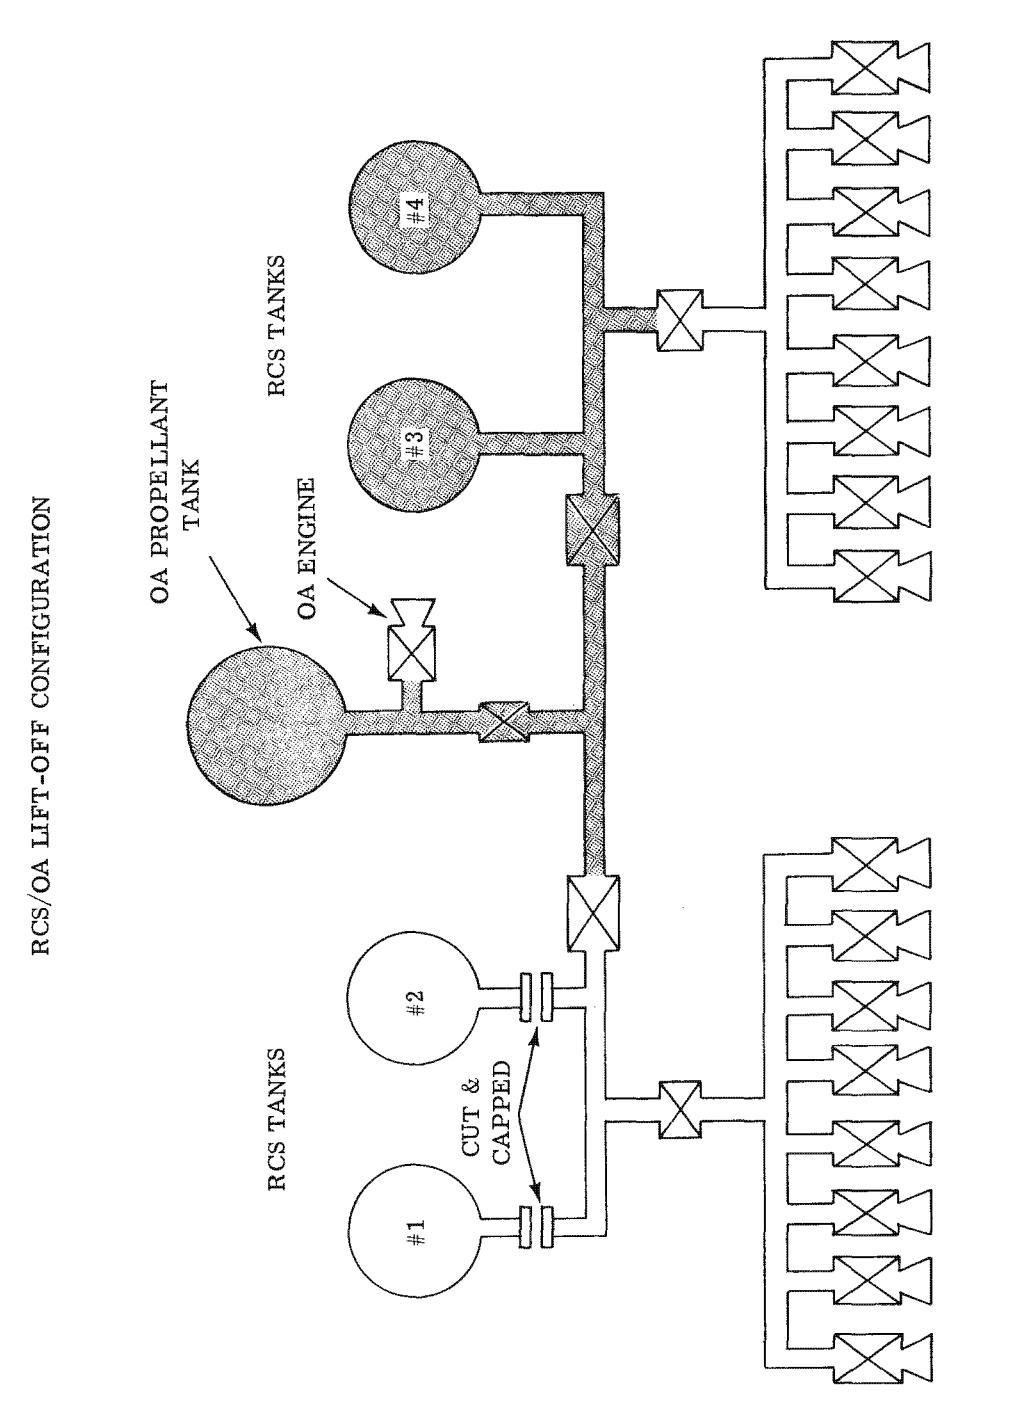
RCS Tanks 1 and 2 were capped and the Primary ACS was hardwired to control the Redundant RCS thrusters which utilized RCS Tanks 3 and 4. This configuration was designed to use the Redundant Thrusters (non-instrumented) until leakage was experienced and then complete the mission on the Redundant ACS and Primary Thrusters (instrumented) with the RCS being supplied directly from the Orbit Adjust 3 (OA) Tank, see Figure 2-1.
