CORONA J FLIGHT REPORT

PTV 1162 - SYSTEM J1 - 1001

SUMMARY

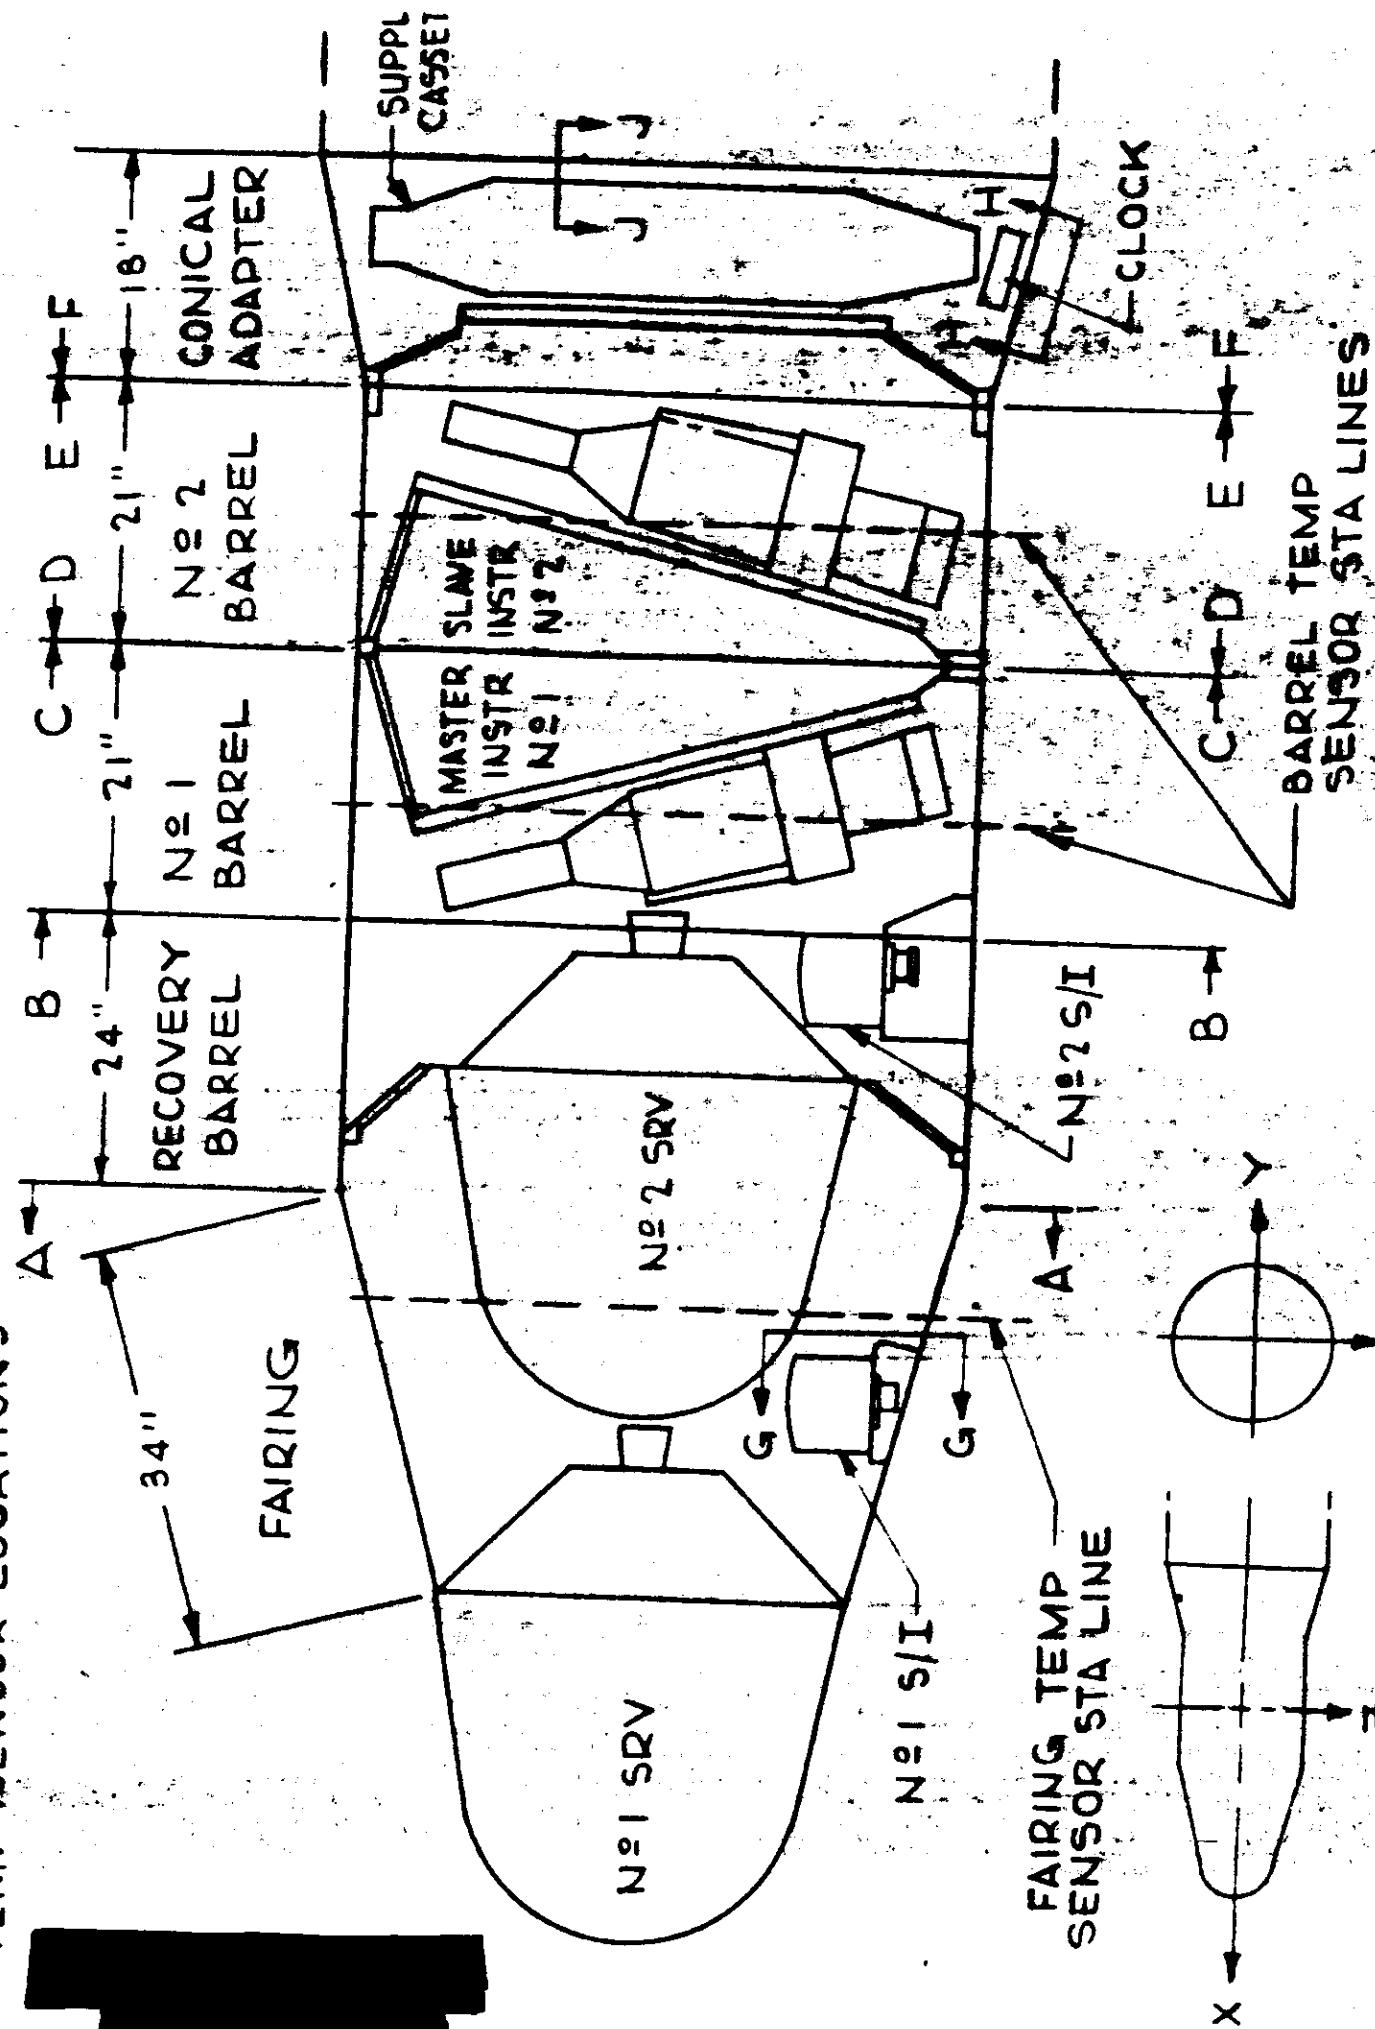
J INBOARD PROFILE TO SHOW APPROX TEMP SENSOR LOCATIONS

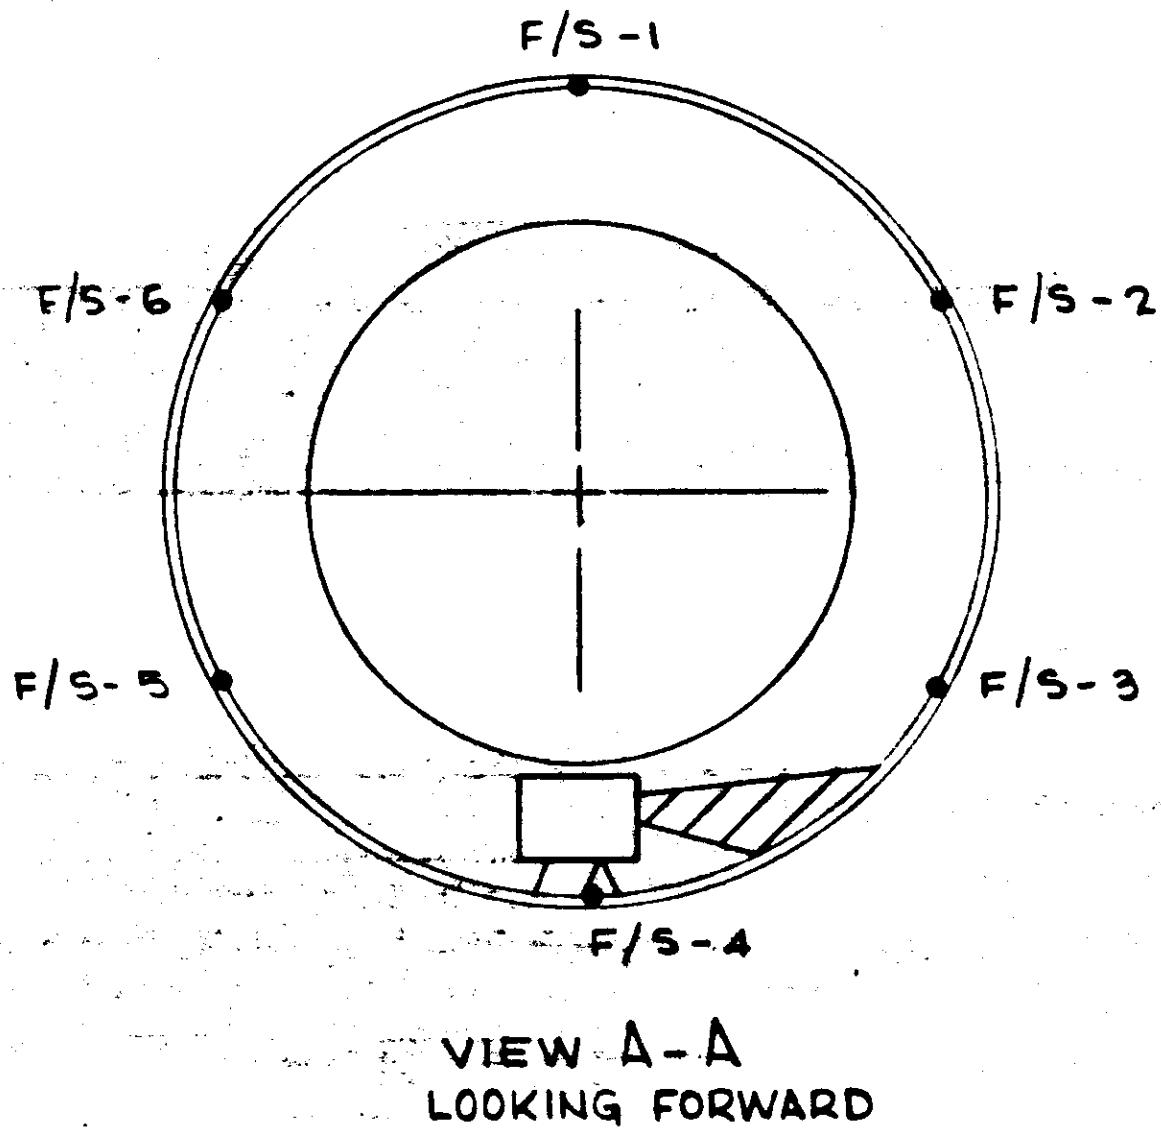
FAIRING TEMP SENSORS

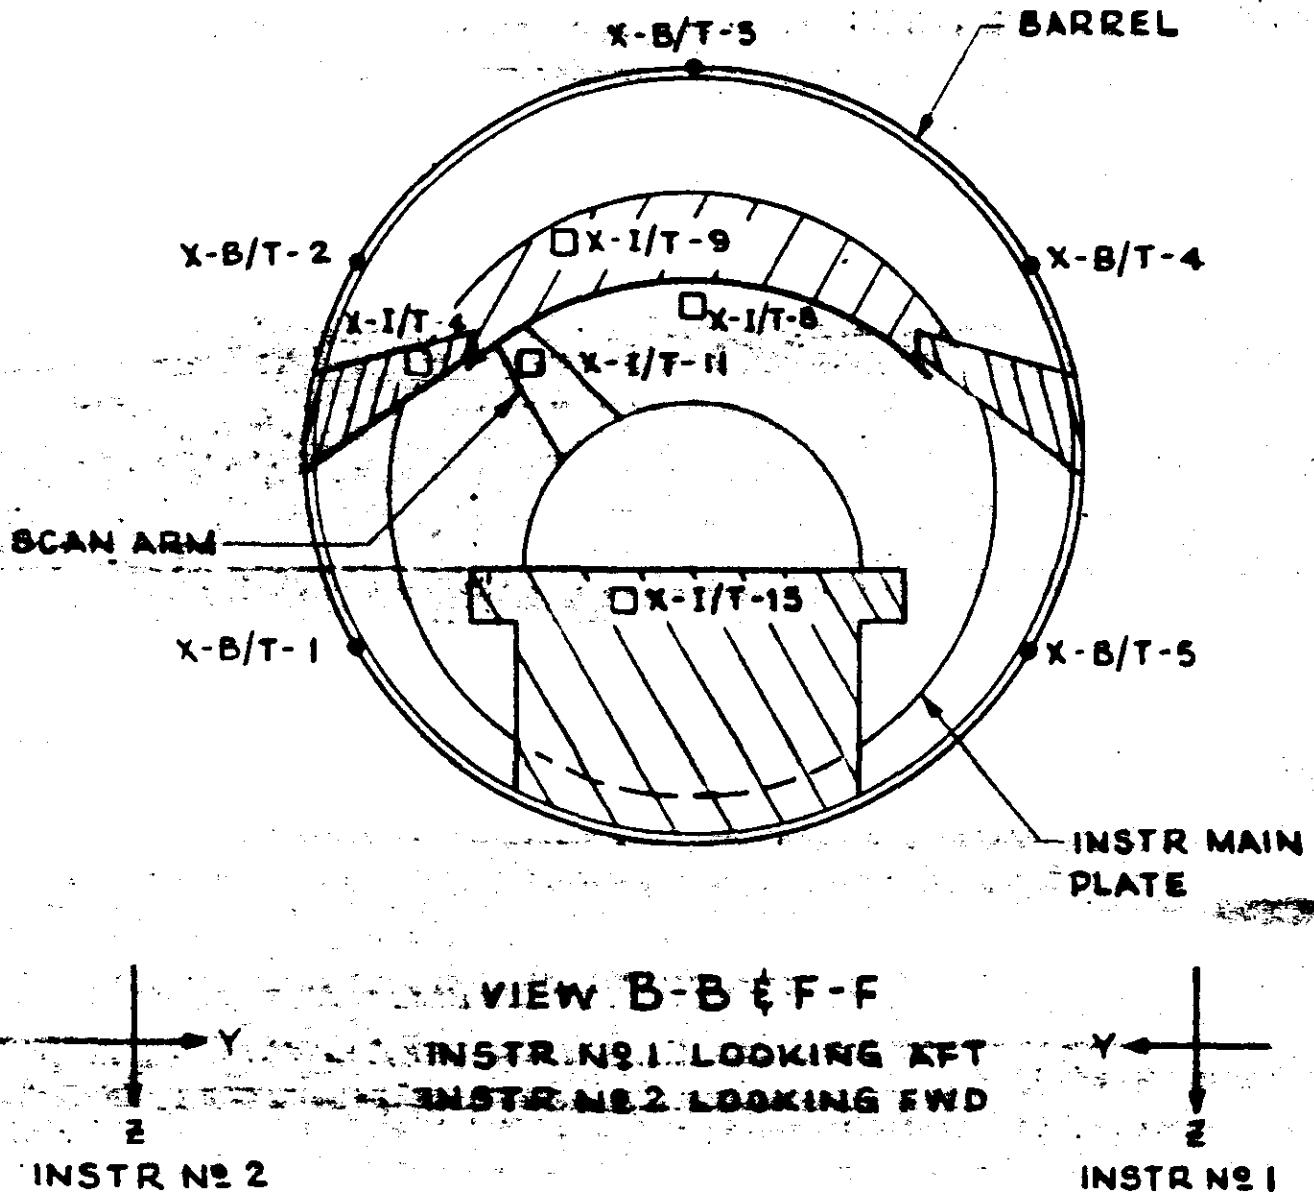
~~SECRET~~
ENCLOSURE 22

~~SECRET~~
NO 1 & NO 2 INSTR TEMP SENSORS (FRONT FACE)
NO 1 & NO 2 BARREL TEMP SENSORS (SKIN)

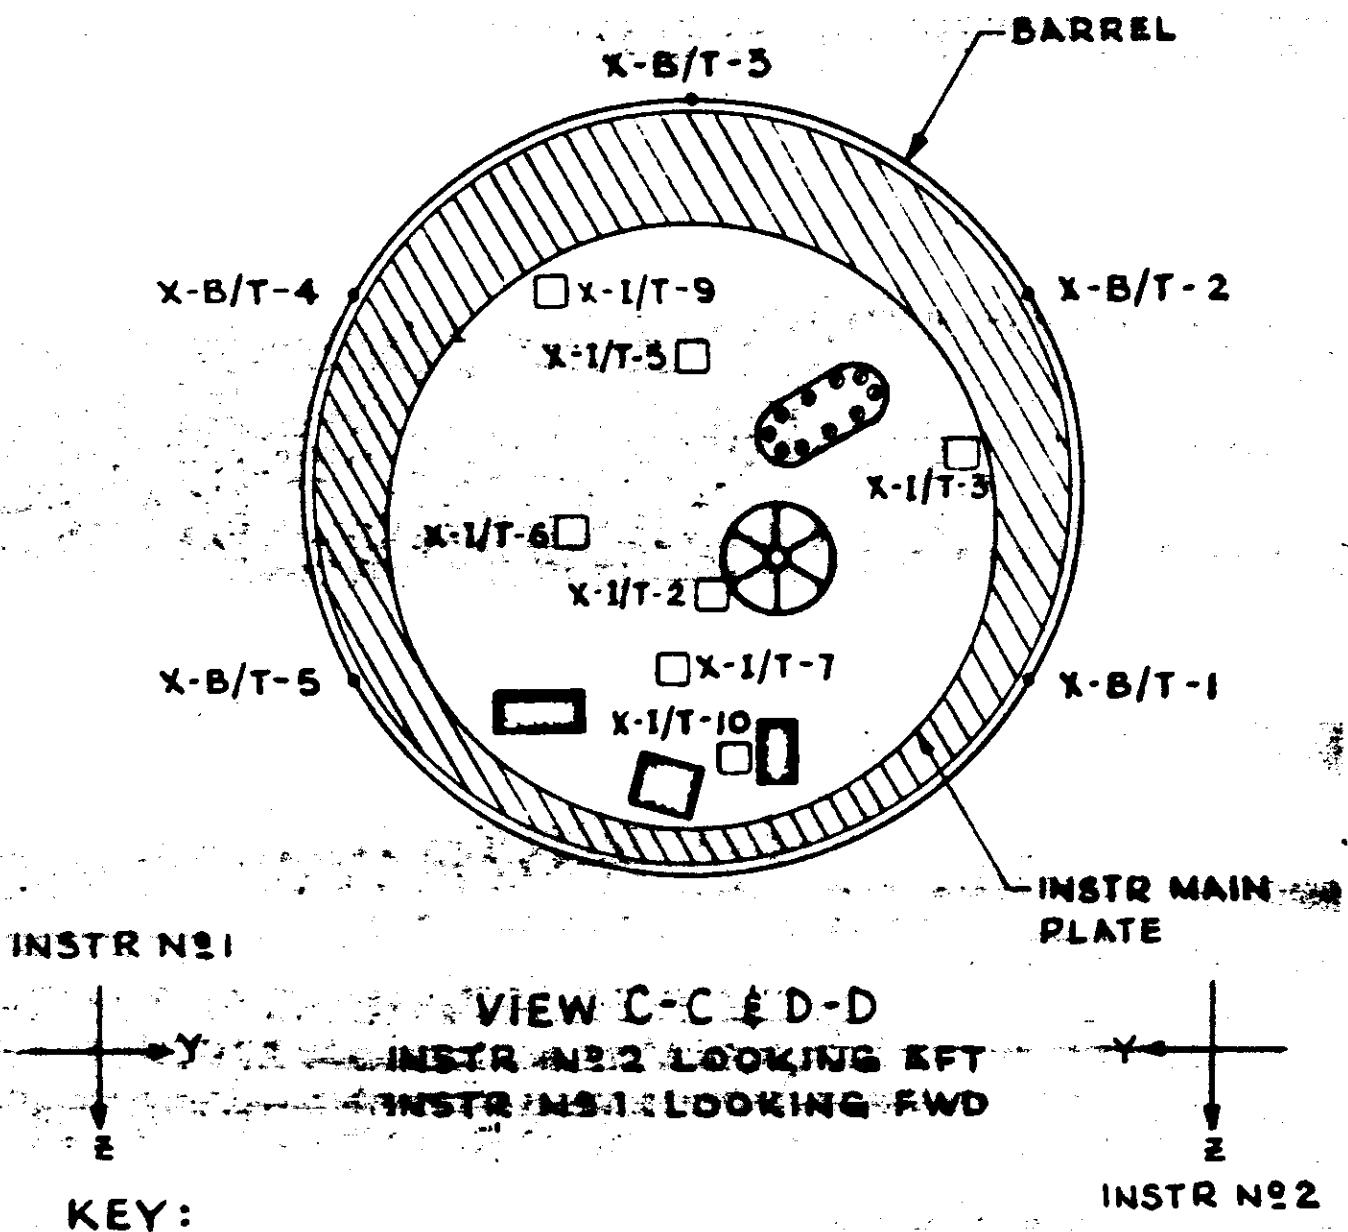
SHT 4 OF 9

N° 1 & N° 2 INSTR TEMP SENSORS (BACKFACE)
N° 1 & N° 2 BARREL TEMP SENSORS (SKIN)

- X DENOTES N°1 OR N°2 INSTR OR BARREL
e.g. X-I/T-8 IS N°1 INSTR TEMP
X-I/T-6 IS N°1 INSTR TEMP
X-I/T-3 IS N°2 BARREL TEMP
X-B/T-4 IS N°2 BARREL TEMP
- SENSORS
- N° 6
- N° 4

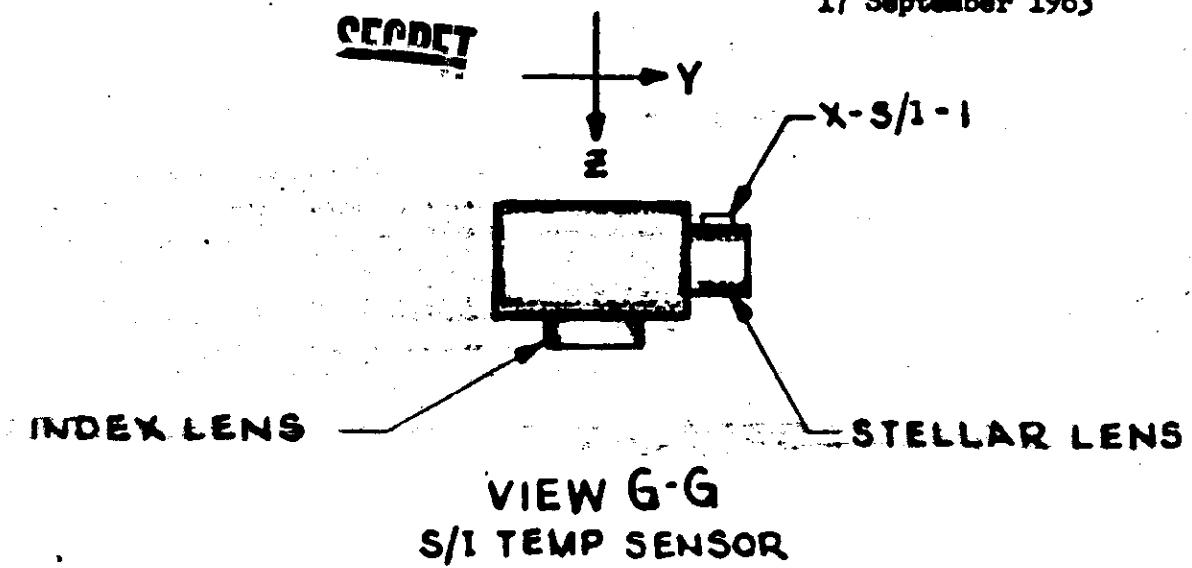
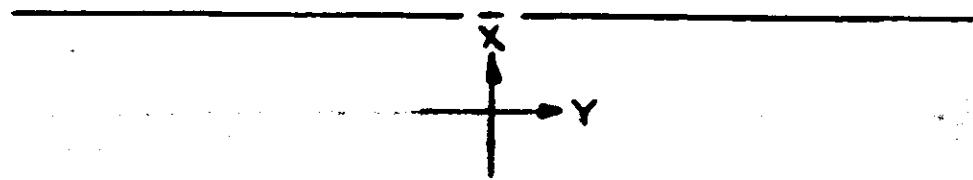
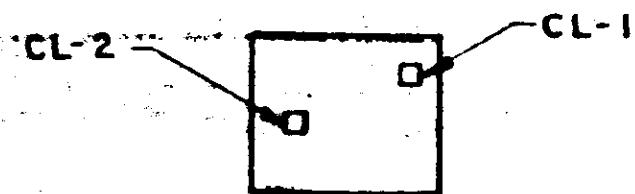
ENCLOSURE 25

VIEW H-H
CLOCK TEMP SENSOR

VIEW J-J
INTERFACE TEMP SENSOR
(SENSOR ON -Y AXIS)

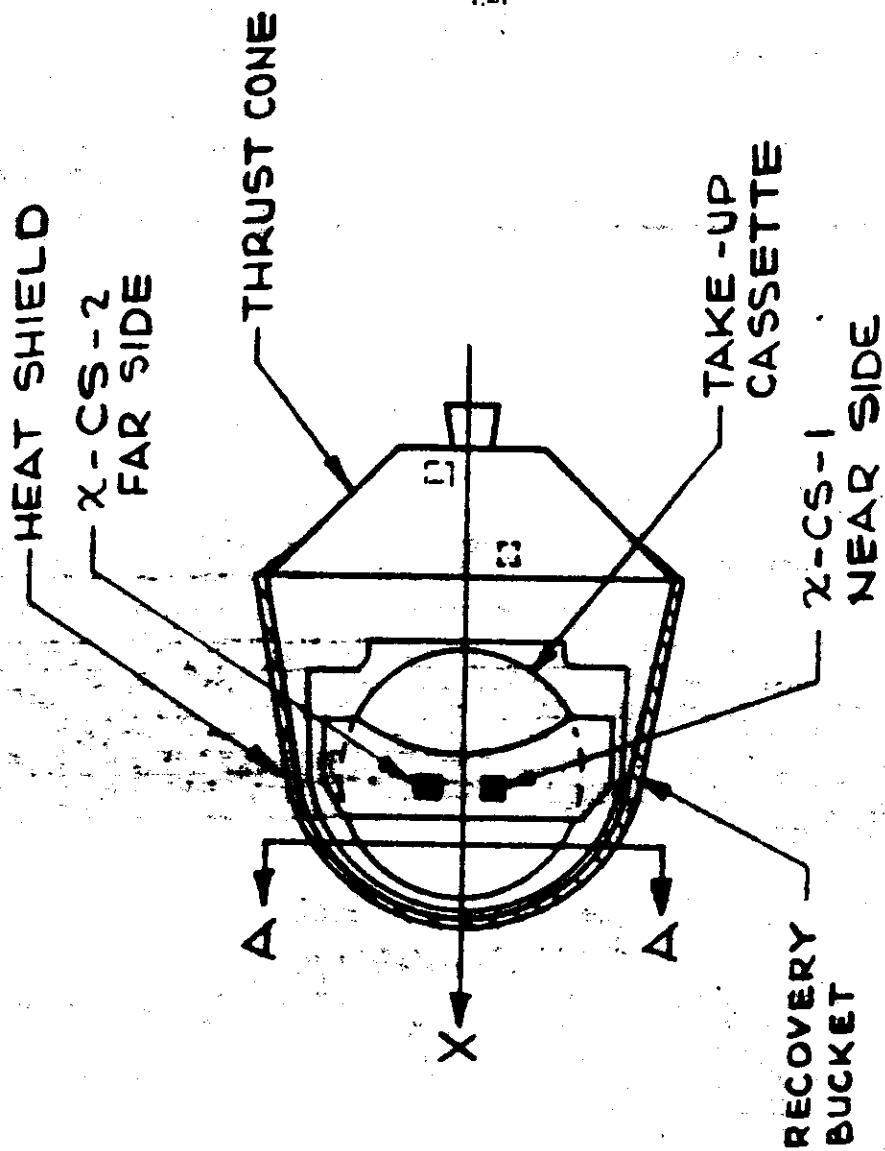
ENCLOSURE 26

TEMP SENSORS

N2 SRV - THRUST CONE TEMP SENSOR

SECTION A-A

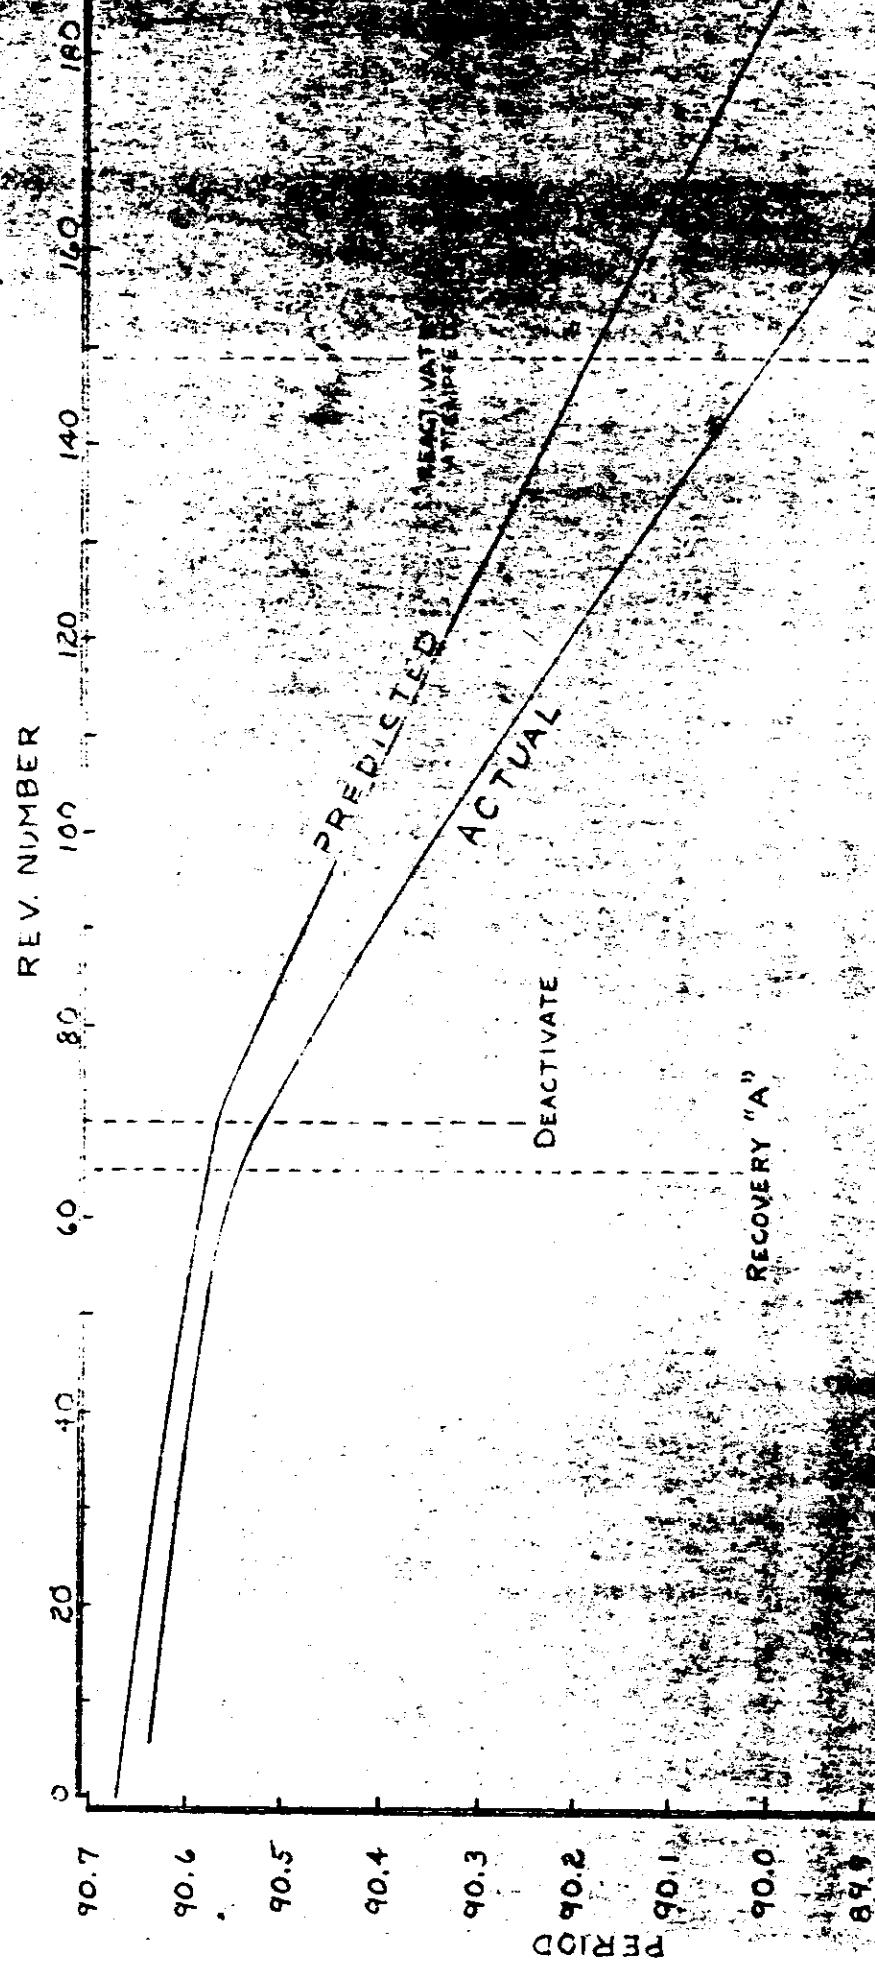
PERIOD DECAY

ACTUAL vs. PREDICTED

The reduction in altitude as a result of period decay was also close to nominal, although as Enclosure b3 shows, the apparent rate of decay in period during the tumble mode was slightly greater than predicted so that the period at time of reactivation on rev. 119 was about 12 seconds less than the nominal value. There were no serious effects on orbit lifetime resulting from this greater decay since predictions at the end of the sixth day of tumbling showed an additional ten days of tumbling life remaining (equivalent to about thirty days of stable life).
