PHOTOGRAPHIC EVALUATION REPORT

MISSION 1006

5-12 JUNE 1964

NATIONAL PHOTOGRAPHIC INTERPRETATION CENTER

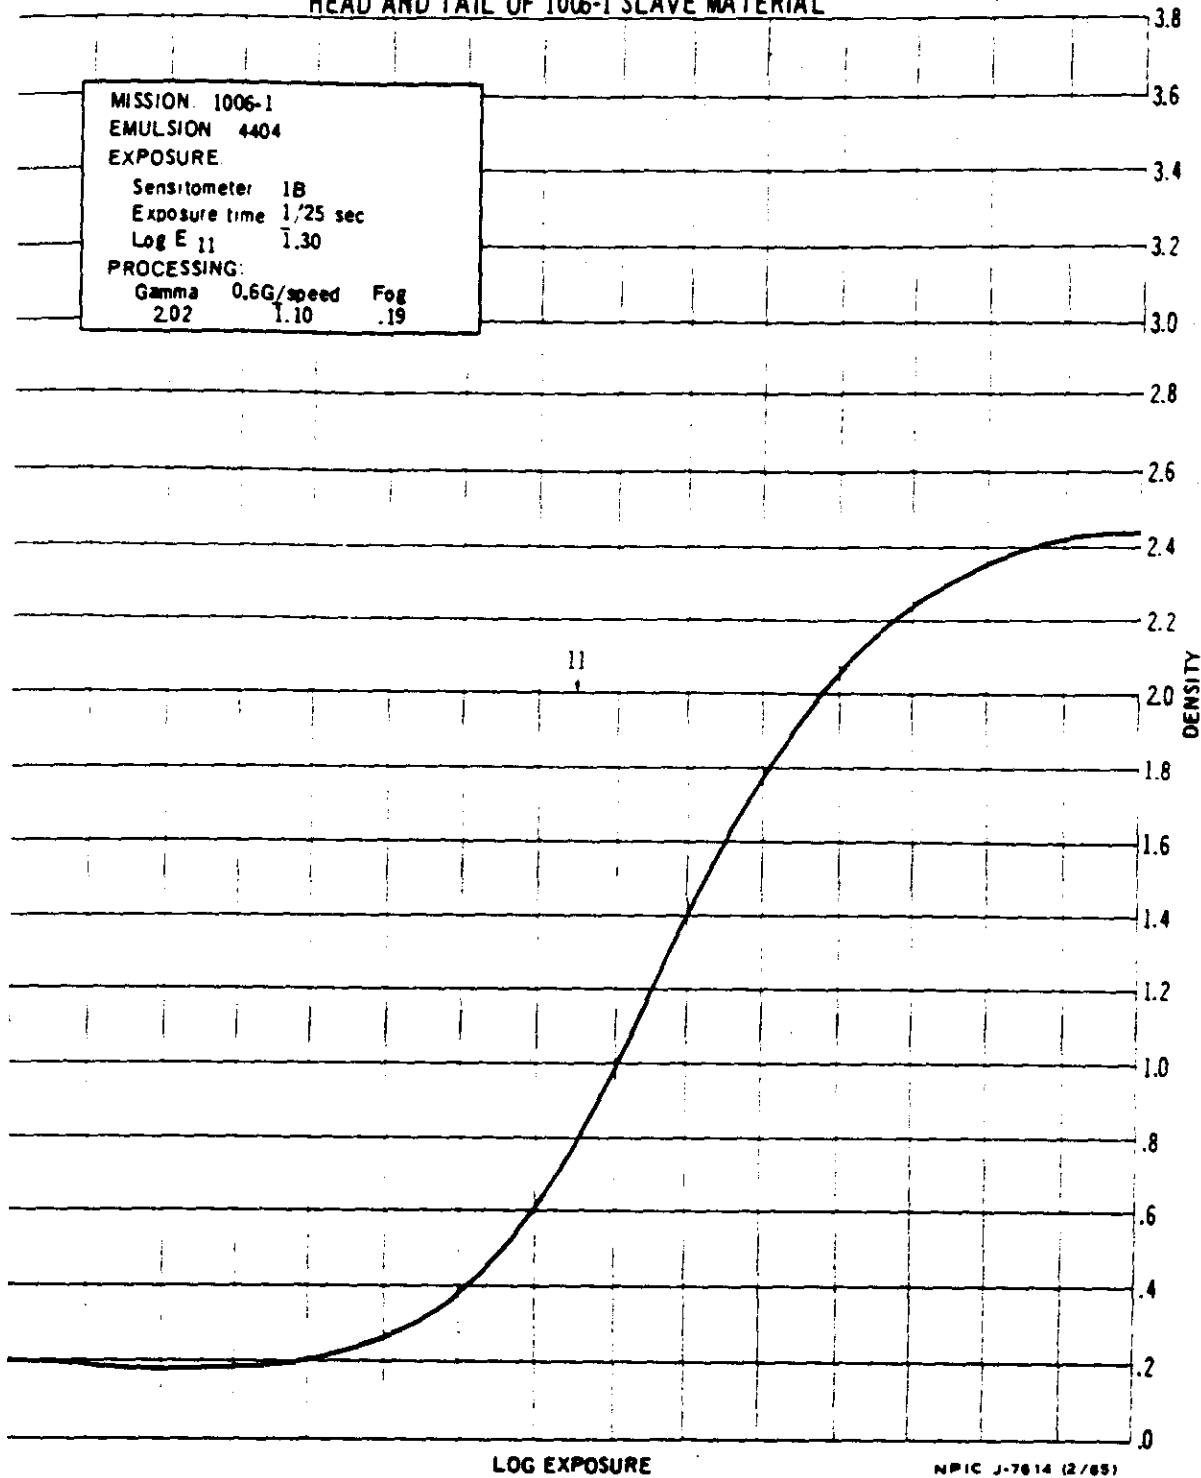
SENSITOMETRIC CURVE FROM HEAD AND TAIL OF 1006-1 SLAVE MATERIAL

MISSION: 1006-1		
EMULSION: 4404		
EXPOSURE:		
Sensitometer:	1B	
Exposure time:	1/25 sec	
Log E 11:	1.30	
PROCESSING:		
Gamma:	0.6G/speed	Fog
2.02	1.10	.19

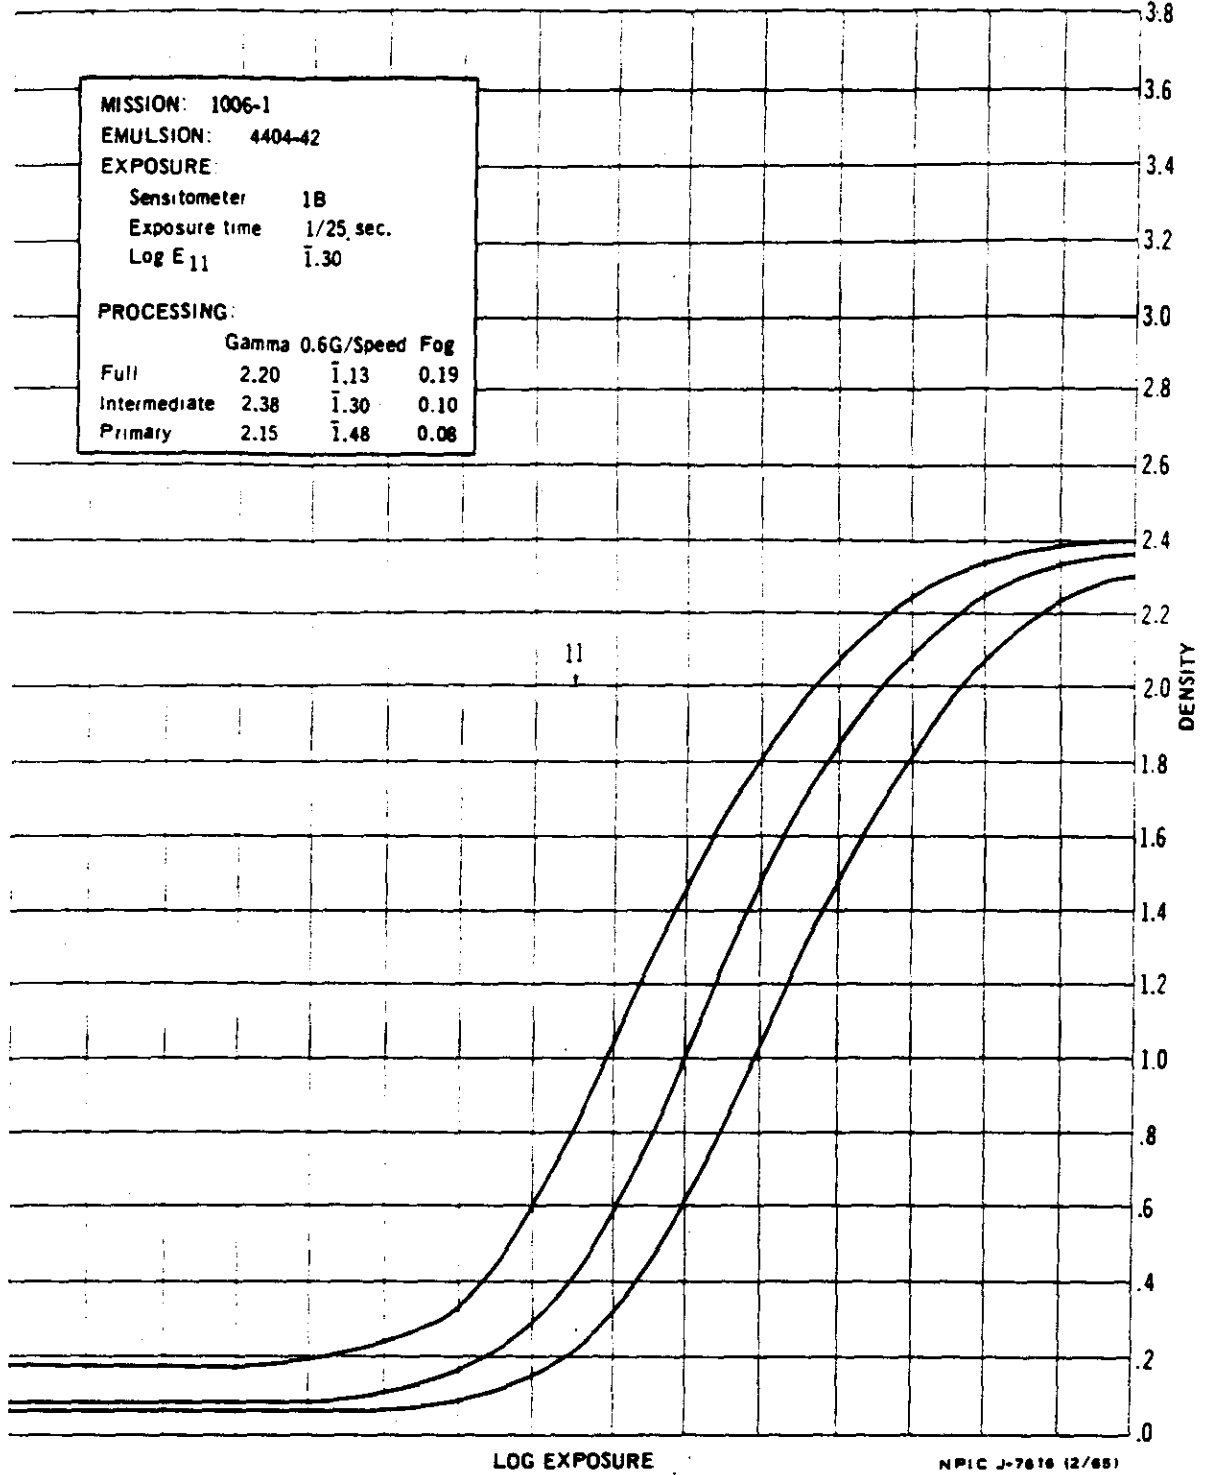
STANDARD SENSITOMETRIC CONTROL CURVES

MISSION: 1006-1			
EMULSION: 4404-42			
EXPOSURE:			
Sensitometer	1B		
Exposure time	1/25 sec.		
Log E ₁₁	1.30		
PROCESSING:			
	Gamma	0.6G/Speed	Fog
Full	2.20	1.13	0.19
Intermediate	2.38	1.30	0.10
Primary	2.15	1.48	0.08
