**PHOTOGRAPHIC  
EVALUATION REPORT  
MISSION 1013-1  
2 - 6 NOVEMBER 1964  
MISSION 1013-2  
6 - 7 NOVEMBER 1964**

PHOTOGRAPHIC EVALUATION REPORT  
MISSION 1013-1  
2 - 6 NOVEMBER 1964  
MISSION 1013-2  
6 - 7 NOVEMBER 1964

NATIONAL PHOTOGRAPHIC INTERPRETATION CENTER

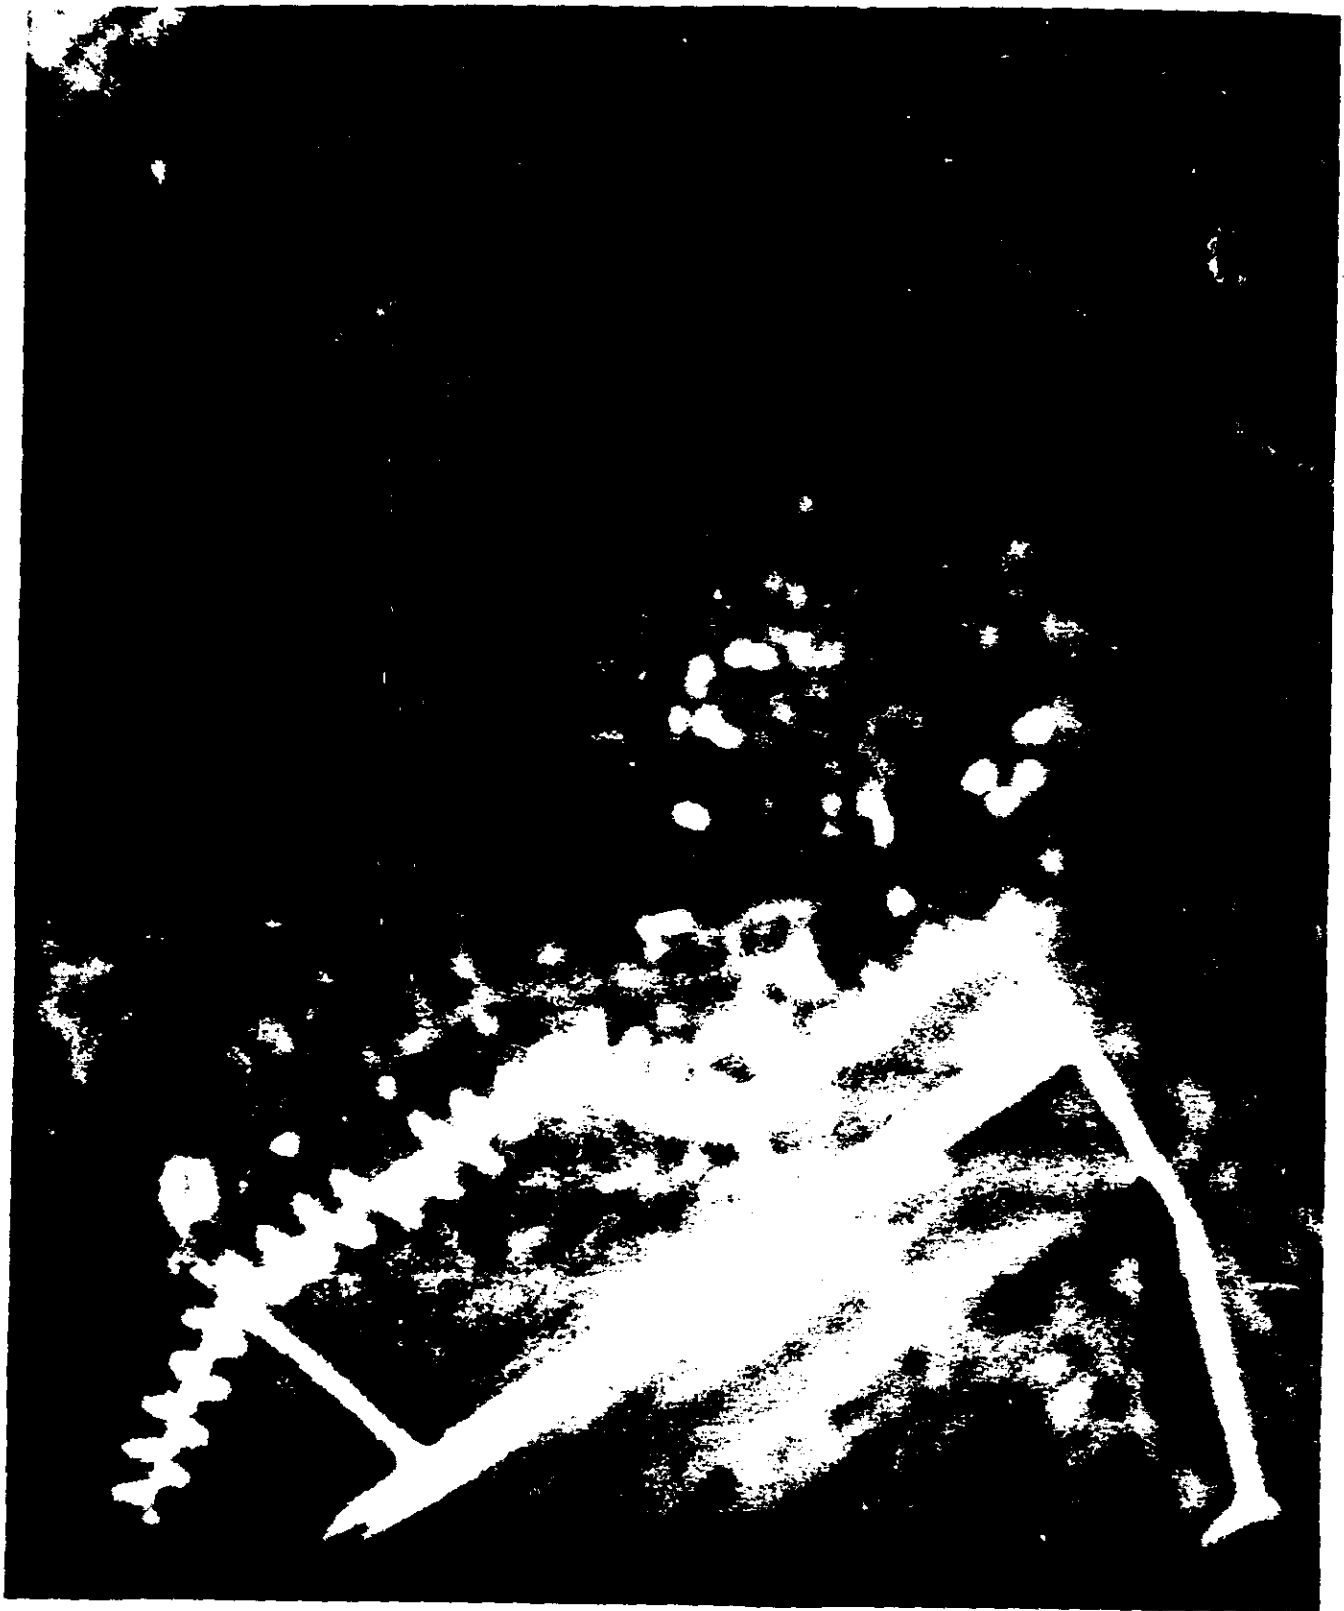
Erratic metering caused several horizon fiducials to be imaged inside the panoramic camera format. The pattern of out-of-focus imagery on the panoramic frames is detectable even on the contact print.

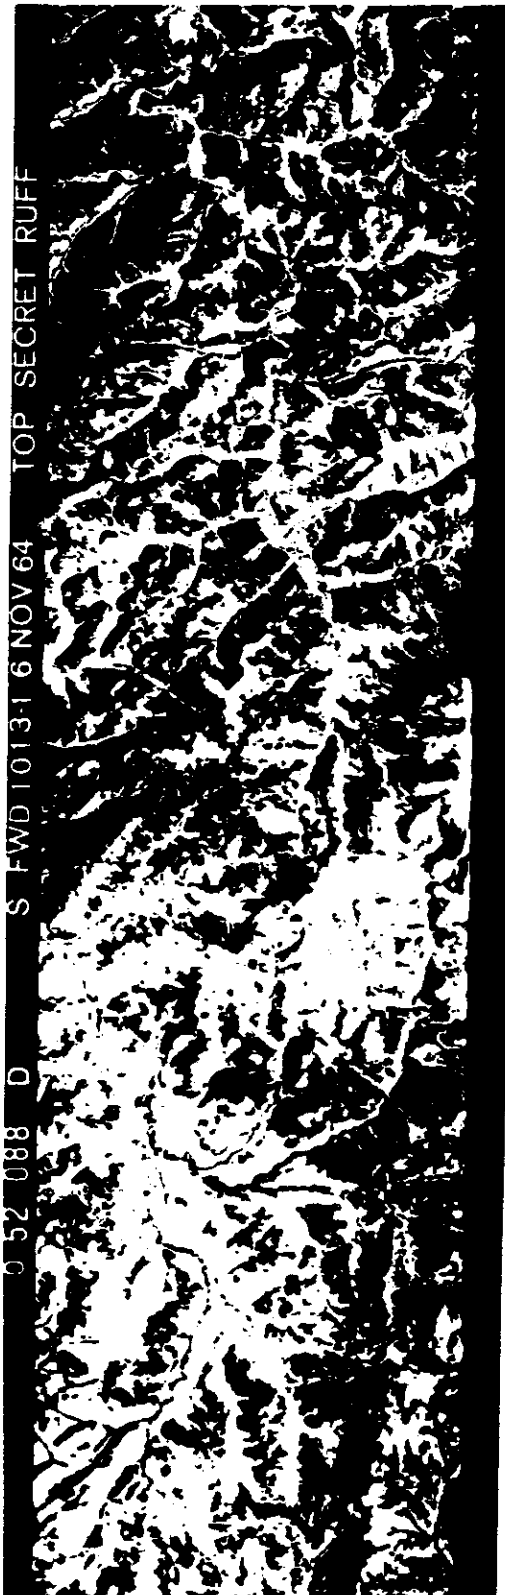
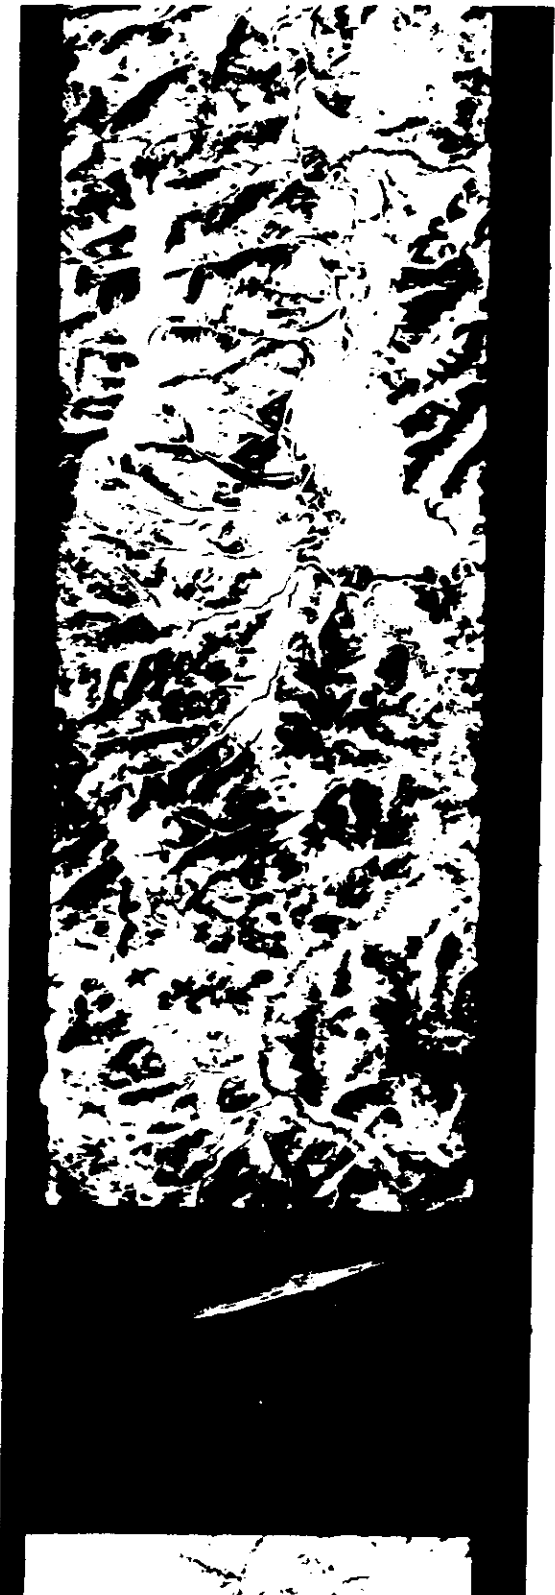
FIGURE 9. MASTER CAMERA HORIZON IMAGERY.

All horizon cameras functioned properly throughout the mission. No out-of-focus imagery was noted in the horizon formats and the horizon arcs are well defined. The quality of the master horizon imagery is shown here.

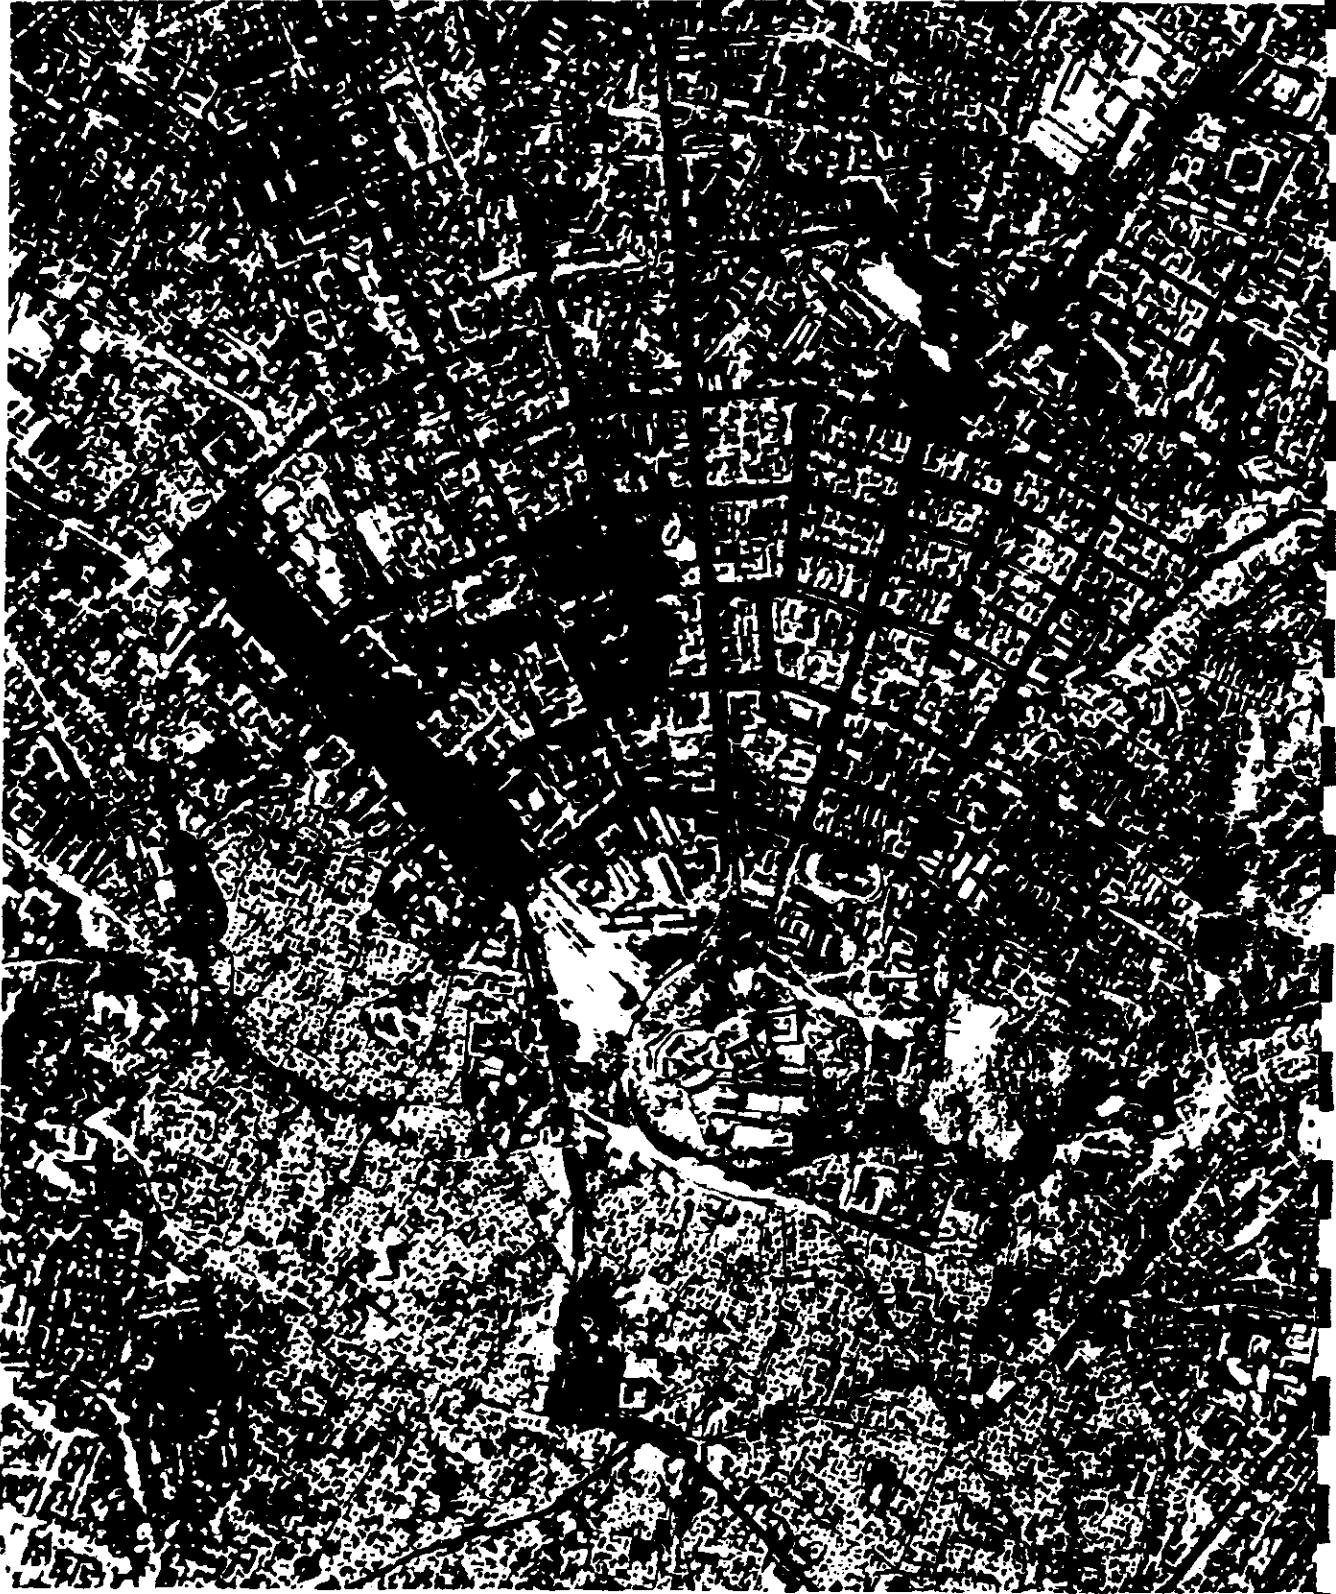
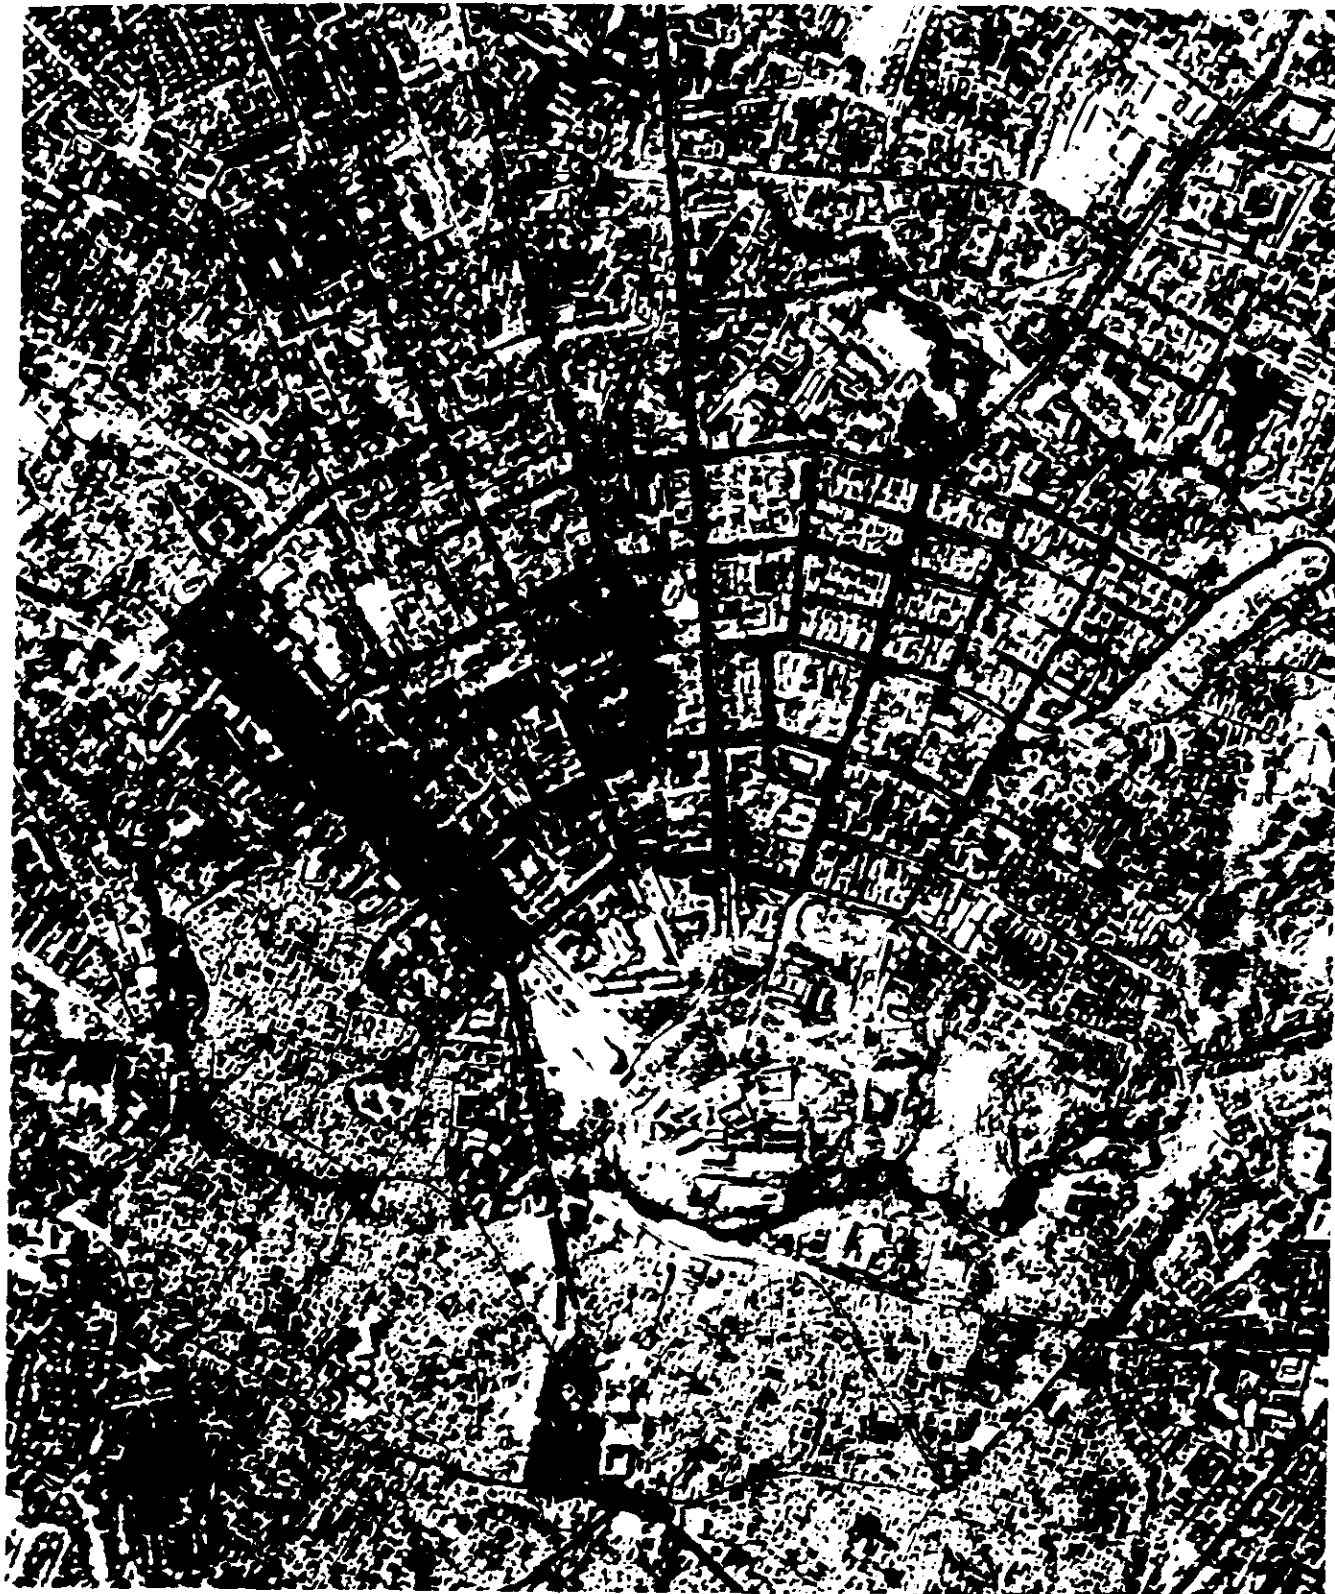
FIGURE 22, FIGURE 23, FIGURE 24 and FIGURE 25.

DEGRADATION CAUSED BY OUT-OF-FOCUS CONDITION.

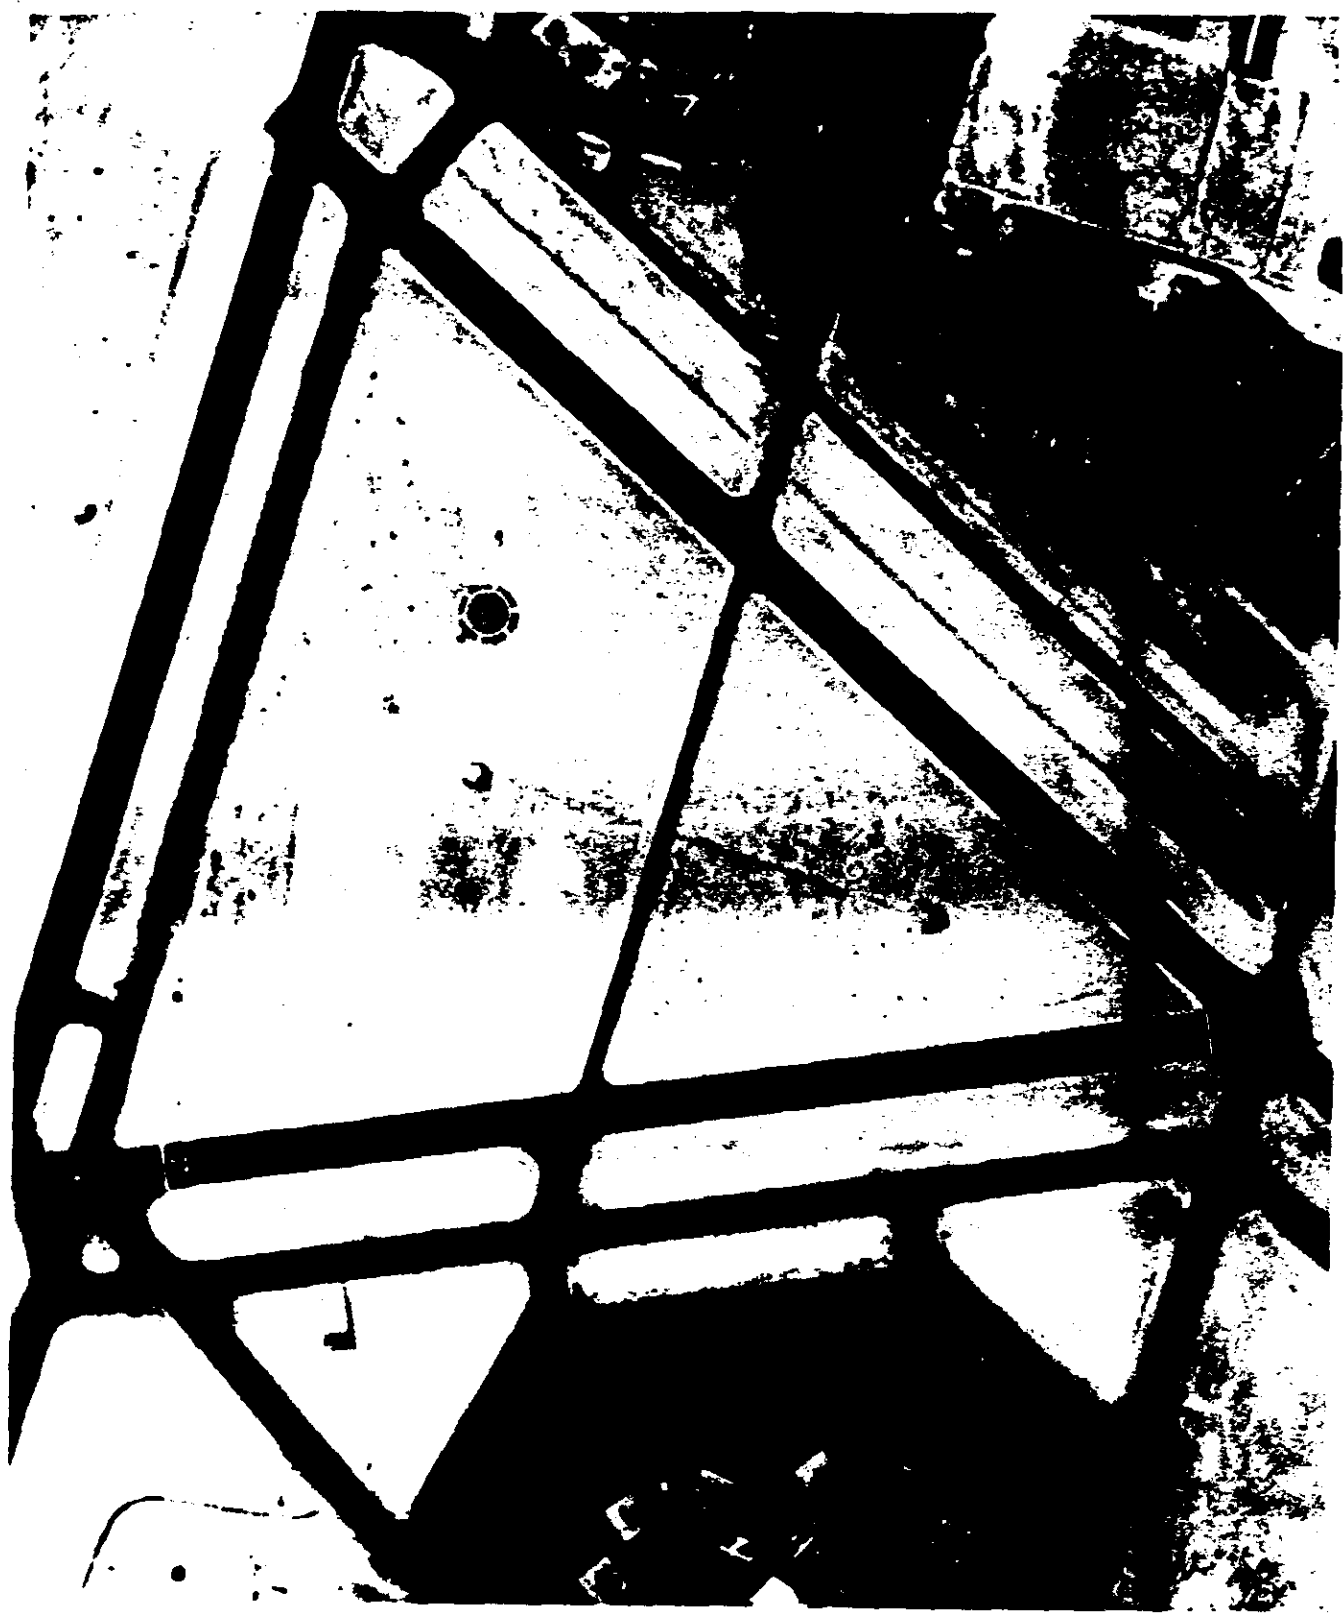
Those edges across which microdensitometric edge traces 5 through 8 were made are illustrated in the accompanying photograph. Arrows indicate the approximate location for each trace.
