PHOTOGRAPHIC EVALUATION REPORT

MISSION 1023-1

MISSION 1023-2

NATIONAL PHOTOGRAPHIC INTERPRETATION CENTER

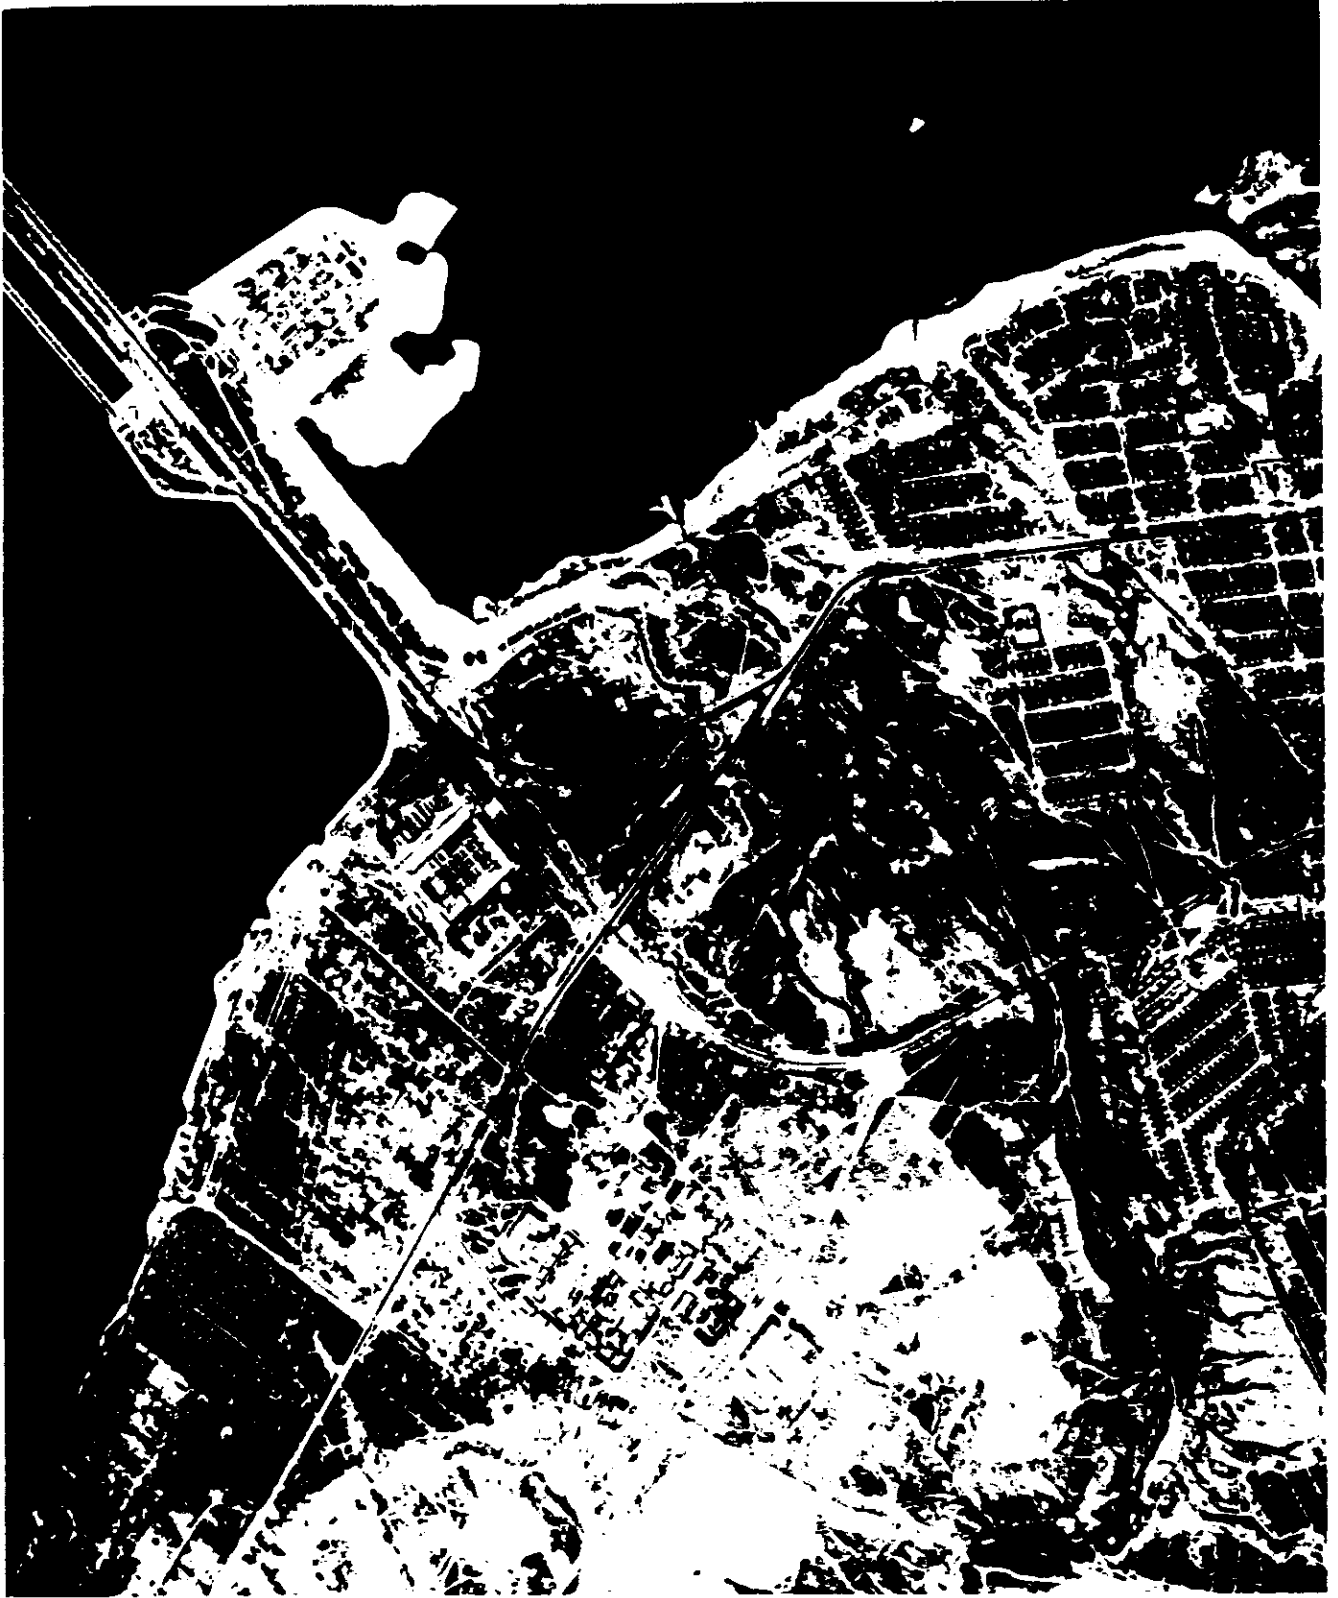
FIGURE 11. EXAMPLE OF HAZE-DEGRADED PHOTOGRAPHY (FWD CAMERA)

Haze condition such as this is a prime factor in the reduction of PI suitability. Only gross cultural details may be defined.

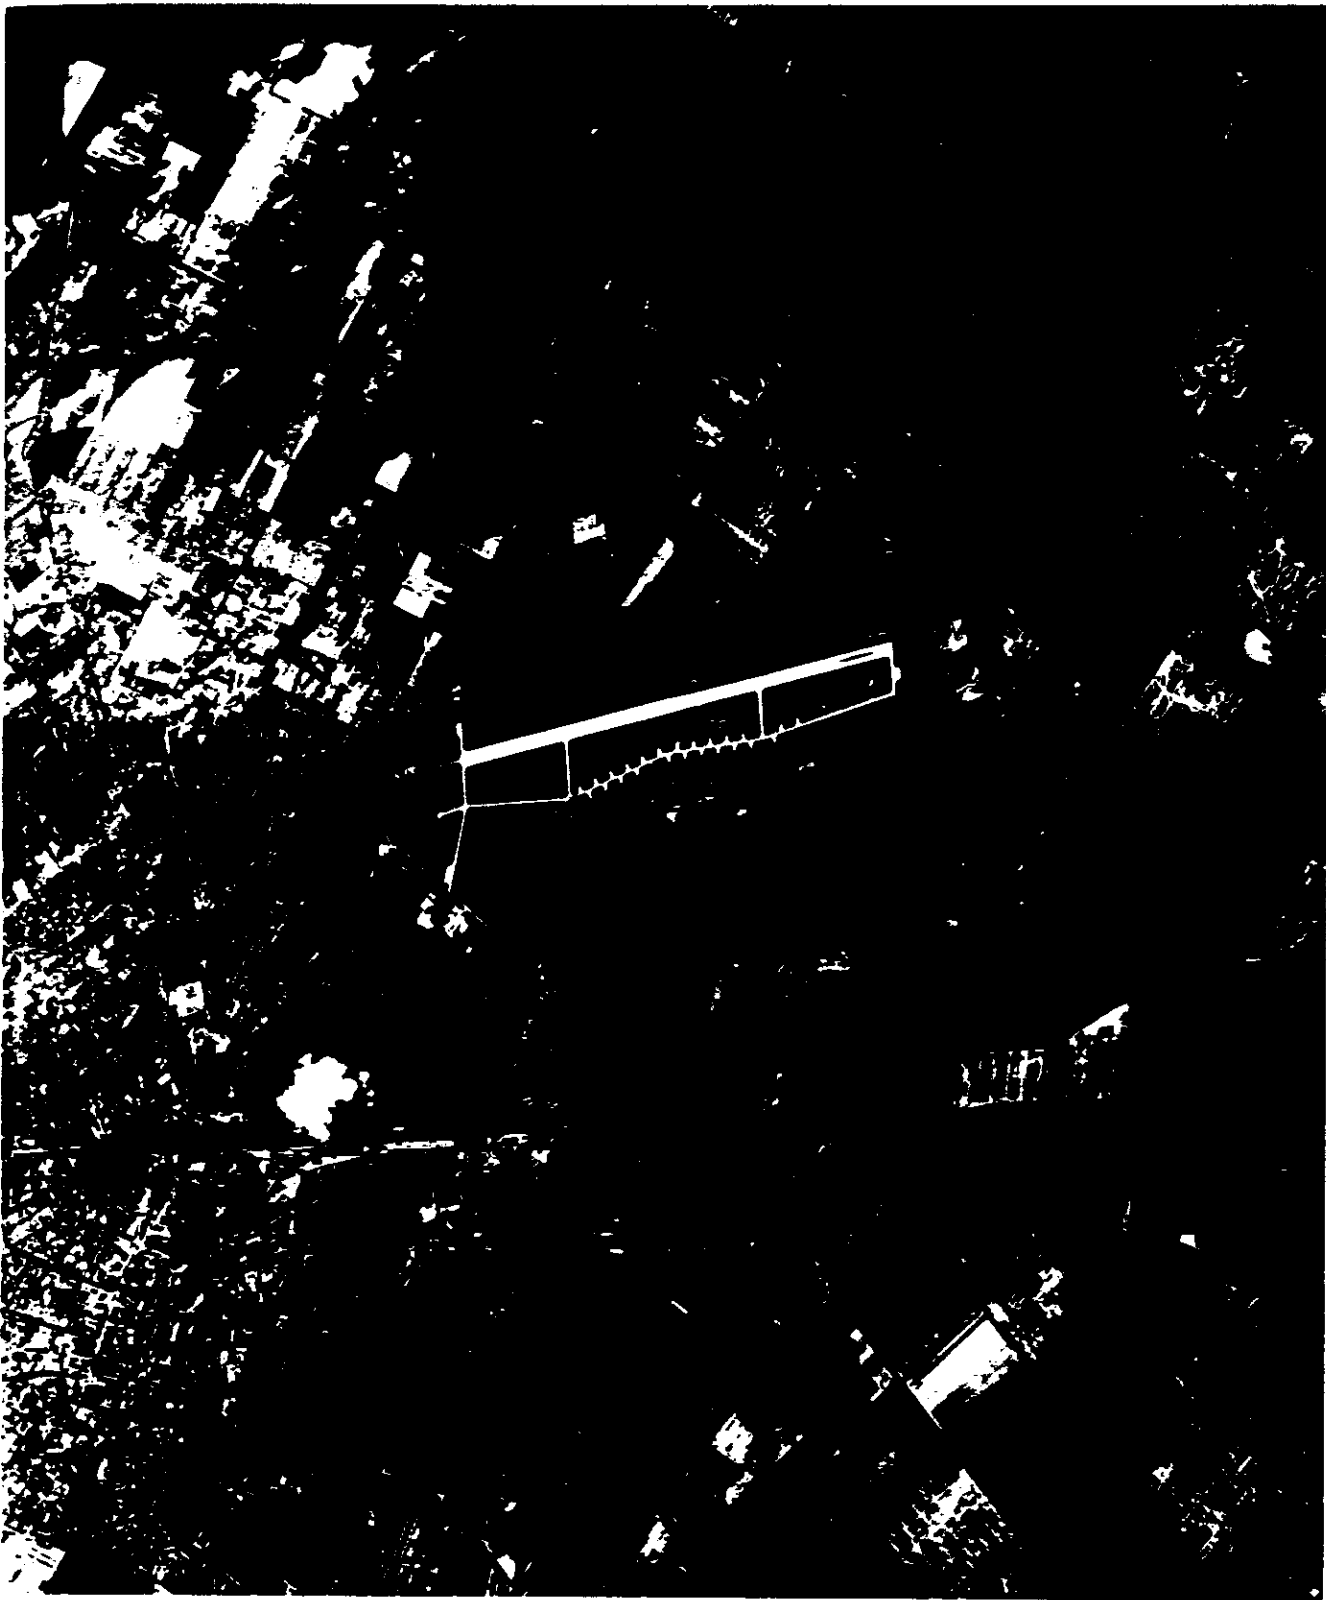
FIGURE 12. EXAMPLE OF HAZE-DEGRADED PHOTOGRAPHY (AFT CAMERA)

Degradation is similar to that noted in the fwd photography. Occasionally, however, the difference in viewing angles between the cameras results in less degradation of one photograph or the other.
