PHOTOGRAPHIC EVALUATION REPORT
MISSION 1021-1
18-23 MAY 1965
MISSION 1021-2
23-28 MAY 1965

JANUARY 1966

NATIONAL PHOTOGRAPHIC INTERPRETATION CENTER

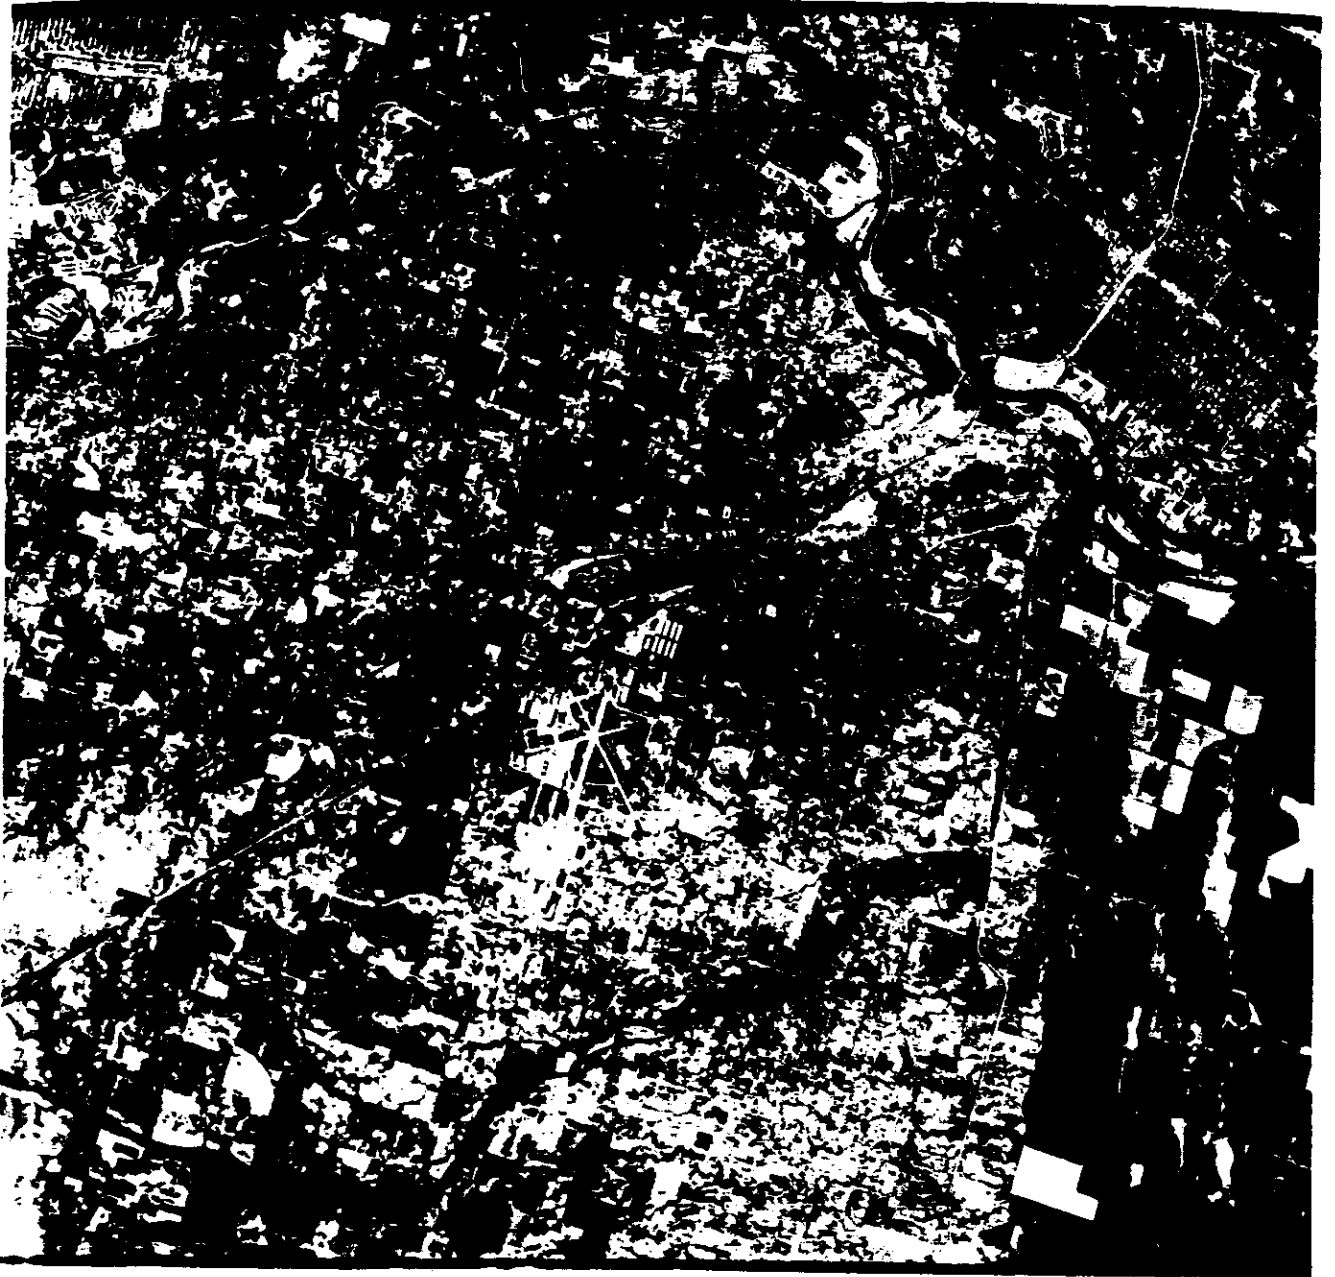
FIGURE 23. EXAMPLE OF TERRAIN COVERED IN MISSION 1021

This photograph shows a small community surrounded by farming areas. The subtle gradations in tone between the different cultivated fields are indicative of the tonal range of this system.
