**PHOTOGRAPHIC
EVALUATION REPORT
MISSION 1030-1
9-14 MARCH 1966
MISSION 1030-2
15-19 MARCH 1966**

**AUGUST 1966
COPY
107 PAGES**

NATIONAL PHOTOGRAPHIC INTERPRETATION CENTER

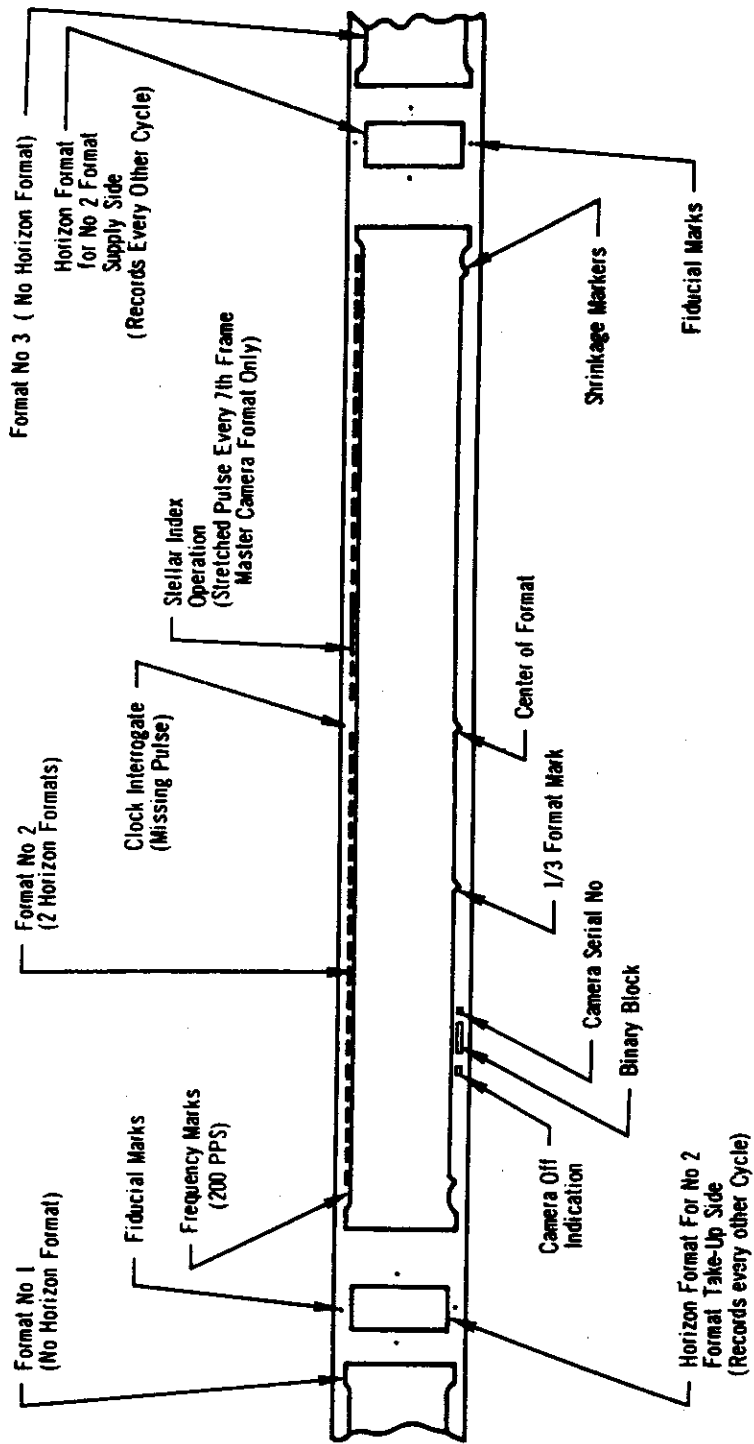
3. PANORAMIC FORMAT CONFIGURATION

Master (Fwd) Panoramic Camera No 182
Viewed With Negative Emulsion Down
Direction of Film Transport →
Direction of Scan →
Direction of Vehicle Motion →

Slave (Aft) Panoramic Camera No 183
Viewed With Negative Emulsion Down
Direction of Film Transport →
Direction of Scan →
Direction of Vehicle Motion →
