**CORONA
TECHNICAL
INFORMATION**

VOLUME 1

EVOLUTION OF CORONA SYSTEM CHARACTERISTICS

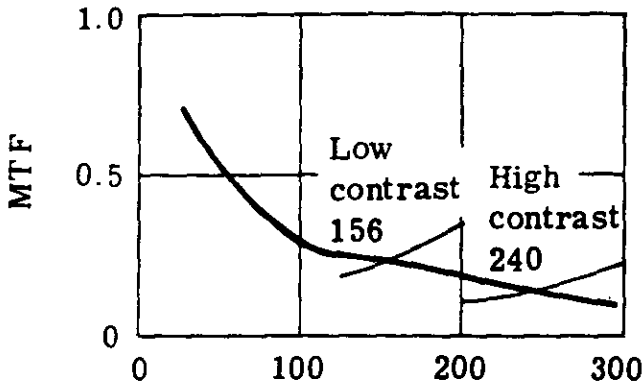
J-3, Type II

Static Resolution Specifications

Filter	Resolution	
	EK 3404 at 2:1	EK 3404 at 1,000
W-21	140 l/mm	240 l/m
W-25	None	None
