NPIC/TP-22/64

PHOTOGRAPHIC EVALUATION REPORT

MISSION 4008

19 MAY 1964

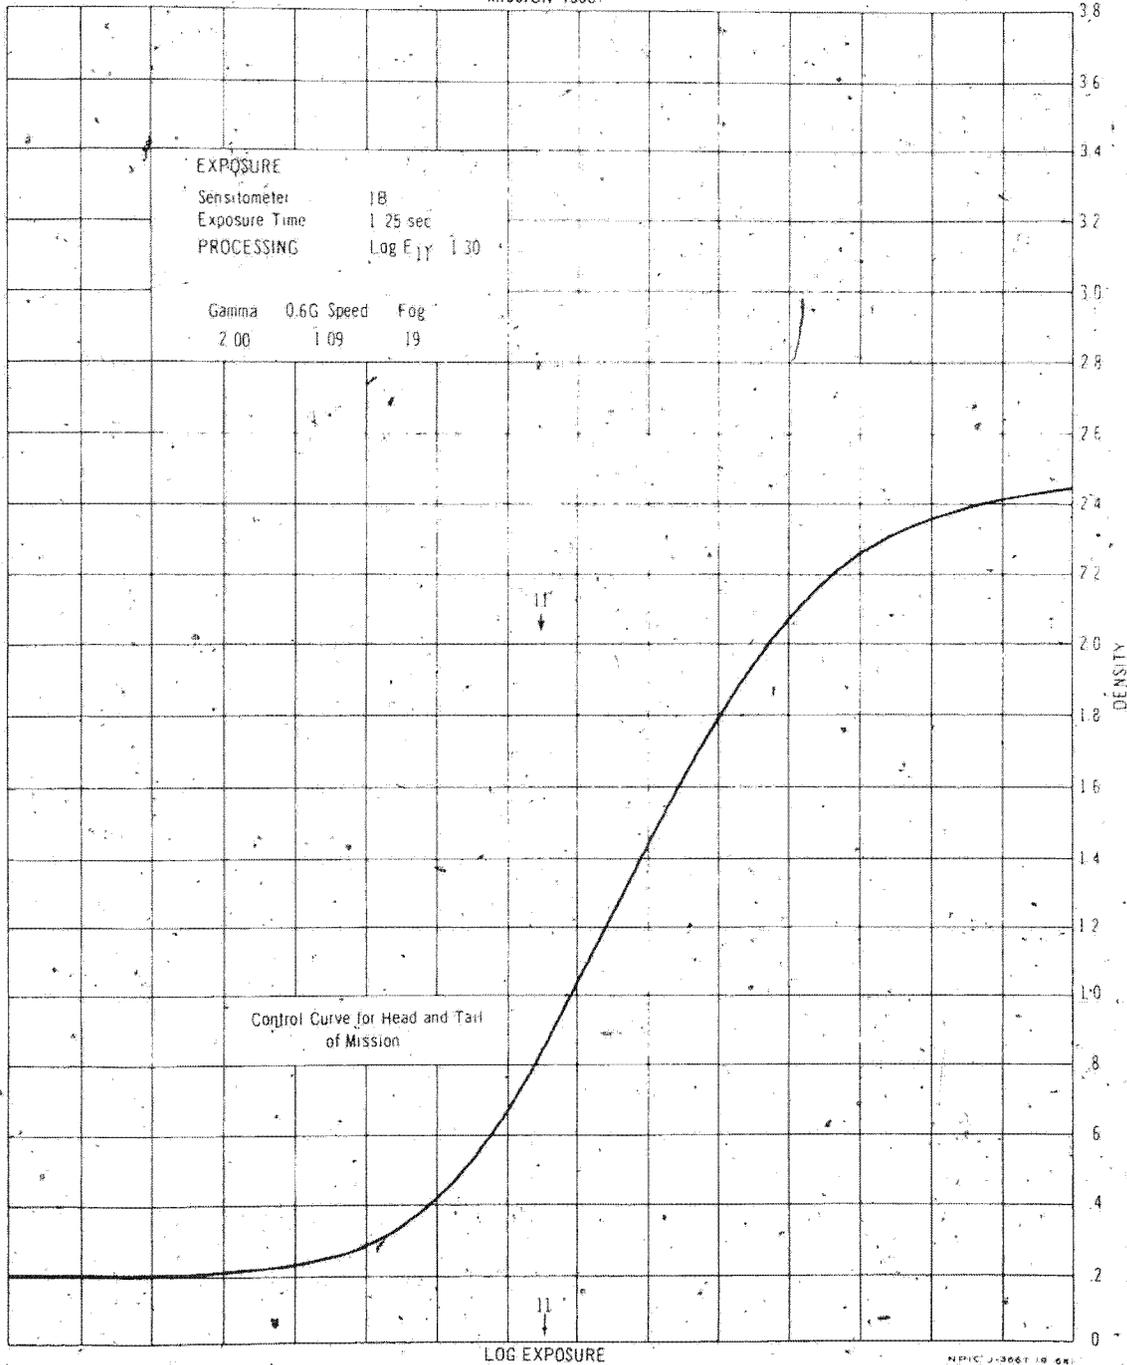
MAIN CAMERA
MISSION 4008

EMULSION 4404-42

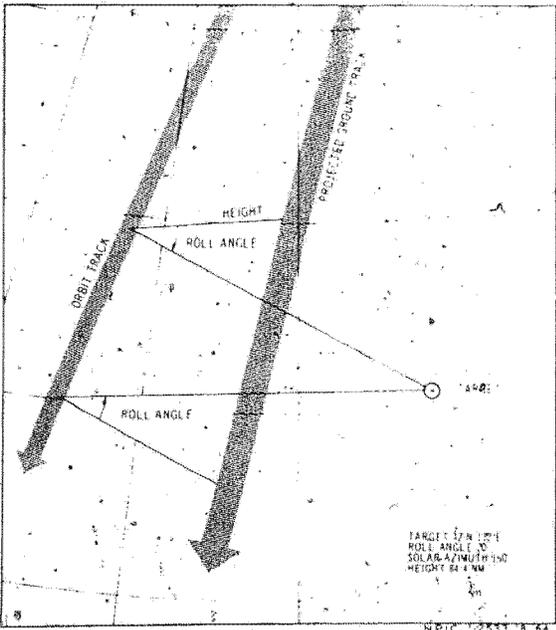
FIGURE 1. RELATIVE ORBITAL TRACK AND THE PROJECTED GROUND TRACK AT 20° RIGHT WING DOWN ROLL, AND AT THE CONVERGENCE ANGLE FOR STEREOGRAPHIC COVERAGE OF A TARGET.

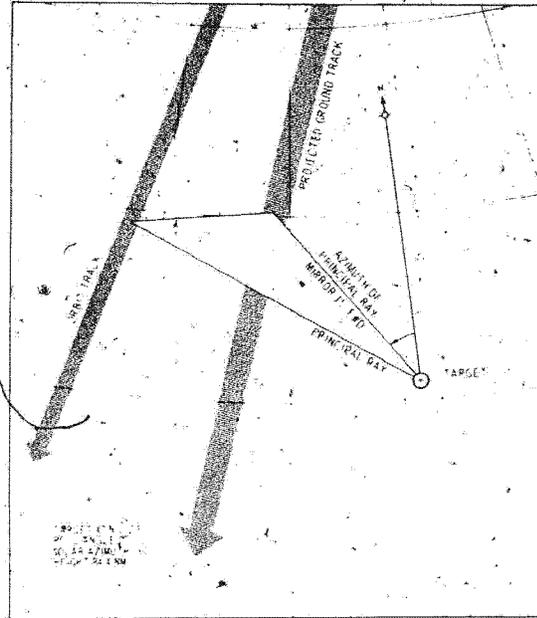
FIGURE 4. RELATIVE LOCATION OF THE PRINCIPAL RAY AND THE AZIMUTH OF THE PRINCIPAL RAY WITH THE MIRROR IN THE 15° FWD POSITION.

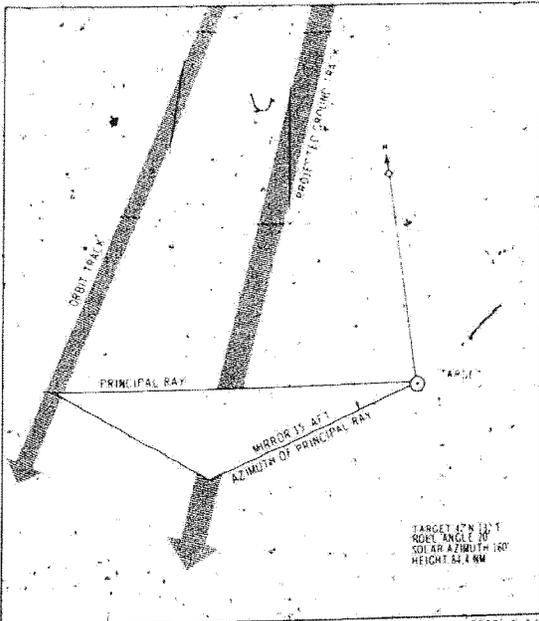
FIGURE 5. RELATIVE LOCATION OF THE PRINCIPAL RAY AND THE AZIMUTH OF THE PRINCIPAL RAY WITH THE STEREO MIRROR IN THE 15° AFT POSITION.

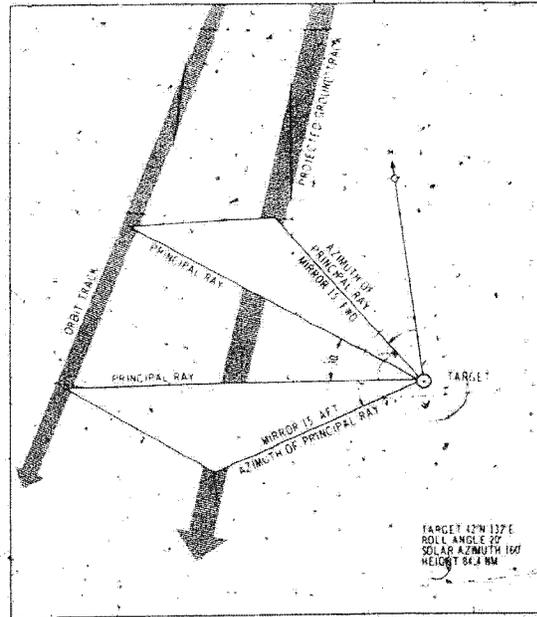
FIGURE 6. ALTHOUGH THE CONVERGENCE OF THE TWO PRINCIPAL RAYS ALWAYS FORMS A 30° ANGLE, THE CONVERGENCE OF THE AZIMUTHS OF THESE PRINCIPAL RAYS FORMS AN ANGLE THAT IS A FACTOR OF THE VEHICLE ATTITUDE AND ALTITUDE.

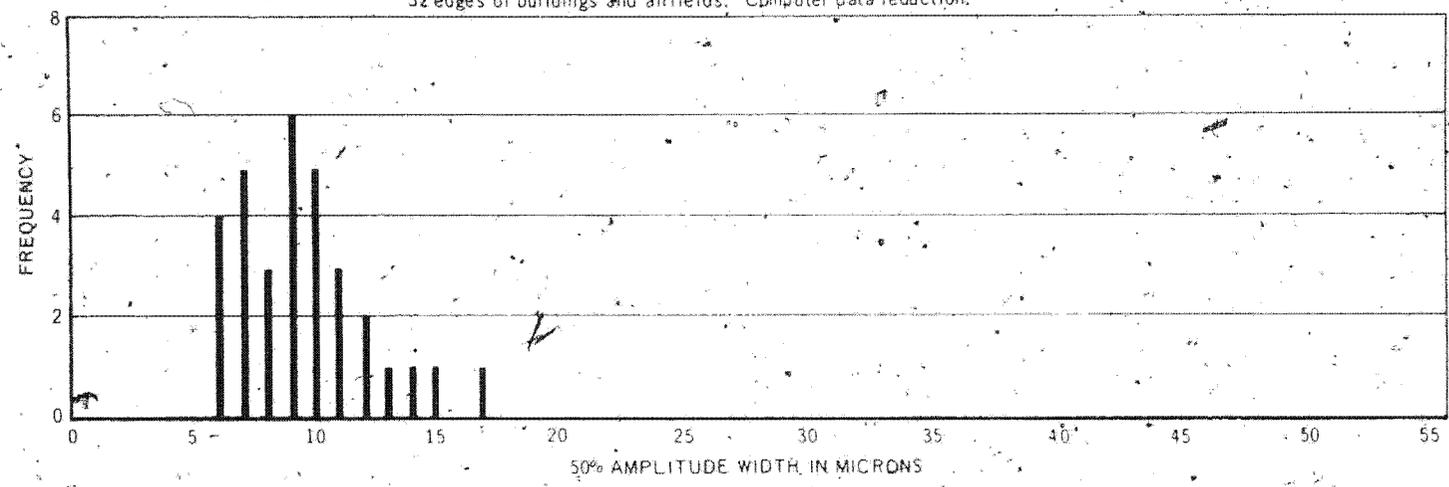
Frequency vs. 50% amplitude width in microns, of line spread function.
32 edges of buildings and airfields. Computer data reduction.

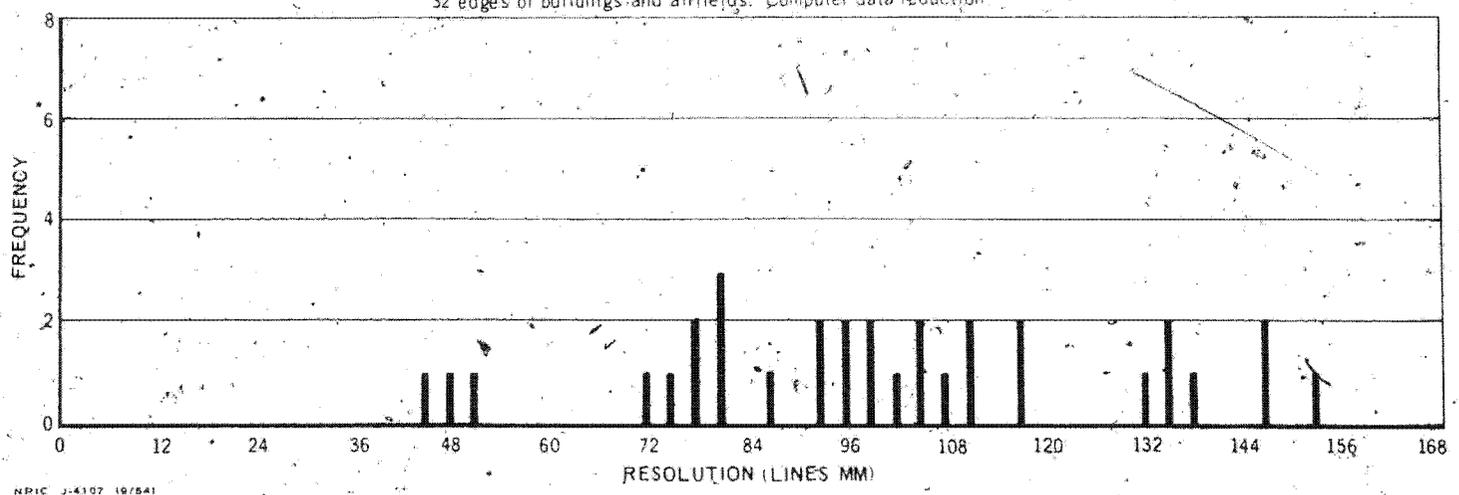
Frequency vs Resolution (lines MM) A.I.M. 4404 Curve.
32 edges of buildings and airfields. Computer data reduction.
