# (U) Buckley Parking Lot Study

## Findings and Recommendations

United States Government

15 October 2019

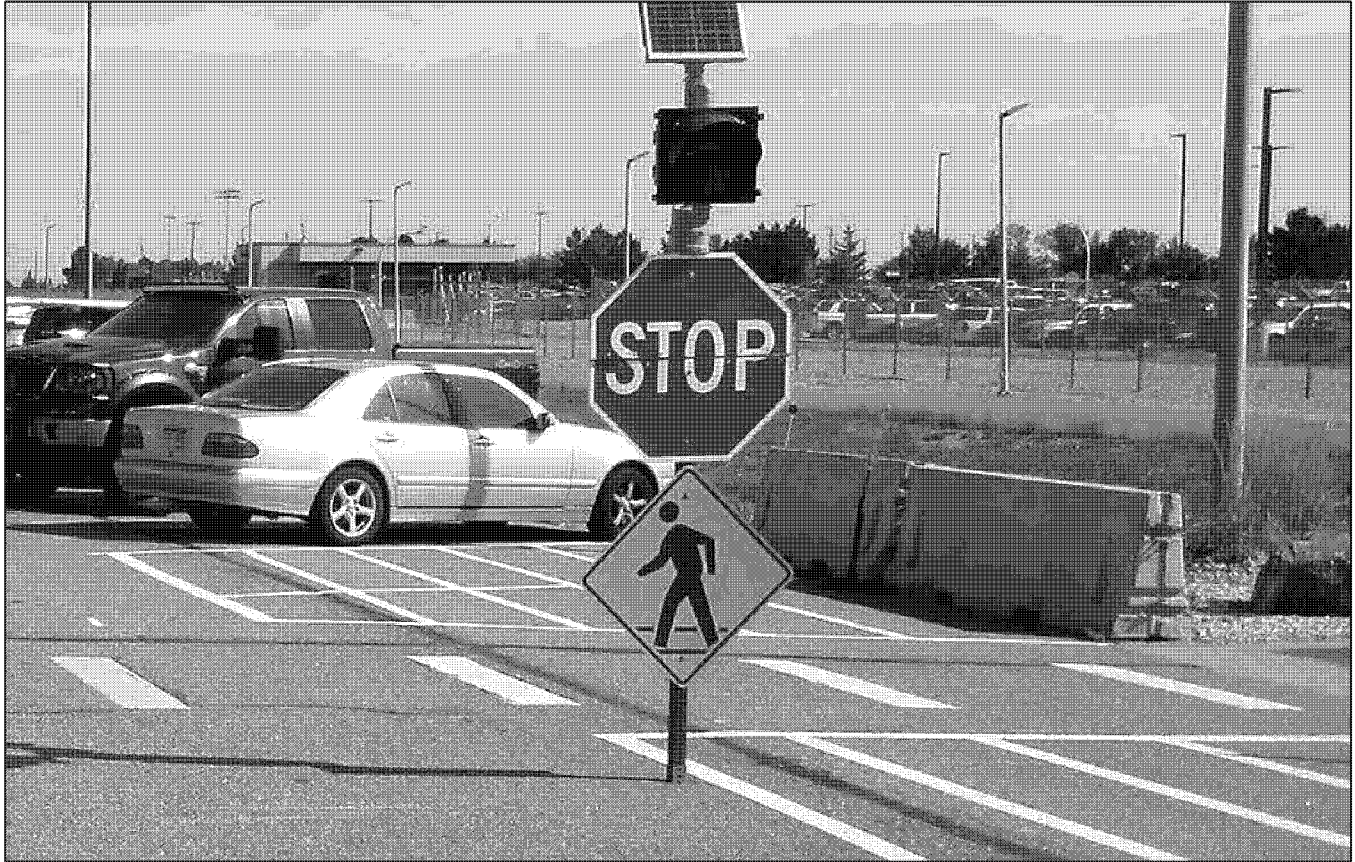
(U) Figure 4-3: Example of Flashing Beacons and Multiple Messages on a Shared Post

(U) The Site’s parking areas have numerous locations where there are Stop signs (regulatory) and Pedestrian Crossing signs (warning) on the same post (see (U) Figure 4-3). These locations create the following issues:

- Drivers may stop at the Stop sign and then forget that they also were warned to look for pedestrians.
- Stop signs at mid-block crossing locations—such as the one shown in (U) Figure 4-3 (at the crossing in front of the VCC)—tend to cause drivers to perform a rolling stop. The driver knows there are no vehicle conflicts at this location and, unless there is a pedestrian present, the driver is likely to slow and then proceed through without fully stopping. Due to the infrequent encounters with pedestrians, the driver becomes used to rolling through the intersection even if a pedestrian is present. Furthermore, if the driver becomes used to rolling through one location, the driver may exhibit similar behavior at all Stop locations in the area.

- Keep the Stop sign and flashing red beacon at these locations but remove the Pedestrian Crossing sign.
- Remove the Stop sign and flashing red beacon while using a concept discussed in *Section 4.3.3.1, High-Visibility Crosswalks Enhanced by Technology* to warn the drivers that pedestrians may cross at this location.
- Place the Pedestrian Crossing sign approximately 30 feet in advance of the crossing on a separate post and then keep the Stop sign and flashing red beacon at the crossing location.
- Move the Stop sign and flashing red beacon about 15 feet in advance of the crosswalk and place the Pedestrian Crossing sign at the crosswalk.

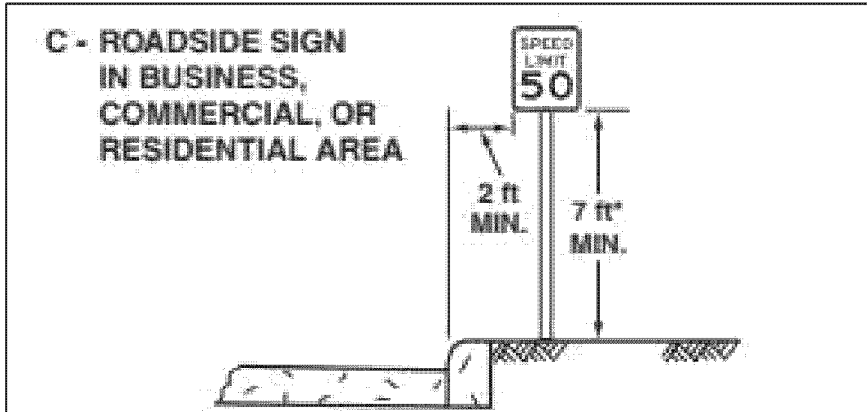
## (U) Figure 4-4: MUTCD Recommended Sign Placements

(U) The MUTCD contains guidance on the mounting height and lateral placement of signs near locations where vehicles are parking or pedestrian activity is expected to occur (see (U) Figure 4-4). Signs should be located at least 2 feet behind a curb (or edge of the travel way) and signs should be mounted at a minimum height (to the bottom of the sign panel) of 7 feet above the sidewalk or pavement. These requirements help to improve the visibility of the sign for approaching vehicles, especially in the situation where there is a vehicle stopped in front of the sign. In addition, signs that are too low to the ground create sight distance obstructions that prevent a driver from seeing a pedestrian that is waiting to enter the crosswalk (the pedestrian may not be able to see the vehicle either). Finally, placement of the signs too close to the travel way tend to result in vehicles hitting the signs, especially at intersections where vehicles are turning.

\* Minimum height to bottom of panel.

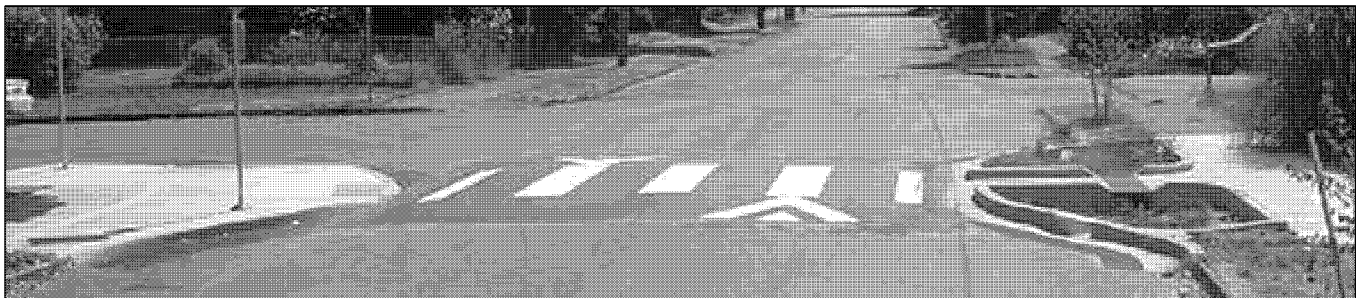
(U) Figure 4-9: Example of a Mountable Raised Crosswalk

(U) Raised crosswalks allow better visibility of and by pedestrians before they enter and while they are crossing a roadway. While they are not the same as speed bumps, approach ramps for raised crosswalks have been shown to reduce speeds, improve motorist yielding rates, and reduce pedestrian crashes by 45 percent.<sup>7</sup> Raised crosswalks can be constructed (see (U) Figure 4-8) with either mountable or non-mountable curbs. Mountable curbs allow vehicles to drive over them, making them less safe for pedestrians but more accessible to emergency vehicles, and have no impact to vehicle circulation patterns in the parking areas. Non-mountable curbs, basically an extension of a sidewalk, are the most safe for pedestrians, but they can slow emergency vehicle access and would result in a change in the circulation pattern of vehicles in the parking area (the raised pedestrian crossing basically closes the road to vehicles). (U) Figure 4-9 illustrates a mountable raised crosswalk design and highlights the features that make it effective. In the case of a non-mountable design, the ramps on either side of the crossing are replaced with additional sidewalk space or landscaping and raised curbs are extended along the length of the crossing to prevent vehicles from driving over the crossing area.

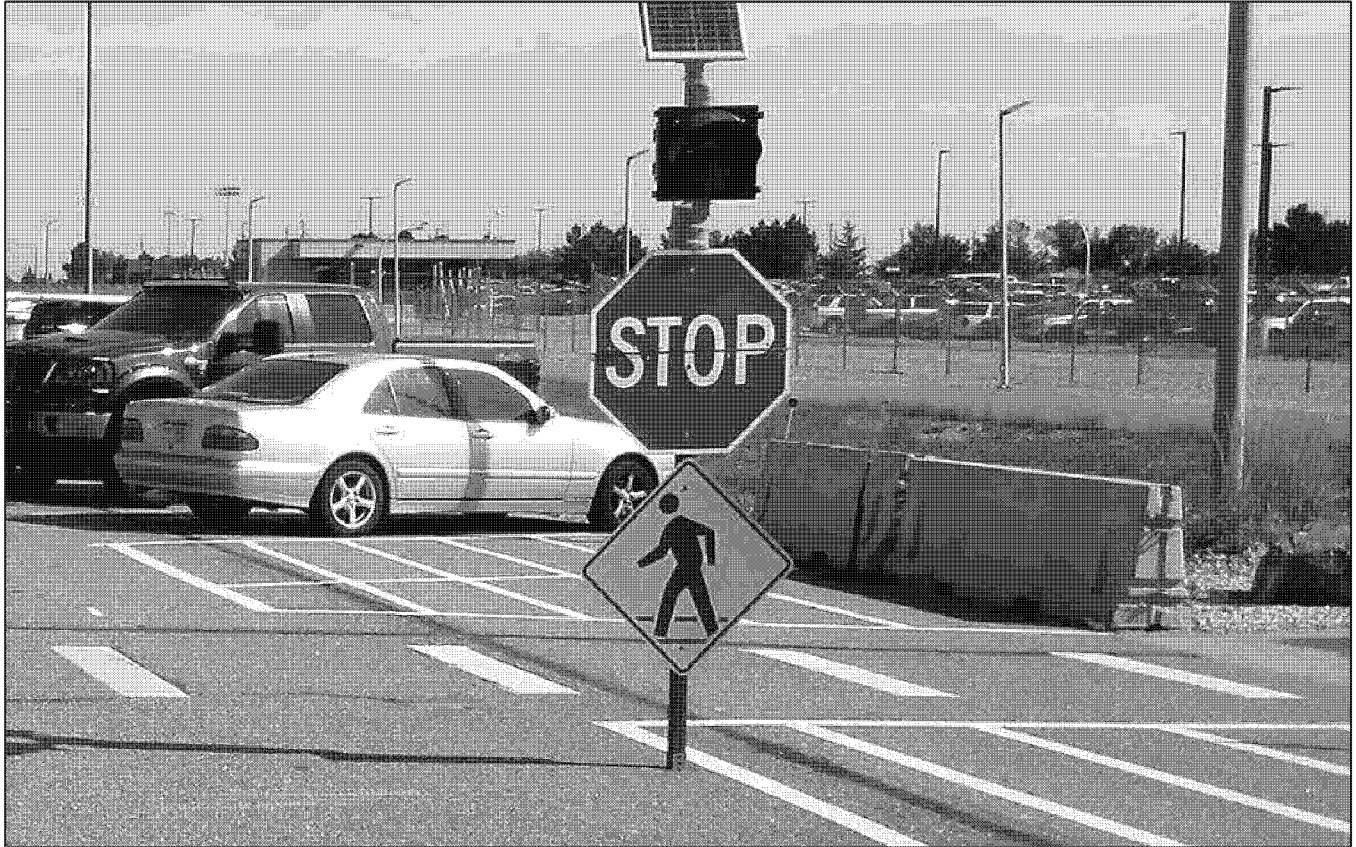
**(U) Figure 4-10: Example of an Existing Pedestrian Crossing at the VCC**

(U) Sidewalk/curb extensions also can help reduce the distance a pedestrian has to cross over a roadway, reducing the pedestrian's exposure time to vehicles. Also, the use of raised curbs helps to make sure that pedestrians begin to cross the roadway from the edge of the travel way instead of moving out from behind parked vehicles or starting from a unexpected position on which a driver's attention is not focused. For example, (U) Figure 4-10 shows the pedestrian crossing at the VCC. The pedestrians exiting the VCC begin their crossing where the crosswalk starts, which is at least 10 feet away from the travel lanes. Pedestrians were observed to stop at the edge of the sidewalk and wait for vehicles to stop, but from this location they are partially behind parked cars, partially behind the signs, and not at the edge of the travel way where drivers expect pedestrians to be waiting to cross the road. (U) Figure 4-11 shows an example of how raised curbs, or bulb outs, are used to narrow the width of roadway that a pedestrian must cross, but also allow the pedestrians to start a crossing from a point that is directly adjacent to the travel lanes. At this location, the pedestrian is more visible to the vehicle driver, making the crossing a safer movement.

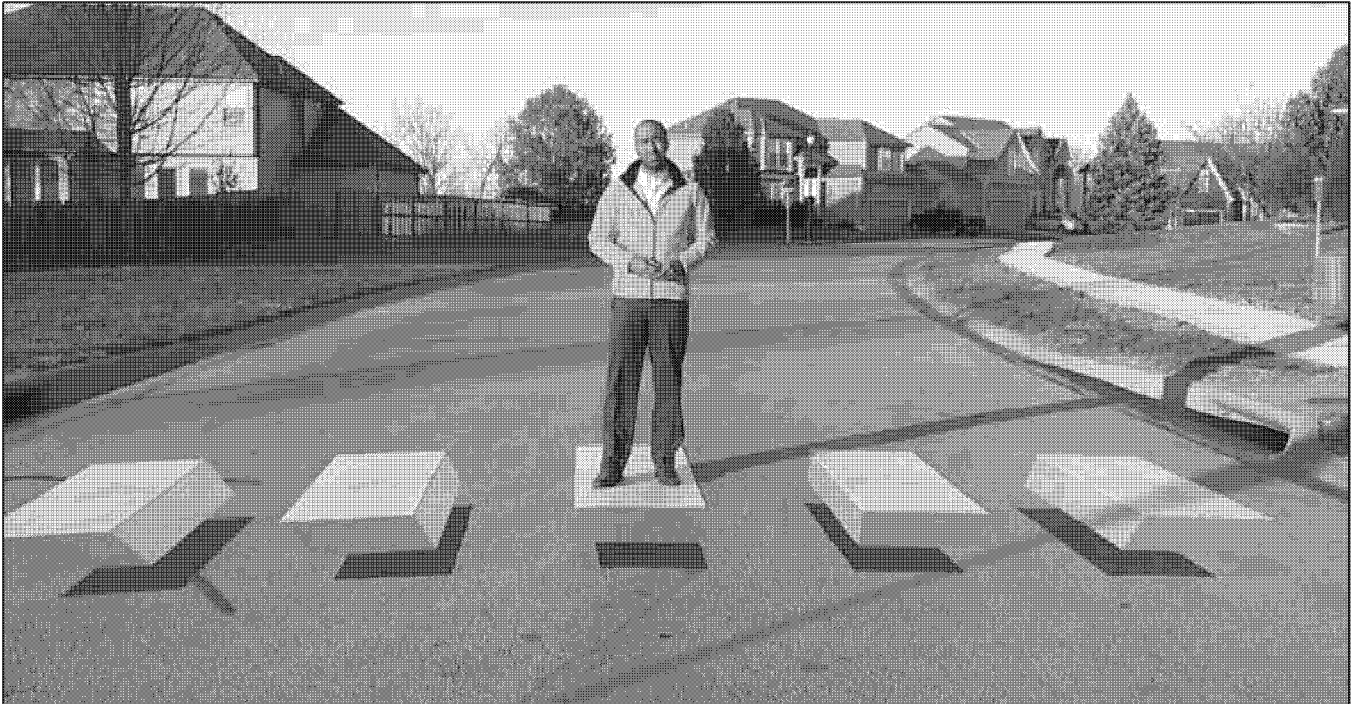
(U) Figure 4-15: Example of a 3-D Painted Crosswalk

(U) A new approach to painted pedestrian crossings includes the use of three-dimensional (3-D) painting. The intention of the design is to get drivers to slow down when approaching the crosswalk and generally they seem to, although no long-term studies on the efficacy of such designs have been completed. The concept, as shown in (U) Figure 4-15, is to make the crossing appear to float above the pavement (3-D effect) and make the driver pay more attention on the approach to the area. It is important to note that this concept does not comply with the MUTCD.

(U) As a result of demonstrated safety concerns, the Federal Highway Administration (FHWA) is no longer considering field experimentation with 3-D crosswalk designs. The FHWA had previously approved field experimentation with 3-D markings until one such experiment showed unintended—and potentially dangerous—effects. A significant percentage of drivers swerved upon seeing the markings, perhaps perceiving them to be real raised objects on the roadway. While this type of driver reaction did decrease over time, the experiment showed that more than 1 in 10 drivers might make an evasive or erratic maneuver upon experiencing this or similar installations for the first time. The results suggest that a 3-D marking design can result in unsafe behavior by drivers. If the design is effective at portraying a 3-D object and drivers believe there are real raised objects on the roadway, it is a reasonable expectation that drivers will take evasive action, such as braking abruptly, in fear of colliding with the perceived obstruction. This type of driver reaction is, in fact, what the experiment showed. The potential for a significant percentage of drivers to react unpredictably is too great a risk to allow further field experimentation.<sup>8</sup>

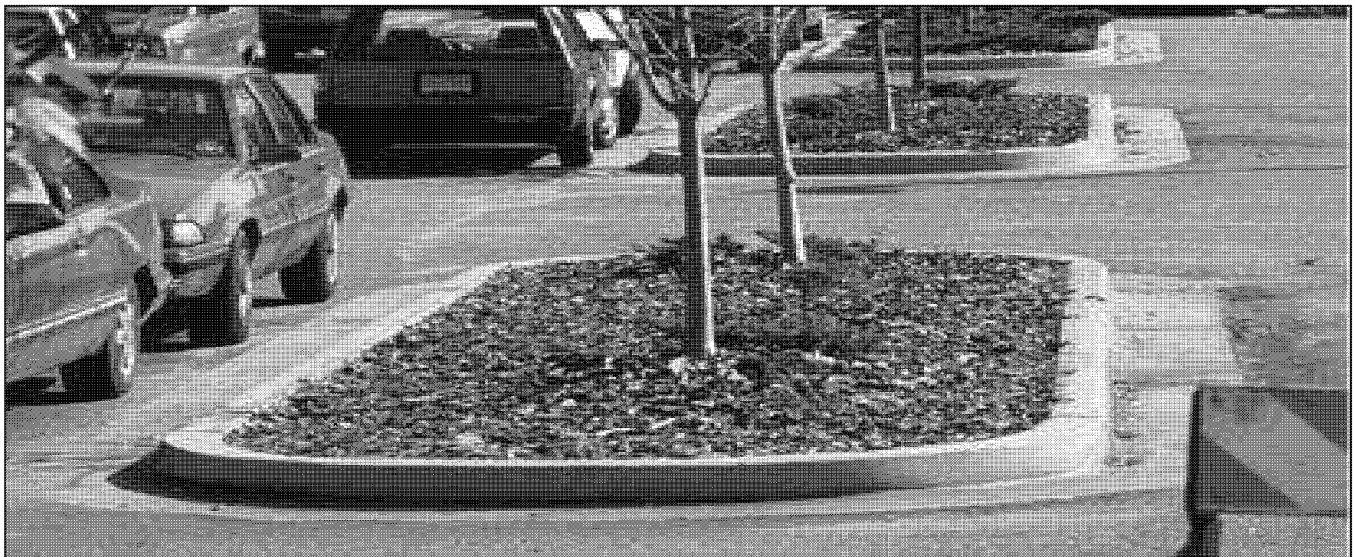
**(U) Figure 4-17: Example of a Raised Concrete End-of-Aisle Island**

(U) One solution is to use concrete to make raised islands (see (U) Figure 4-17) at the end of each parking aisle. This would help to clearly indicate where vehicles are not to park so that adequate sight distance is preserved at the intersections. The raised nature of these islands allows the light pole bases to be protected and eliminates the possibility of vehicles striking them. Also, the raised islands can provide opportunity to introduce landscaping into the parking areas.

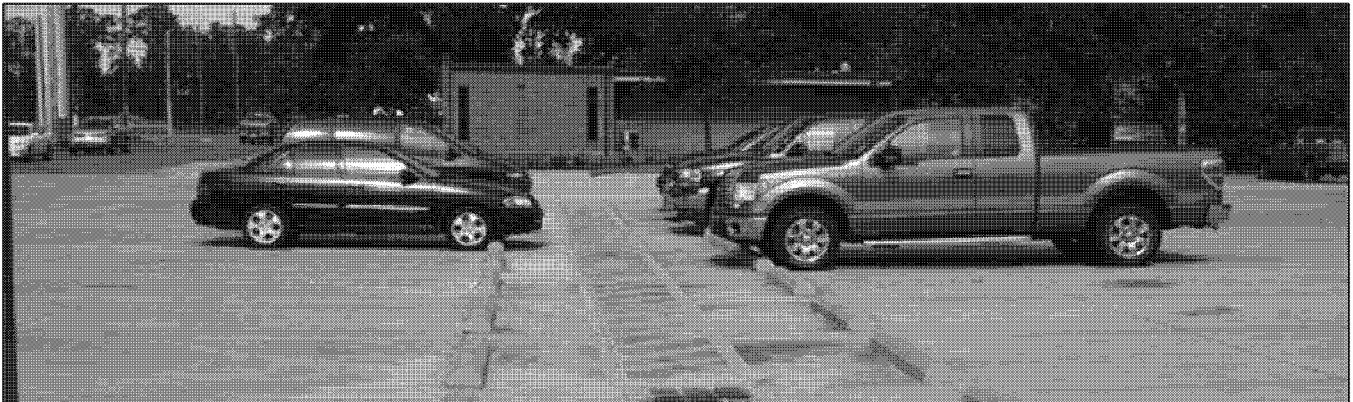
**(U) Figure 4-21: Example Use of Parking Wheel Stops**

(U) The use of wheel stops (as shown in (U) Figure 4-21) helps drivers know when they are fully in the spaces, prevents vehicles from opposing aisles from contacting each other, and reduces the degree to which vehicles protrude in the aisle. The use of wheel stops can help create walkways for pedestrians (painted or raised) in the area in between parking aisles, which is easier to do in parking lots with 90-degree parking spots.

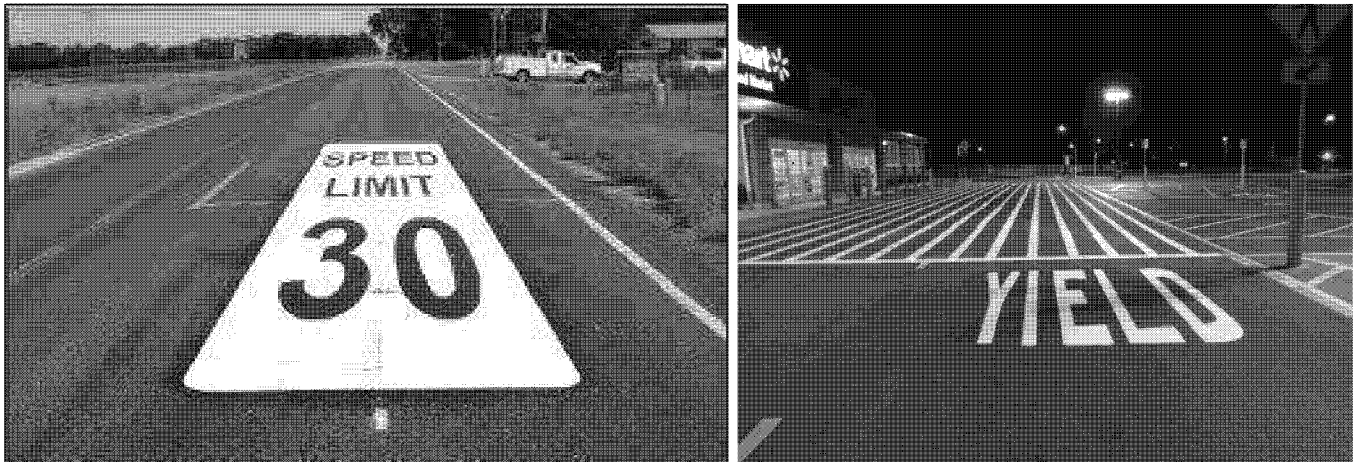
#### (U) Figure 4-22: Example of Other Pavement Markings

(U) The MUTCD identifies pavement markings that are allowed that can help influence driver behaviors to improve safety, and some of these can be applied to parking areas. In locations where speed is a concern or a recurring issue, speed limit pavement markings (see (U) Figure 4-22) can be used to supplement posted speed limit signs. A few locations where these markings would provide benefit include:

(U) One issue that was observed in the parking areas was at the end of the parking aisles, where vehicles were observed to pull out of the aisles and into the circulating roadways or frontage road without slowing or stopping. Vehicles exiting a parking aisle should yield to vehicles on the circulating or frontage roads. Installation of YIELD pavement markings (see (U) Figure 4-22) at the end of each parking aisle will reinforce the need for drivers to slow in this area and to warn the drivers that they have reached the end of the row and are entering a roadway where drivers are not required to yield. The YIELD markings also can be used at crosswalk locations.

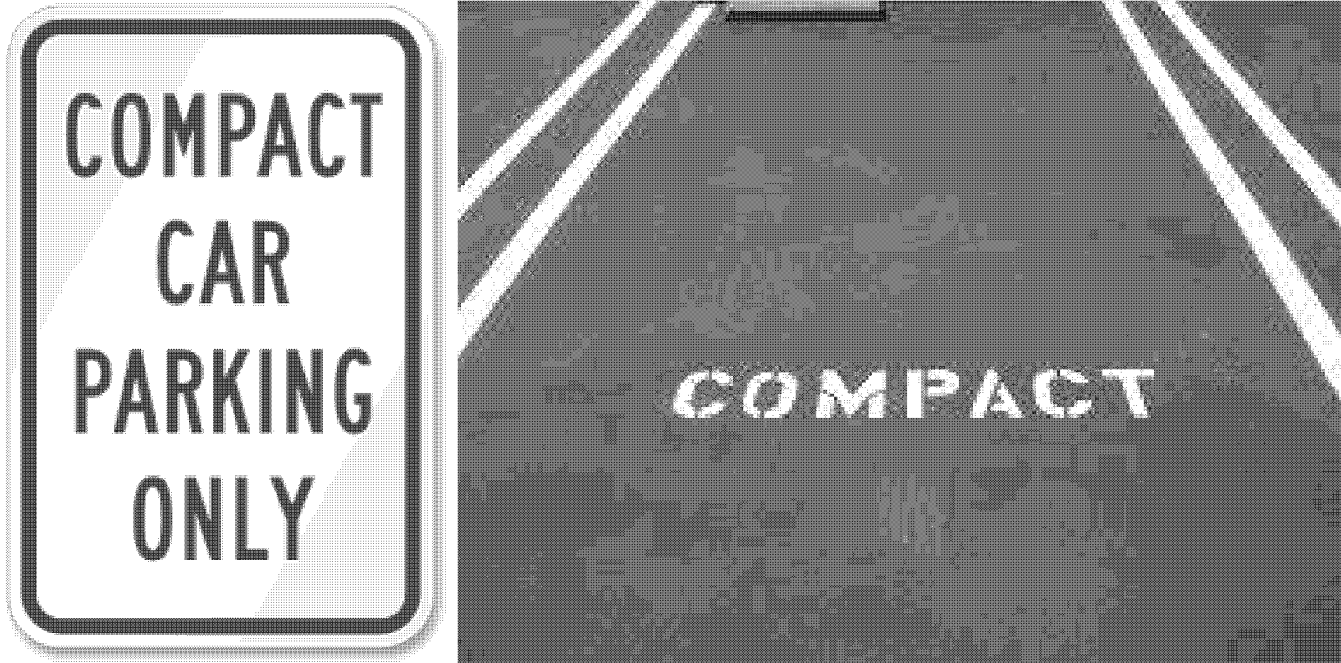
(U) Figure 4-24: Example Compact Car Parking Sign and Pavement Marking

(U) One possible solution would be the implementation of restrictions that prohibit large vehicles from parking in the last couple of parking spots in each aisle. This could be accomplished by using signs or pavement markings that indicate the last few spots are reserved for compact vehicles only (see (U) Figure 4-24). The implementation of this concept requires investment in the resources to enforce the rule or relying on drivers to follow the honor system and adhere to the rule.
