Post Flight Analysis Report

MISSION 1208-5

POST FLIGHT ANALYSIS REPORT NO. 1208-5/74 ***

15 AUGUST 1974

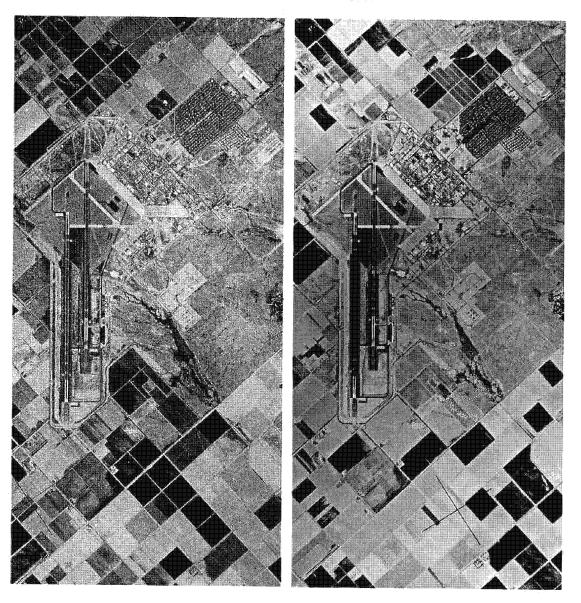
COMPOSITE OF MISSIONS 1205-5 AND 1206-5

Terrain camera: 1205-5—Op 152; frame 004/1206-5—Op 054; frame 003; Luke AFB, Phoenix, Arizona; 10× enlargement*

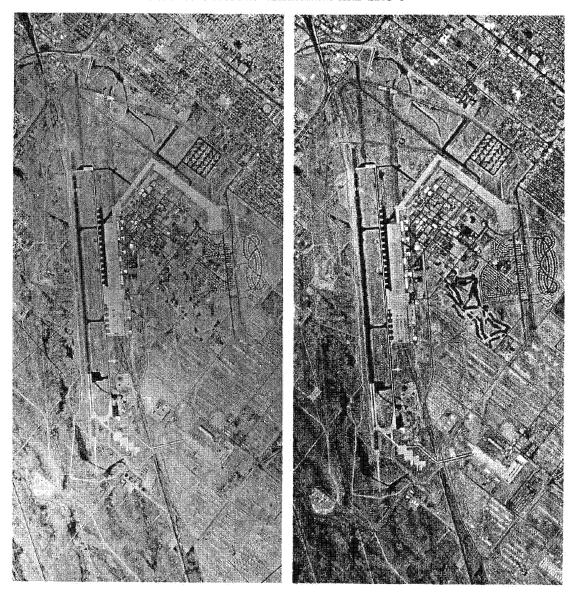
FIGURE 2-8

COMPOSITE OF MISSIONS 1207-5 AND 1208-5

Terrain camera: 1207-5—Op 076; frame 006/1208-5—Op 037; frame 006; Davis Monthan AFB, Tuscon, Arizona; 10× enlargement*
*Image size is a function of altitude.
