26 June 1963

PRELIMINARY FLIGHT SUMMARY REPORT

FTV 1161 CM 21

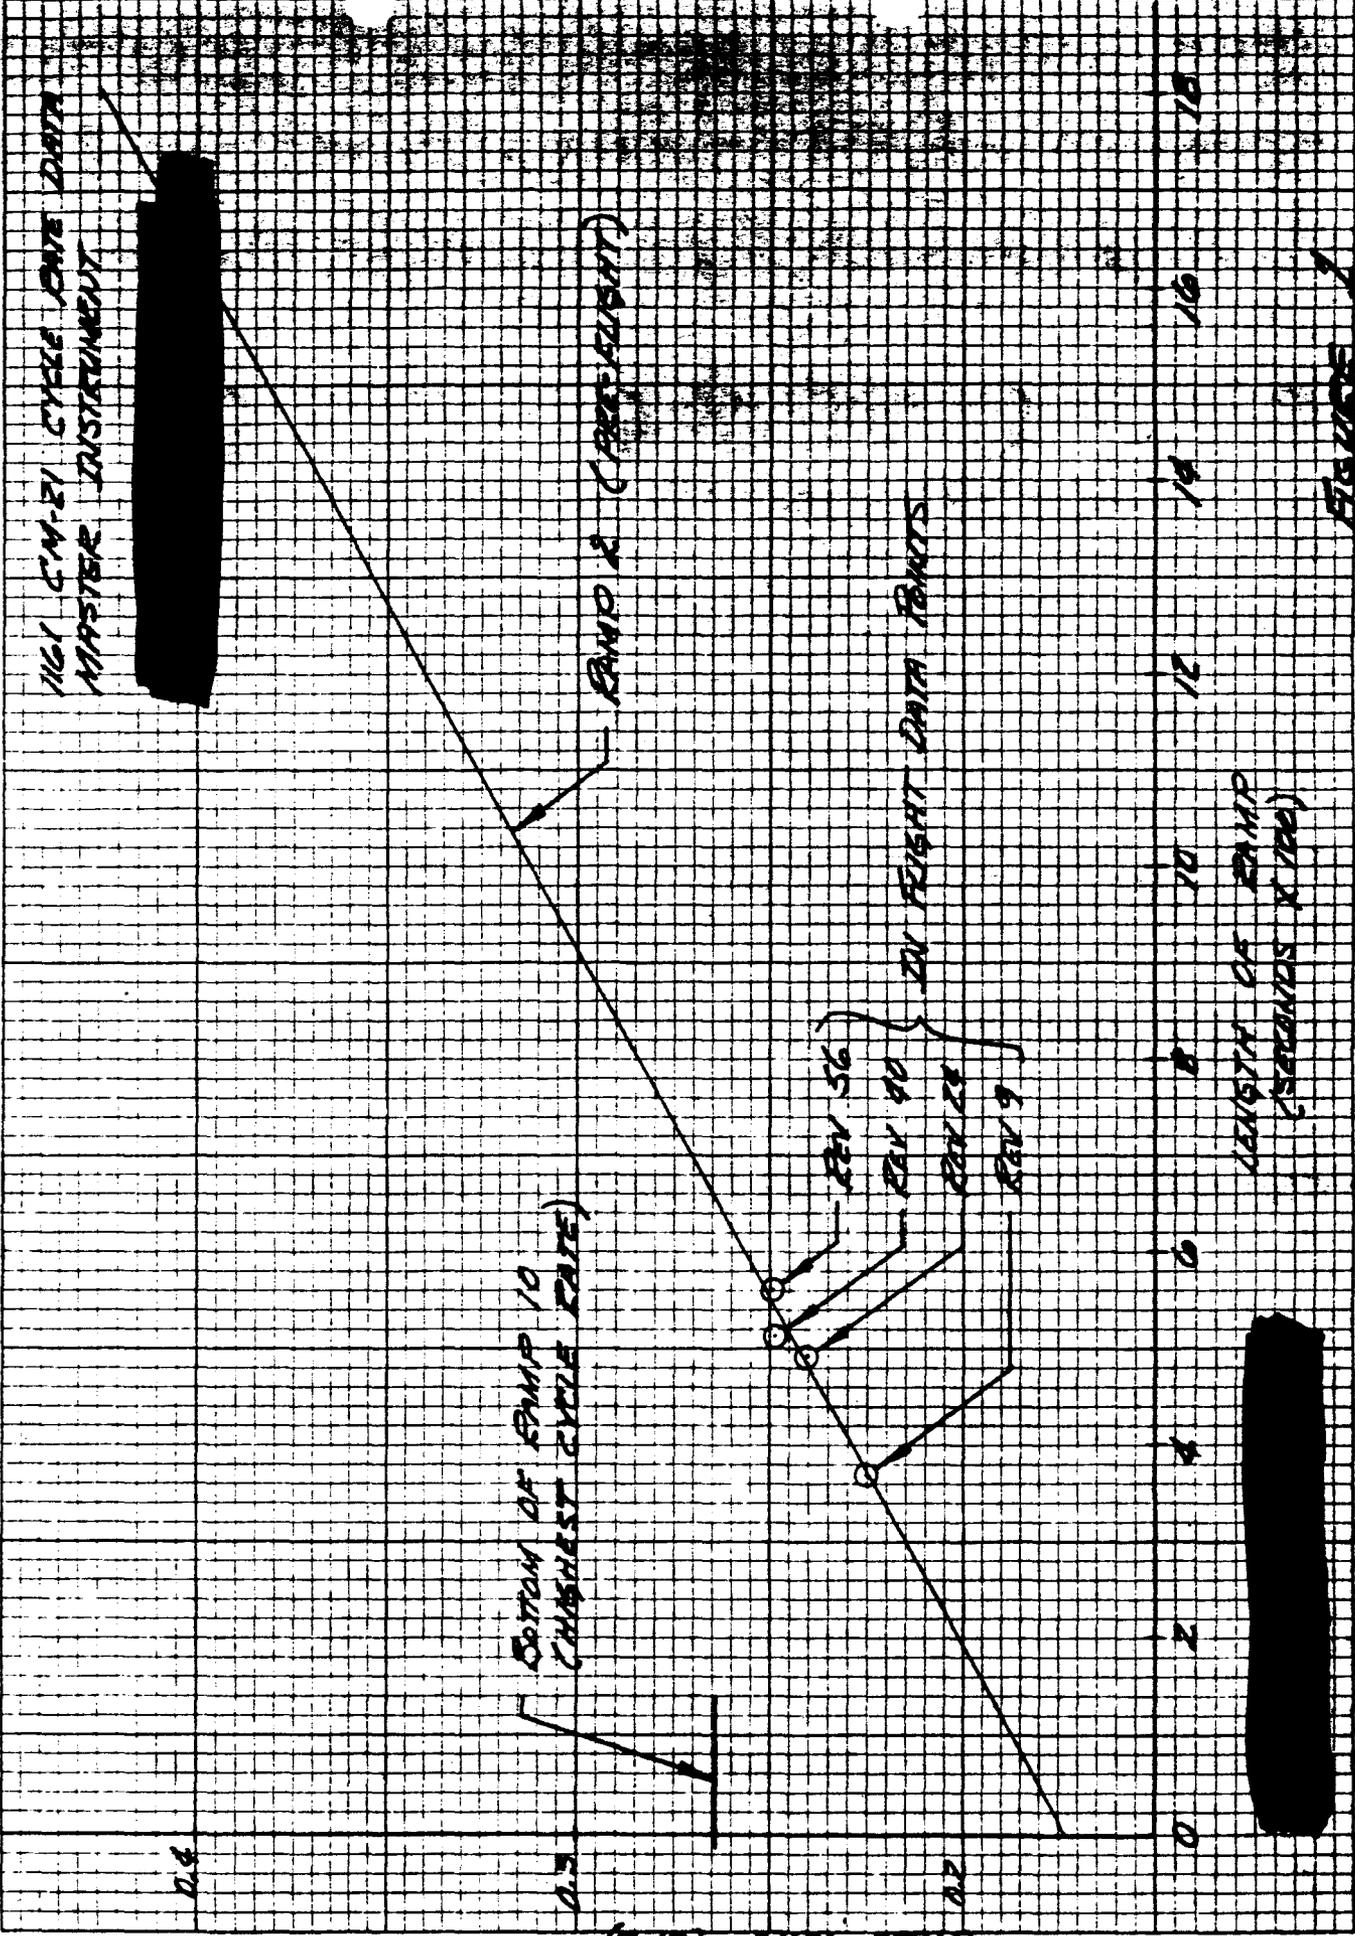
FIGURE 1

161 CM-21 CYCLE RATE DATA
MASTER INSTRUMENT

BOTTOM OF RAMP 10
(HIGHEST CYCLE RATE)

RAMP 2 (PREVIOUS)

IN FLIGHT DATA POINTS

REV 36
REV 40
REV 28
REV 9

Operation of the panoramic instruments appeared satisfactory with no dynamic problems evident in the telemetry data. The cycling periods of both instruments were very near nominal on all engineering operations observed on telemetry. Plots of the pre-flight and inflight cycle rates are included in the appendix.

Four engineering operations, orbits 9, 24, 40, and 56 were monitored by telemetry, all within 600 seconds of the bottom of ramp 2. The telemetered lens rotation monitor indicated the lens rotated past the home or stowed position by approximately 10 to 15 degrees on all four operations. The maximum cycle rate possible at the bottom of a ramp was on ramp 10. The cycle rate at the bottom of ramp 10 corresponds to the cycle rate on ramp 2 at a time of 660 seconds after programmer start (see cycle rate data in Appendix). By extrapolation it appears that the lens would have been in a safe position (10 degrees before home to 20 degrees past home) for protection during retro rocket ignition at the end of an operation run at the bottom of any ramp.

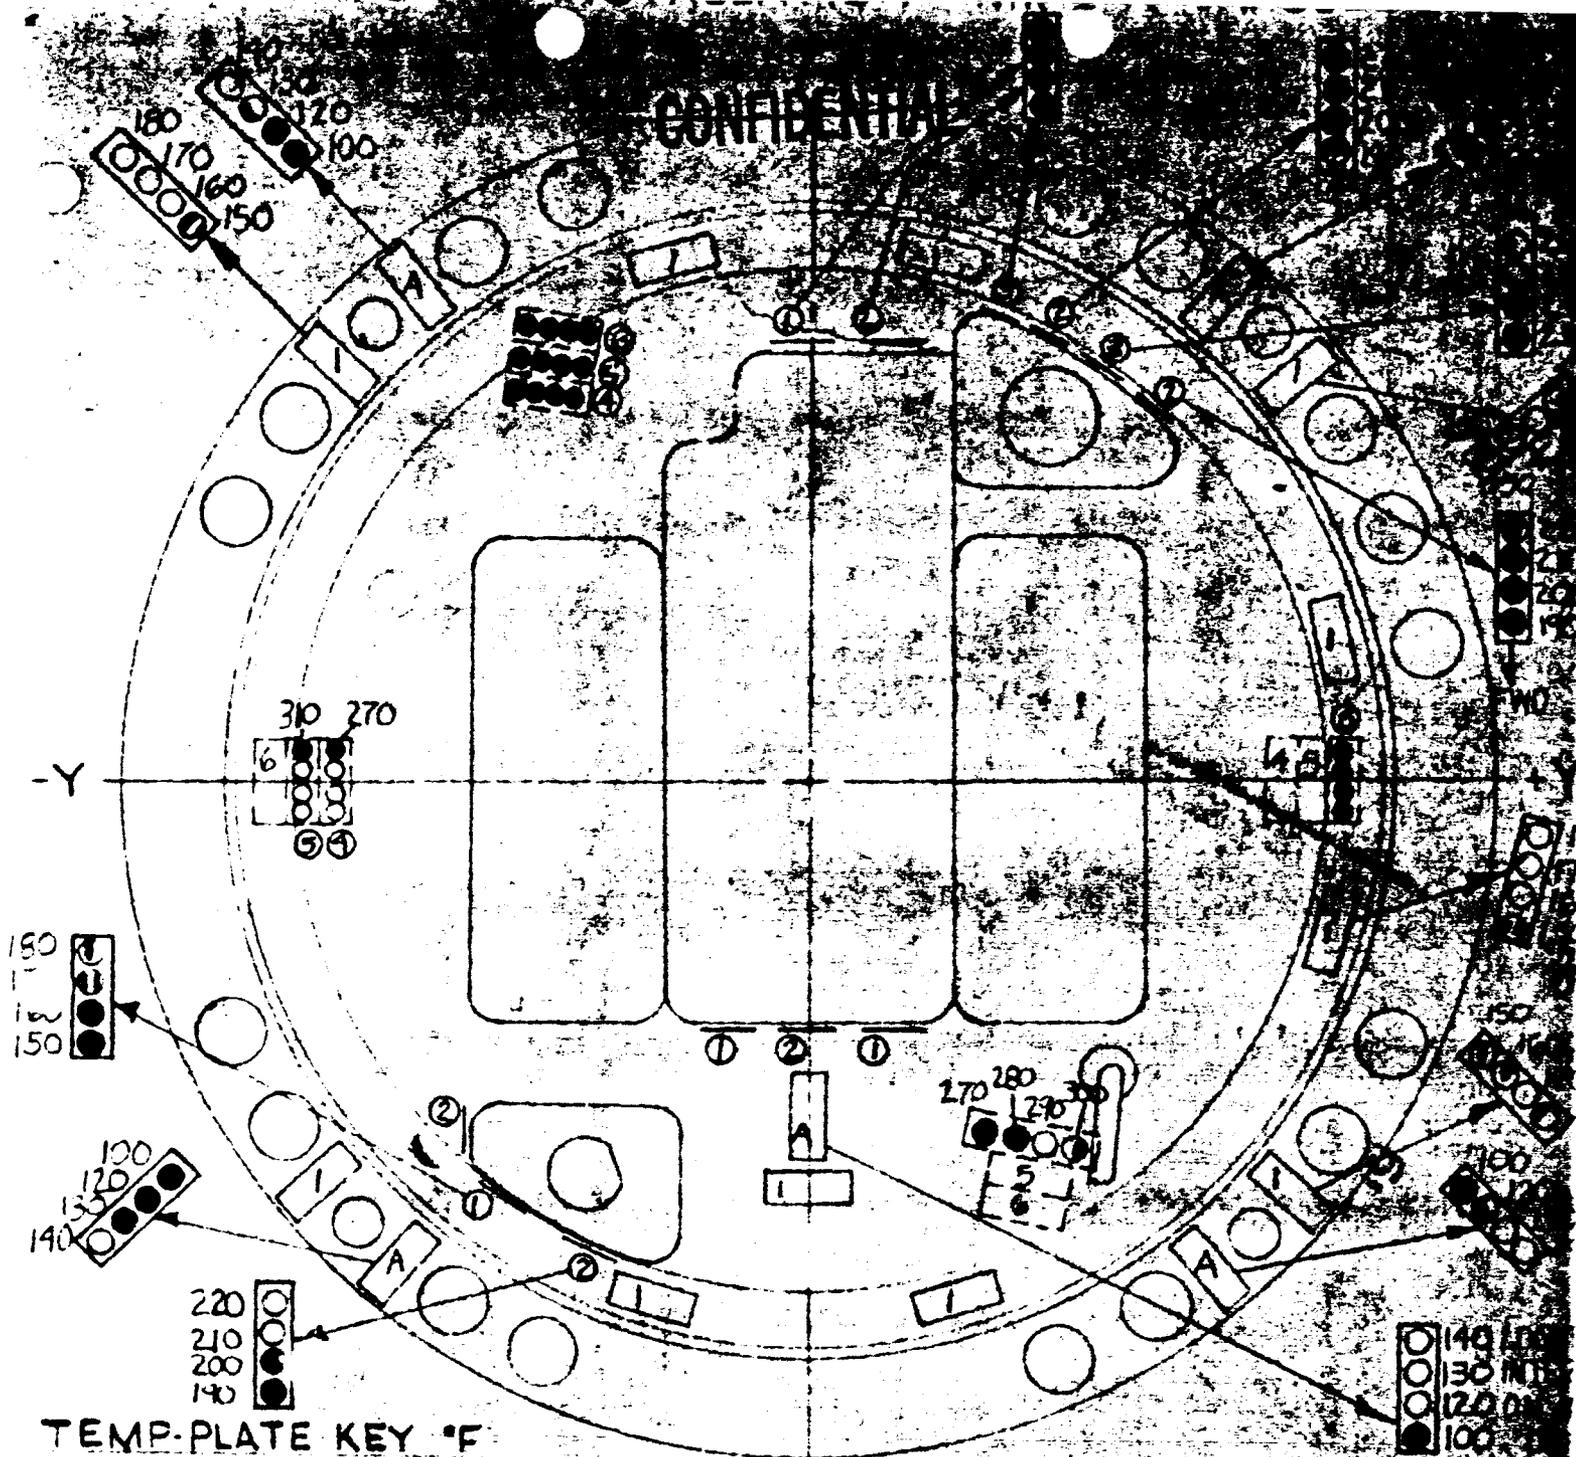
TEMP-PLATE KEY °F

- A - 100-120-130-140
- 1 - 150-160-170-180
- 2 - 190-200-210-220
- 3 - 230-240-250-260
- 4 - 270-280-290-300
- 5 - 310-320-330-340
- 6 - 350-360-370-380
- 7 - 390-410-435-450

LOOKING FORWARD
VEHICLE 1161

(16TH USE OF TEMP-PLATES)

● INDICATOR TURNED ON
TEMP REACHED OR EXCEEDED
INDICATED LEVEL

▬ TEMP-PLATE LOCATED
ON PARACHUTE RISER

The recovered capsule (serial No. USE 616 blossom serial No. 68) showed no signs of damage due to re-entry or air catch. Diagrams showing the location of temp-plates and the temperatures encountered during re-entry and a plot of the re-entry trajectory are presented in the Appendix.
