PHOTOGRAPHIC EVALUATION REPORT

MISSION 4009

6-8 JULY 1964

NATIONAL PHOTOGRAPHIC INTERPRETATION CENTER

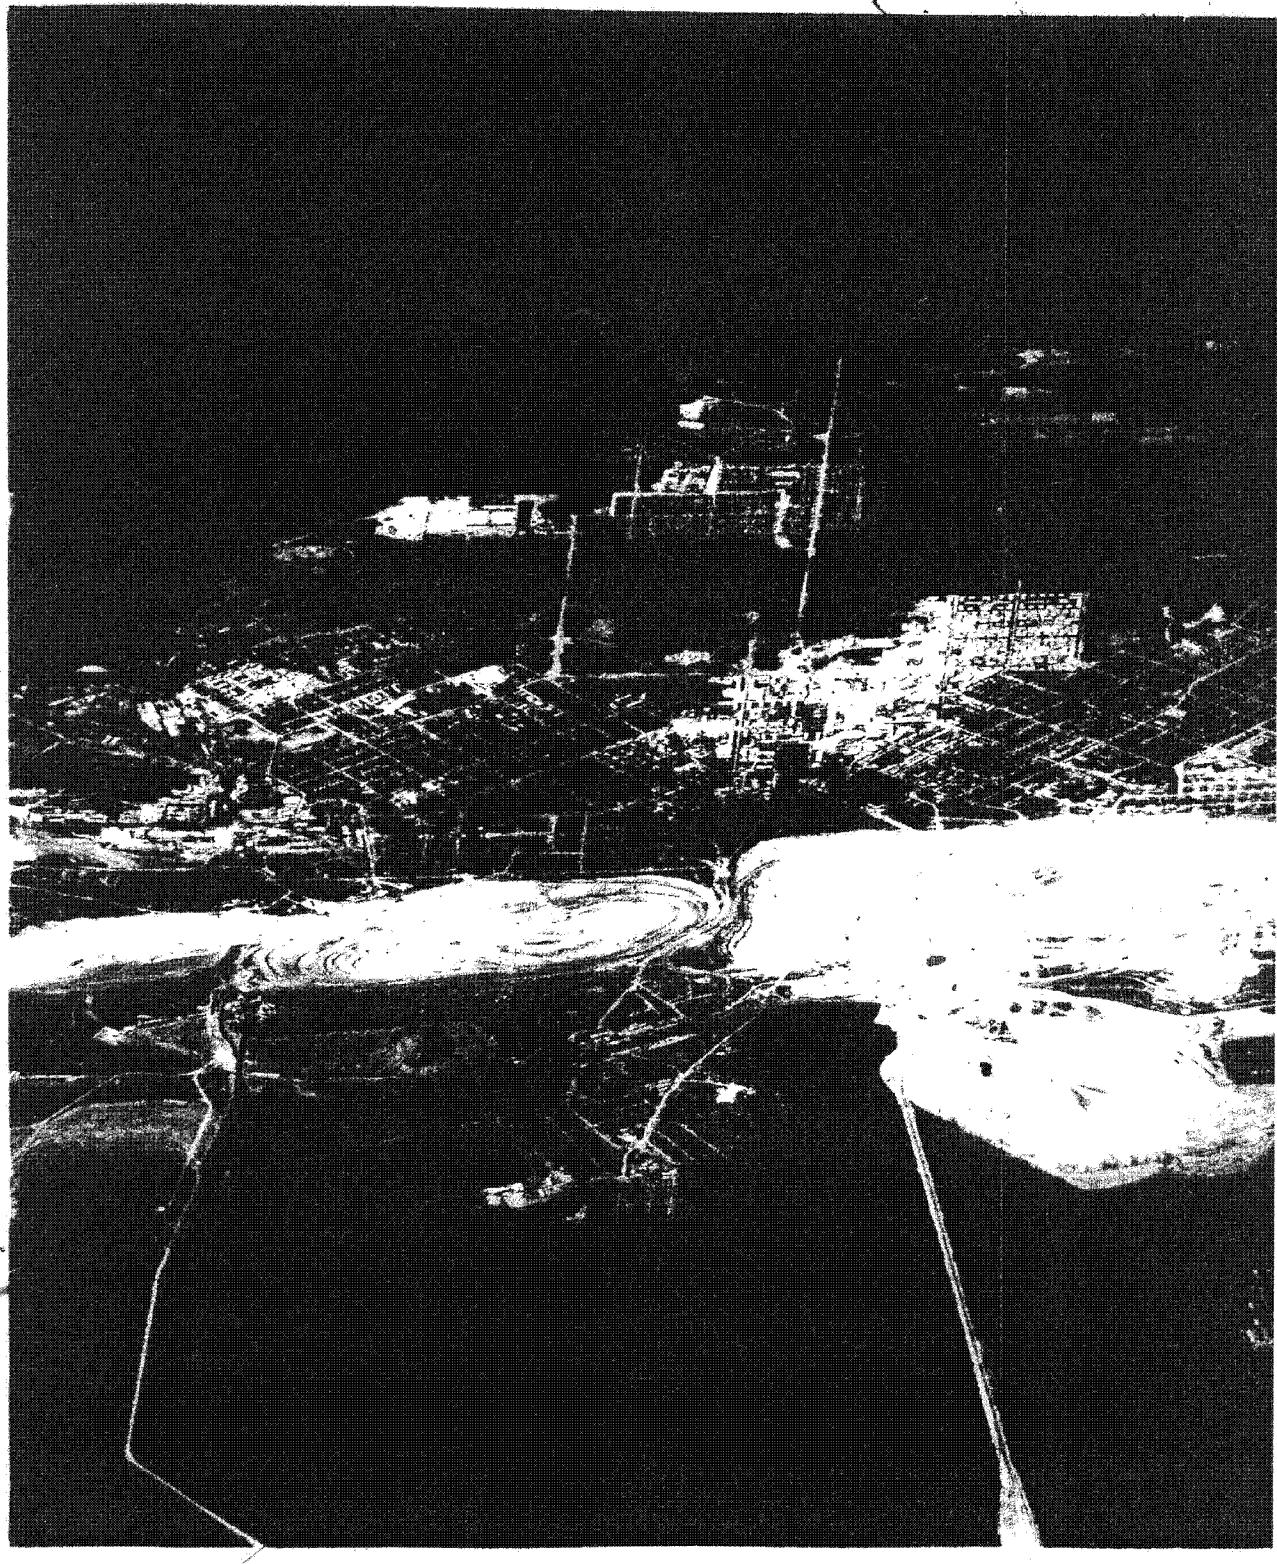
FIGURE 1. QUALITY OF PHOTOGRAPHY

Pass	1008
Frame	02
Planned Roll	-10
Actual Roll	-49
Pitch	-19
Yaw	Not Determined
Enlargement	3X

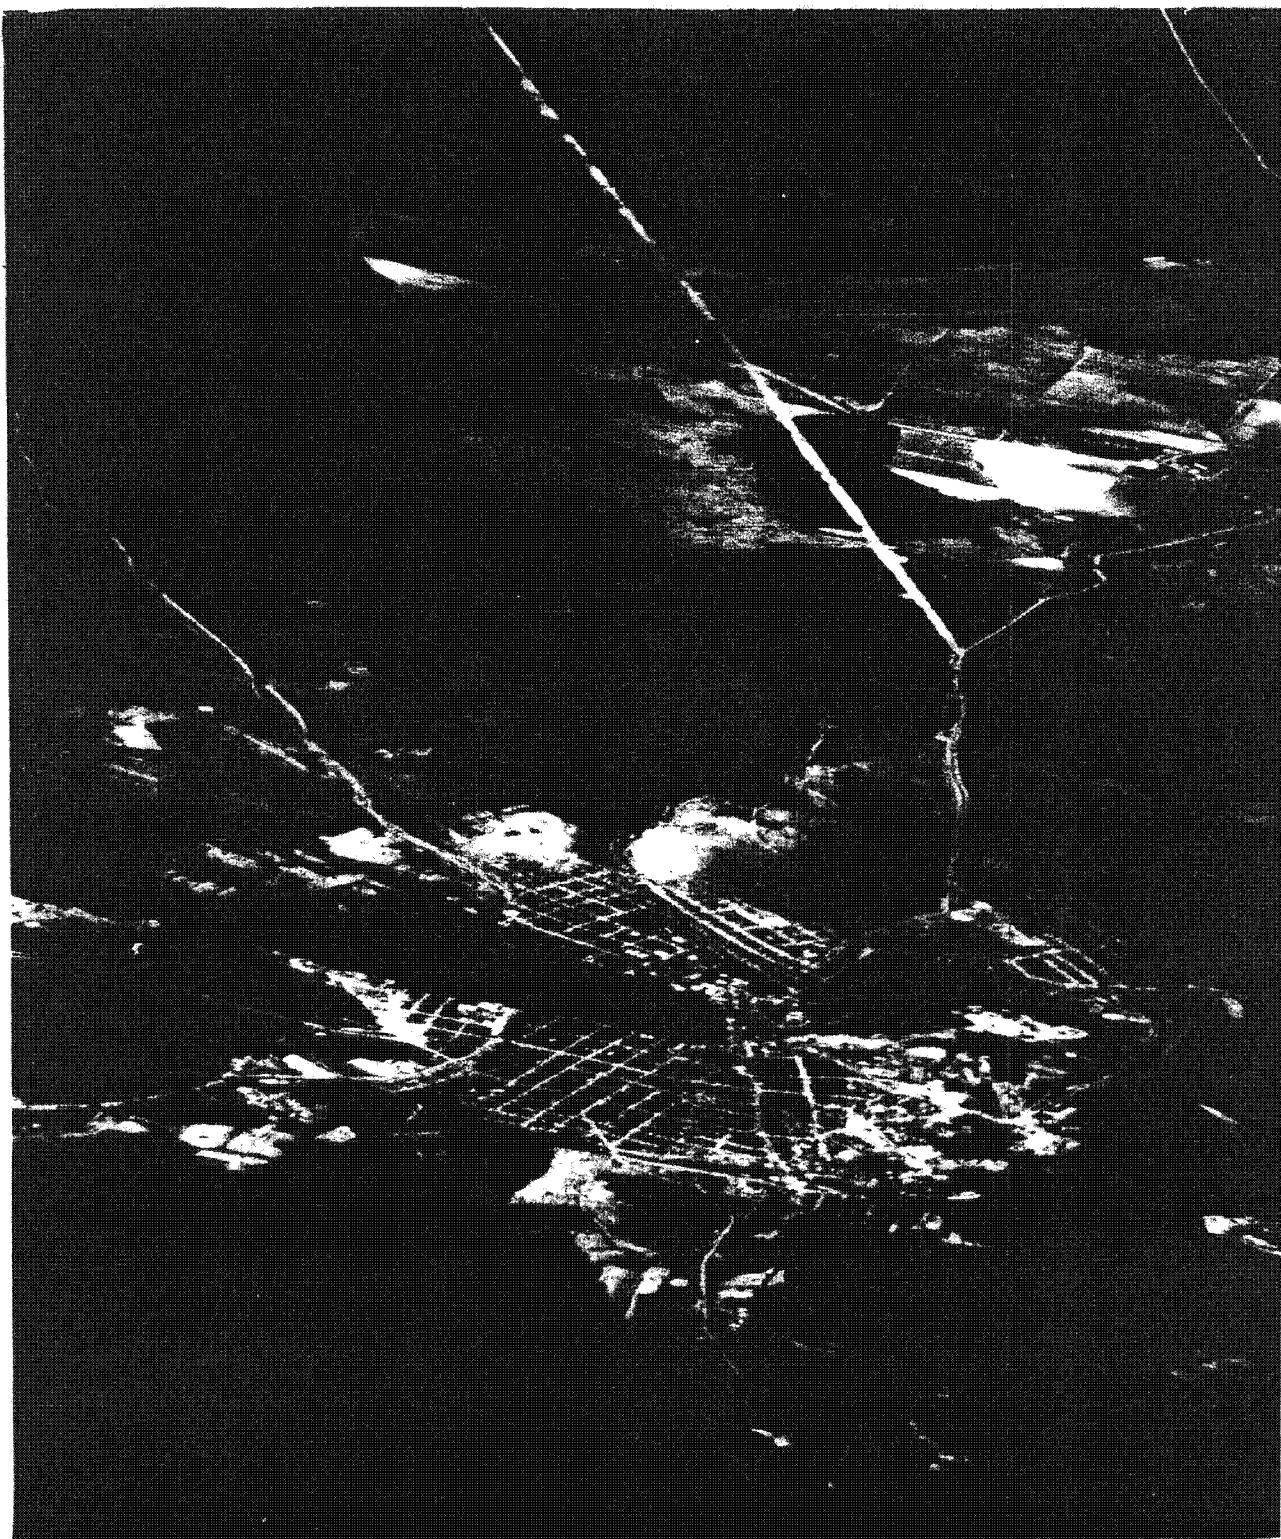
FIGURE 2. QUALITY OF PHOTOGRAPHY.

Pass 1008
Frame 03
Planned Roll 10°
Actual Roll -50°
Pitch -20°
Yaw Not Determined
Enlargement 3X

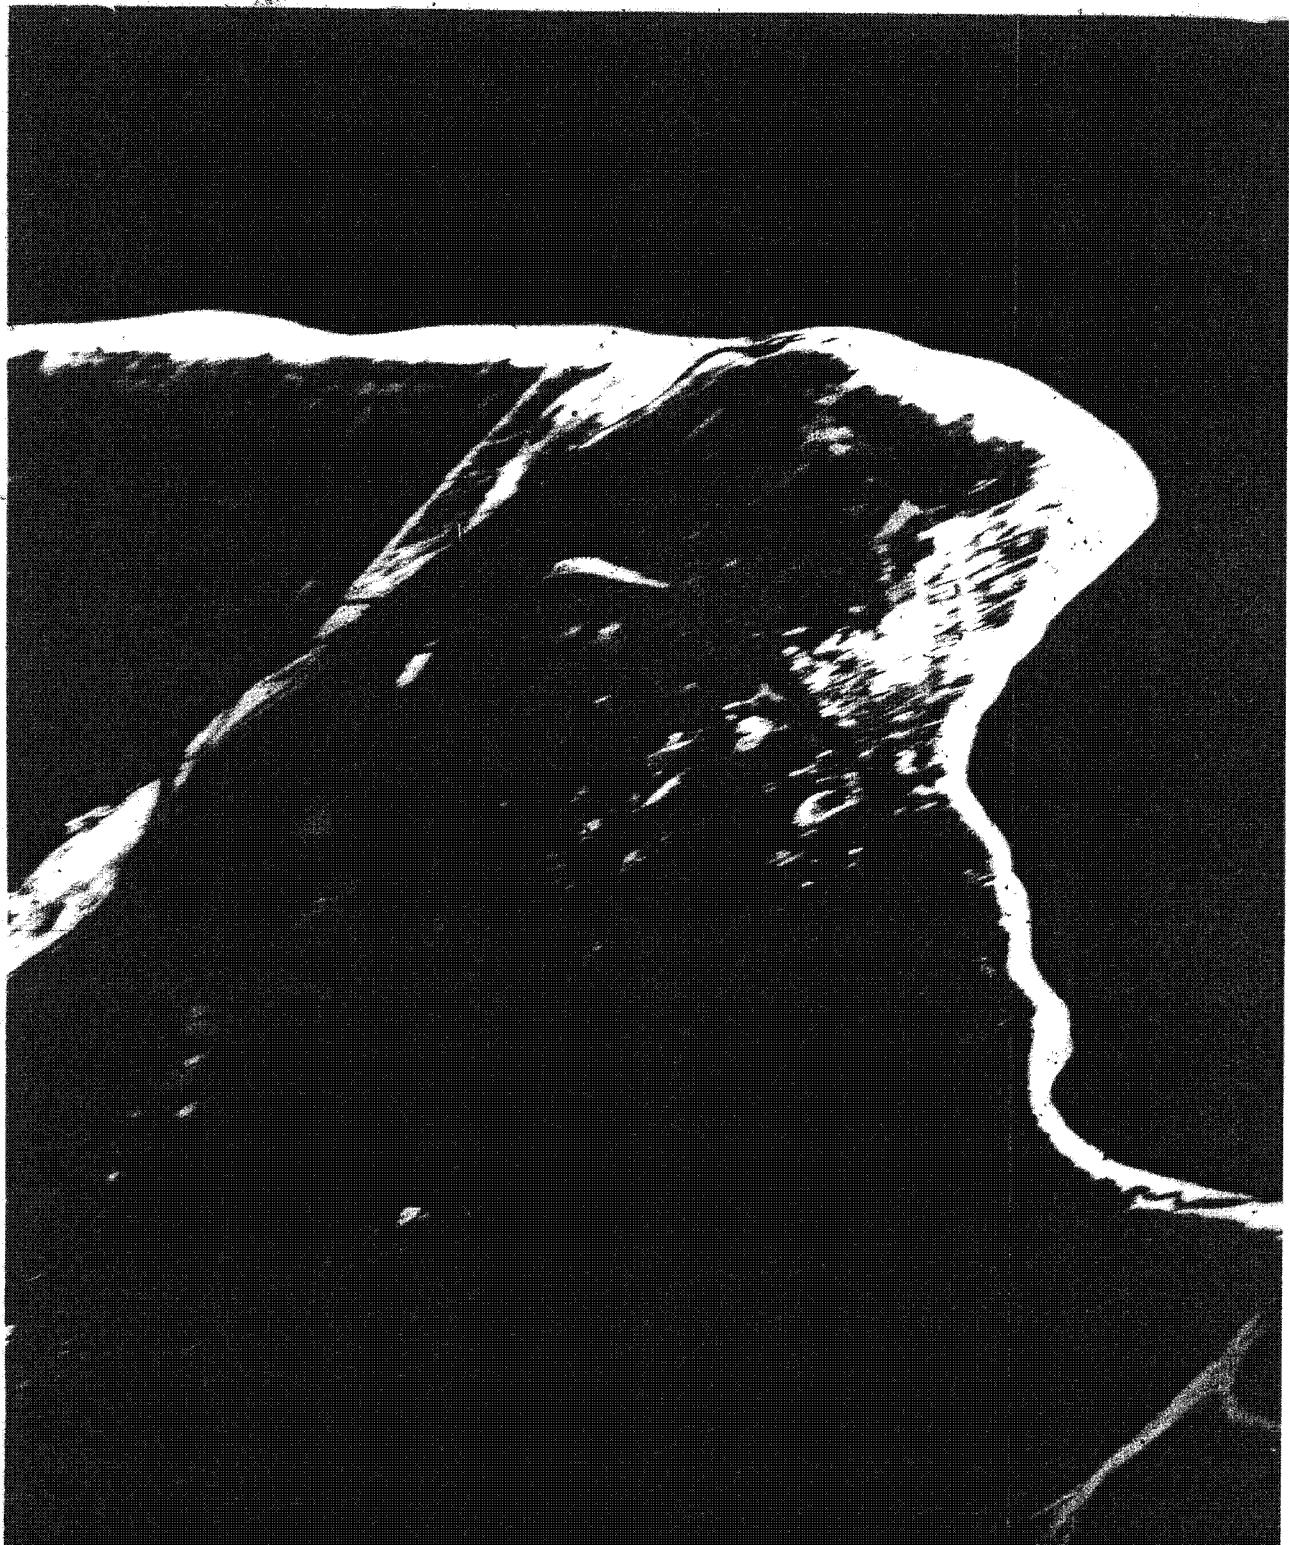
FIGURE 4. QUALITY OF PHOTOGRAPHY.

Pass 100
Frame 16
Planned Roll Not available
Actual Roll Not Determined
Pitch Not Determined
Yaw Not Determined
Enlargement 3X

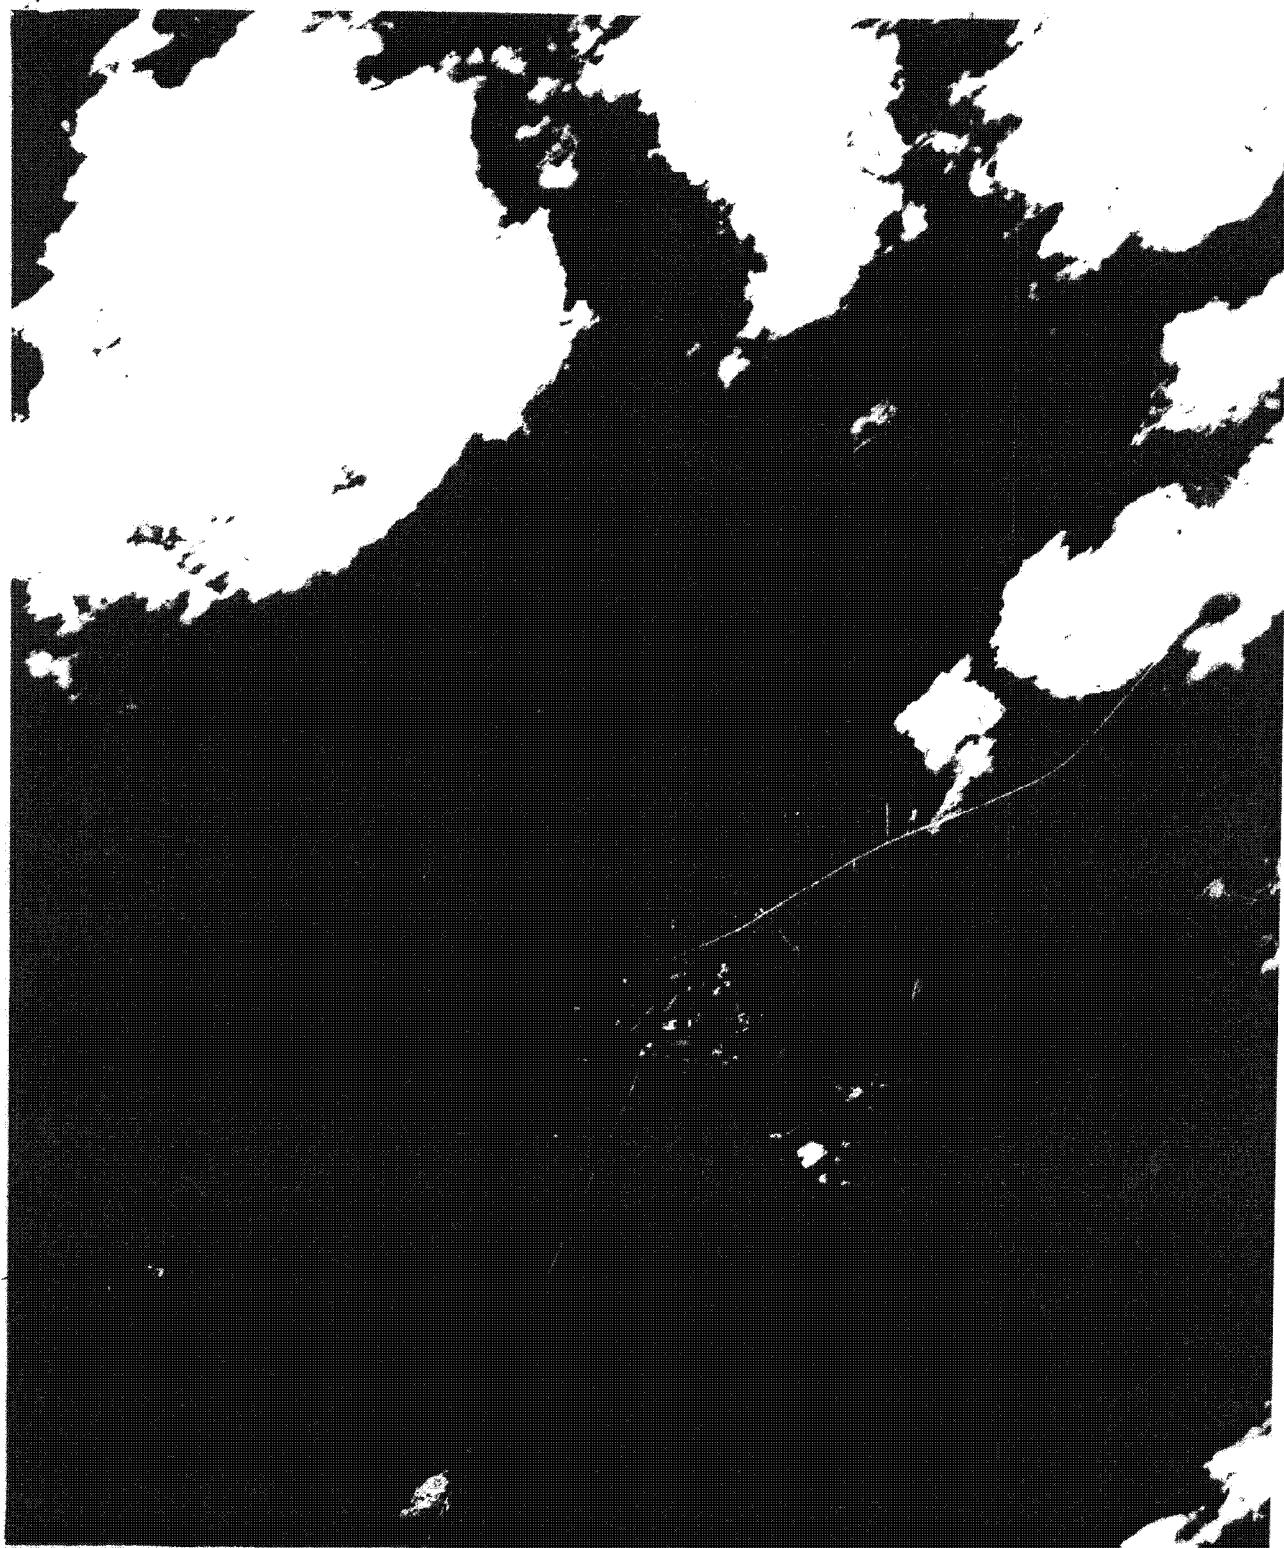
FIGURE 6. QUALITY OF PHOTOGRAPHY.

Pass	D26
Frame	03
Planned Roll	Not Available
Actual Roll	Not Available
Pitch	Not Available
Yaw	Not Available
Enlargement	3X

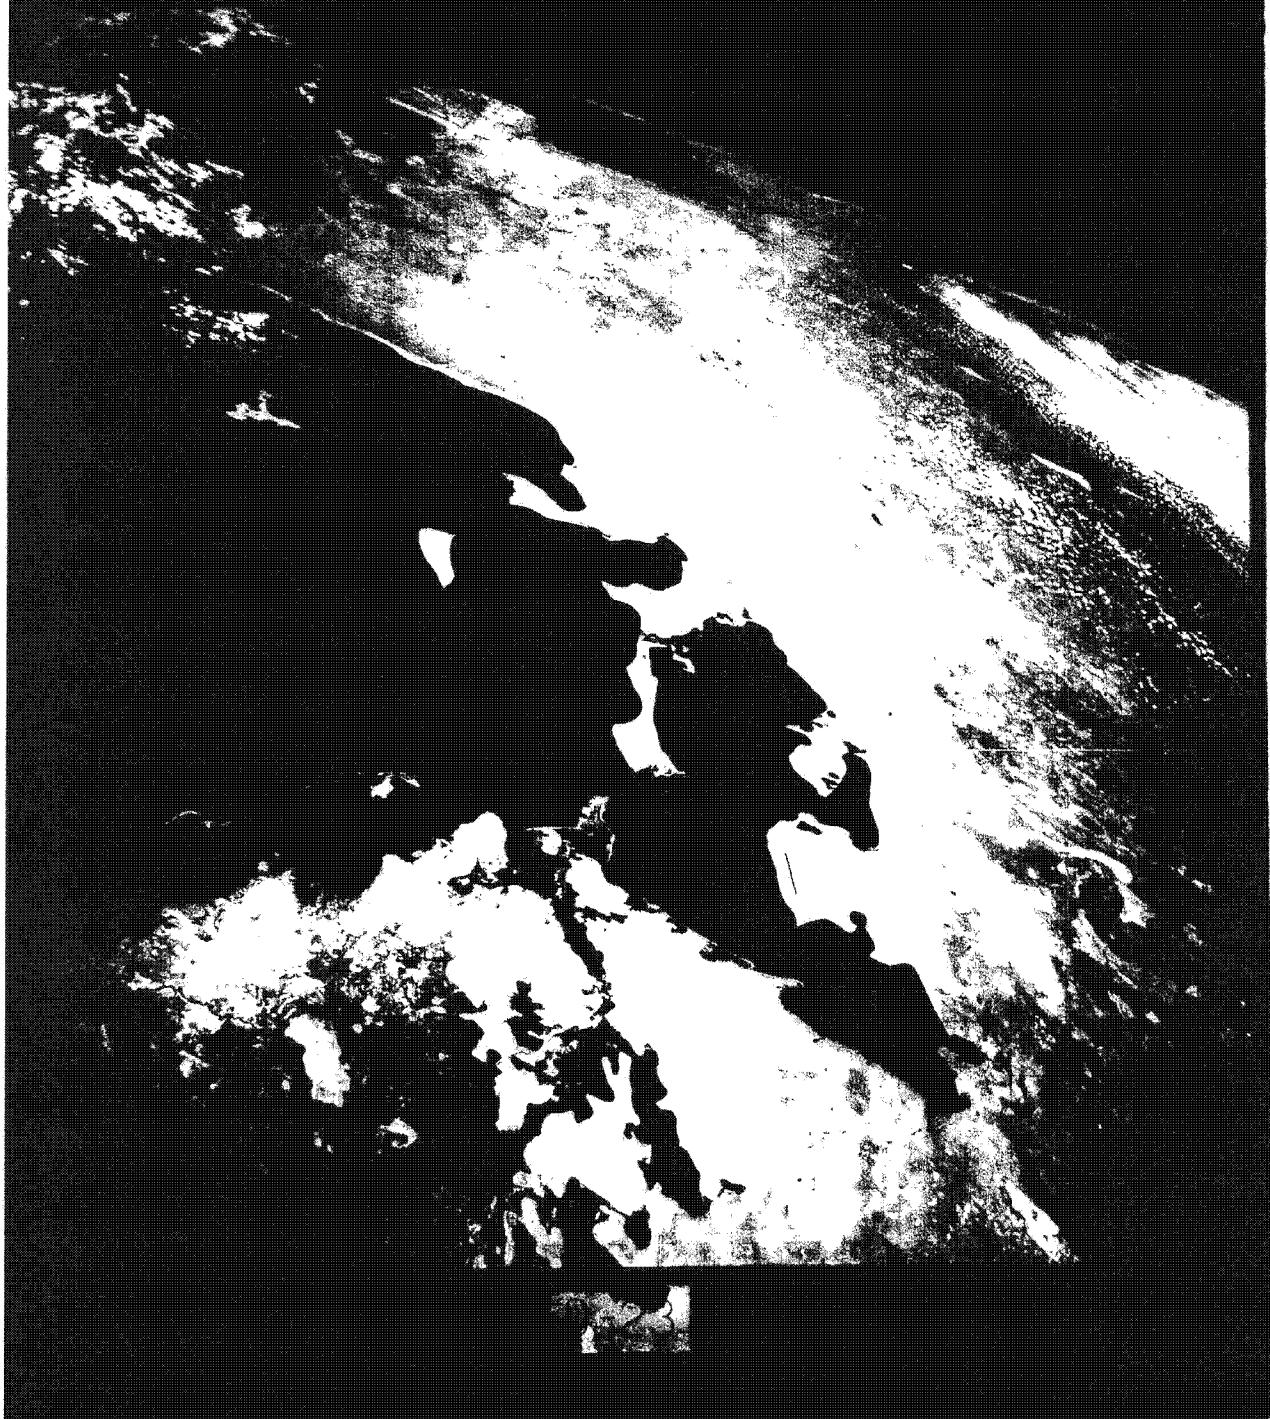
FIGURE 8. INDEX PHOTOGRAPHY.

Frame 025
Roll -3°
Pitch -24°
Yaw Not Determined
Enlargement 3X

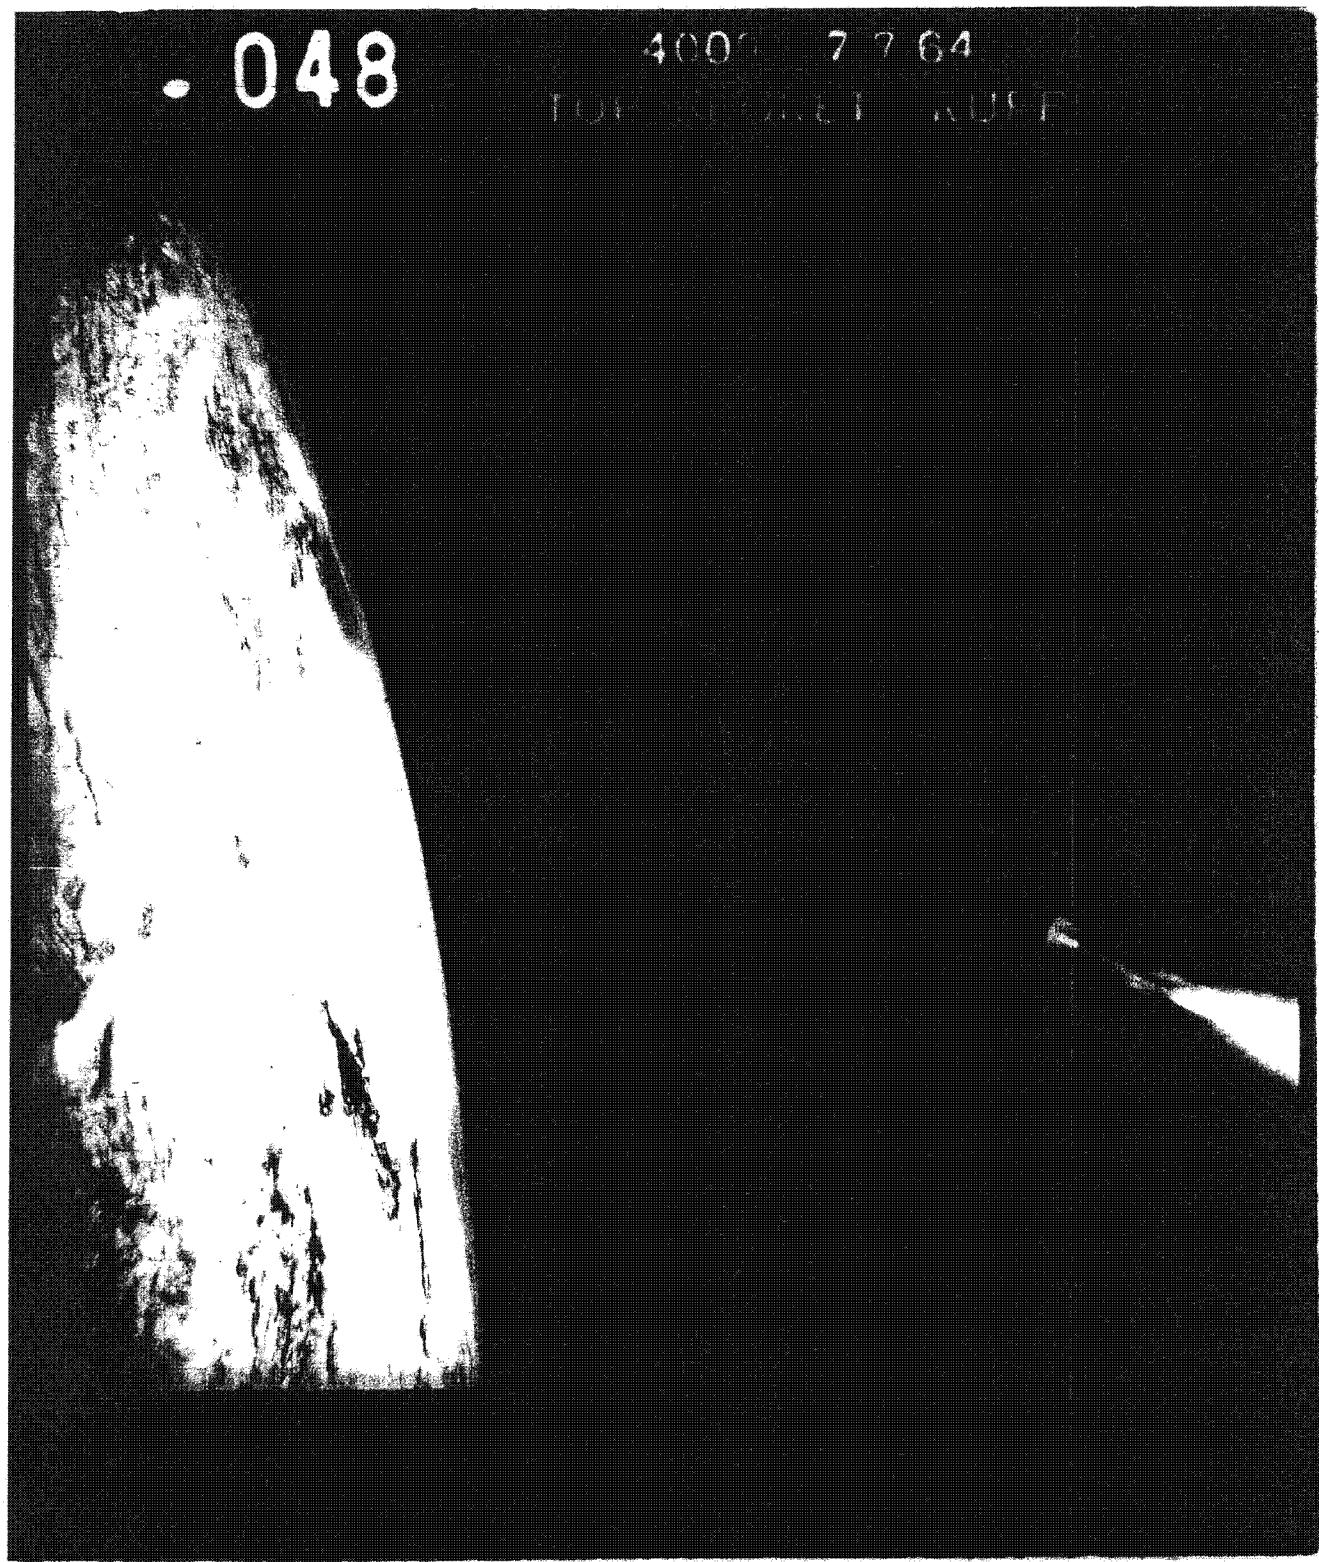
FIGURE 9. INDEX PHOTOGRAPHY.

Frame 048
Roll $\pm 11^\circ$
Pitch $\pm 92^\circ$
Yaw $\pm 180^\circ$
Enlargement 3X

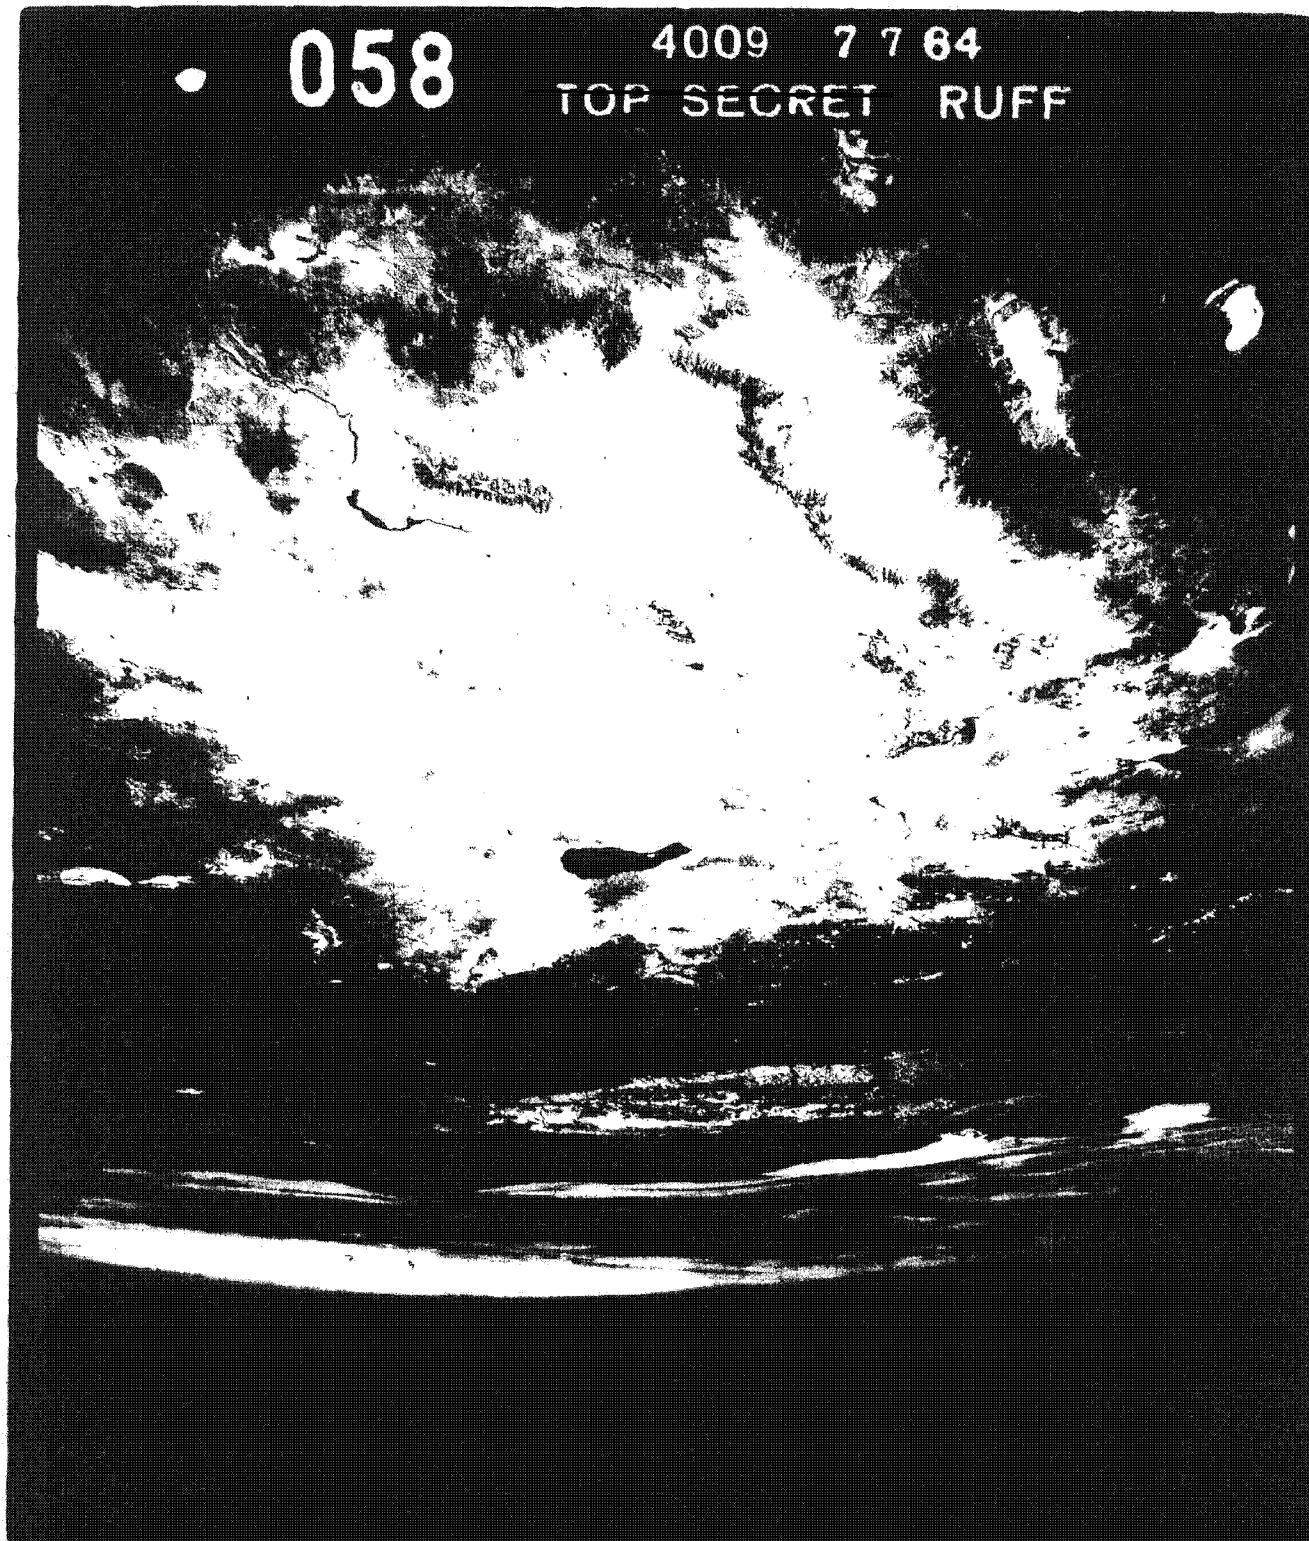
FIGURE 11. INDEX PHOTOGRAPHY.

Frame	058
Roll	44
Pitch	2.5
Yaw	±180
Enlargement	3X
