# **MISSION 1201**

## **SENSOR SUBSYSTEM POST FLIGHT ANALYSIS REPORT**

**PHOTO RECONNAISSANCE SYSTEMS DIVISION  
OFFICE OF SPECIAL PROJECTS**

30 SEPTEMBER 1971

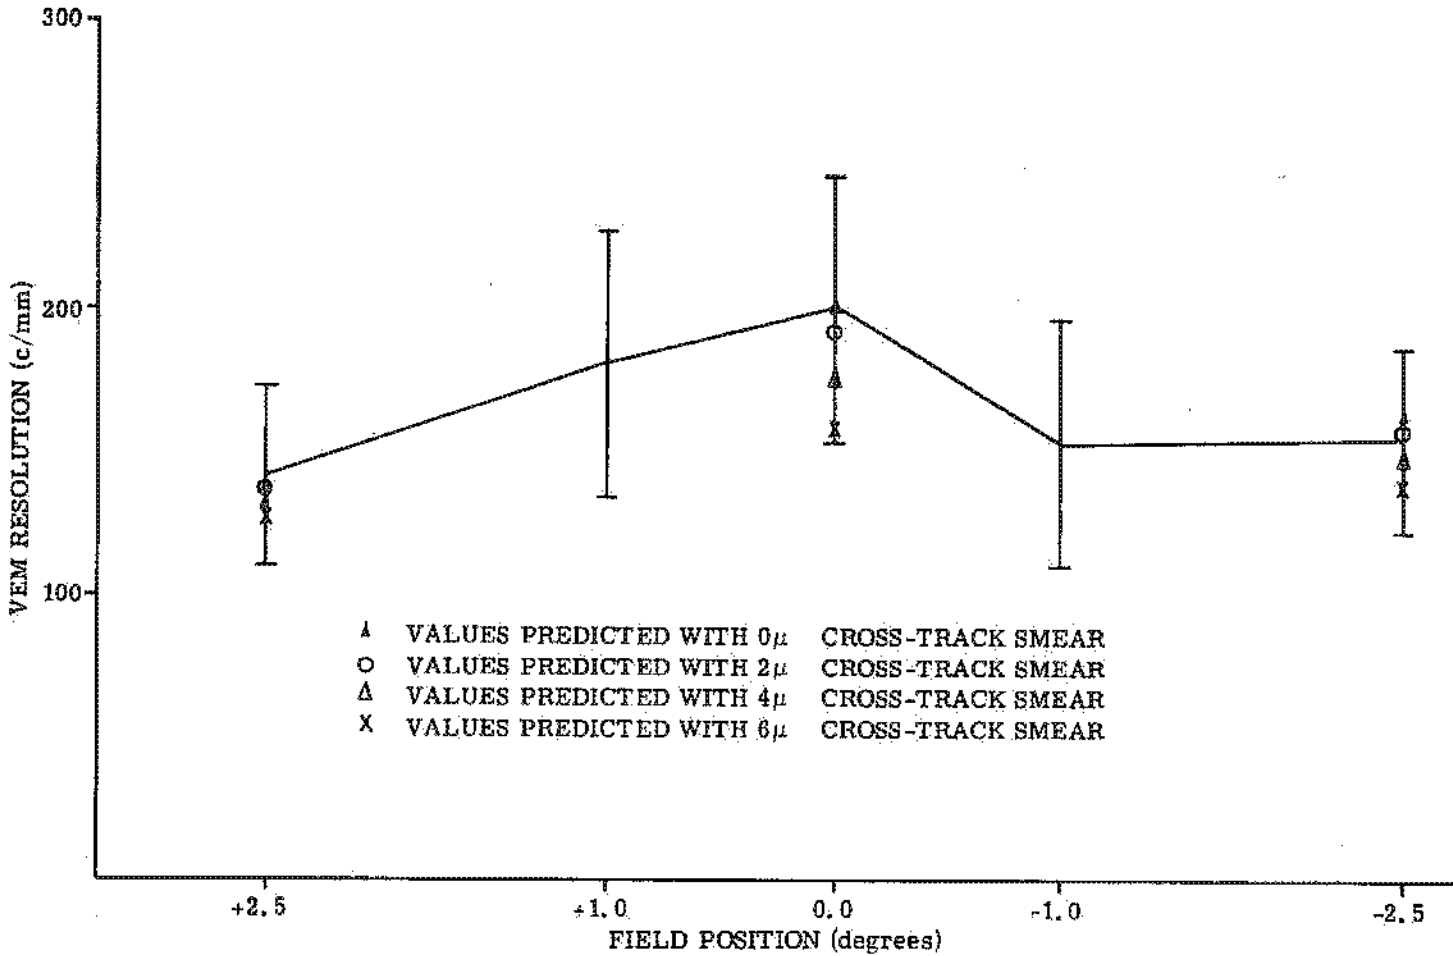
FIGURE 3-15

FORWARD CAMERA MINOR AXIS GEOMETRIC MEAN RESOLUTION PROFILE  
(84μ PLATEN POSITION, 15° SCAN ANGLE)

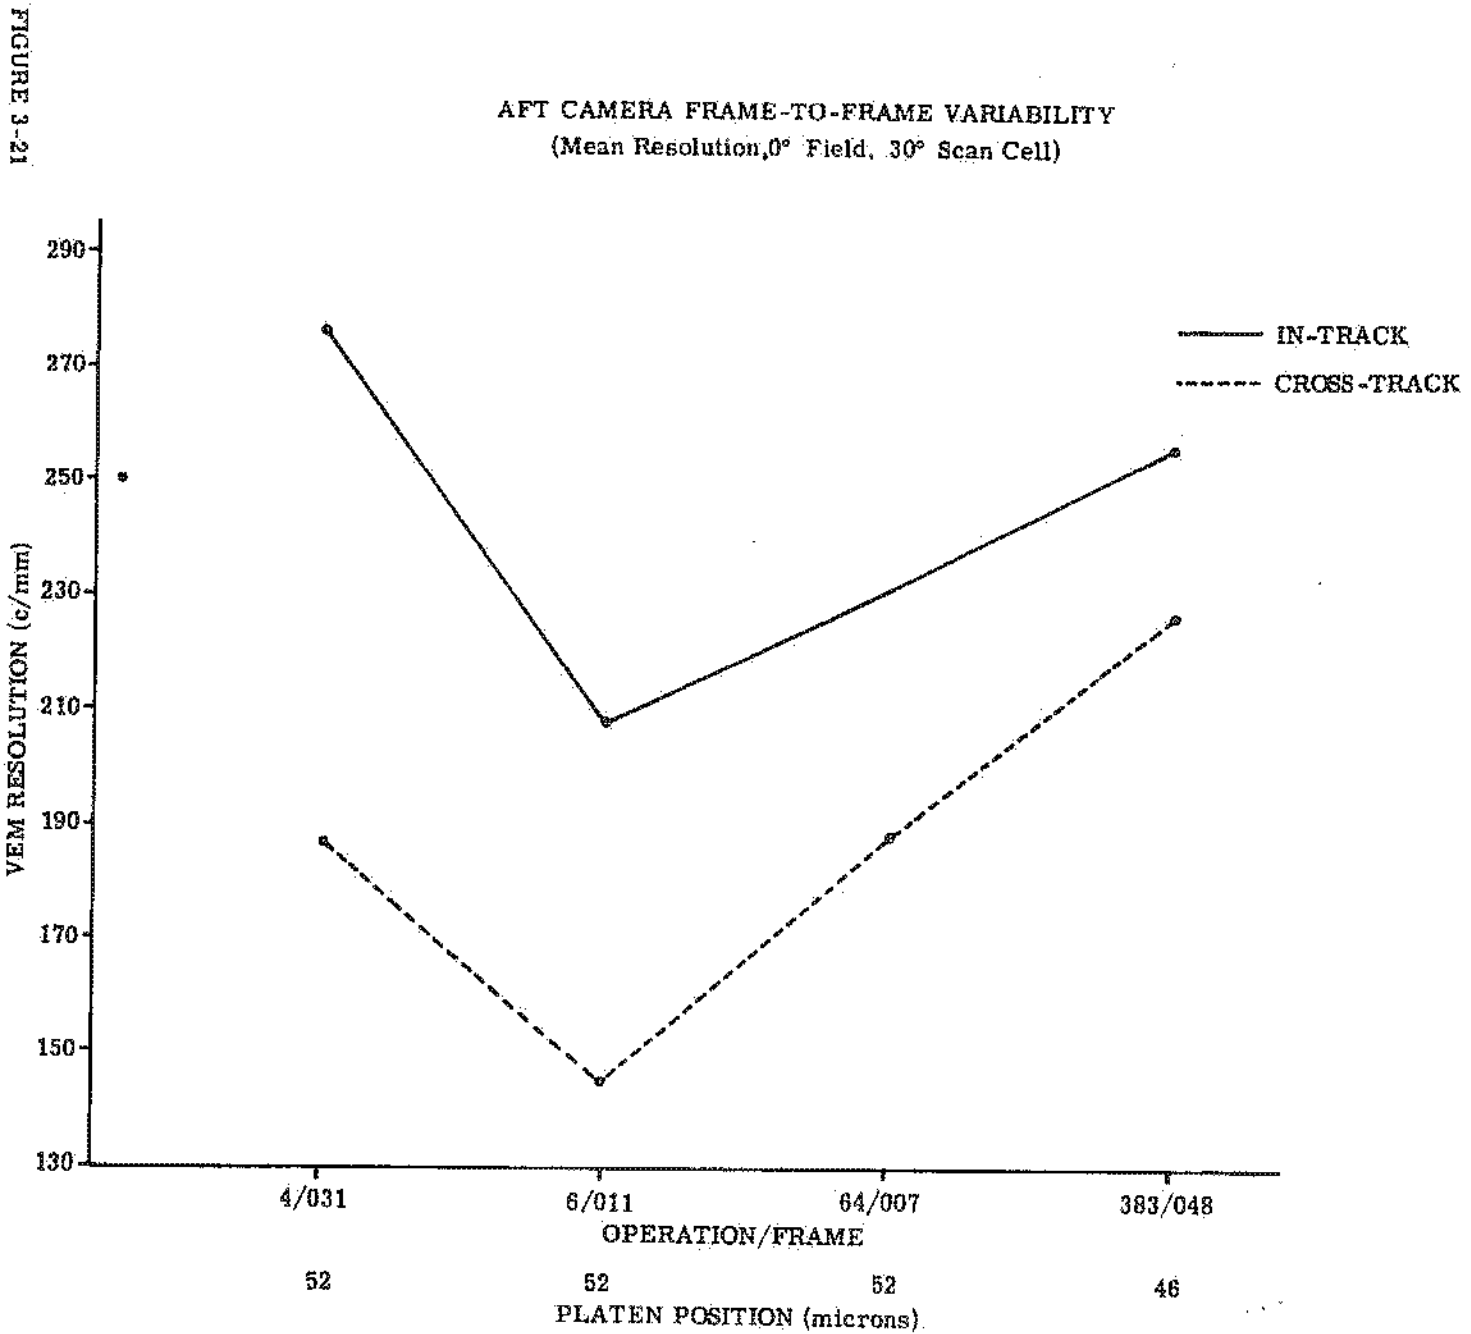
AFT CAMERA FRAME-TO-FRAME VARIABILITY  
(Mean Resolution, 0° Field, 30° Scan Cell)

Forward Camera		
Direction	Mission 1201	Chamber A-2
In-Track (c/mm)	150-240	190-250
Cross-Track (c/mm)	120-190	150-210
Aft Camera		
Direction	Mission 1201	Chamber A-2
In-Track (c/mm)	210-275	110-180
Cross-Track (c/mm)	145-225	50-170

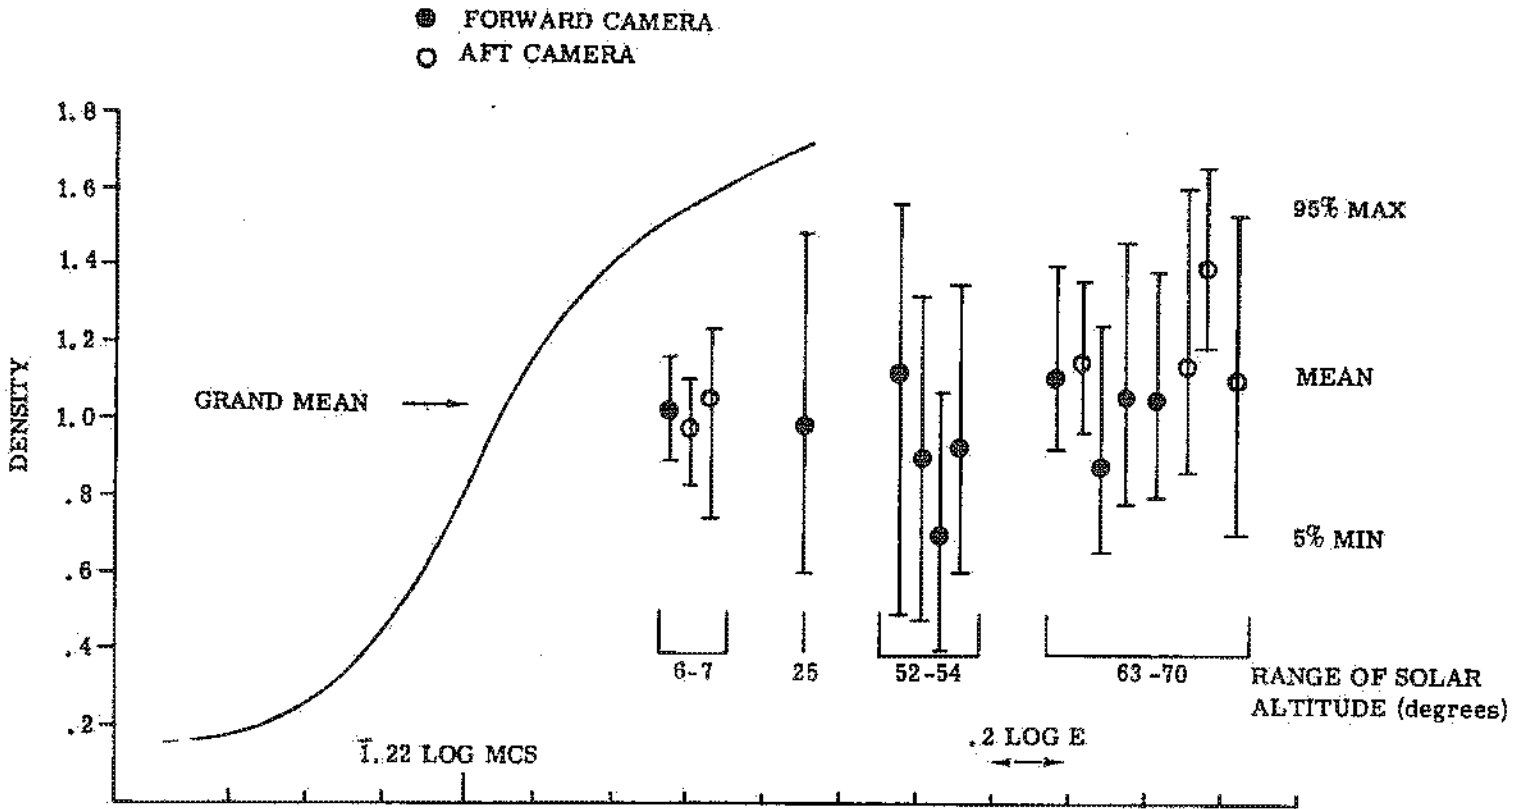
FIGURE 3-38

URBAN/INDUSTRIAL SCENE DENSITY DISTRIBUTIONS  
USING NOMINAL CORRECT EXPOSURE

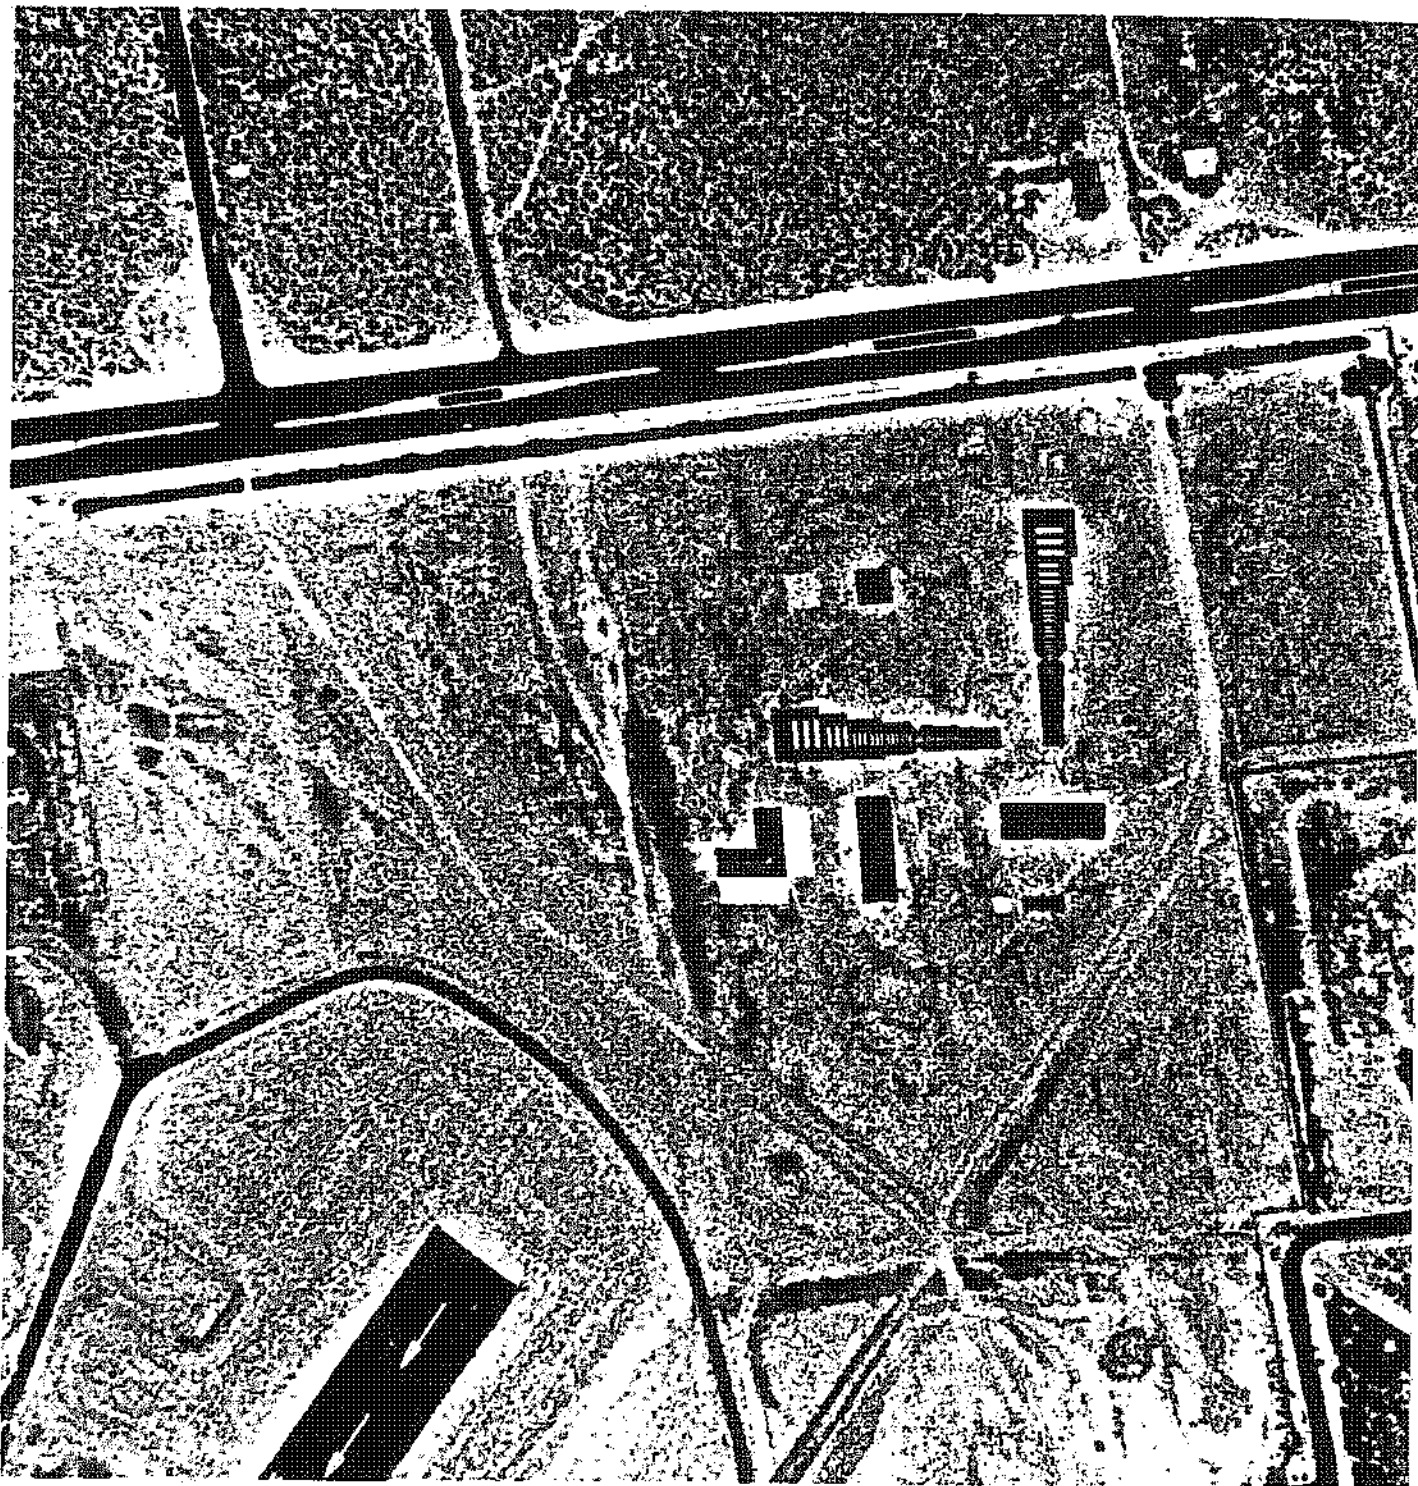
FIGURE 6-1

TYPICAL CORN TARGET DISPLAY

MISSION 1201-4 FWD CAMERA OP 384 FRAME 002

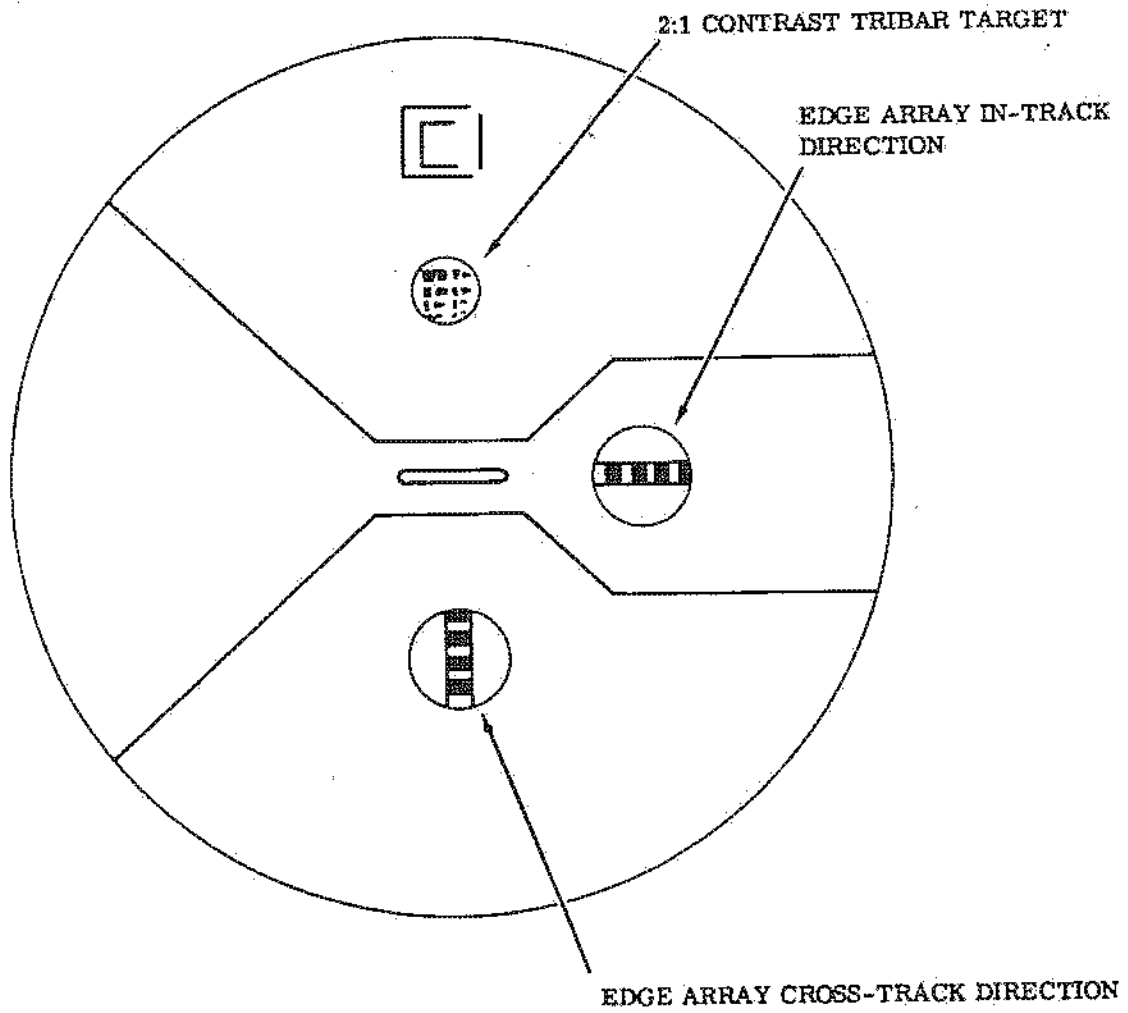
FIGURE 6-21

EDGE AND TRIBAR TARGETS IN TEST RETICLE
