21 October 1963

REPORT

CORONA J FLIGHT REPORT

PTV 1163

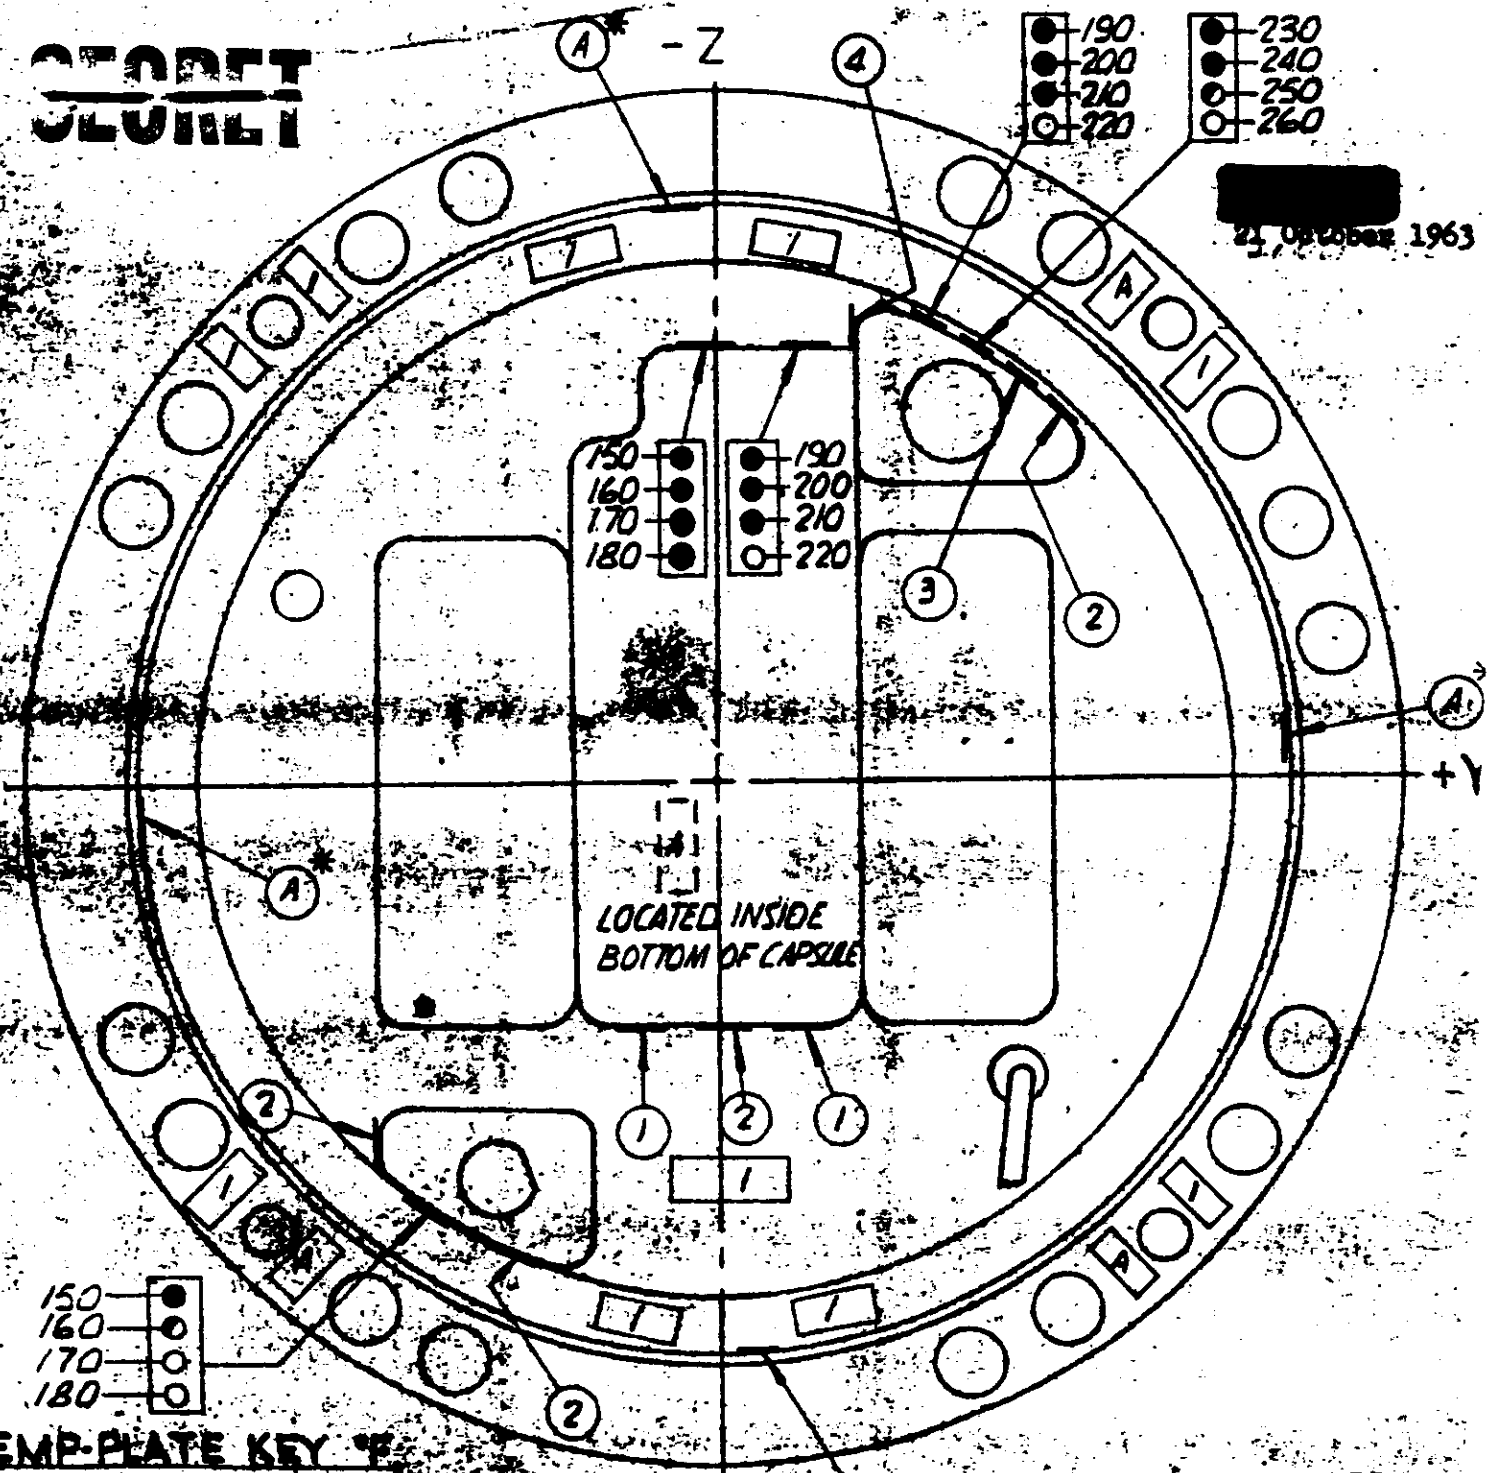
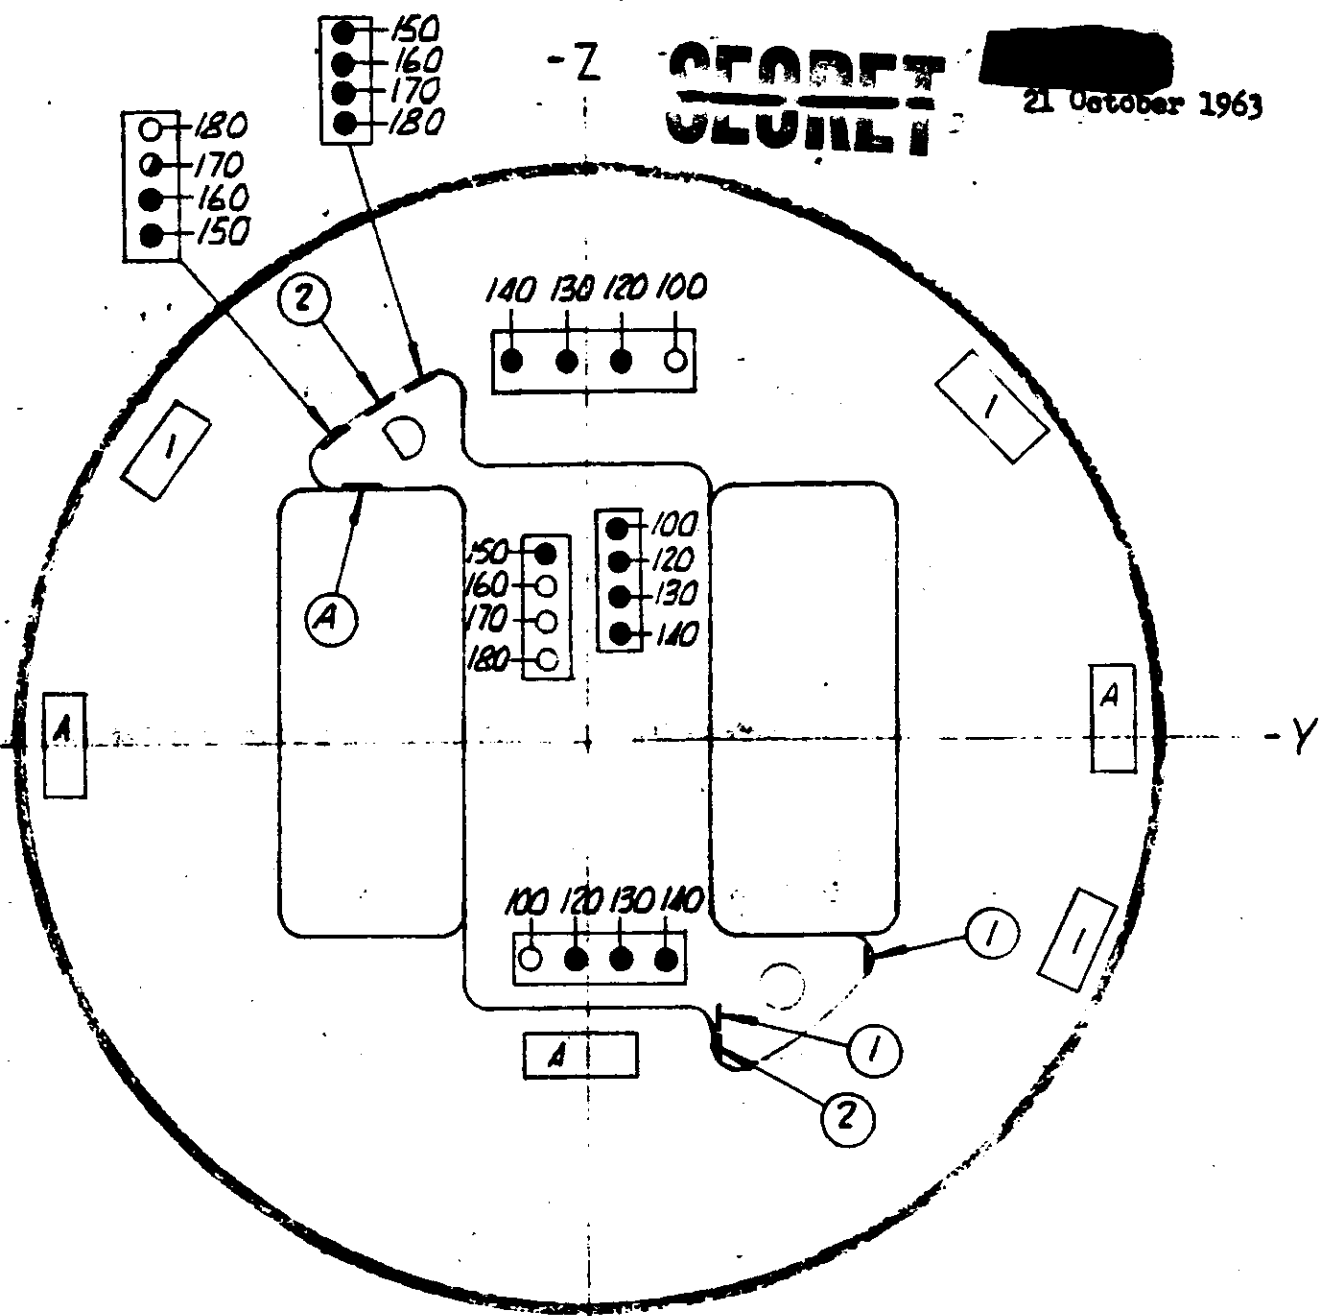
FIGURE 7.
(SHT 2 OF 2)

within tolerance. Parachute events were derived from accelerometer data and are subject to interpretation errors. The condition of the recovery capsule was satisfactory, with damage limited to normal paint blistering. Figure 7 diagrams the location and temperatures encountered by the templates attached to the recovery system cover. A re-entry sequence of events is included in table 3.
