CORONA J

PERFORMANCE EVALUATION REPORT

MISSION 1046-1 and 1046-2

FTV 1638, J-48

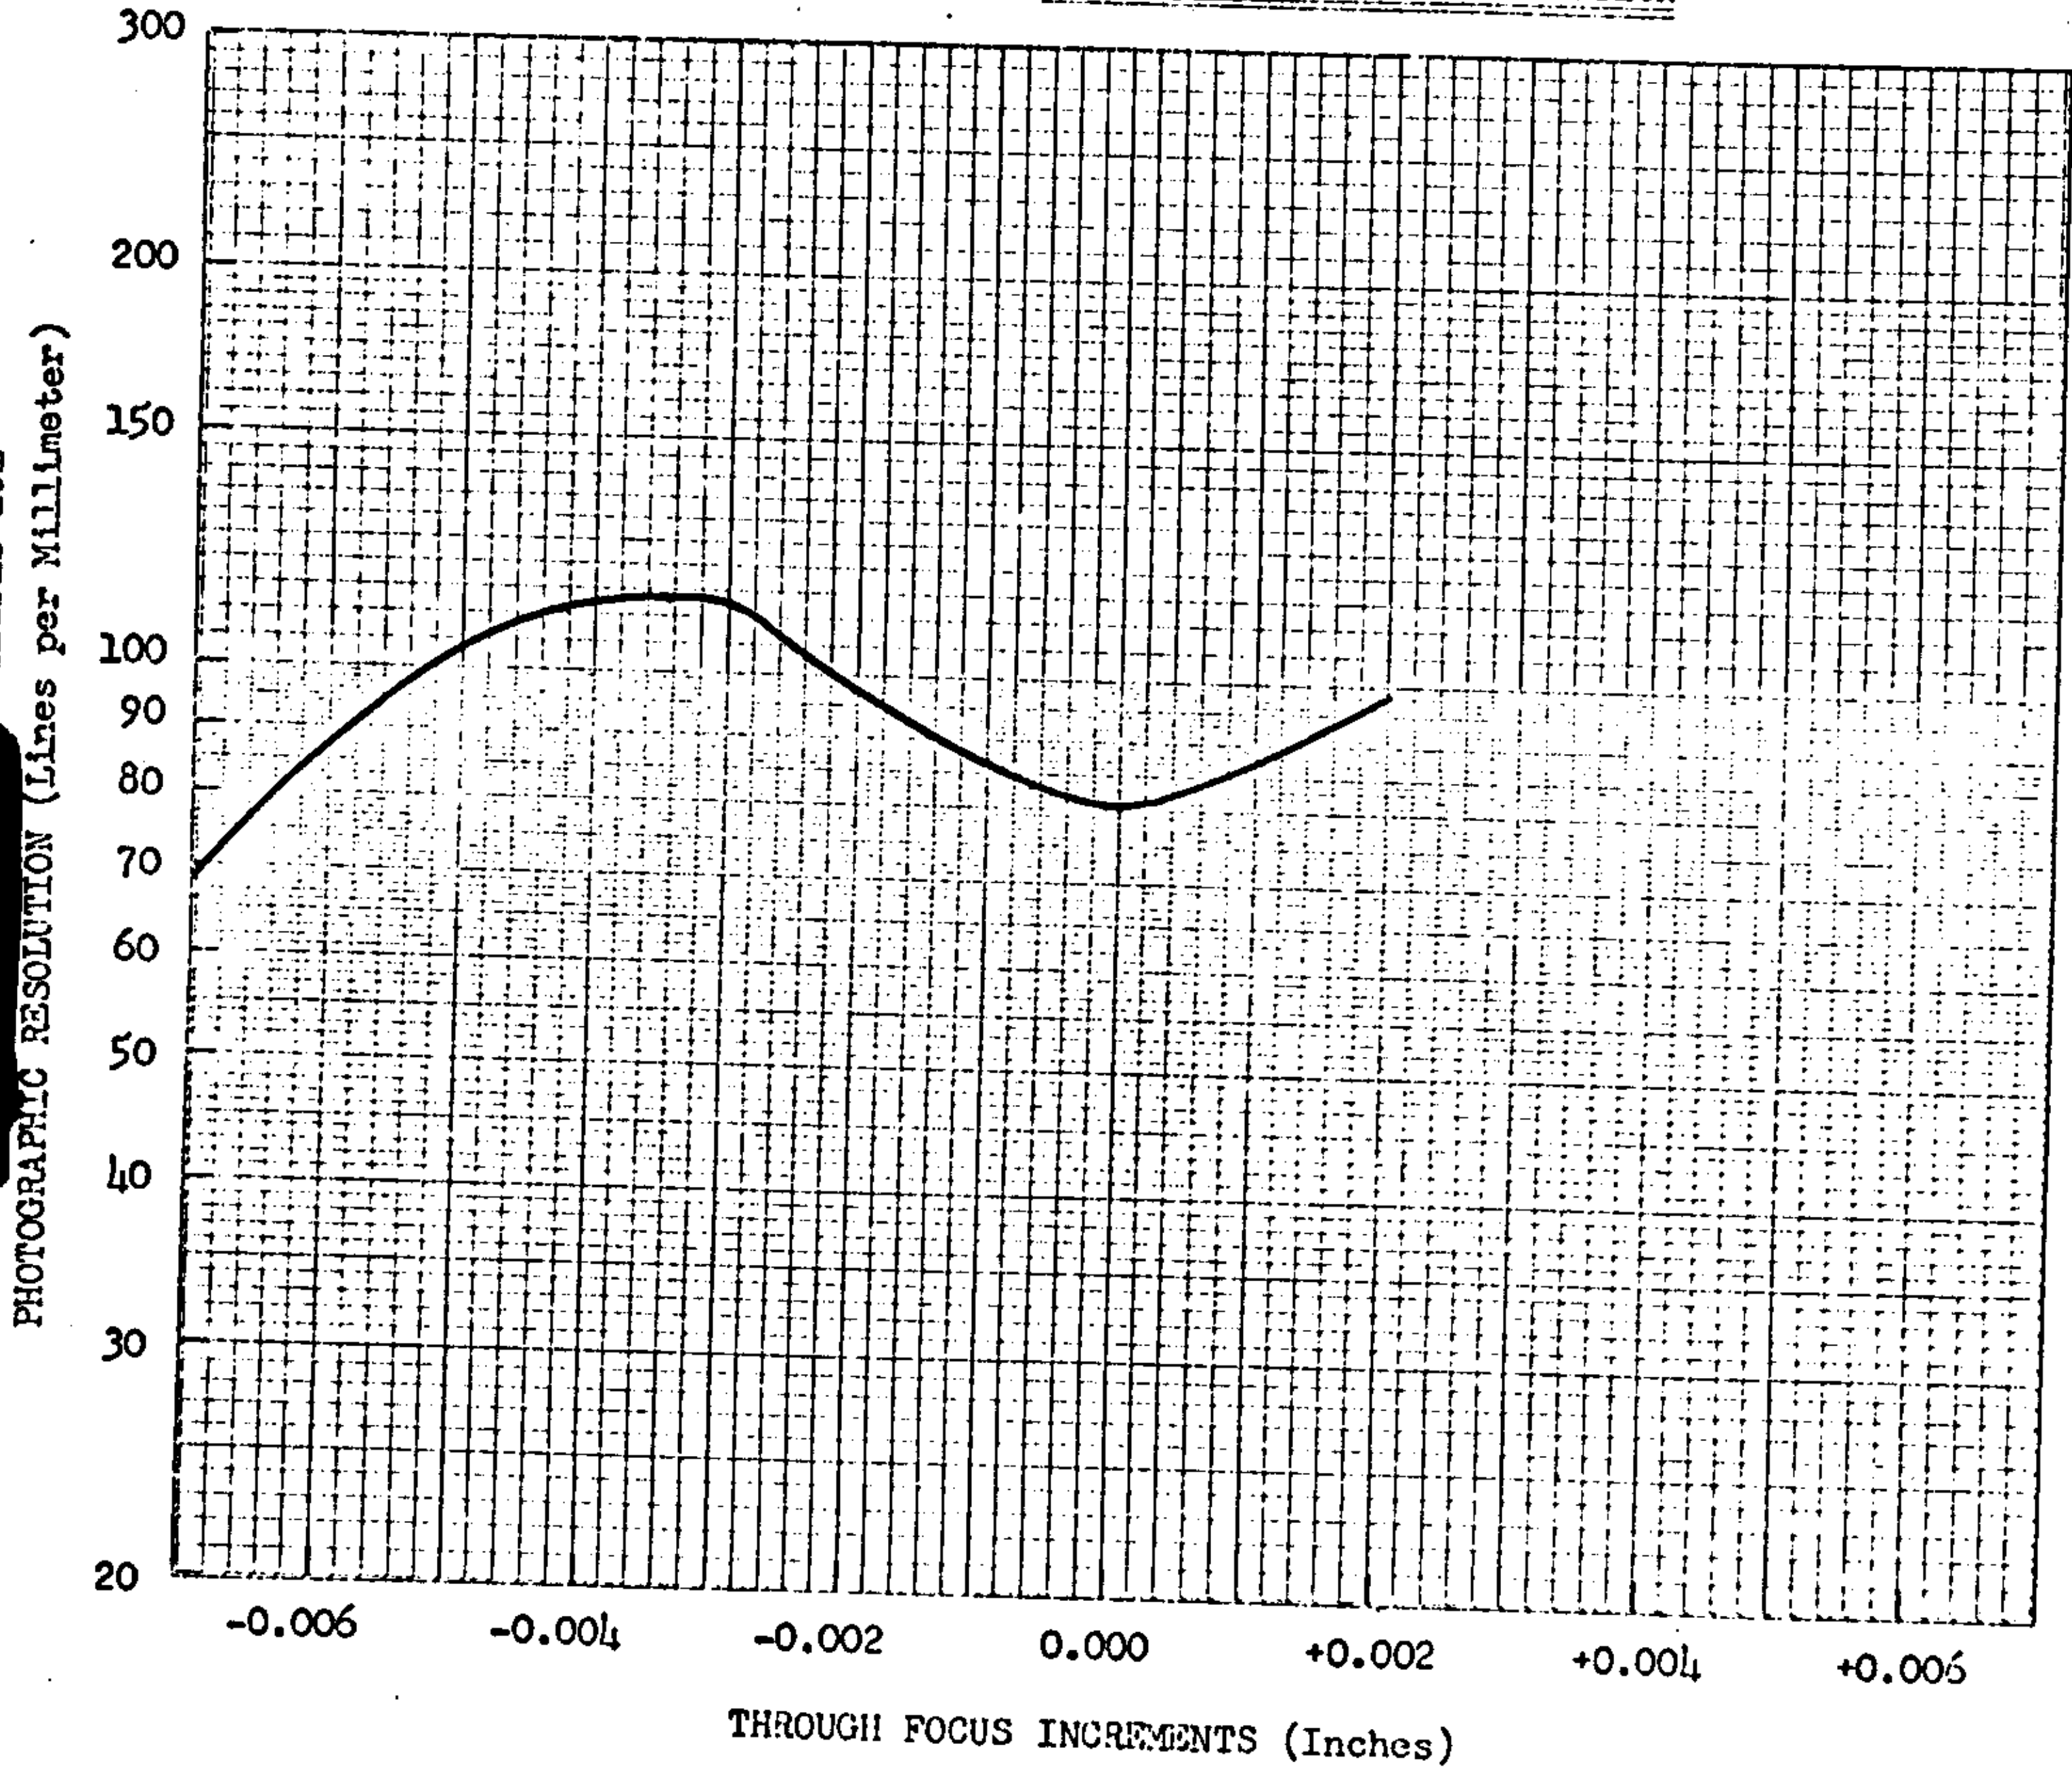
FIGURE 2-1

The final test data for both instruments is shown in Figures 2-1 and 2.2. Both instruments met the system requirements specification.

Additional Boston investigations indicated that optimum focus position would be attained by adding 0.0015" shim to the scan head of the Slave instrument, and 0.0020" shim to the Master instrument. The modified instruments were retested 30 November 1967, with the following results:

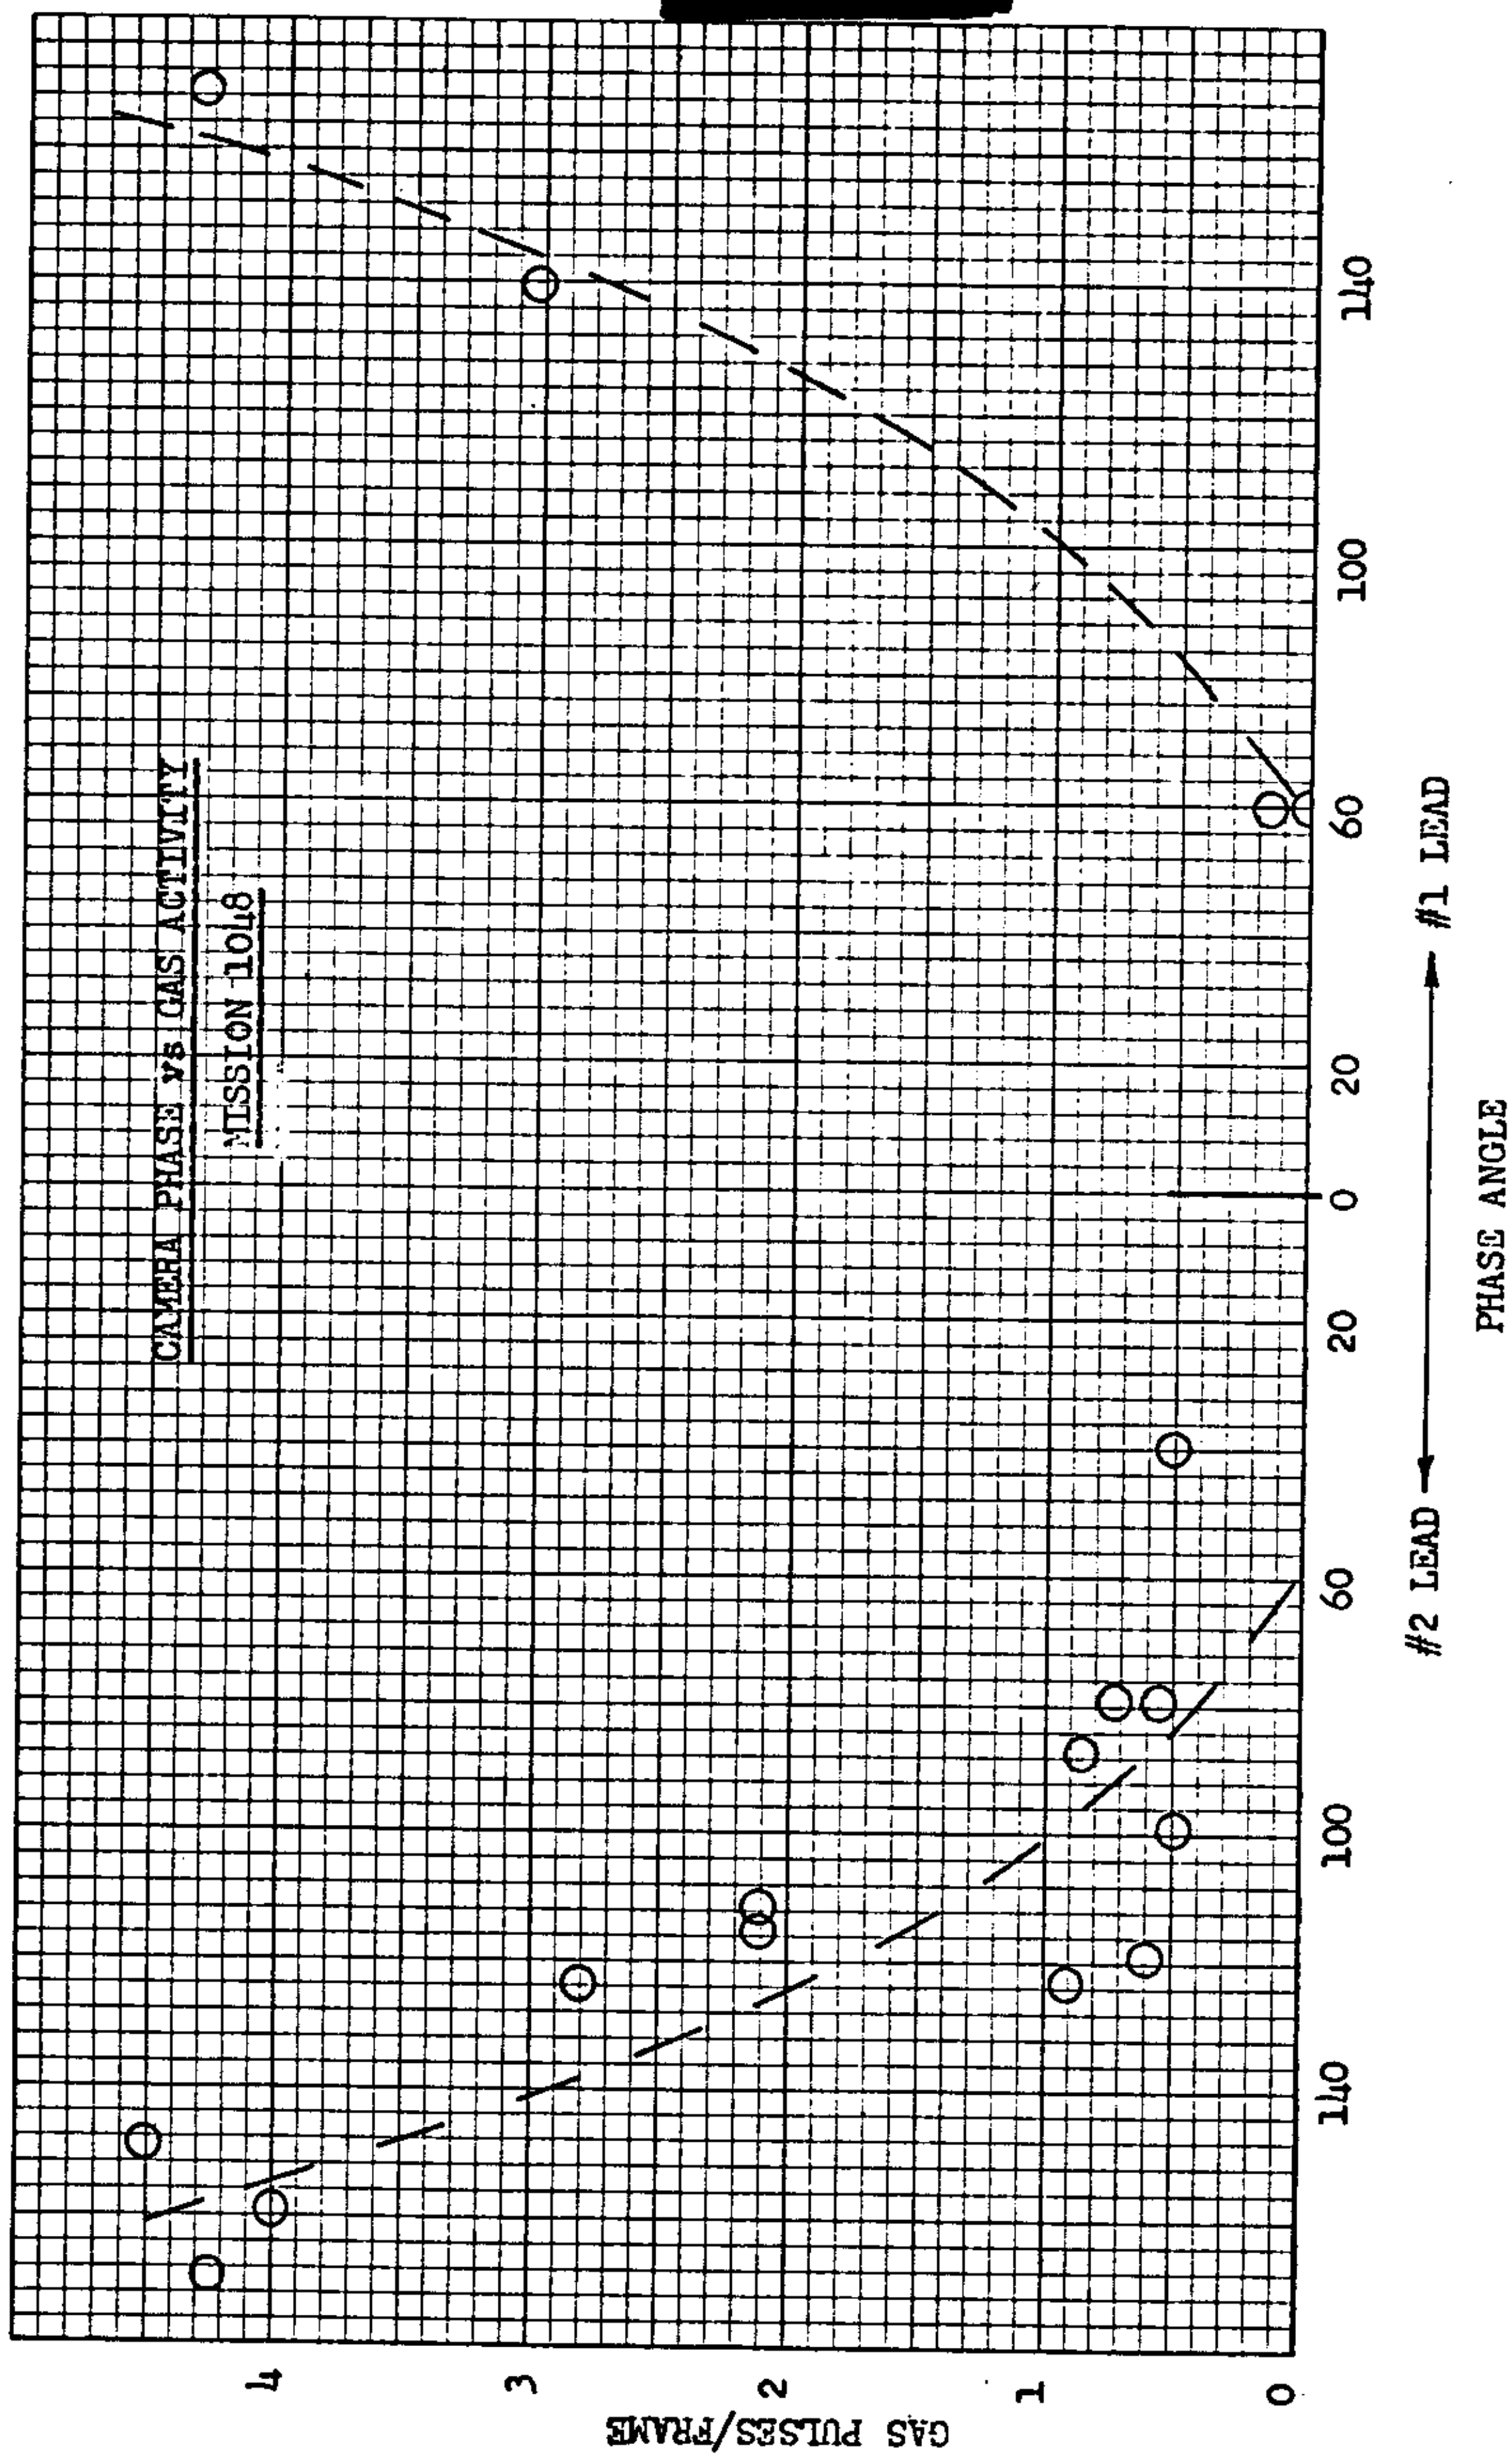
FIGURE 3-1

The final analysis of all available telemetry data revealed a condition that had been experienced on previous J-1 payload systems. This condition occurs as a result of the phase relation of the two panoramic cameras. There exists an $I\omega$ unbalance on each unit as the scan head is accelerated prior to photograph scan and when these $I\omega$ unbalances are phased correctly an oscillatory roll motion is imparted to the Agena vehicle. Normally the cycle rates of the two units of a J-1 system are slightly different so their phase relationship is constantly changing. However, the two units of the J-48 system were cycling at almost identical rates and this permits the phase relationship between units to remain constant. When an adverse phase relationship was obtained at the start of an operation it would remain throughout the operation and a repetitive pattern of roll perturbations resulted. Figure 3-1 describes the relationship of periodic gas valve activity vs phase angle between the panoramic instruments.

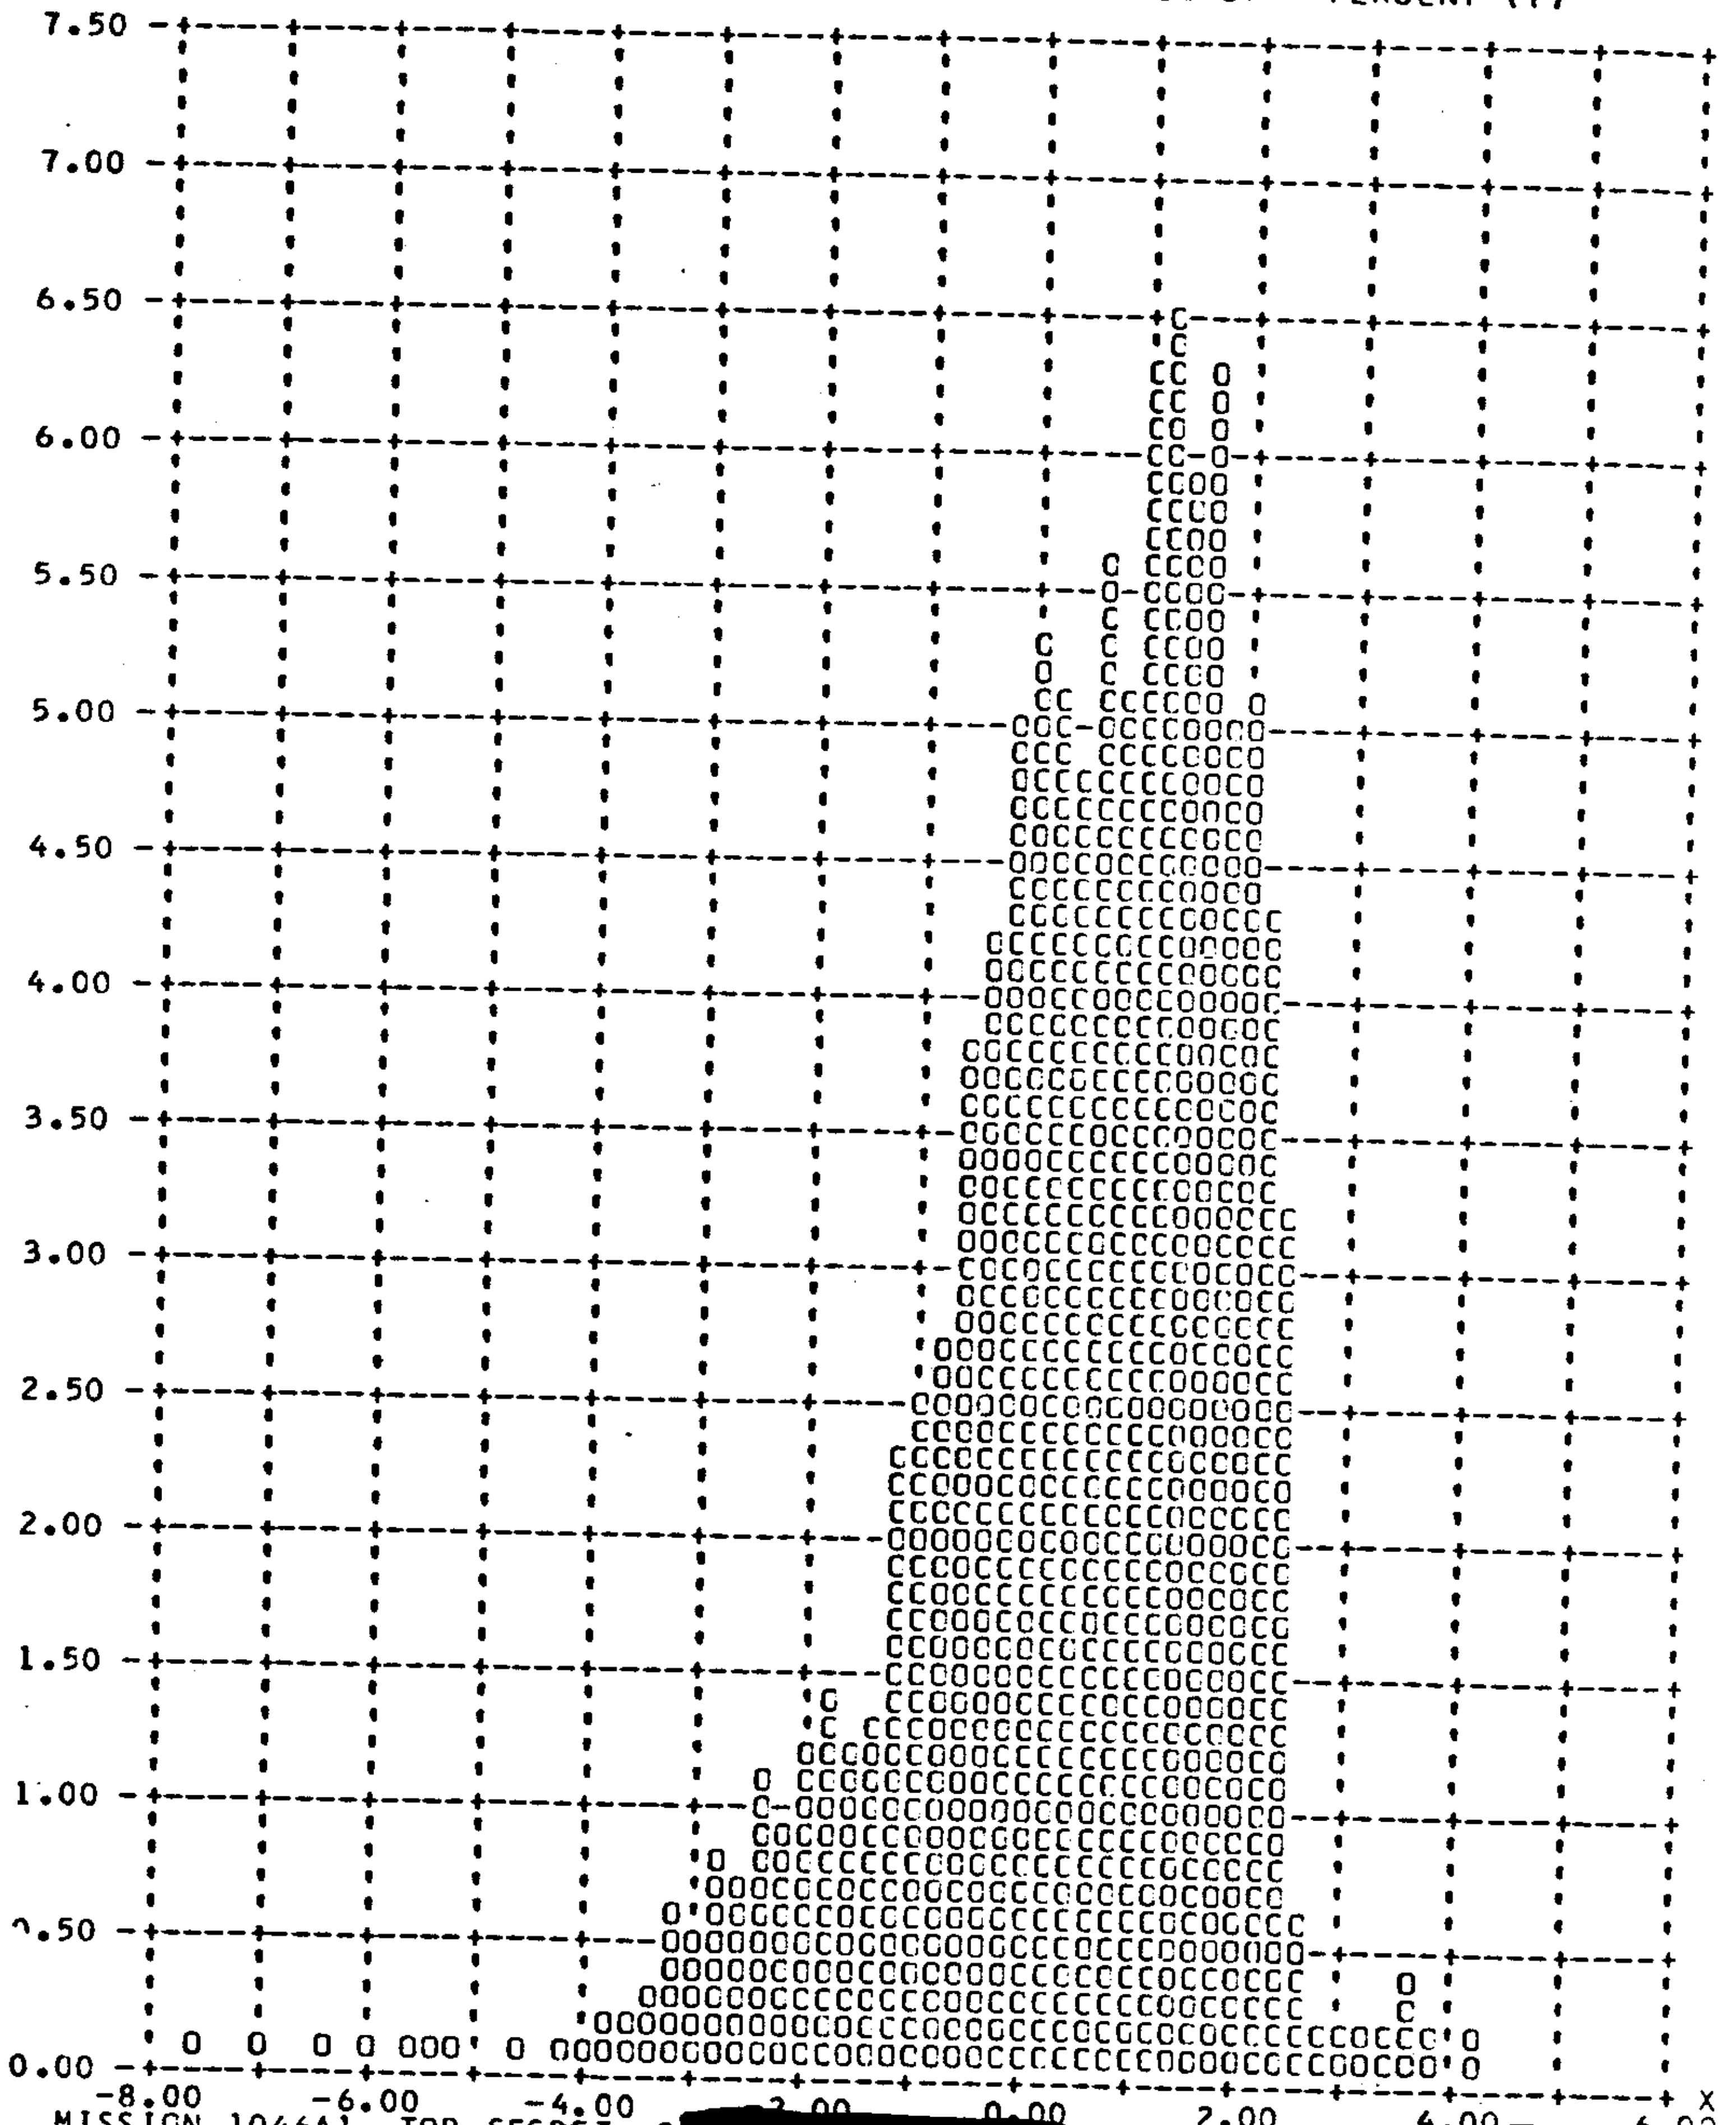
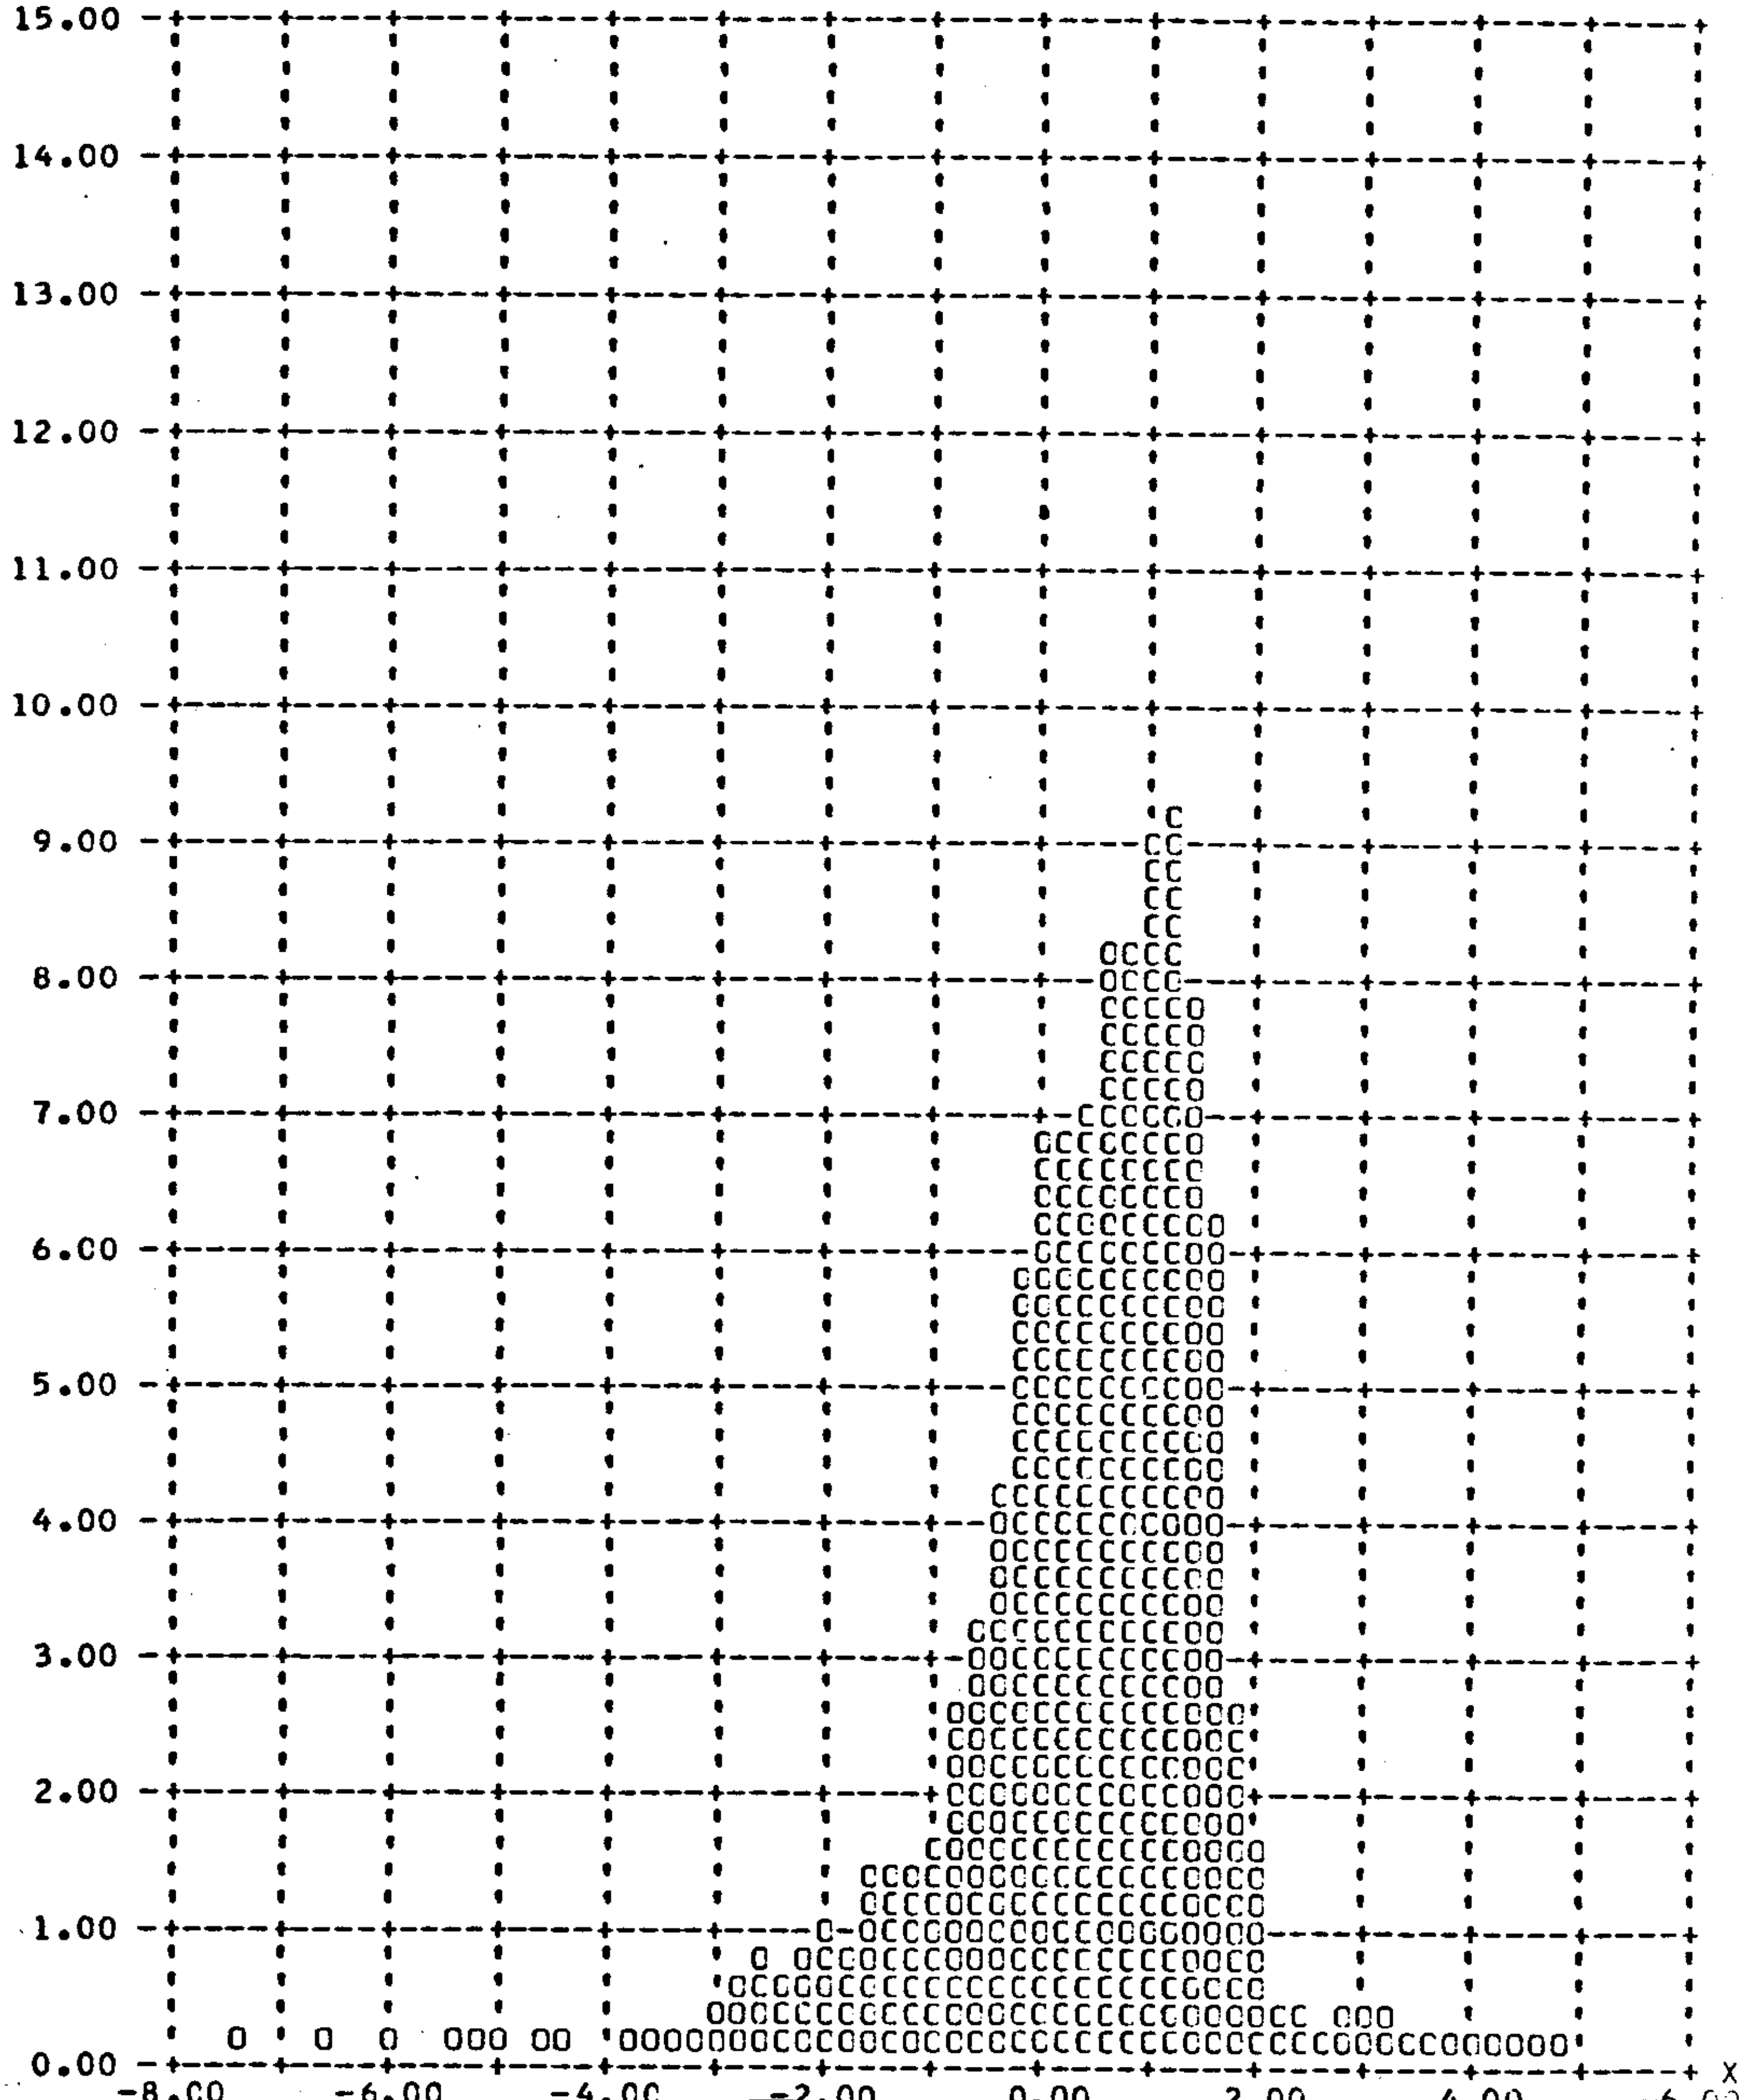
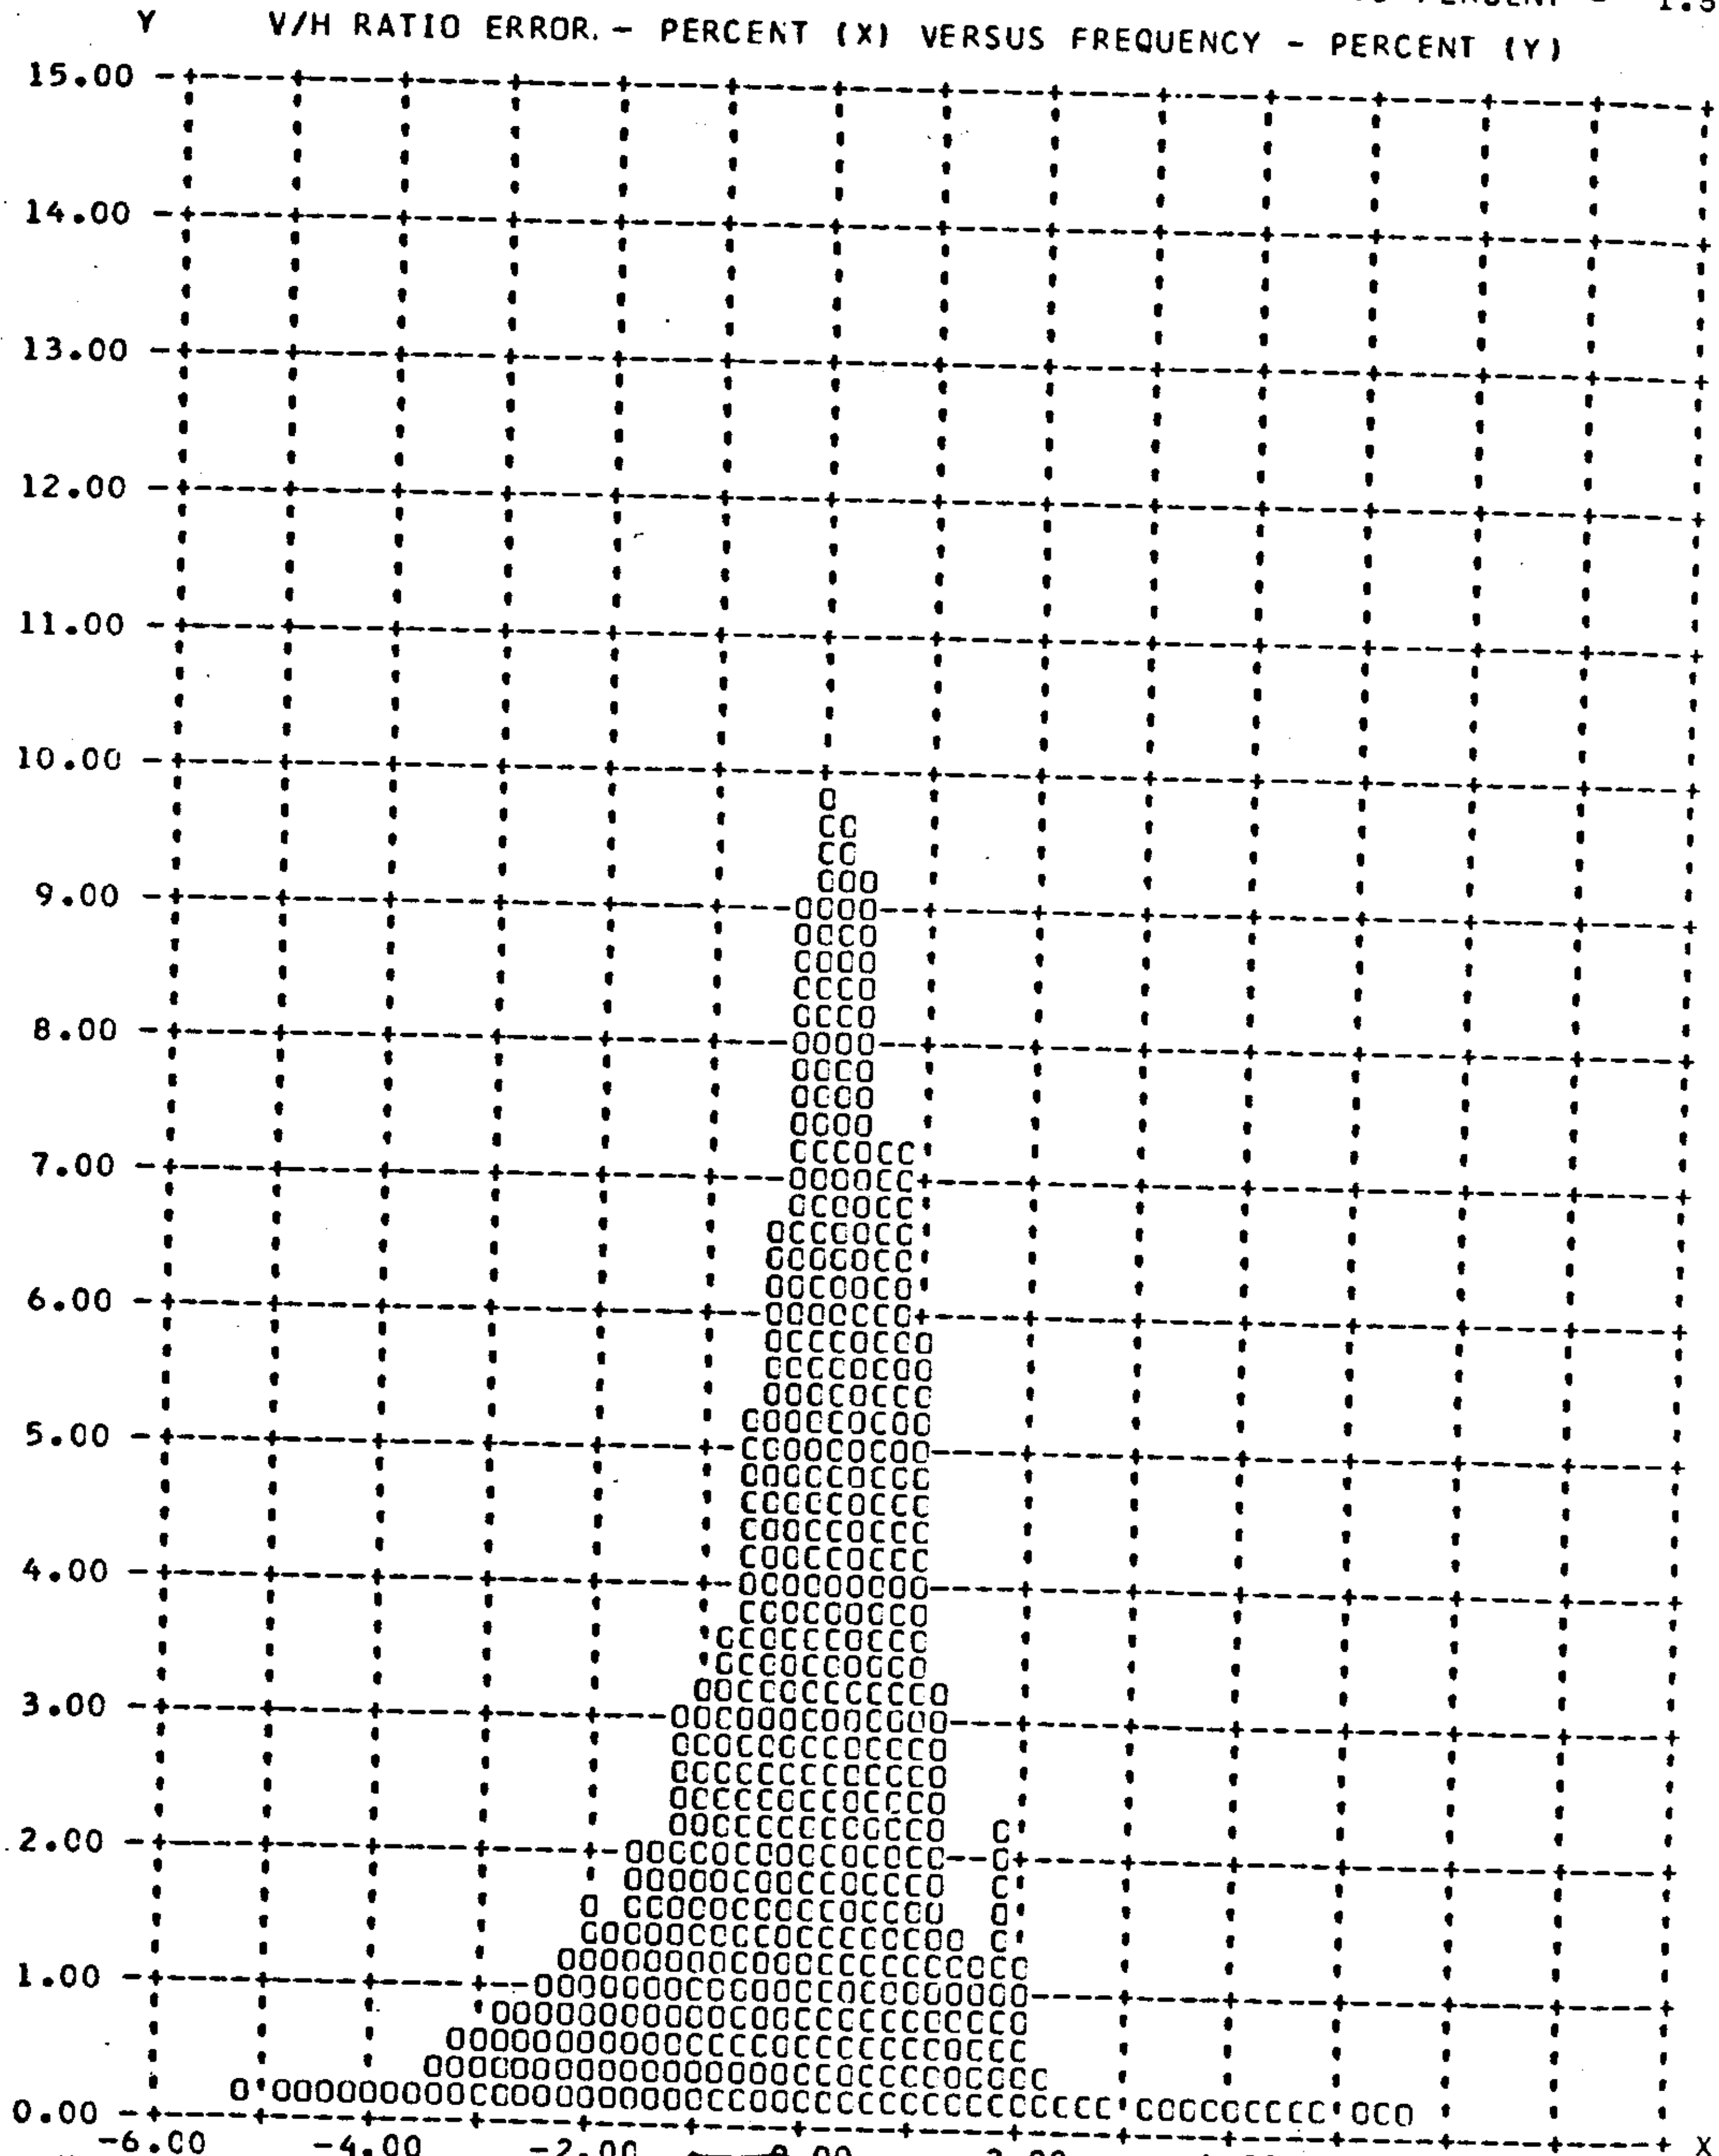
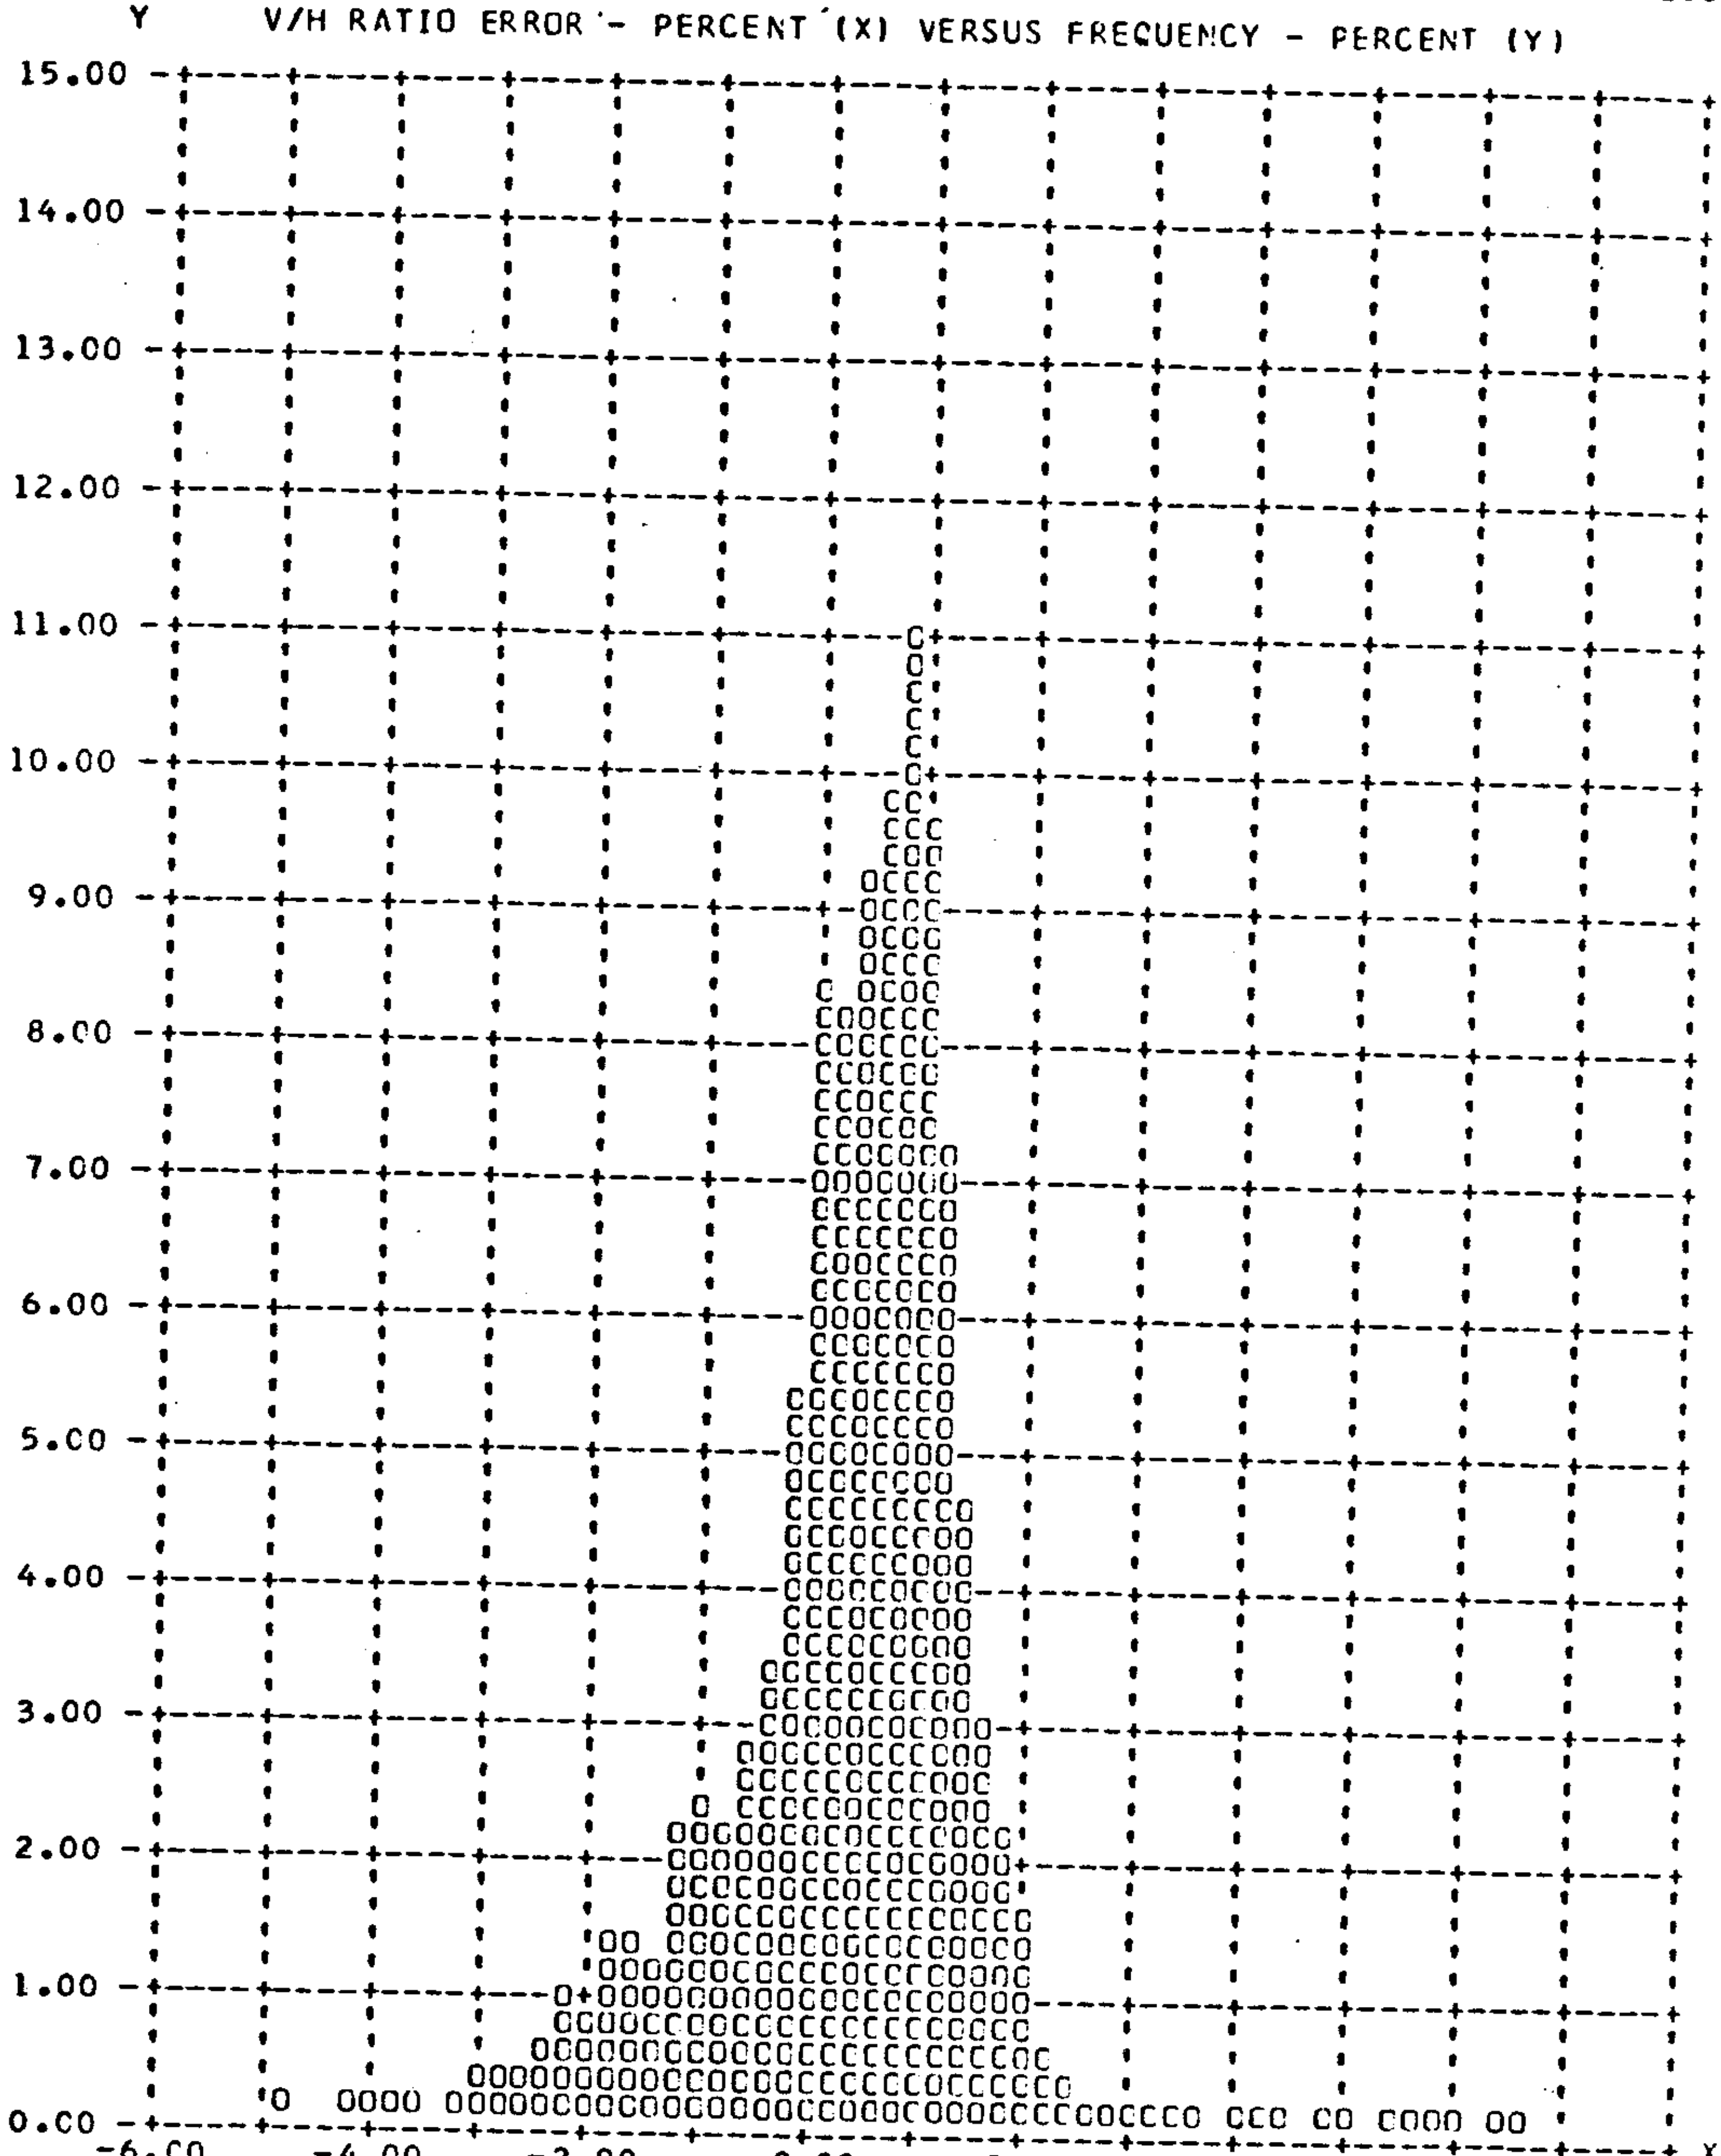
The resulting performance of the overall V/H match is statistically summarized in Figures 3-2 through 3-5.
