CORONA J

PERFORMANCE EVALUATION REPORT

MISSION 1046-1 and 1046-2

FTV 1638, J-48

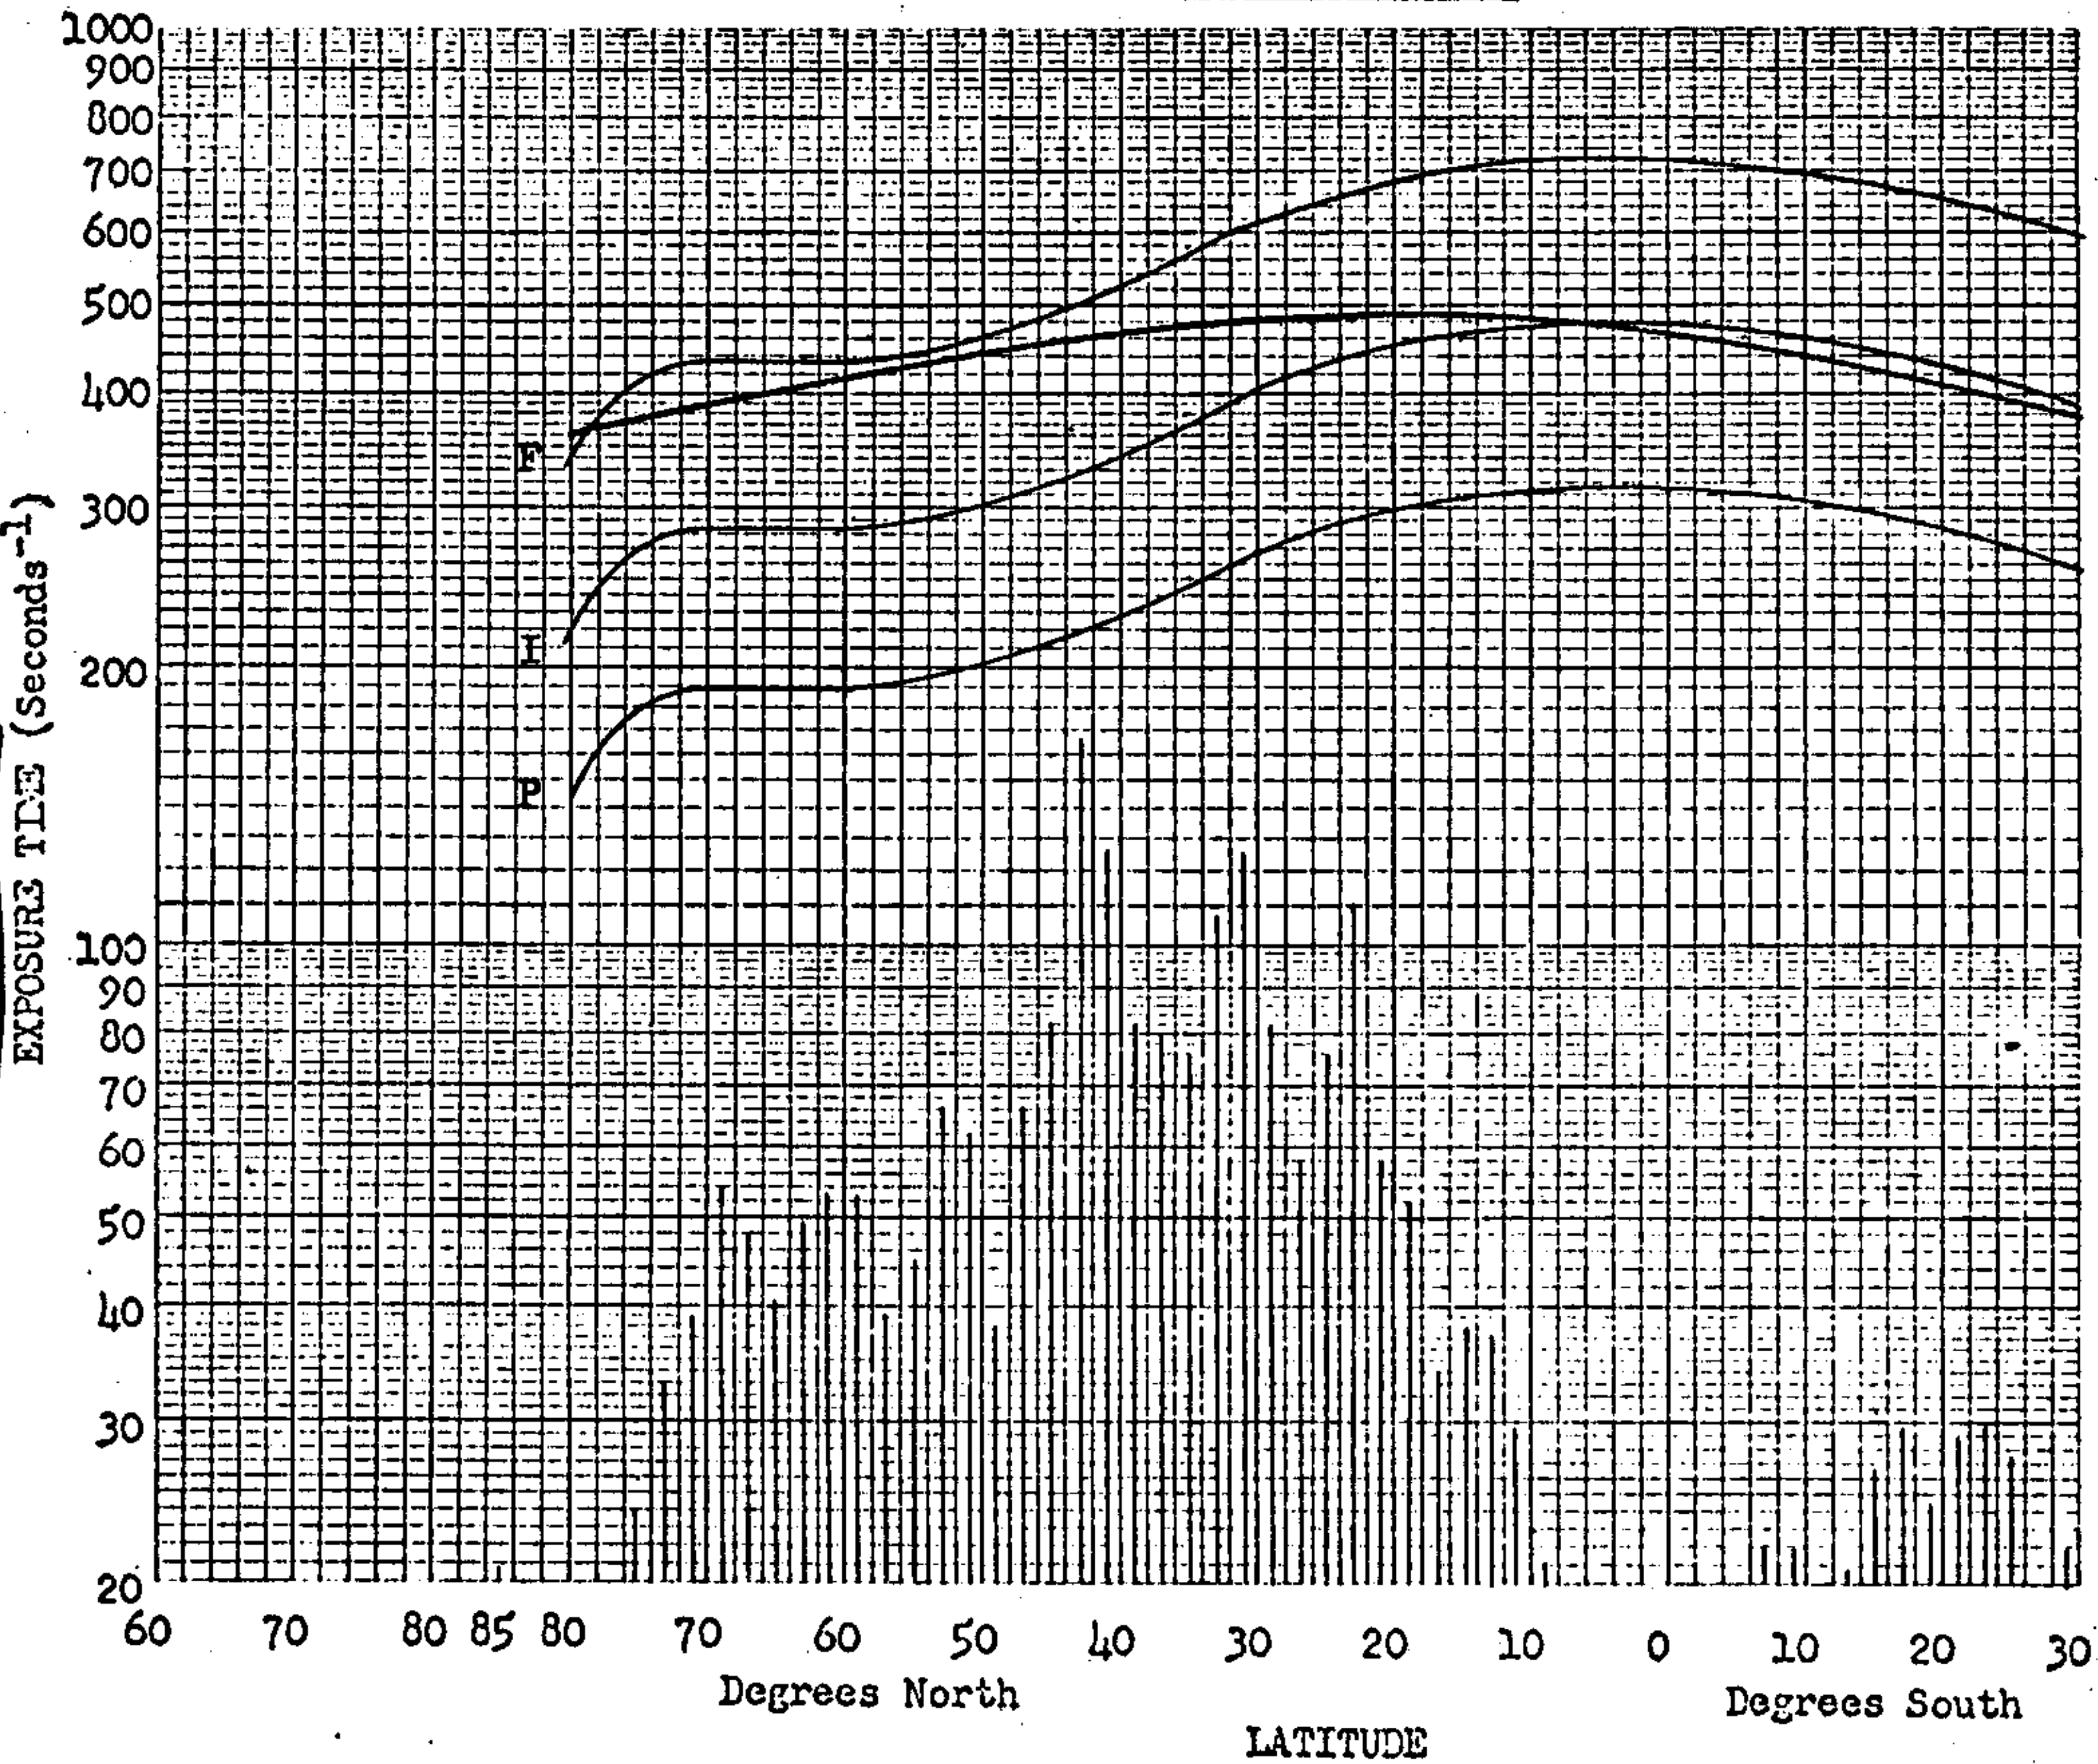
FIGURE 5-1

The photographic results obtained during the mission indicate that the exposure criteria was not adjusted sufficiently to accommodate an increased sensitivity of the SO-230 emulsion in the high vacuum environment. This phenomenon is discussed more extensively in Section 6 of this report.
