PHOTOGRAPHIC EVALUATION REPORT MISSION 1052

SO-293 SECOND GENERATION VS. THIRD GENERATION NEGATIVE

MARCH 1970

NATIONAL PHOTOGRAPHIC INTERPRETATION CENTER

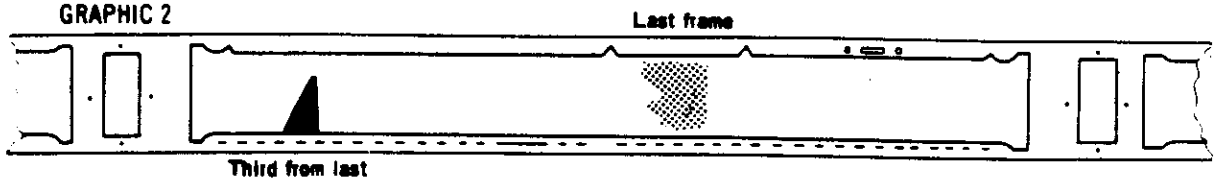
GRAPHIC 1

a. Light Leaks - Light-leak-induced fog patterns are present on the fifth, sixth from last, third from last and last frame of most passes. These fog patterns are minor and do not cause any serious degrading of the imagery. These fog patterns are illustrated in Graphics 1 and 2, page 10.
