POST FLIGHT EVALUATION
OF RECOVERED SRV HARDWARE

PROGRAM [REDACTED]

JANUARY, 1965

GENERAL (GE) ELECTRIC
Re-Entry Systems Department
A Department of the Missile and Space Division
3198 Chestnut Street
Philadelphia 4, Penna.

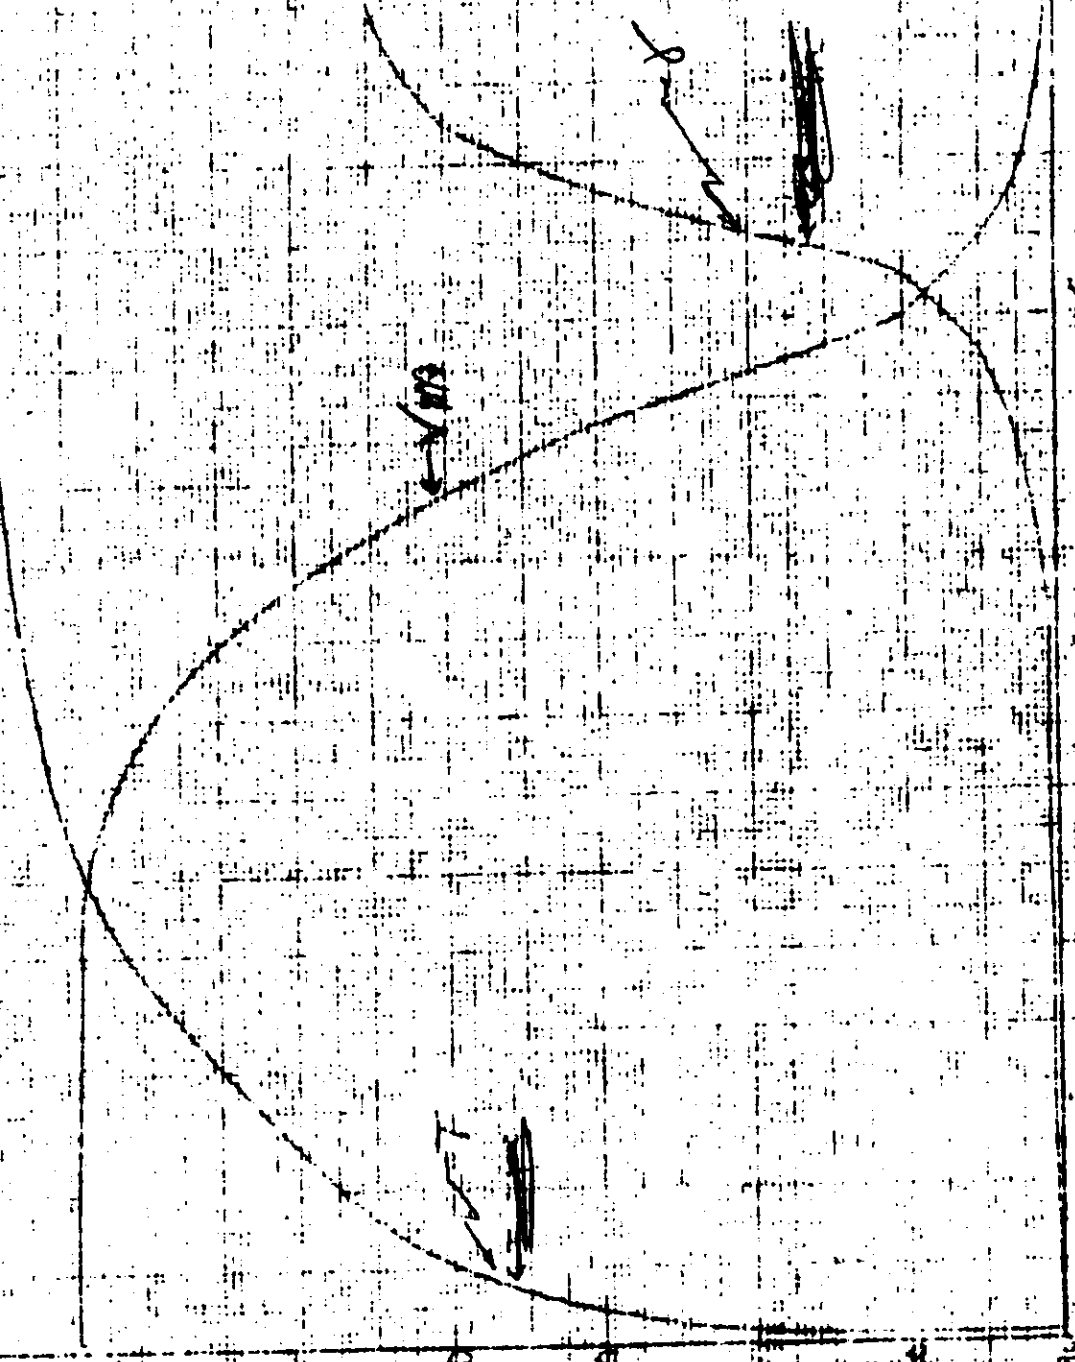
FIGURE 511

The motion behavior of the vehicle can only be a subject of speculation since the aerodynamic and mass characteristics are not known. However, it is most probable that the vehicle stabilized and the R/V separated from the rest of the orbital system at a high altitude. The R/V then continued into impact. Assuming a W/C_pA of 55 psf the trajectory parameters are given in Figures 5 and 6. This trajectory gives rise to the thermal shield weight loss which was observed.

REENTRY PATH, ALTITUDE, VELOCITY, AND TIME VS. ALTITUDE

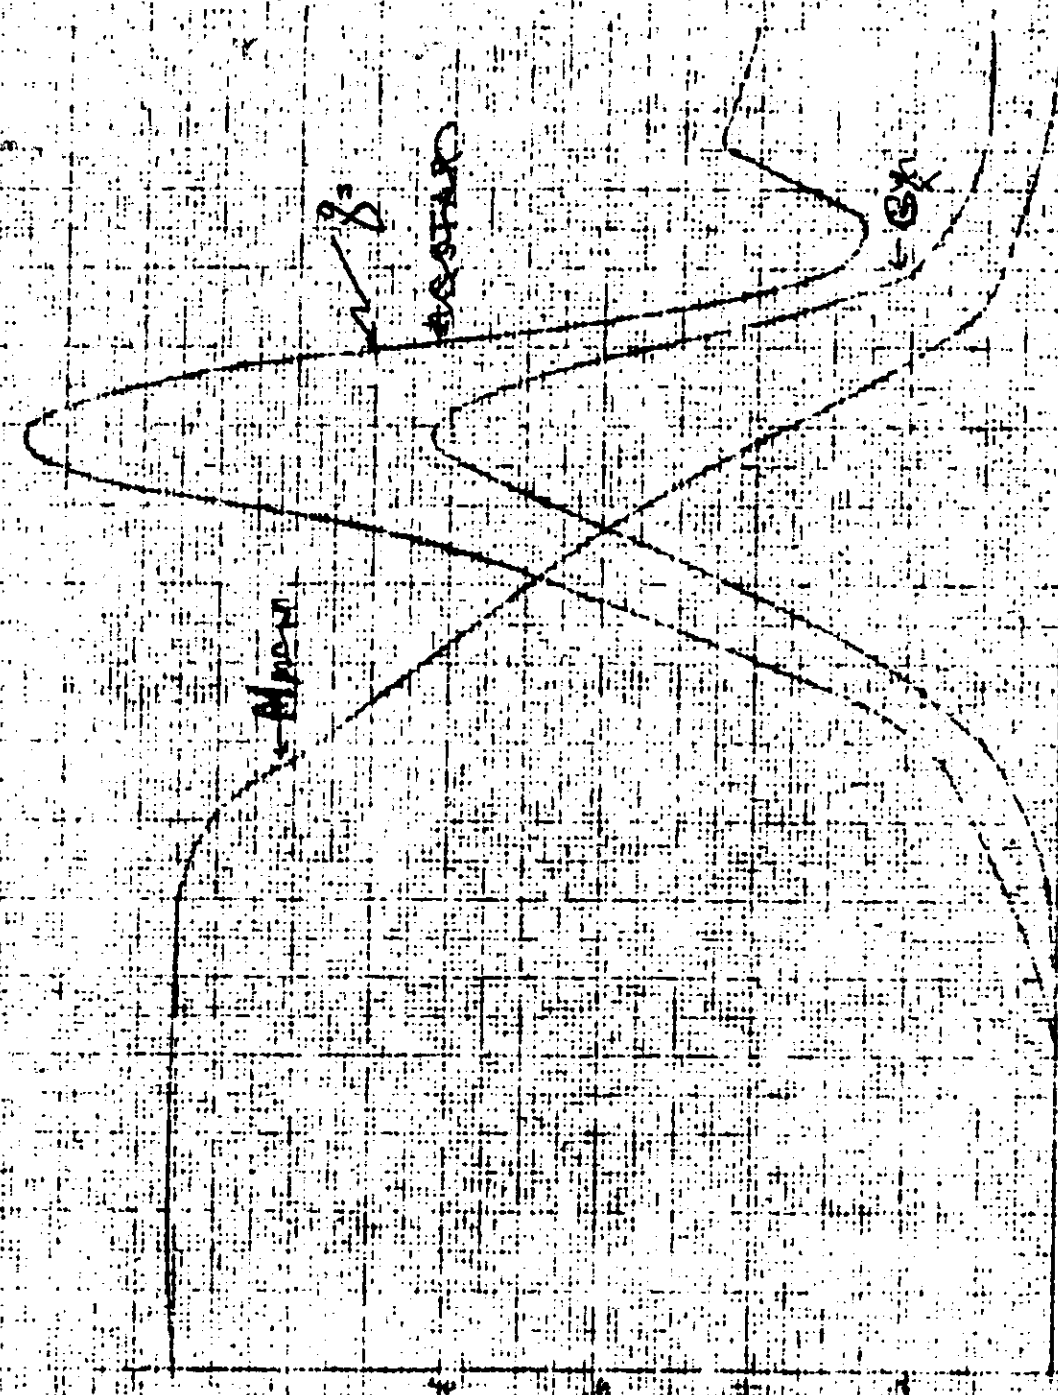
FIGURE 6
 PRE-ENTRY MACH NUMBER, DYNAMIC PRESSURE, AND AXIAL LOAD VS. ALTITUDE

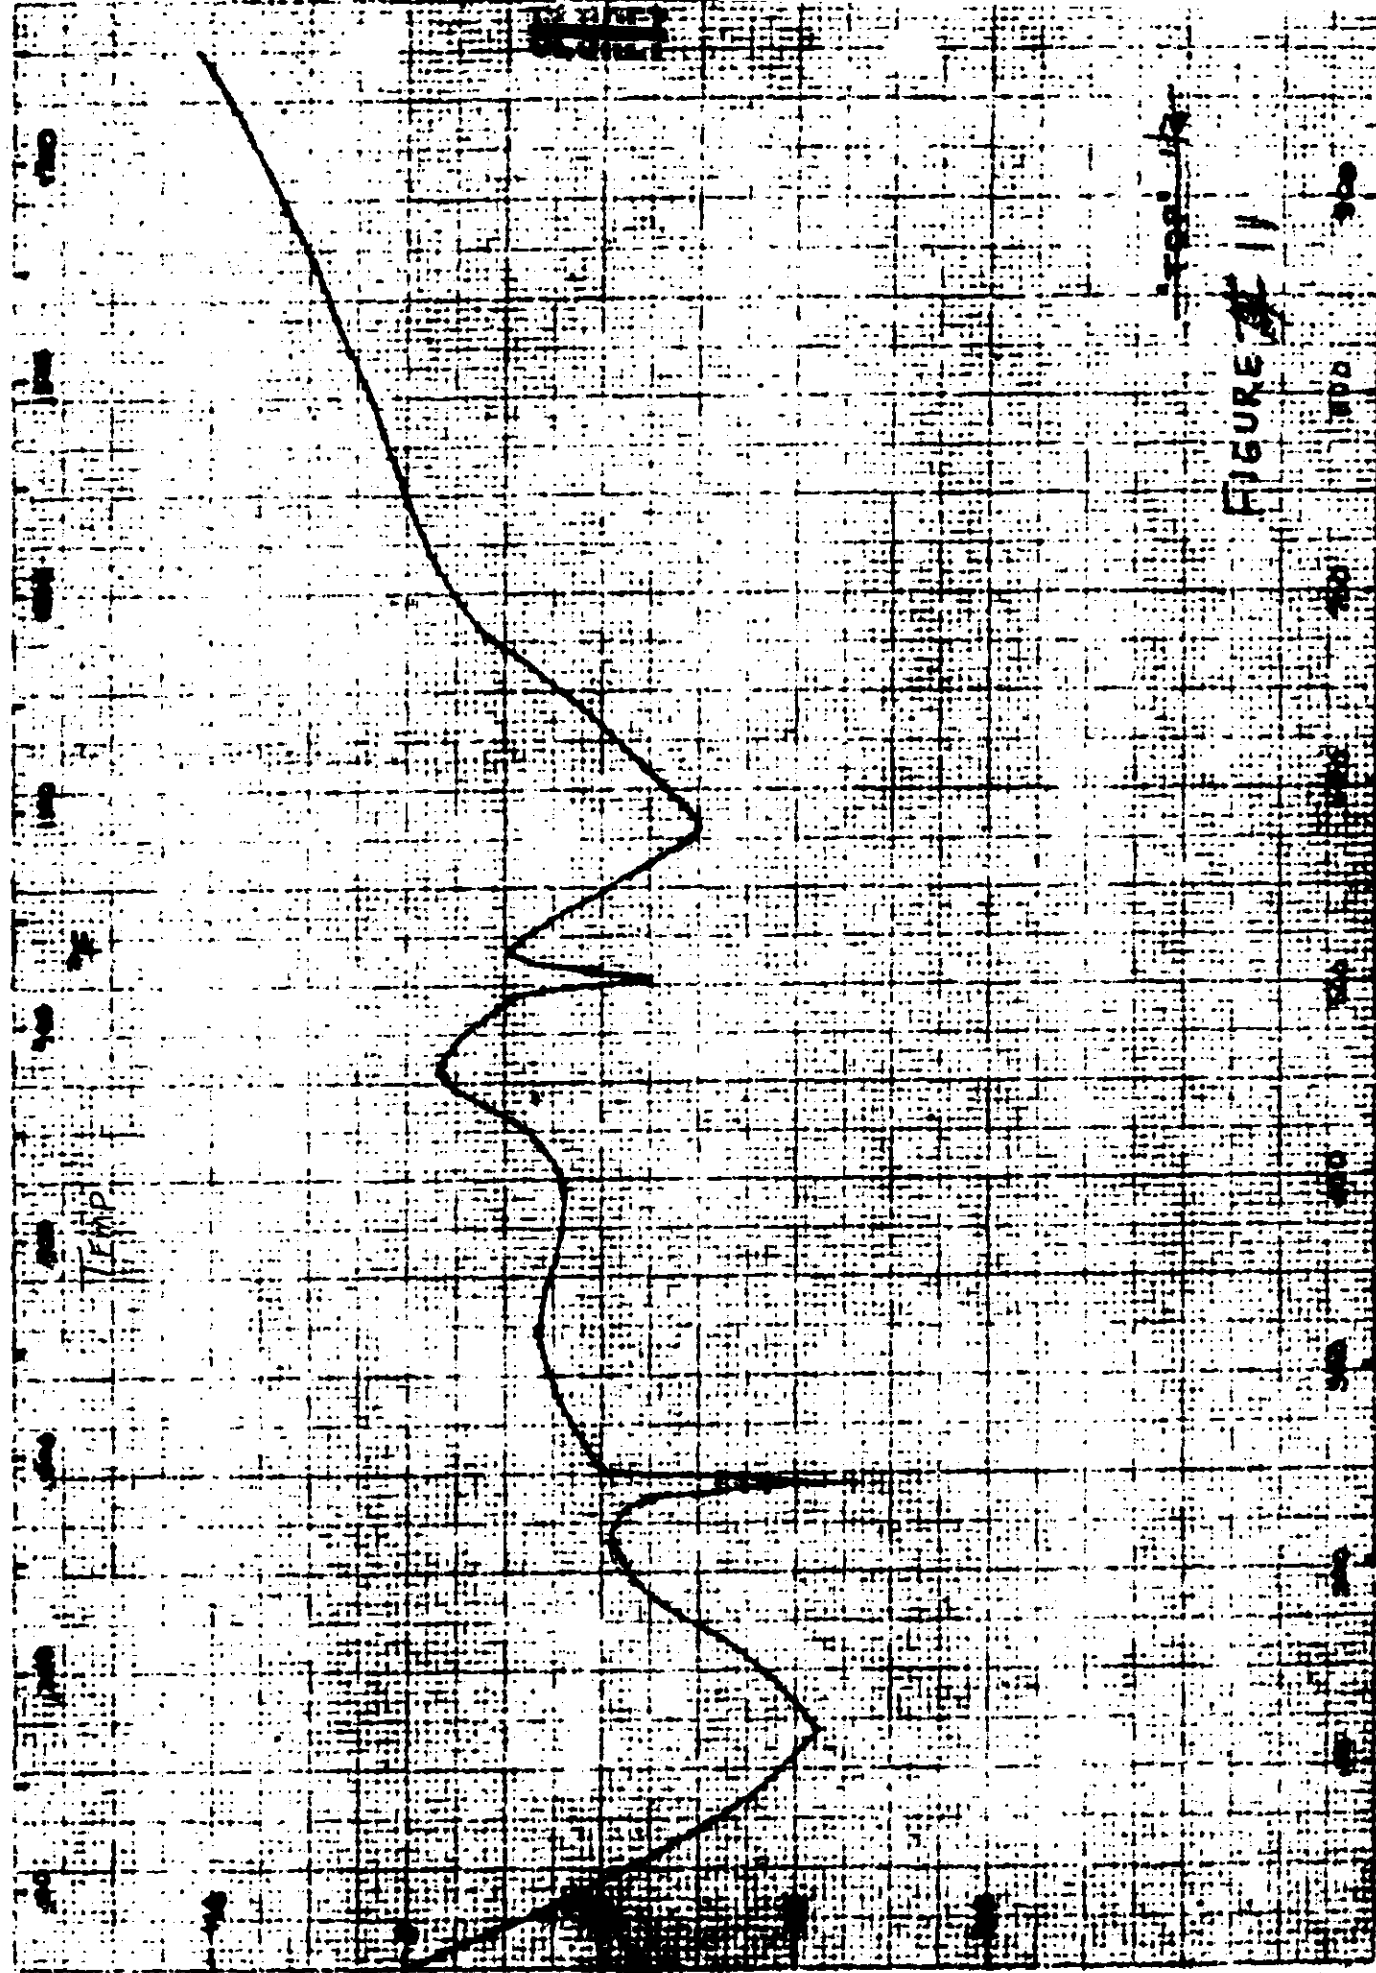
FIGURE 11

Thermogravimetric analysis (TGA) curves were run on samples from the same core and depths as the DTA samples. In addition, a reference sample was run to make comparison more complete. The top third curve showed a marked lower residual weight fraction at a given temperature than the ^{deeper or reference samples did.} ~~standard or the unblasted portions of the specimen used:~~ Figures ¹⁴13, ¹⁵14, ¹⁶15, and ¹⁷16 are thermograms of the ^{reference} standard, and top, middle, and bottom thirds of the phenolic-nylon shield samples. Figure ¹⁸17 is a ^{cross-plot} plot of ^{the ratio} (residual weight fraction of the reference material)/(residual fraction of the debris) versus depth, ^{selected} at given temperatures. ^{Data was} taken from the ^{for mentioned} appended TGA curves. Figure ¹⁹18 is a ^{cross-plot of DTA data:} plot of ΔT (the differential temperature of deflection on the ΔT axis) versus depth, ^{selected} at given temperatures for the same material ^{samples}. The same gradation is shown as is in Figure ¹⁹17.

DTA THERMOGRAM OF TOP THIRD PHENOLIC NYLON SAMPLE

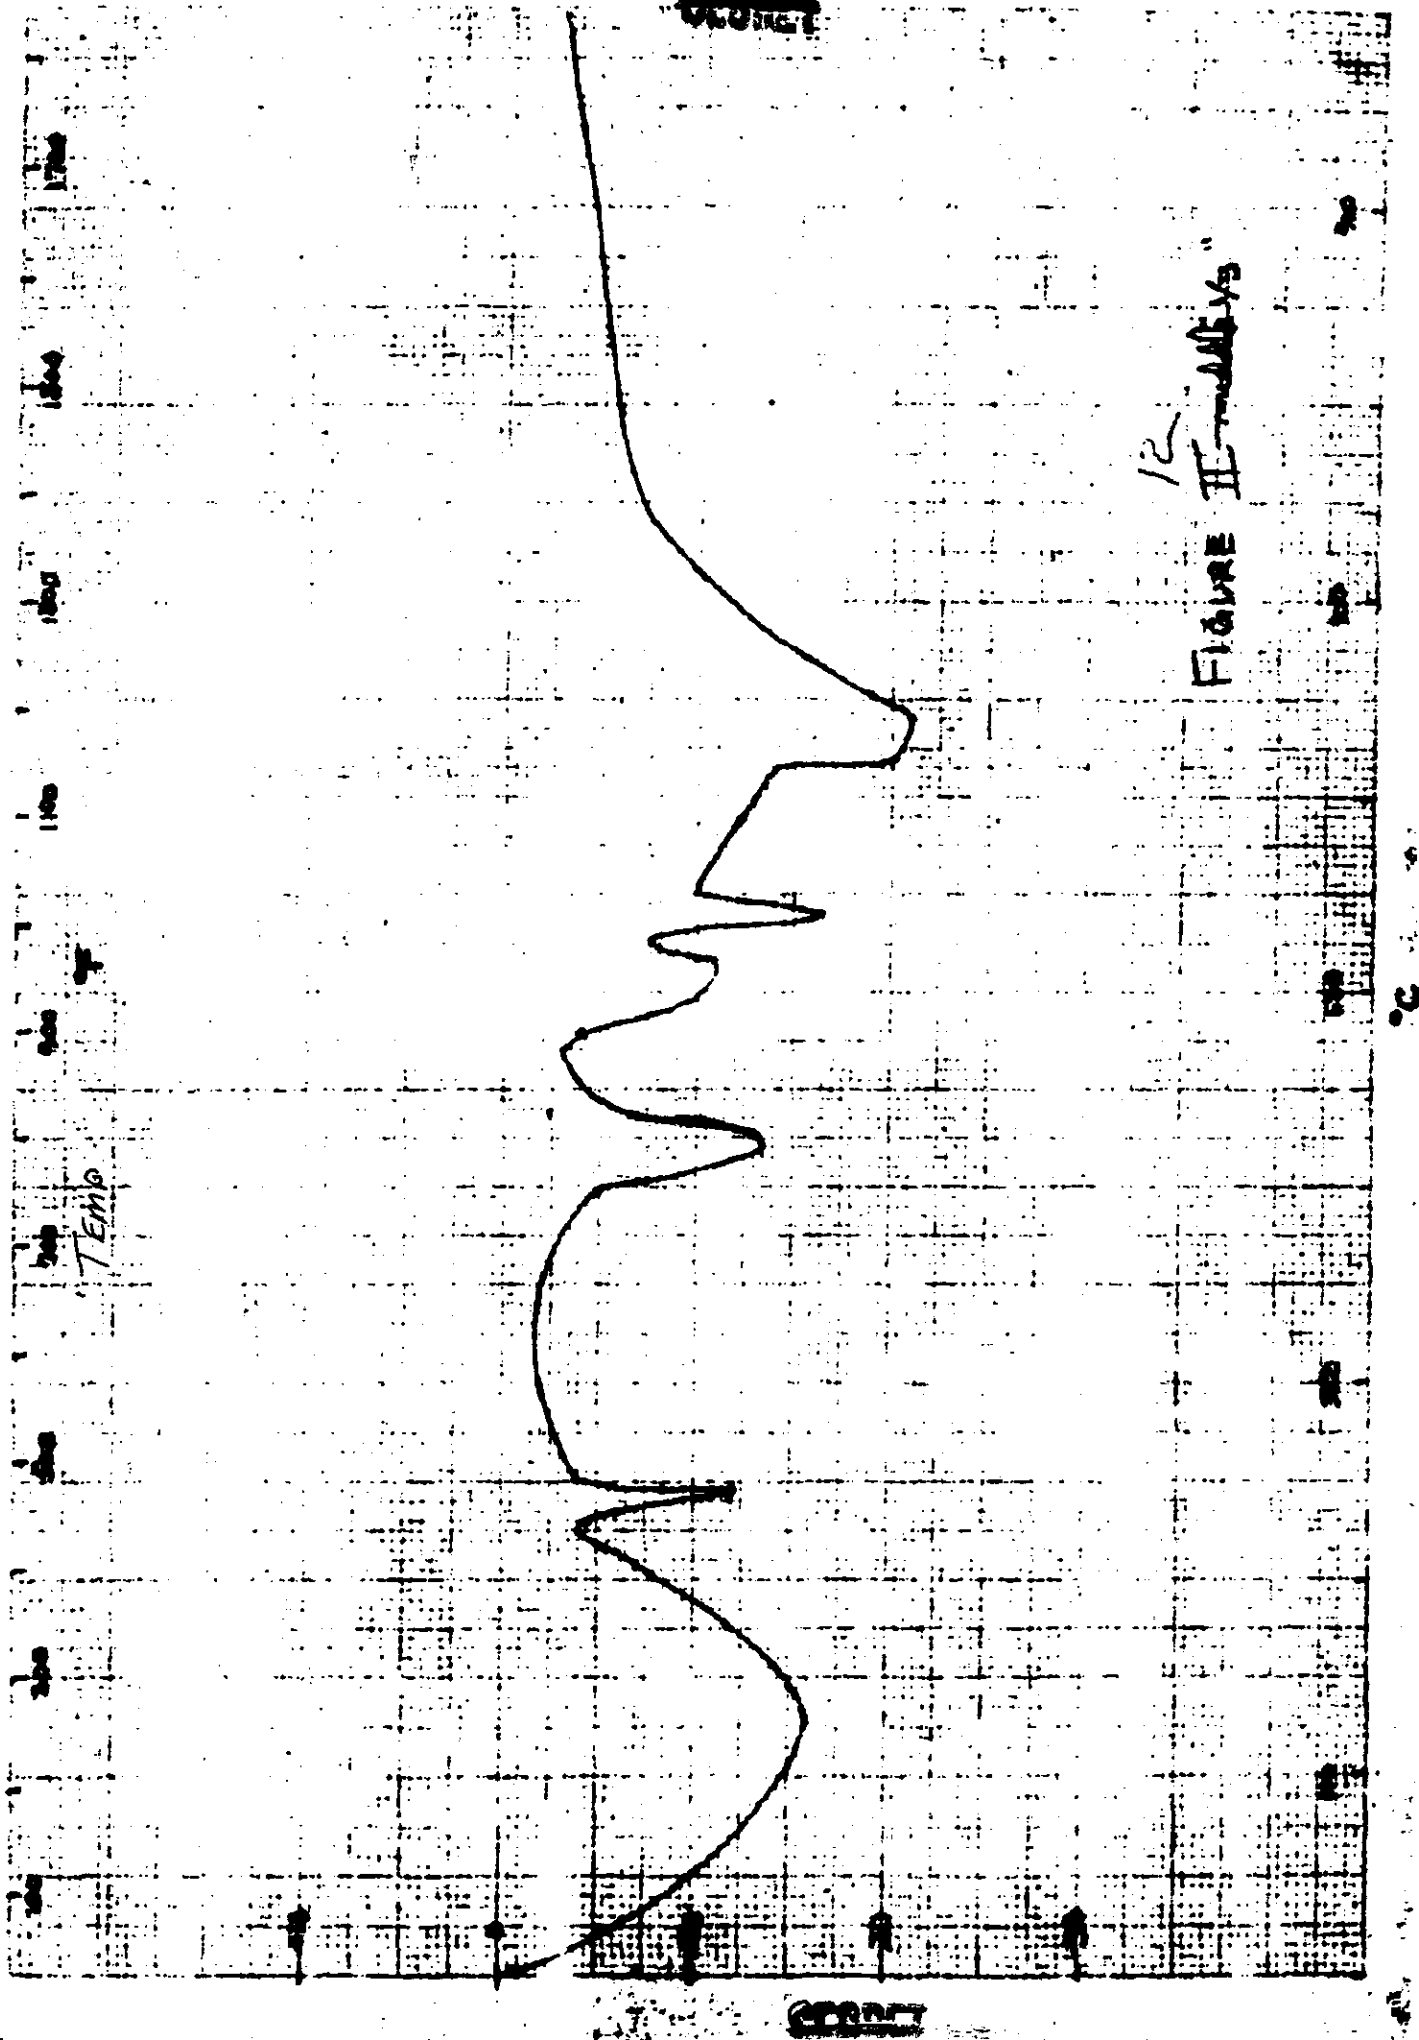
12
FIGURE II - ANALYSIS

DTA THERMOGRAM OF MIDDLE THIRD PHENOLIC - NYLON SAMPLE

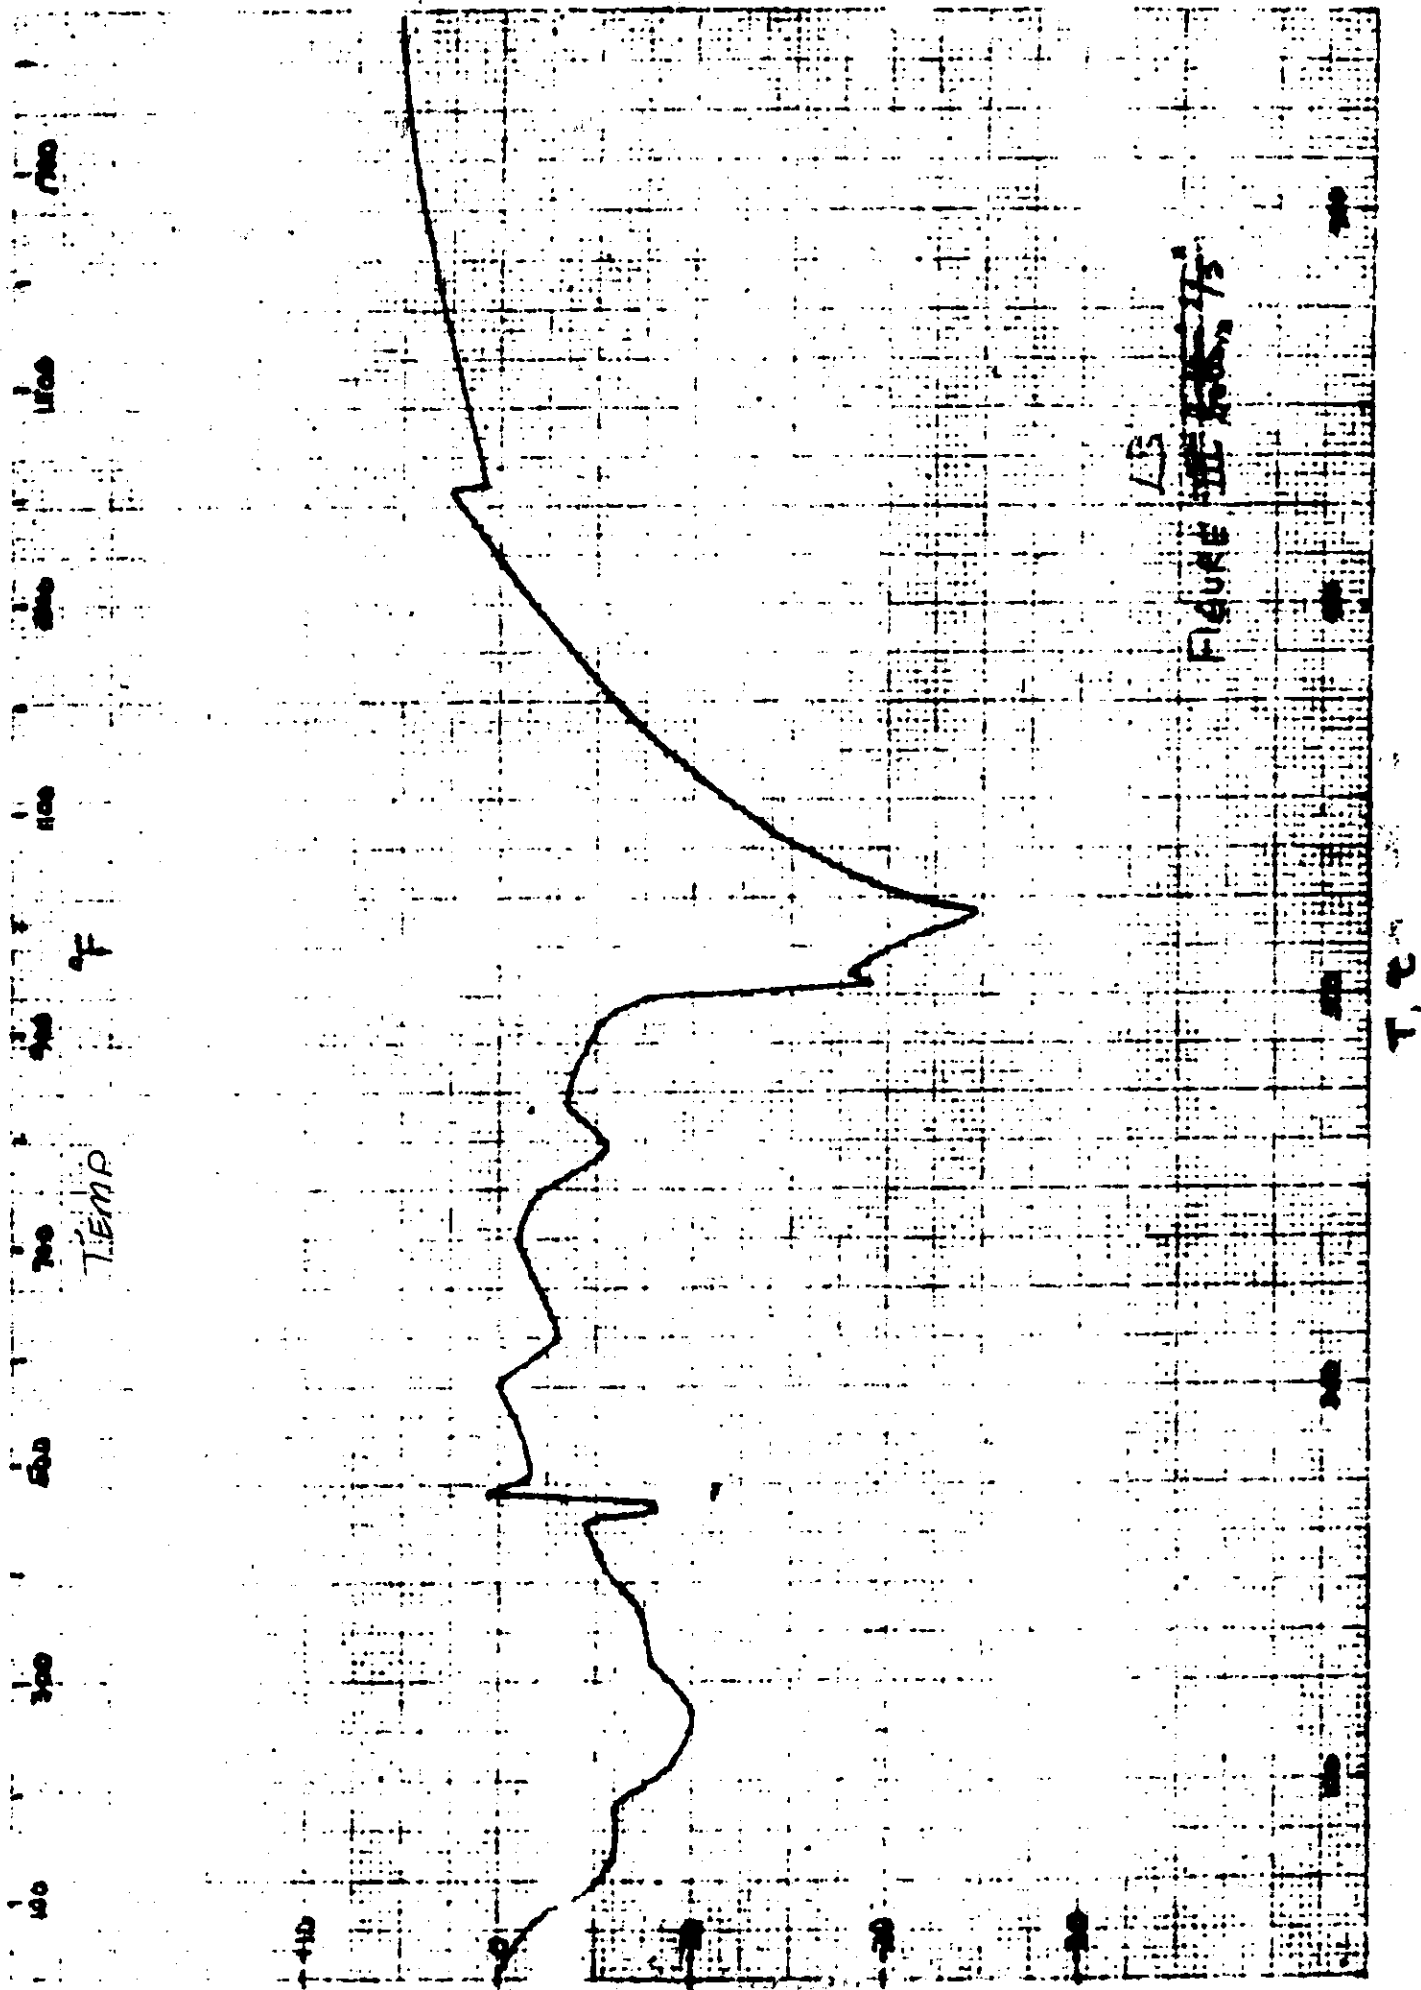
DTA THERMOGRAM OF BOTTOM THIRD P-N SAMPLE
