MURAL SYSTEM [REDACTED]

PERFORMANCE EVALUATION

REPORT

24 January 1964

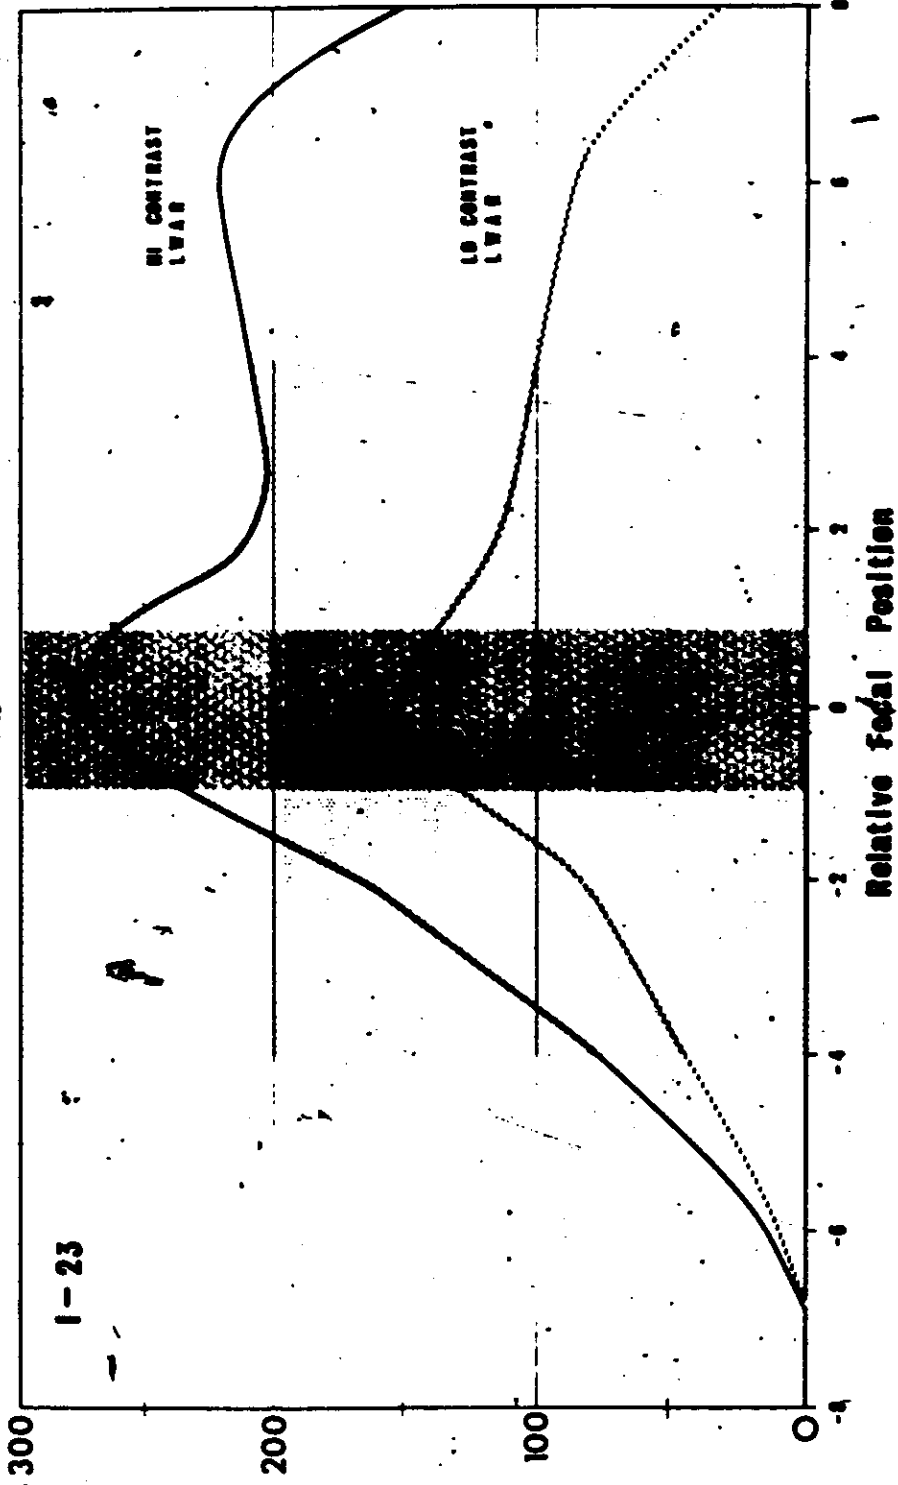
FIGURE 10

The effect of temperature variation on the resolution is shown on Figure 10, Lens System Thermal Response.

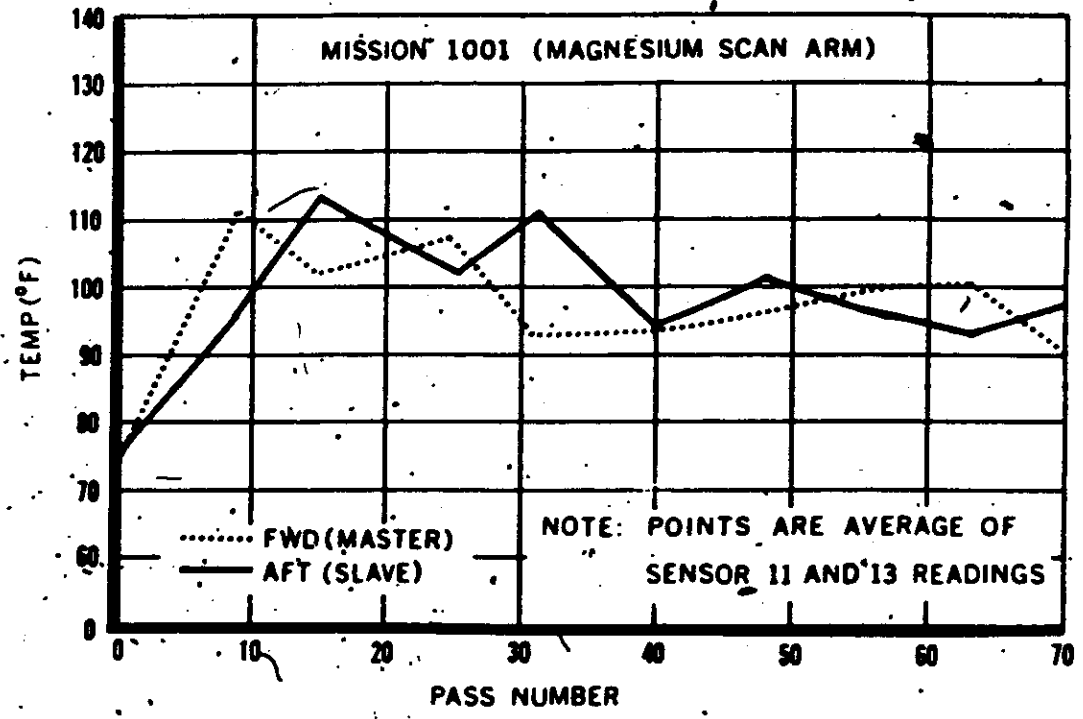
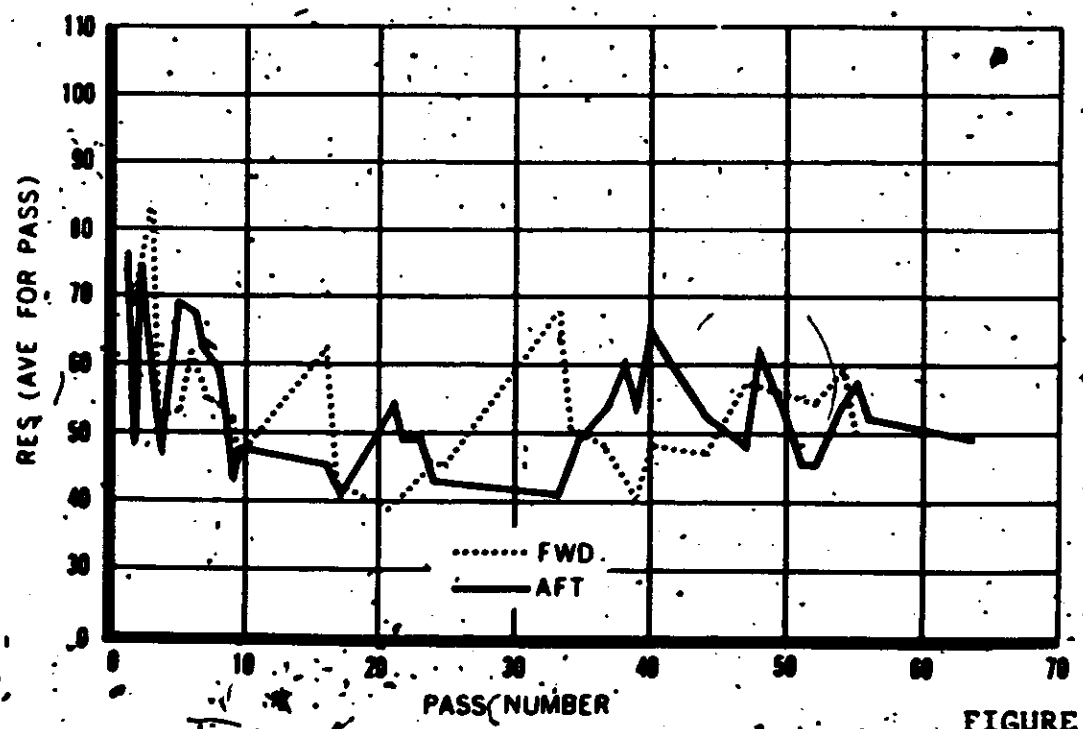
FIGURE 1.

Although the drum and stove temperatures are markedly different throughout the first few passes, RES data does not show any significant improvement as this difference is reduced. Instead, significant correlation does appear between RES values and average temperature, particularly on 1001-1 (magnesium scan arm) where average temperature rose from 75°F on Pass 0 to 105°F by Pass 9 (see Figure 13). Over the same period, RES dropped from about 80 to 50. Reference to the Lens System Thermal Response data (Figure 10) shows that a 30° temperature rise causes a focus error of about .008", sufficient to account for a 50% drop in resolution.

COMPARISON OF CAMERA TEMPERATURE WITH RES READINGS

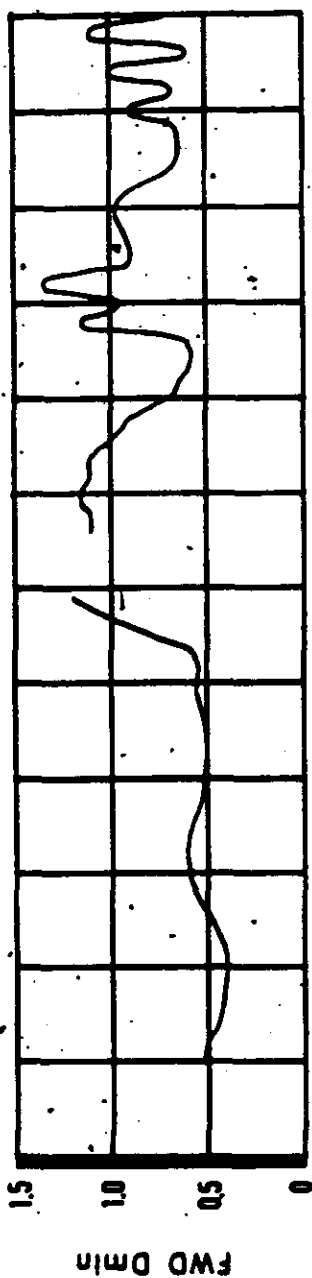
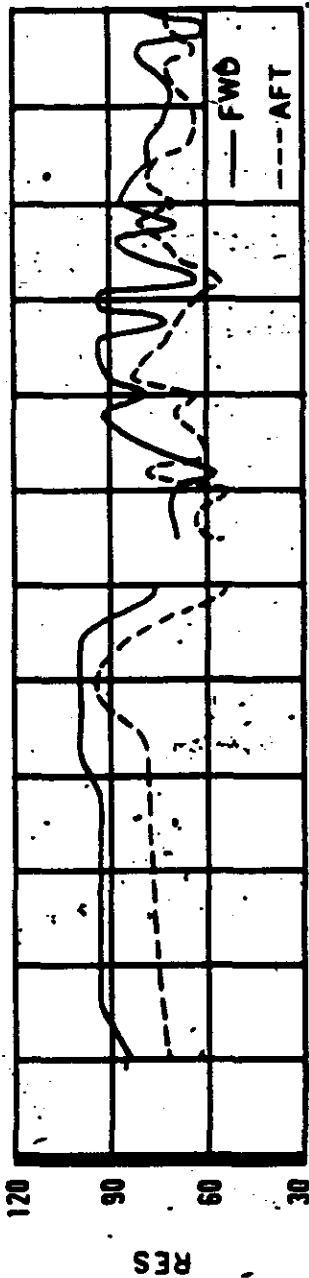
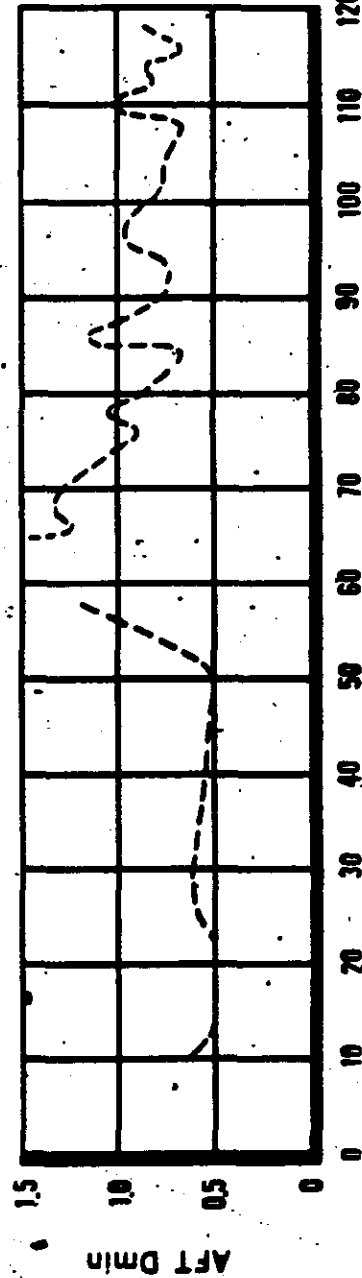
FIGURE 1

In Mission 9057 the Index camera showed a malfunction that precluded its use in the system evaluation. The malfunction is characterized by the appearance of a boot shaped flare in the center of each format. Camera metering appeared to be normal, and the failure is thought to be associated with the shutter trip mechanisms. Since this mission, the Stellar-Index camera has been modified to include new shutters and improved shutter rewind and tripping mechanisms. These modified cameras have worked successfully since their introduction on Missions 1002-1 and 9062. An unmodified camera on Mission 1001-1 showed shutter failures traceable to the shutter rewind mechanism which caused loss of approximately 50 per cent of the possible take. For this

VARIATION IN RES AND Dmin VALUES
MISSION 9057 PASS D4I

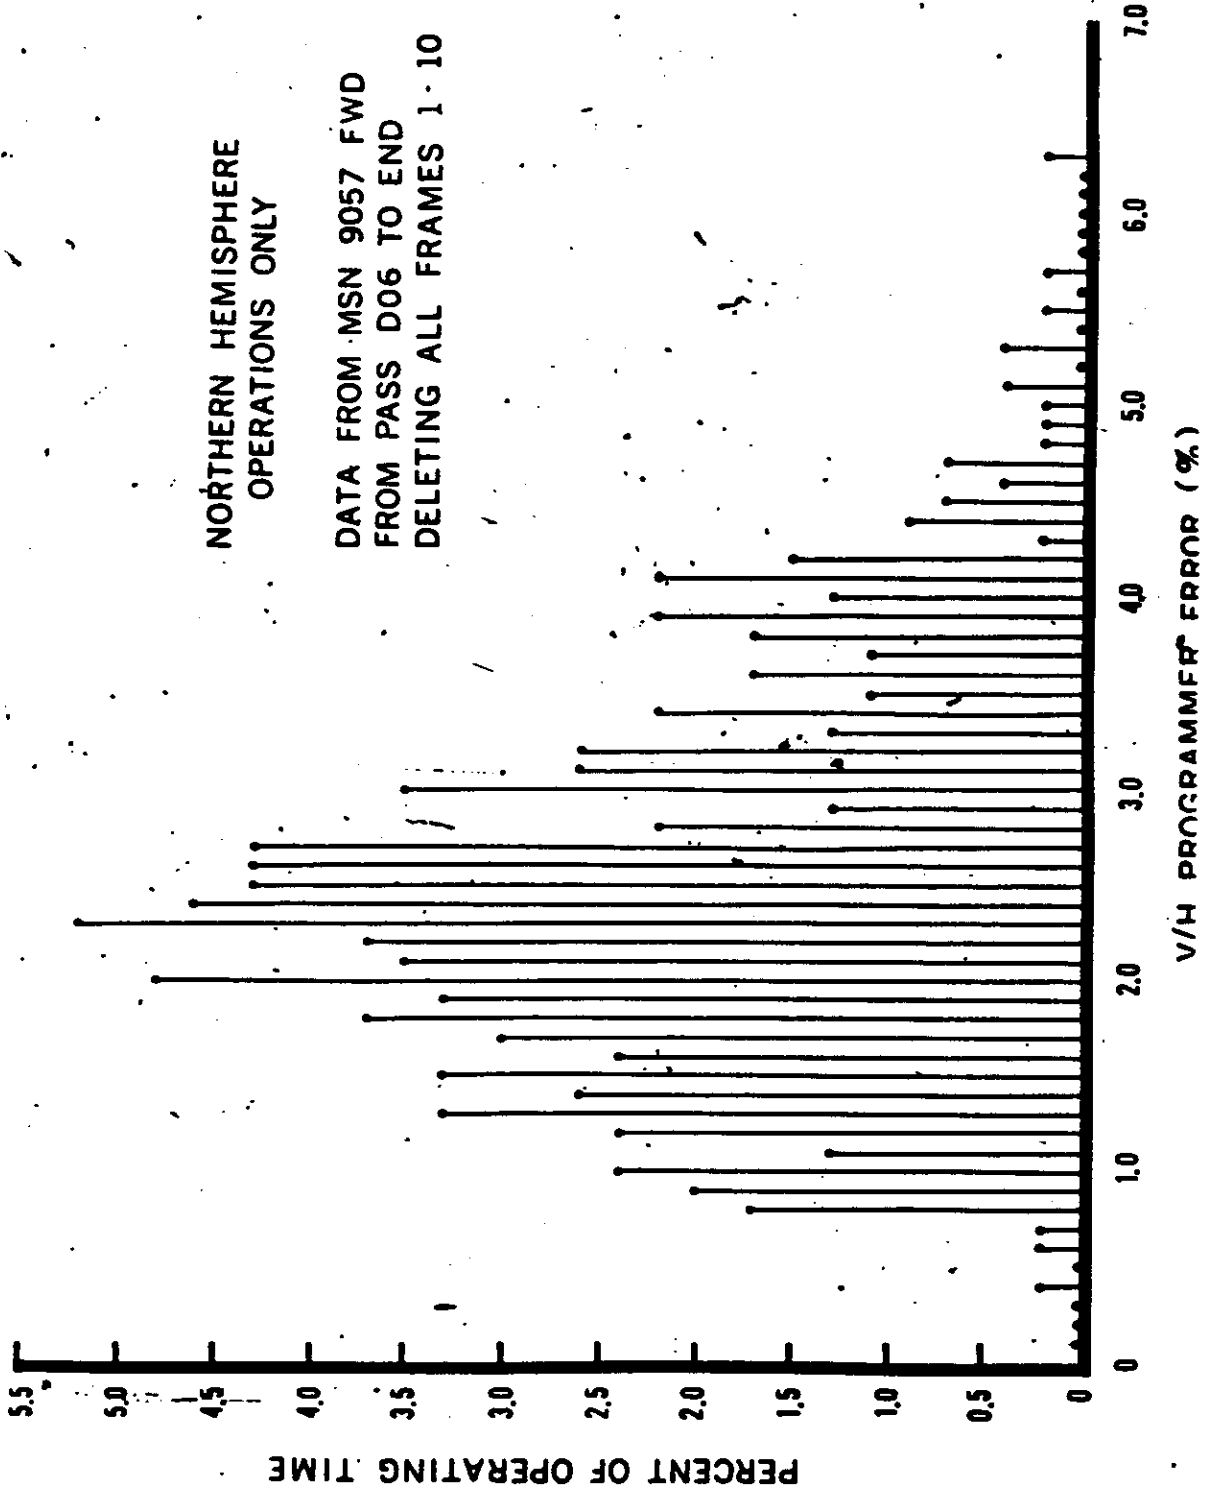
FIGURE 20

exceeds the predicted V/h error of 3.0% (90% probability) and exceeds the normally observed V/h programming error of other Mural operations. Figure 20 shows the frequency distribution of the programming error.

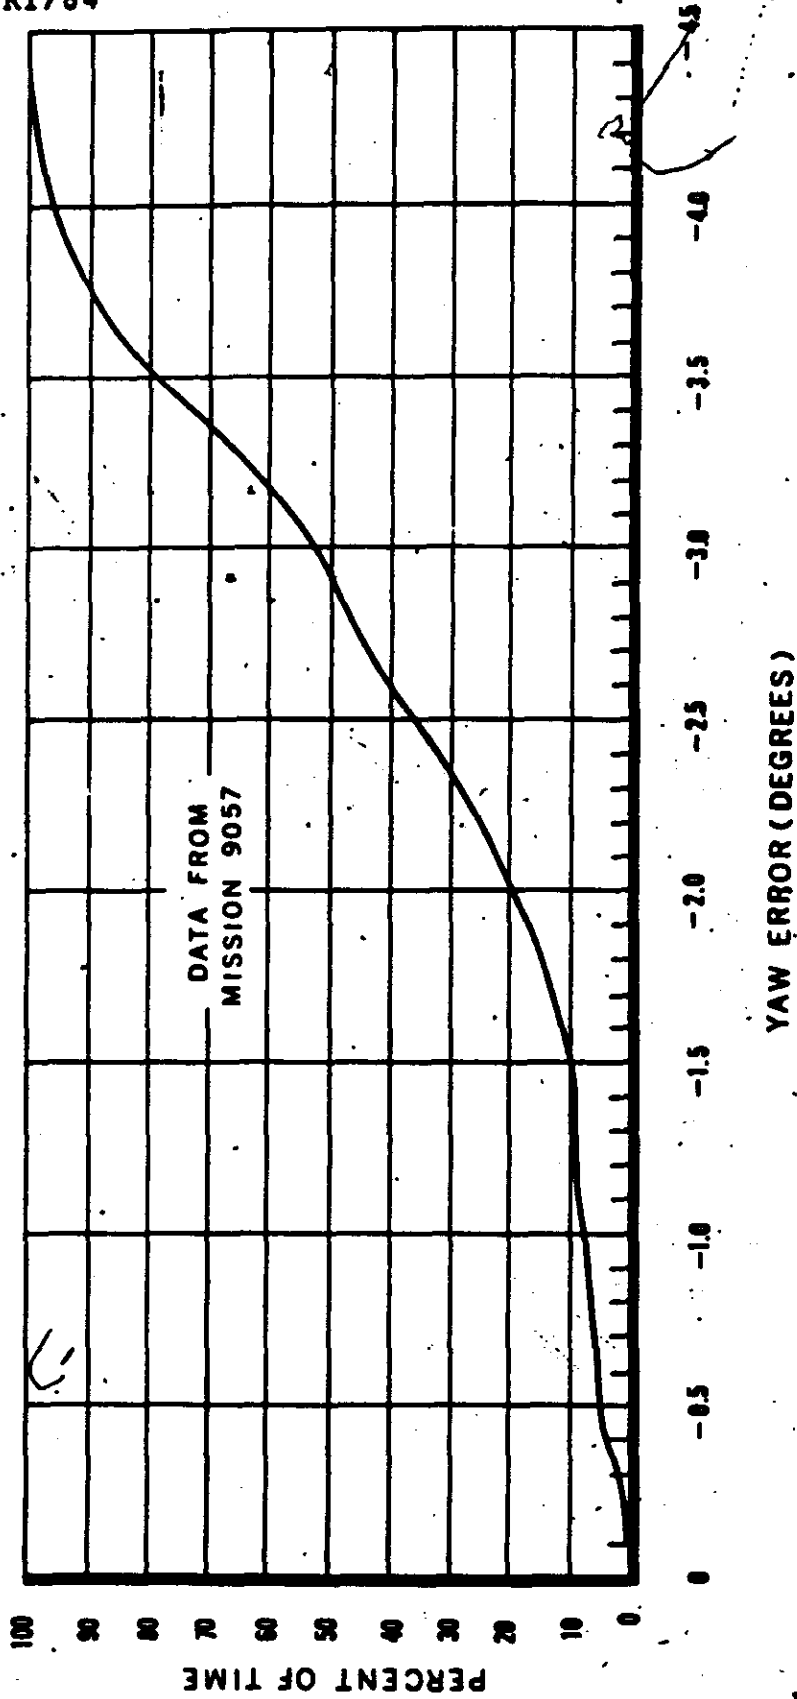
FIGURE 28

The yaw error probability for Mission 9056 is plotted in Figure 28 and shows that the yaw error was -3.77° or less during 90% of the mission operations. This yaw exceeded the predicted 90% probable yaw error of $\pm 2.19^\circ$ by a significant amount. The yaw error by frame for some of the passes of Mission 9057 is shown in Figure 29. The sum of the crab and yaw error for this mission is plotted in Figure 30. Since the yaw error was biased negative and the crab error is negative for descending operations, the total error is quite large. The plot shows a 5.75° or less yaw plus crab error during 90% of the mission operating time.

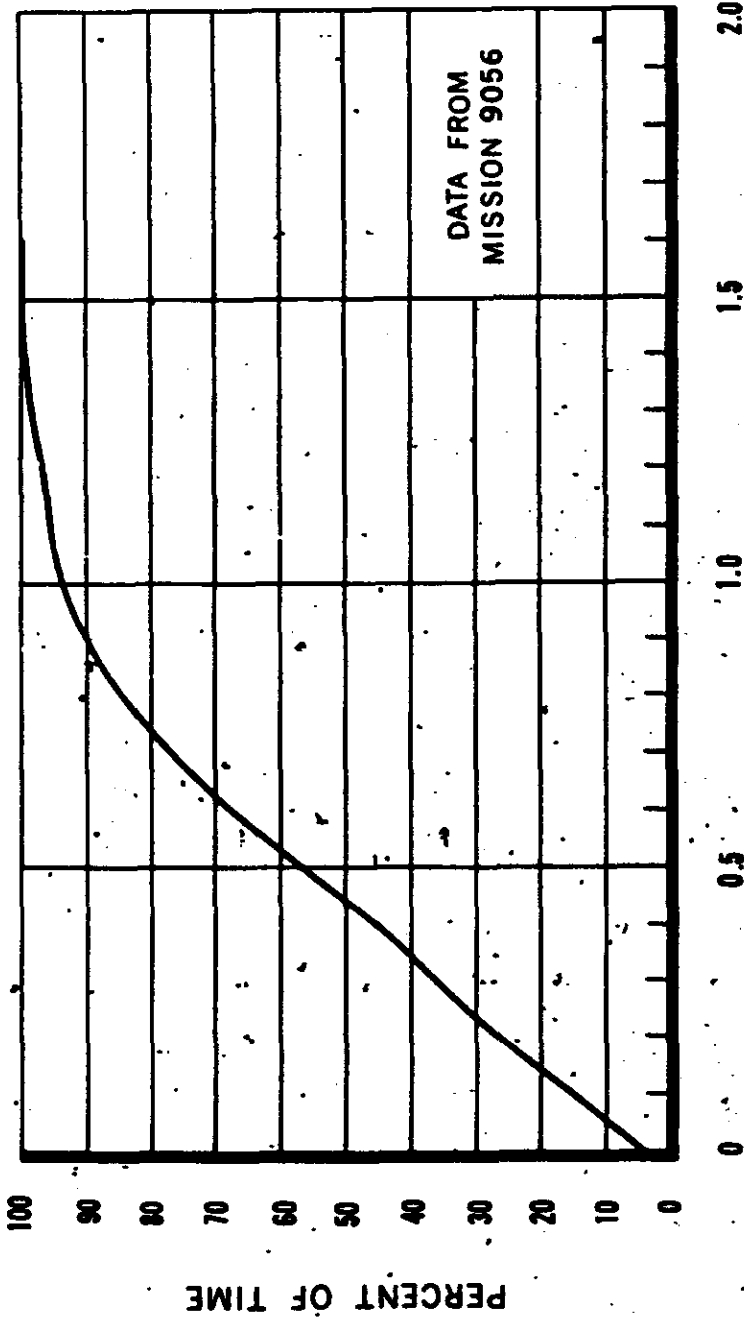
FIGURE 31

The sum of the yaw plus crab error for Mission 9056 is shown in Figure 31. As noted in Section I, this mission had yaw steering which places an intentional yaw bias into the

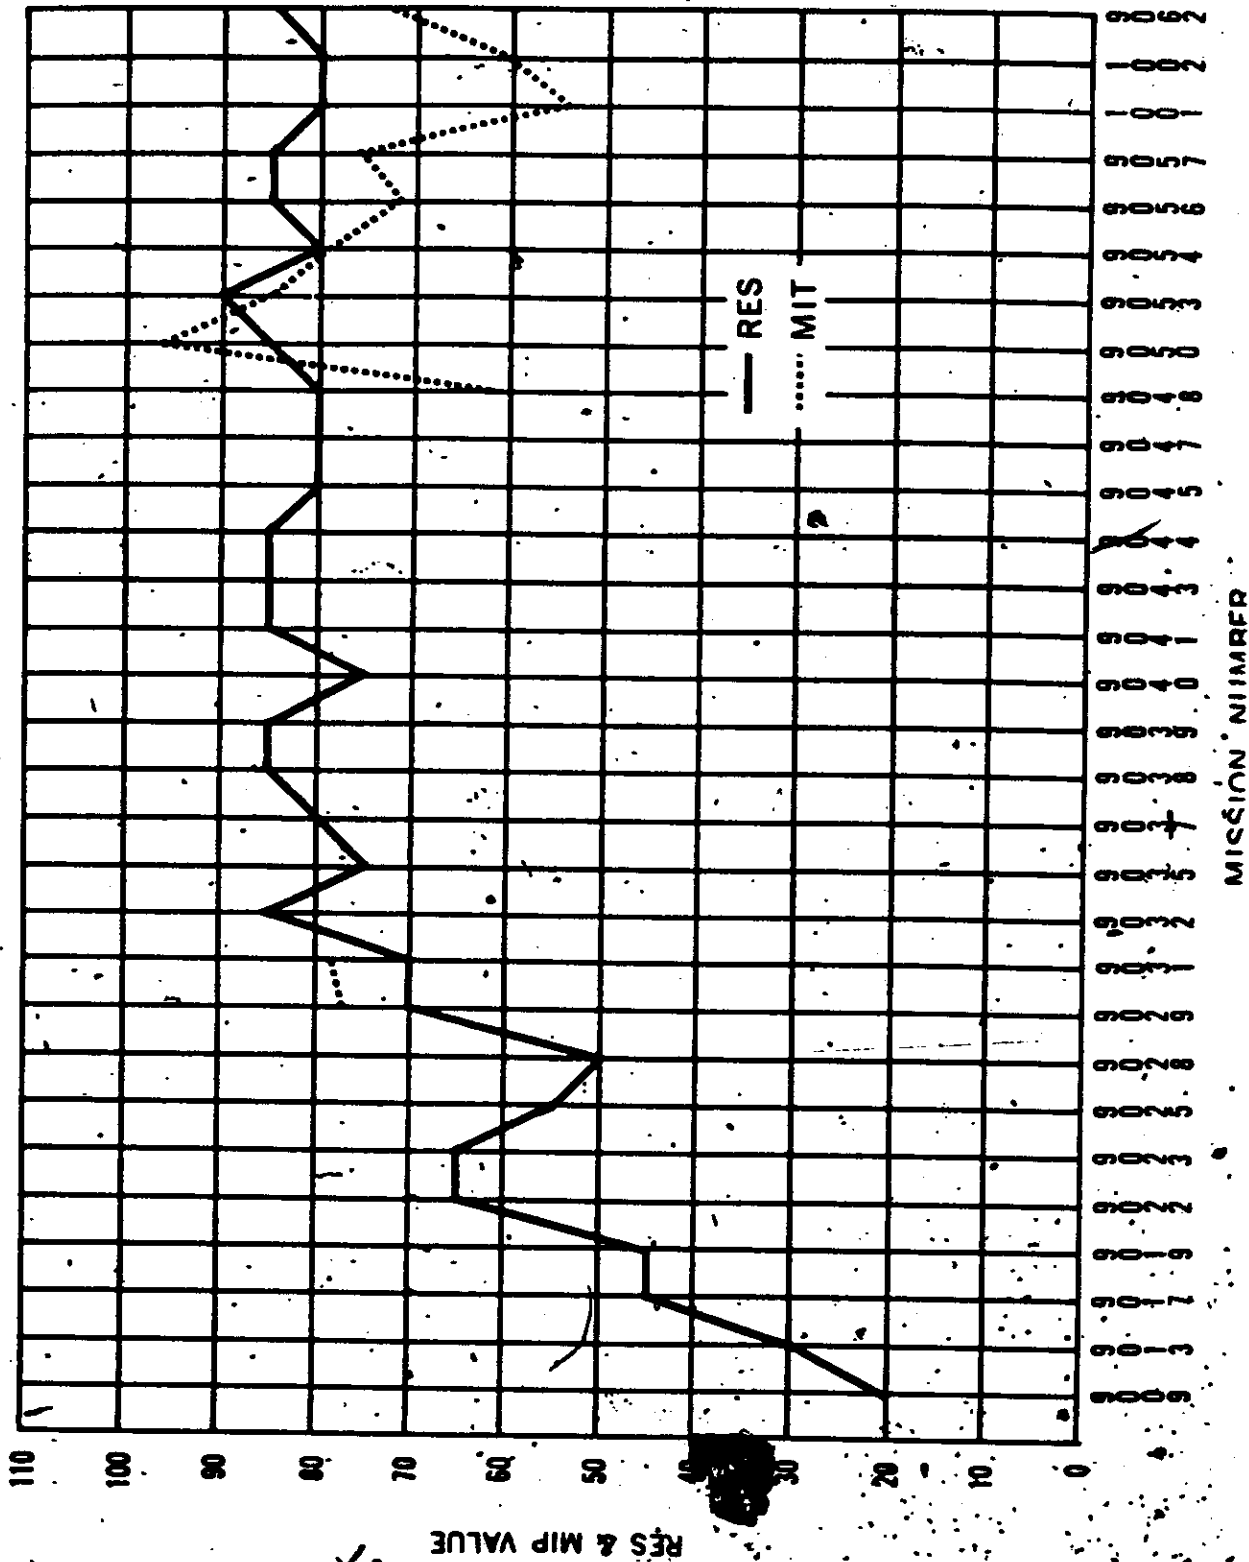
FIGURE 33

Correlation of RES and MIP values is shown in Figure 33. Since MIP restricts itself to the best frame in a mission and RES is a more rigorous evaluation of a mission, the lack of correlation is not surprising.
