PHOTOGRAPHIC EVALUATION REPORT  
MISSION 1021-1  
18-23 MAY 1965  
MISSION 1021-2  
23-28 MAY 1965

JANUARY 1966

NATIONAL PHOTOGRAPHIC INTERPRETATION CENTER

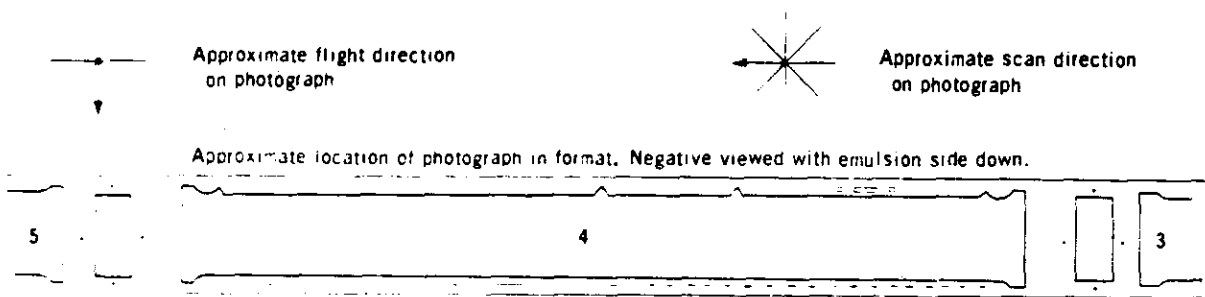
Camera . . . . . 167  
Pass . . . . . 73D  
Frame. . . . . 4 fwd  
Date of Photography. . . . . 23 May 65  
Universal Grid Coordinates . . . . . Not Applicable  
Enlargement Factor . . . . . 3X  
Geographic Coordinates . . . . . 29-00N 027-02E  
Altitude (feet). . . . . 666,553  
Camera:  
Pitch . . . . . 15°14'  
Roll. . . . . -0°15'  
Yaw . . . . . -0°17'  
Local Sun Time . . . . . 0915  
Solar Elevation. . . . . 51°45'  
Solar Azimuth. . . . . 94°  
Exposure (fractions of second) . . . 1/263  
Processing Level . . . . . Intermediate  
Vehicle Azimuth. . . . . 165°51'

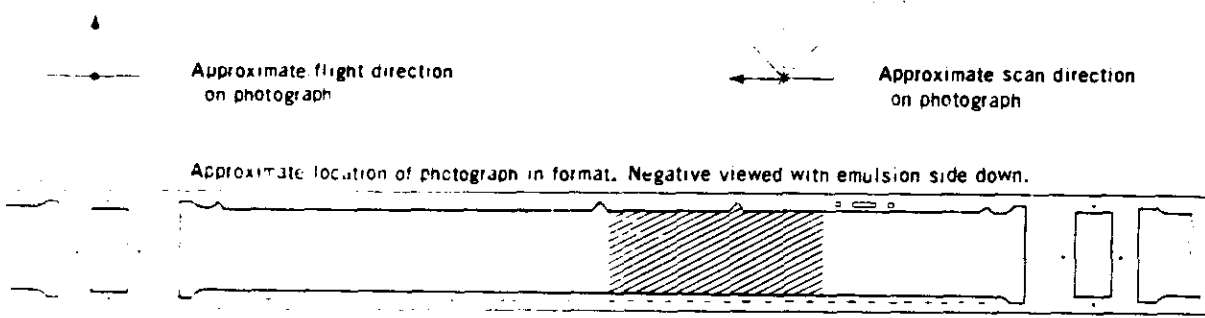
FIGURE 8. PRINT OF CUT AND SPLICE WHICH CAUSED FILM TO COME OUT OF THE RAILS

The master panoramic camera functioned properly on the first part of the mission and through a portion of pass 85D of the second part. Good quality photography was obtained up to this point. However, the film came out of the guide rails on pass 85D, frame 11, and severely degraded the imagery through pass 102D, frame 10. At this time, the film jammed and caused a premature termination of the master camera record. The malfunction was caused by a cut that existed in the film when it was transported into the platen area prior to exposure. Because of the cut the film slipped from the rails as it was being transported. The film contractor conceded that a cut is made during film manufacturing to signal the end of a useable roll of film. The conclusion is that the cut was made in the customary manner by the film manufacturer and a splice was erroneously made on the wrong side of the cut. For a more detailed analysis of the anomaly see Part II, Section 3. Degradations attributed to camera operation include:

Camera . . . . . 166  
Pass . . . . . 85D  
Frame . . . . . 11 aft  
Date of Photography . . . . . 24 May 65  
Universal Grid Coordinates . . . . . 46 - 65  
Enlargement Factor . . . . . Contact  
Geographic Coordinates . . . . . 53-08N 104-38E  
Altitude (feet). . . . . 708,620  
Camera:  
Pitch . . . . . -14°39'  
Roll . . . . . -0°06'  
Yaw . . . . . Not Determined  
Local Sun Time . . . . . 817  
Solar Elevation . . . . . 36°36'  
Solar Azimuth . . . . . 106°  
Exposure (fractions of second) . . . . . 1/334  
Processing Level . . . . . Full  
Vehicle Azimuth . . . . . 156°14'

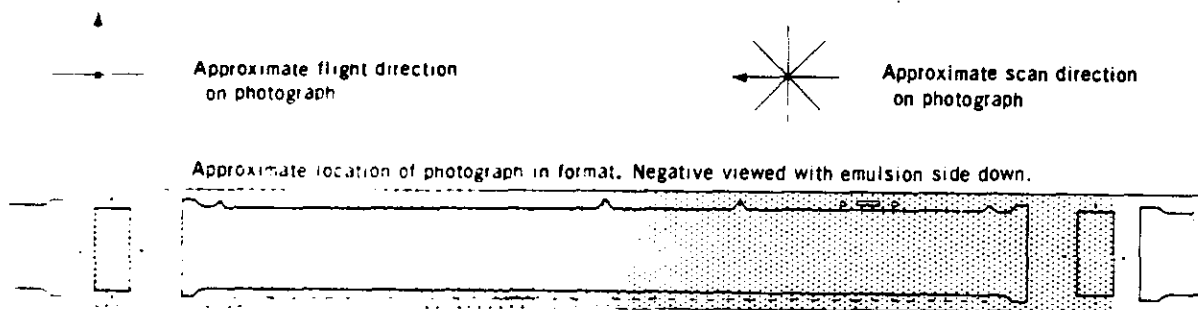
Camera . . . . . 166  
Pass . . . . . 95D  
Frame. . . . . 17 aft  
Date of Photography. . . . . 24 May 65  
Universal Grid Coordinates . . . . . Not Applicable  
Enlargement Factor . . . . . Contact  
Geographic Coordinates . . . . . 33-27N 012-28W  
Altitude (feet). . . . . 670,736  
Camera:  
Pitch . . . . . Not Applicable  
Roll. . . . . Not Applicable  
Yaw . . . . . Not Applicable  
Local Sun Time . . . . . Not Applicable  
Solar Elevation. . . . . Not Applicable  
Solar Azimuth. . . . . Not Applicable  
Exposure (fractions of second) . . . . . Not Applicable  
Processing Level . . . . . Intermediate  
Vehicle Azimuth. . . . . Not Applicable
